SUPPLEMENT  
VOLUME 15 • NO. 4  
1 9 9 2

## Collection Storage— Making a Case for Microenvironments

Donald R. Cumberland, Jr.

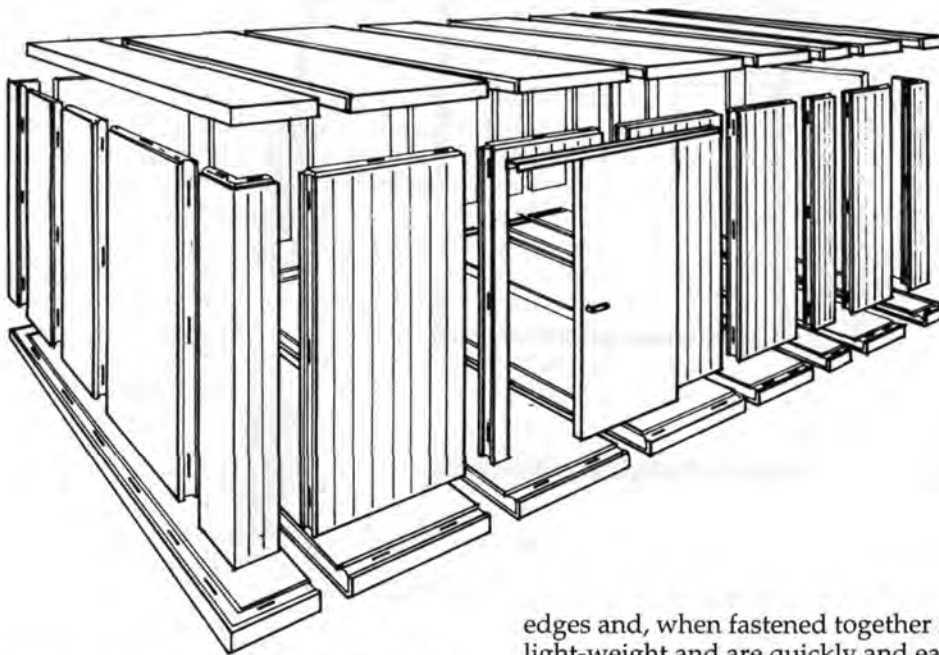
Exploded view of a museum storage facility showing the various prefabricated units that comprise the walls, corners, floor, ceiling, and sliding doors. Drawing by Christina Henry.

Storage space is formed by assembling foam-core (generally high-density polyurethane), metal clad (aluminum or galvanized steel) panels. The panels of most of the manufacturers have an insulation "R" value above 30; Bally panels are R-34. The panels are gasketed along the

edges and, when fastened together form air-tight joints. The panels are light-weight and are quickly and easily assembled with ordinary hand tools. (In one instance at Harpers Ferry, WVA, an inexperienced NPS staff put together a non-conditioned Bally building of 100 square feet in less than one hour). Panels can be carried through the building's doors and assembled inside. Weatherproof roof panels are available to allow the building to be placed outside on a concrete slab.

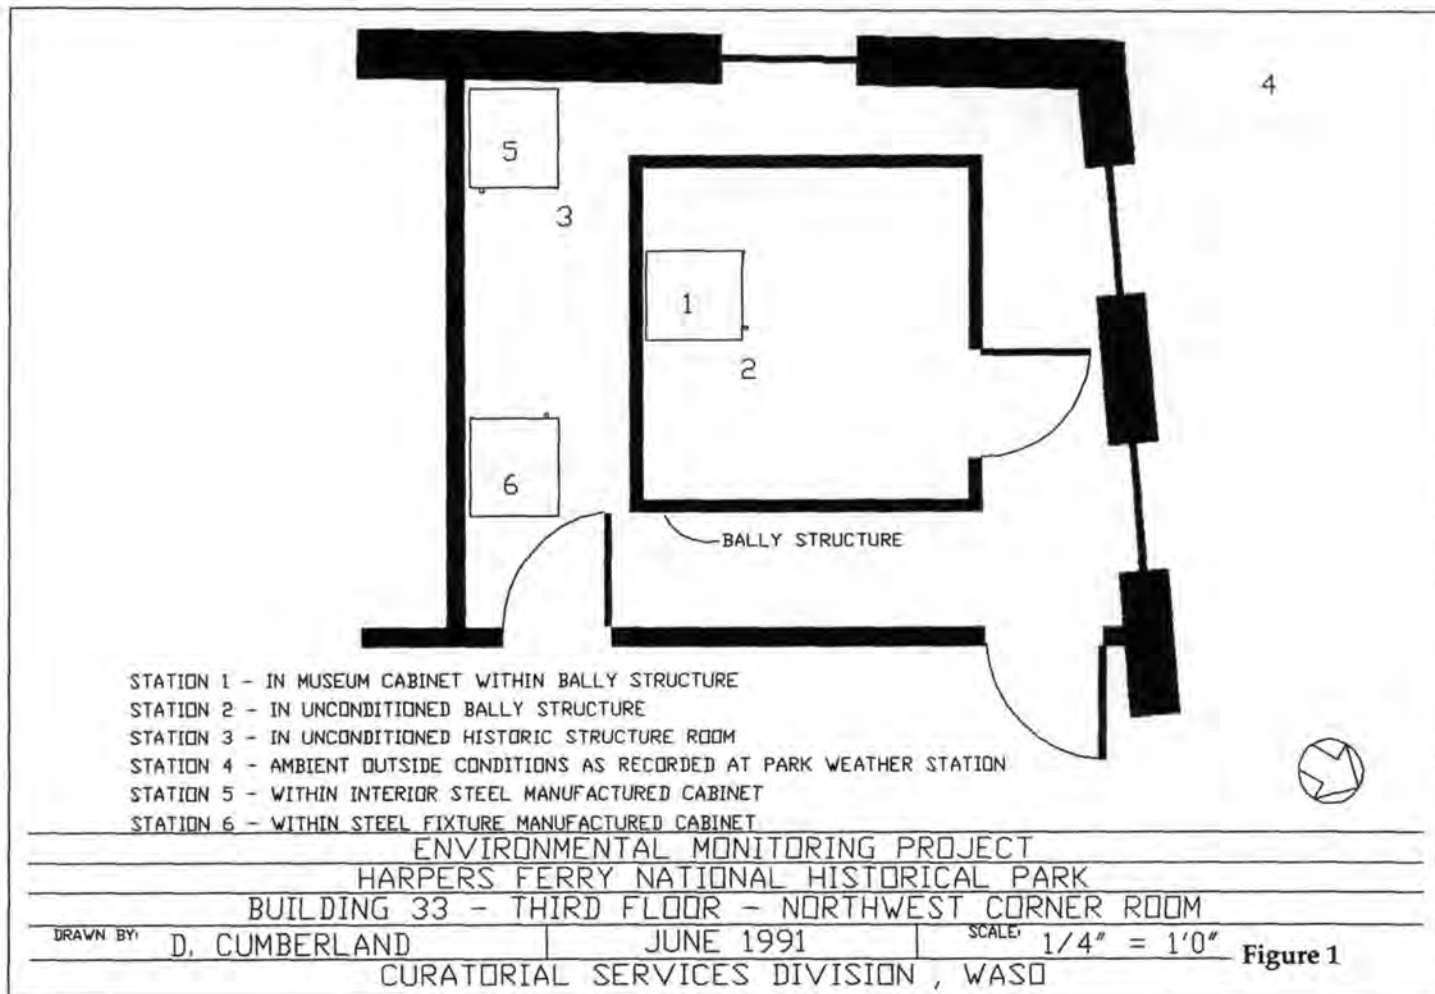
Hygrothermographs were placed in six monitoring stations as indicated below and on Figure 1.

Station 1. Recorded conditions within a museum cabinet in the unconditioned Bally building.

Station 2. On top of a cabinet (Station 1 in the Bally building) to record conditions within the Bally building itself.

Station 3. Exposed in the unconditioned northwest corner room on the third floor of Building 33 to record room conditions.

Station 4. In the park's weather station to record ambient weather conditions.

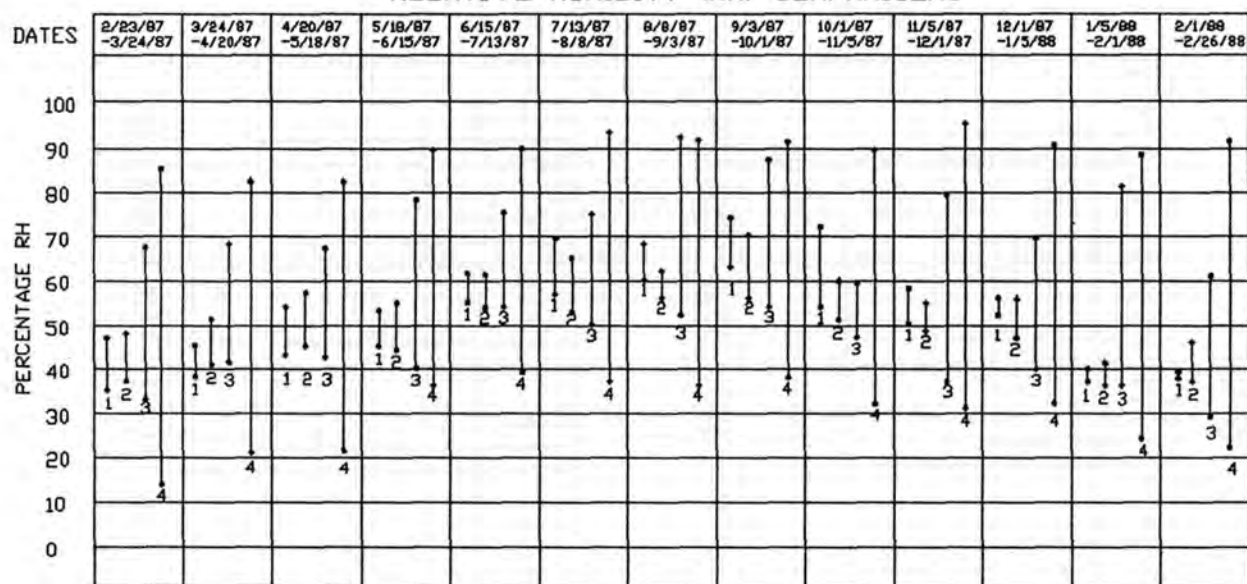
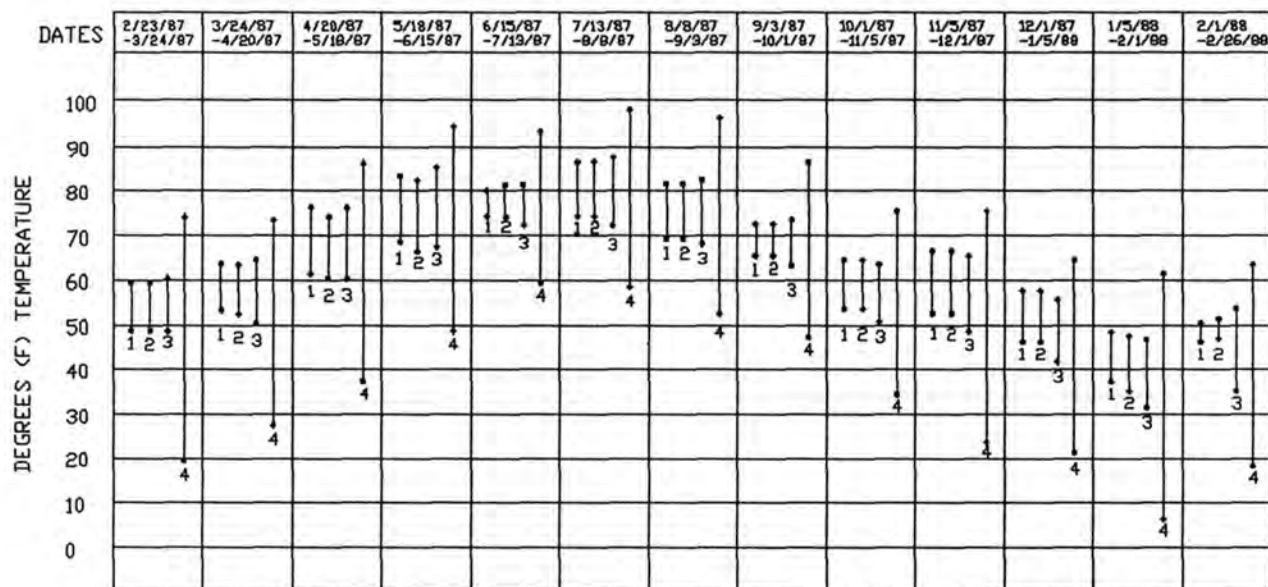
Figure 3

# HARPERS FERRY PROJECT MONTHLY MAXIMUM/MINIMUM LEVELS

## RELATIVE HUMIDITY (RH) COMPARISONS

## TEMPERATURE COMPARISONS

STATION 1 - IN CABINET IN BALLY STRUCTURE  
 STATION 2 - IN UNCONDITIONED BALLY STRUCTURE  
 STATION 3 - IN UNCONDITIONED ROOM WITHIN HISTORIC STRUCTURE  
 STATION 4 - AMBIENT OUTDOOR CONDITIONS

An analysis of the records resulted in the information in Figure 2. Salient information on the chart was organized in graph form to produce Figure 3, which represents the highest and lowest temperatures and humidities recorded during the test period, and Figure 4, which represents the greatest 24-hour change of RH and temperature.

Hygrothermograph records reveal that over the course of the two-year testing period and without any energy input for heating, cooling and humidity control, the greatest 24-hour RH and temperature changes recorded on the interior of the Bally building were 6% and 6°F respectively (which were virtually the same changes recorded for inside the cabinet within the Bally building). These findings are quite impressive when compared to the maximum 24-hour fluctuation of 25% RH and 47°F temperature recorded in the historic structure room itself and 63% RH and 46°F temperature recorded in the weather station.

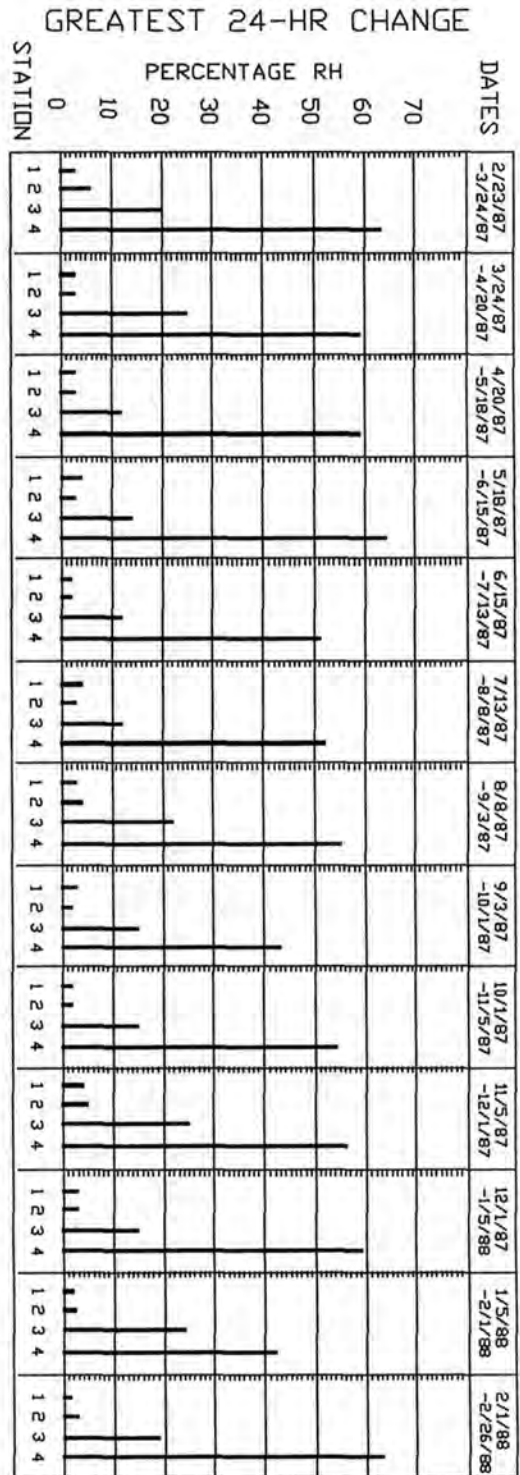
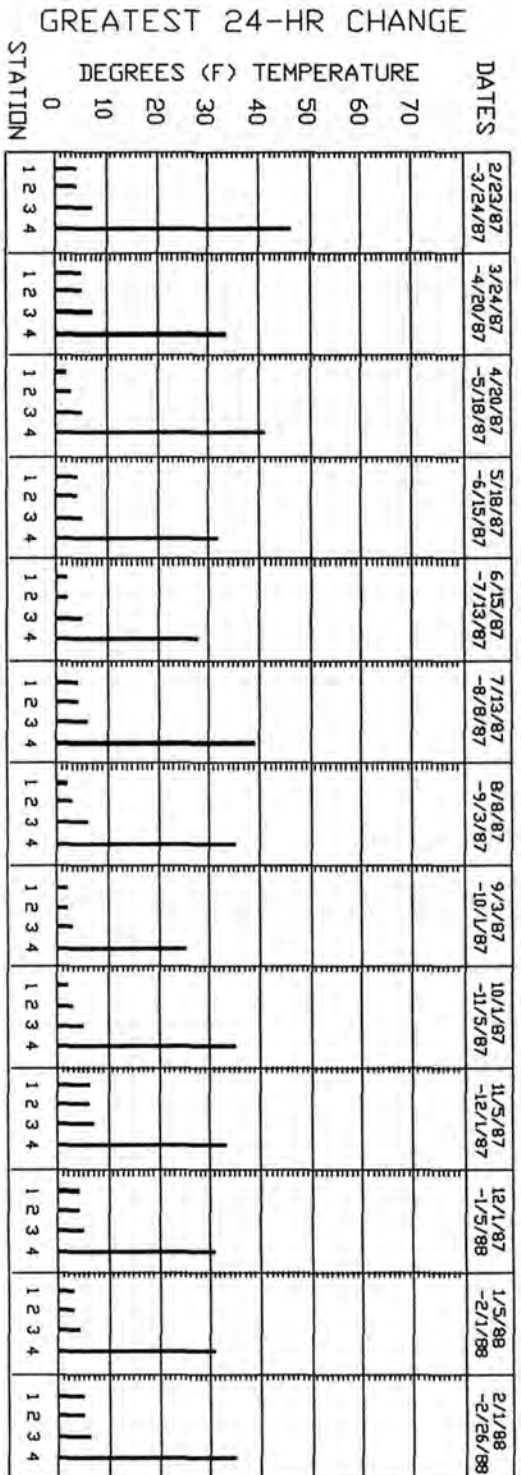
Figure 4

# HARPERS FERRY PROJECT GREATEST 24-HR CHANGE

## RELATIVE HUMIDITY (RH) COMPARISONS

## TEMPERATURE COMPARISONS

STATION 1 - IN CABINET IN BALLY STRUCTURE  
STATION 2 - IN UNCONDITIONED BALLY STRUCTURE  
STATION 3 - IN UNCONDITIONED ROOM WITHIN HISTORIC STRUCTURE  
STATION 4 - AMBIENT OUTDOOR CONDITIONS

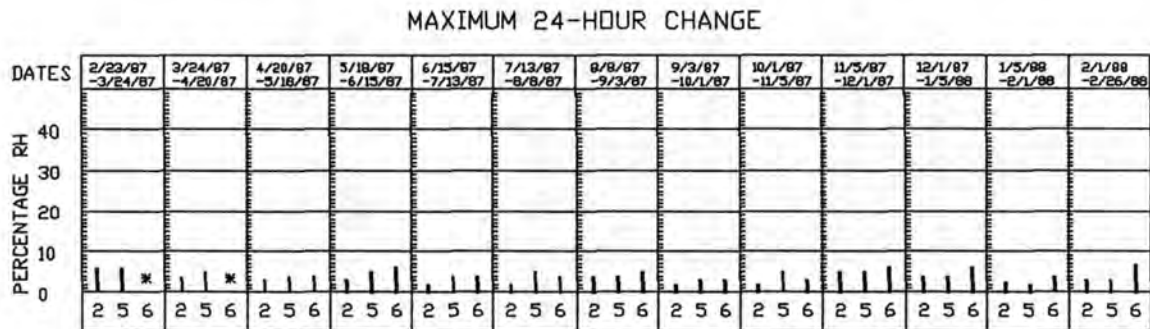
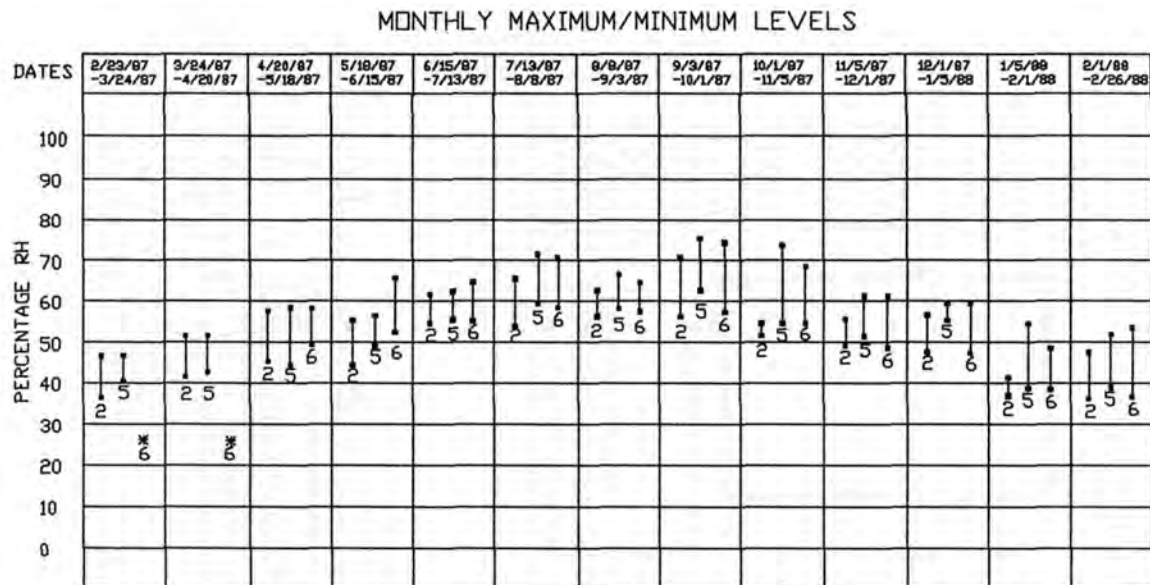
HARPERS FERRY PROJECT  
RELATIVE HUMIDITY (RH) COMPARISONS  
BETWEEN MUSEUM STORAGE CABINETS AND BALLY STRUCTURE

STATION 2 - IN UNCONDITIONED BALLY STRUCTURE  
STATION 5 - WITHIN A MUSEUM STORAGE CABINET MANUFACTURED BY INTERIOR STEEL EQUIPMENT CORP. IN AN UNCONDITIONED ROOM  
STATION 6 - WITHIN A MUSEUM STORAGE CABINET MANUFACTURED BY STEEL FIXTURE MFG. CO. IN AN UNCONDITIONED ROOM  
\* - STEEL FIXTURE MANUFACTURED CABINET UNAVAILABLE FOR TEST UNTIL APRIL, 1988

Figure 5 gives results of the test comparing the two brands of museum storage cabinets ability to maintain stable interior RH conditions. The test also allows the performance of the cabinets to be compared against the Bally building.

Cabinets by both manufacturers were equal in maintaining a stable microenvironment.

The unconditioned Bally building was equivalent to the museum cabinets in maintaining a stable microenvironment in the same unconditioned space.

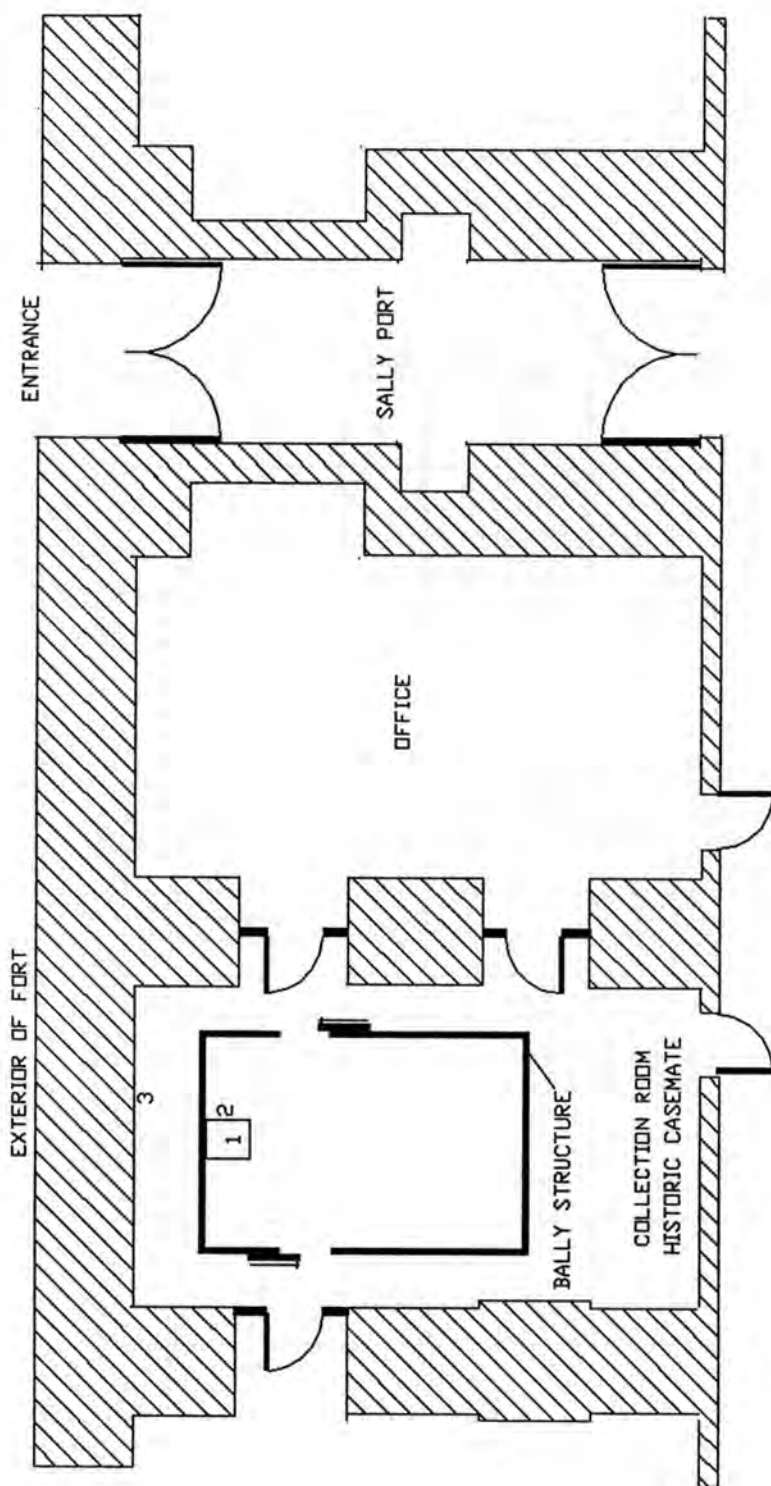
Figure 6

- STATION 1 - IN MUSEUM CABINET WITHIN BALLY STRUCTURE
- STATION 2 - EXPOSED IN CONDITIONED BALLY STRUCTURE
- STATION 3 - WITHIN MINIMALLY CONDITIONED HISTORIC CASEMATE
- STATION 4 - AMBIENT OUTSIDE CONDITIONS AS RECORDED IN PARK WEATHER STATION

# MICROENVIRONMENT MONITORING TEST FORT PULASKI NATIONAL MONUMENT

CONDITIONED BALLY STRUCTURE WITHIN HISTORIC CASEMATE

Hygrothermographs were placed in four stations in order to monitor the ambient outdoor conditions and conditions within three layers of microenvironment (i.e. the historic casemate, the Bally building, and within a

cabinet in the Bally building) as depicted in the drawing in Figure 6. Stations were designated as follows:

Station 1. Recorded conditions within a cabinet in the conditioned Bally building;

Station 2. On top of the cabinet (Station 1) to record conditions within the Bally building;

Station 3. Exposed in the minimally conditioned casemate to record conditions there;

Station 4. In the park's weather station to record ambient conditions.

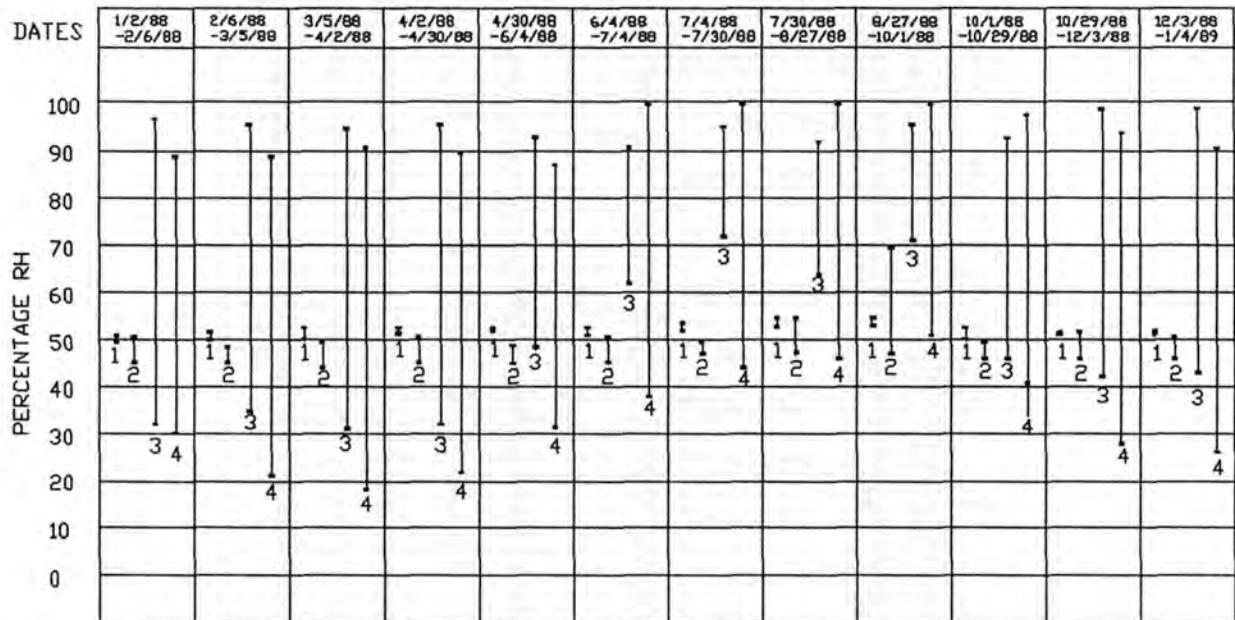
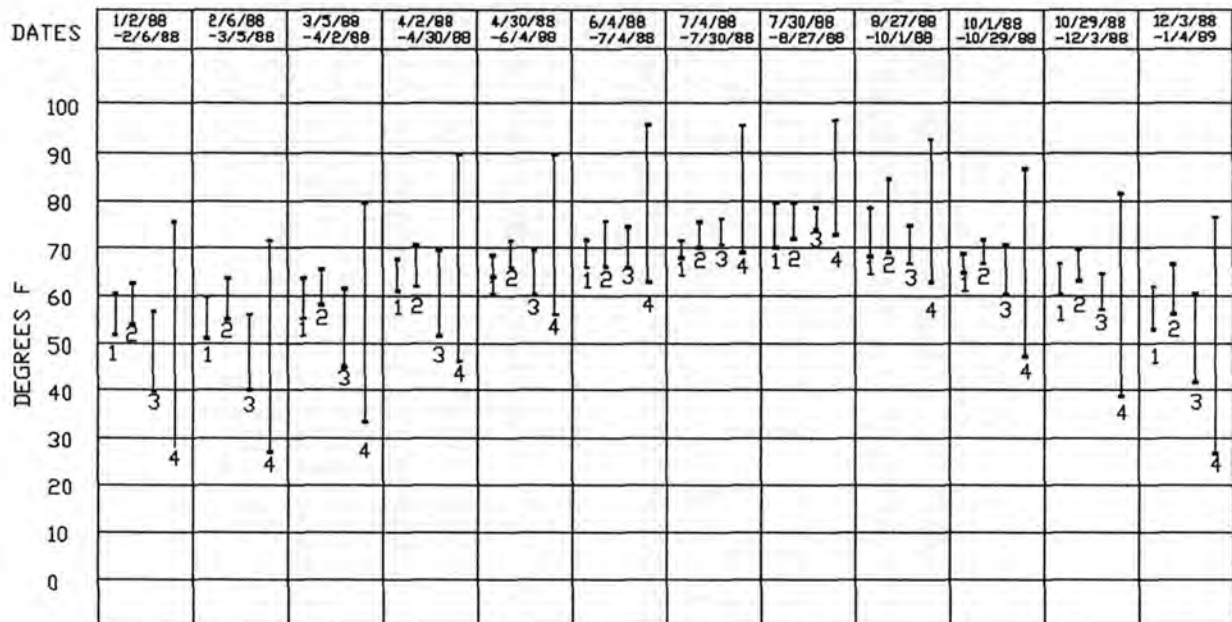
Figure 8

# FORT PULASKI PROJECT

## MONTHLY MAXIMUM/MINIMUM LEVELS

### RELATIVE HUMIDITY (RH) COMPARISONS

### TEMPERATURE COMPARISONS

STATION 1 - IN CABINET IN BALLY STRUCTURE  
 STATION 2 - IN CONDITIONED BALLY STRUCTURE  
 STATION 3 - IN MINIMALLY CONDITIONED HISTORIC FORT CASEMATE  
 STATION 4 - AMBIENT OUTDOOR CONDITIONS  
 STATION 2 ANOMALY ,8/27/88-10/1/88, DUE TO HVAC MALFUNCTION

Hygrothermographs were recorded on a 7-day (weekly) basis. Four or five charts were analyzed to organize information in approximately 30-day increments that roughly corresponded to the calendar months. This information was used to produce the data in Figure 7 and the graphs in Figures 8 and 9.

The greatest 24-hour changes at the weather station were 68% RH and 33°F temperature. The casemate with the HVAC system set to conditions of human comfort levels experienced a surprisingly large 24-hour maximum RH change of 58% and a less radical temperature change of 11°F. The Bally building, with a heat pump dedicated to controlling interior conditions enabled almost perfect conditions to be maintained. The conditioned Bally building maintained interior conditions at desired levels with maximum 24-hour changes of 3% RH and 2°F temperature. Average 24-hour changes of RH and temperature were 1/2% and 1°F respectively. The cabinet within the Bally building never experienced a 24-hour change greater than 1% and had an average change of only 1/2%. The greatest and average temperature changes inside the cabinet were 2°F and 1°F respectively.

The abnormally high RH and temperature levels in Station 2 during the period August 27, 1988 through October 1, 1988 were a result of an HVAC equipment malfunction.

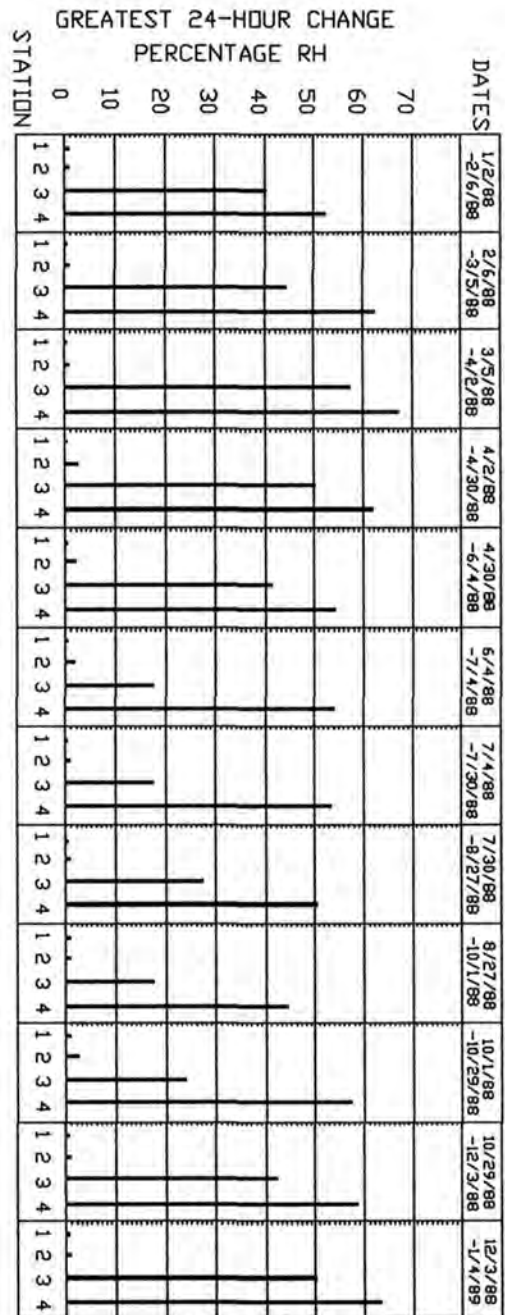
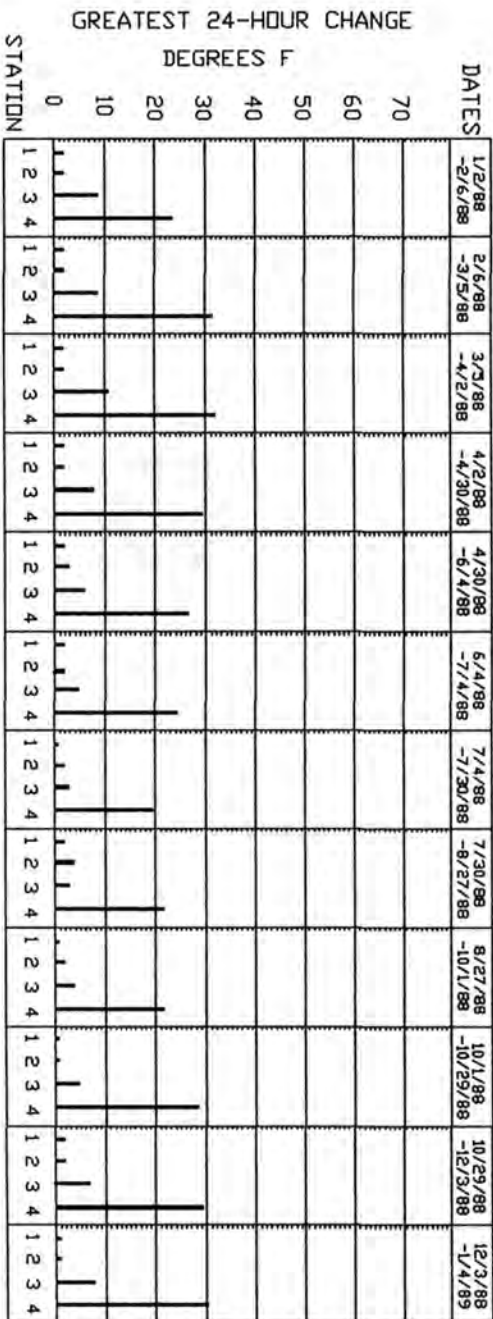
Figure 9

# FORT PULASKI PROJECT GREATEST 24-HOUR CHANGE

## RELATIVE HUMIDITY (RH) COMPARISONS

## TEMPERATURE COMPARISONS

STATION 1 - IN CABINET IN BALLY BUILDING  
STATION 2 - IN CONDITIONED BALLY BUILDING  
STATION 3 - IN MINIMALLY CONDITIONED HISTORIC FORT CASEMATE  
STATION 4 - AMBIENT OUTDOOR CONDITIONS  
STATION 2 ANOMALY .8/27/88-10/1/88, DUE TO HVAC MALFUNCTION
