# Landscape Preservation Maintenance Plan

Frederick Douglass National Historic Site

# Frederick Douglass NHS Site Plan 2007 Revised 2011

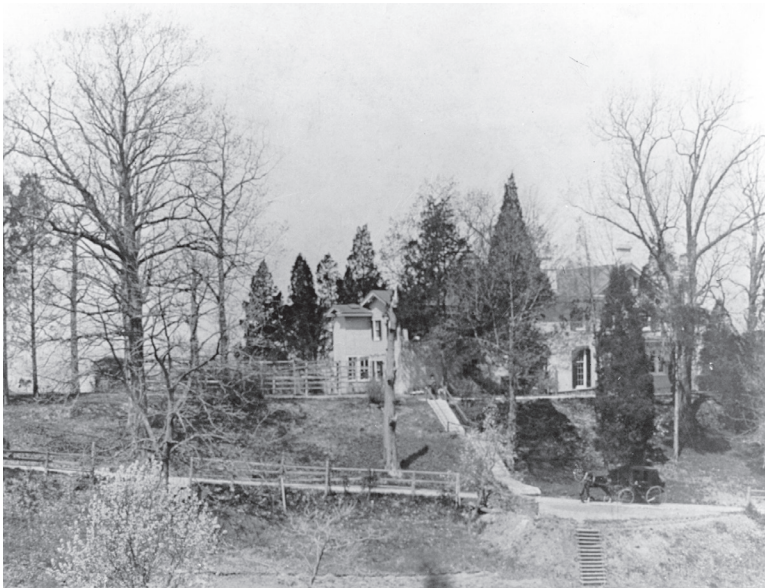
Historic photo (right) shows a flight of wooden stairs that led from the carriage turnaround to the low terrace of the east glen. The east glen is one of the lowest areas on the property, and according to historic photographs and maps, it appears to have been a moist swale (Photo #4540 FRDO files).

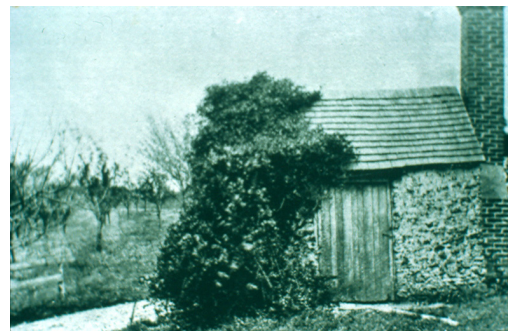
**Growlery bed** (feature 5-37): Currently, daylillies and burdock occupy this space. Neither are historic. Over time, this bed has expanded and has become larger than its historic configuration. To correct this, lawn should be allowed to grow in to the edge of the growlery on its northwest side and a large flowering shrub with a similar character to the specimen shown in the a historic photograph should be planted on the northeast side of the growlery. In keeping with the character of the historic planting, several plants, including lilac, mock orange and weigelia could be considered. Regional historical landscape architects should come up with a suitable planting.

In the 1890s a large shrub was growing on the northeast side of the growlery. (NCR CLP files).

Existing Conditions: The front of the Growlery is currently planted with daylilies, and contains burdock, a weed. The planting bed has expanded over time to a size that is incompatible with its historic conditions.

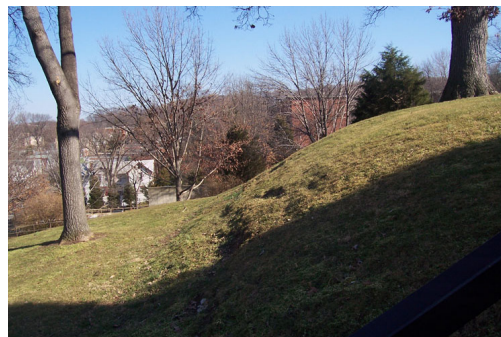
Erosion of slopes is an ongoing concern along the terraces. Especially along the edges of north stair flights and in the areas where the downspout chute-drains expel water on the side of the hilltop. Erosion damage is also seen along the eastern edge of the driveway where water escapes from the road and drains into the turf at high rates of speed. Slow, gravity-driven slumping of the steep slopes, especially along the northern edge of the property, is also a concern.

The terraced slopes at Frederick Douglass NHS are subject to erosion. On-going maintenance is needed to correct and prevent future erosion and protect the cultural landscape(NCR CLP 2006).

| Date | Feature Type and Location Number | Work Needed | Completed (x) |
|---|---|---|---|
| | Lawn area on west side of slope. | Monitor and patch eroded areas at drain outlets on west side of slope.<br><br>Monitor slope slumping. | ( ) |
