National Park Service  
Cultural Landscapes Inventory

Revised: 7/2026

Saratoga Monument  
Saratoga National Historical Park

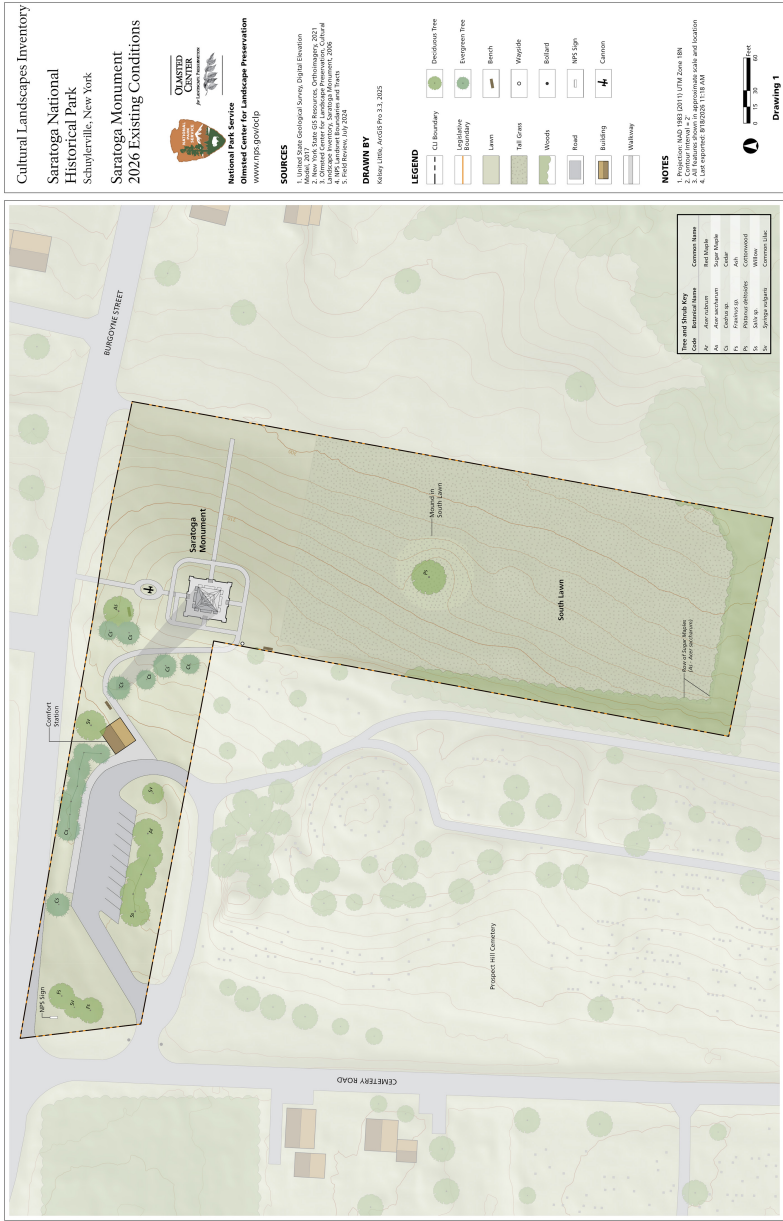
Site Plan

Site map, July 2026.

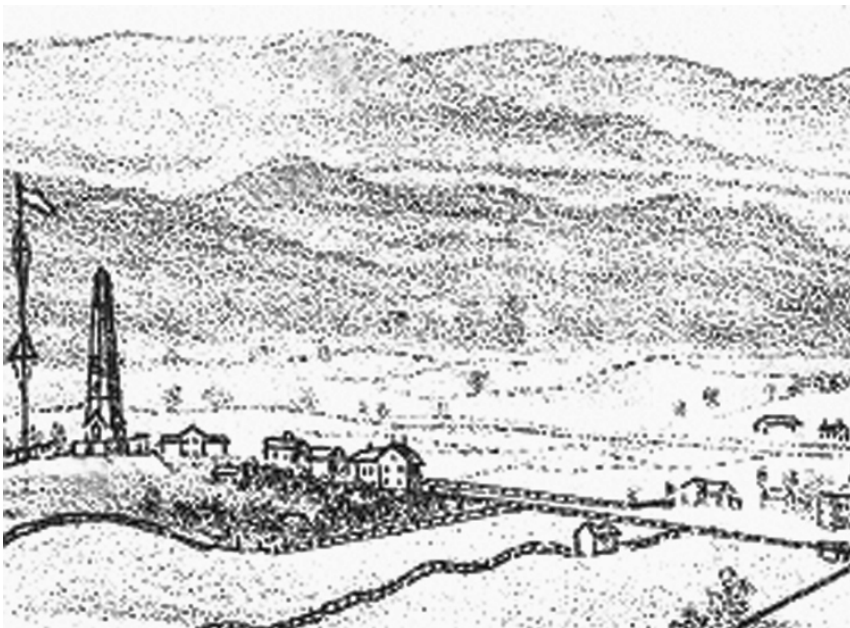
Figure 6. The Saratoga Monument under construction, 1877. Portion of birds-eye view of Schuylerville, NY drawn by Nathaniel Sylvester. Note the ship mast flagpole with the garrison flag. (Sylvester 1878)

(Figure 5). The plan called for a tower to symbolize victory with an allegorical decorative program. Markham combined the Egyptian obelisk with gothic architecture. Monument excavation was completed by September 27, 1877, and workman began laying the massive concrete foundation (Figure 6). Quarried granite was delivered to Schuylerville by canal and horse-drawn wagons. The corner stone was laid on October 17, 1877 with great fanfare celebrating the one hundredth anniversary of Burgoyne's surrender. Around this time Burgoyne Street was improved as an avenue to better connect the town to Prospect Hill Cemetery and to the monument. (CLI 2009: 34)

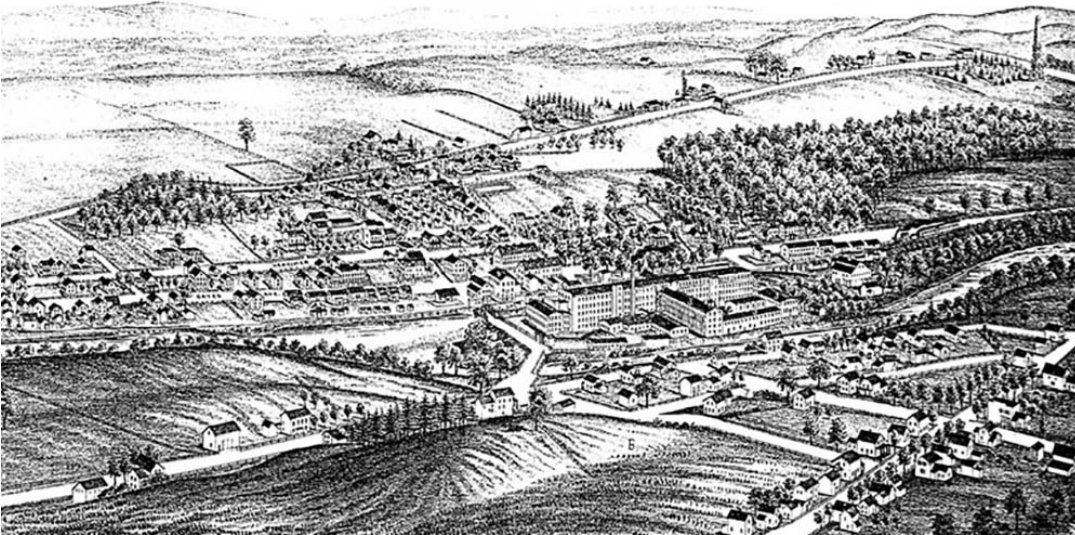
Figure 7. Birds-eye view of Victory Mills, N.Y., 1883. Saratoga Monument and Prospect Hills Cemetery are at the upper right, Victory Mills is at the center, and Victory Woods is in between. (L.R. Burleigh, Troy, N.Y. 1883, reproduced in Quinn and Bittermann 1992)

In 1880 Bennett sold the parcel to Ada L. and Cornelius Allen. According to Walworth, the New York Legislature passed a law on May 9, 1881, that "would enable the Association to settle all difficulties concerning the land on which the Monument was to be built." The law, Chapter 226, authorized "the board of trustees of any incorporated village, the trustees of any monument association and the town board of any town to acquire lands for monument purposes." On August 31, 1881, Cornelius Allen conveyed 1.865 acres to the SMA for \$724. Between 1881 and 1895, the SMA acquired additional acreage increasing the total to 2.865 acres. Work on the monument also resumed in 1881, but the foundation was determined by Markham to be insufficient and in August of that year a replacement foundation was laid. The capstone was set into place on November 3, 1882 (Figure 7). (CLI 2009: 34, citing Quinn and Bittermann 1992)

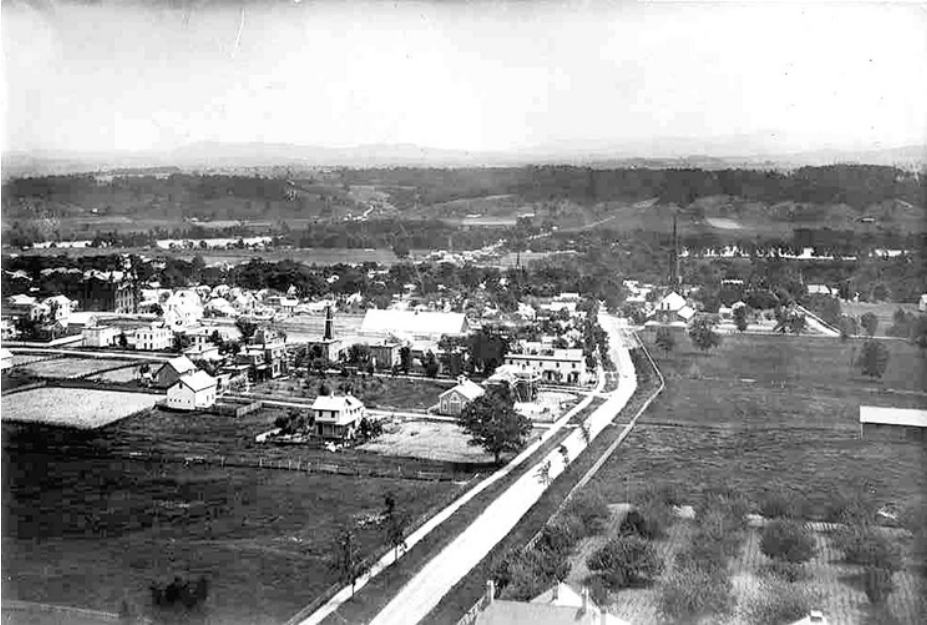
Figure 9. View looking east across Schuylerville and the Hudson River from the top of the monument, c.1890s. The Liptak house and orchard are visible in the lower right. (Saratoga NHP Archives)

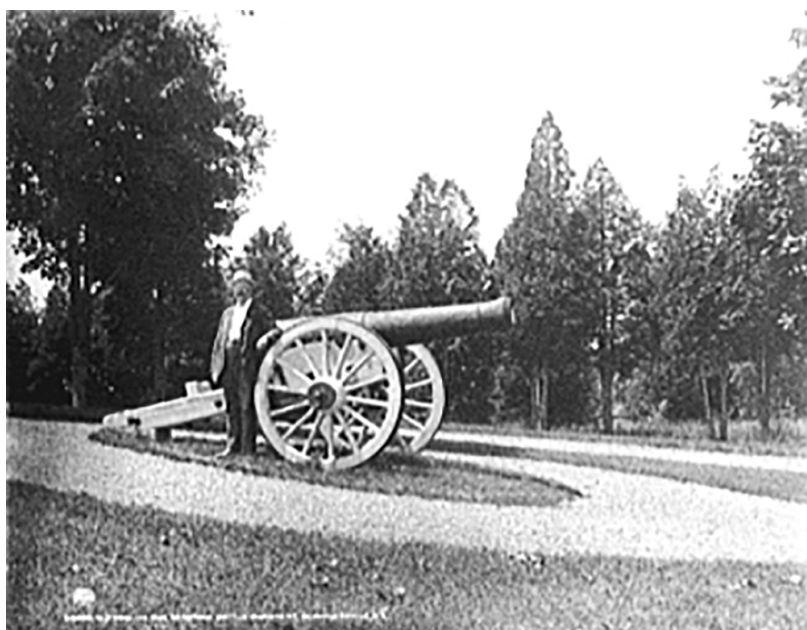
Figure 11. Cannon on the north lawn of Saratoga Monument, 1900s. (Detroit Publishing Co. reproduced digitally by the Library of Congress, <http://memory.loc.gov/ammem/amhome.html>)

Monument photographs from 1900-1920 show a well-kept lawn bordering the gravel walks and carriage road. A rectangular walk surrounded the base of the monument with additional paths extending from the north, south, and east elevations. The eastern path was straight. The southern path curved around a mound with a cottonwood in the middle of the south lawn. The northern path led straight to Burgoyne Street, circling around the DePeyster cannon on display at its midpoint. The cannon, a twenty four pounder naval iron gun captured from the British during the War of 1812, was placed here by October 1912, around the time the monument was formally dedicated (Figures 11, 12, 13). (CLI 2009: 42)

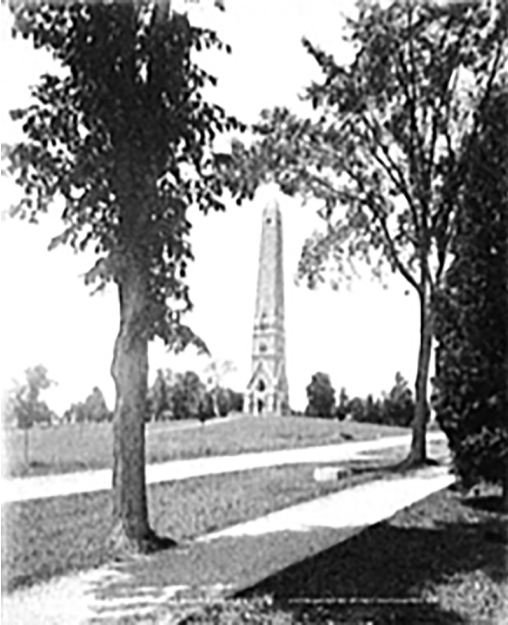
Figure 12. Saratoga Monument from a point northeast across Burgoyne Street, 1901. Elm trees are growing along the street and sidewalk. (Detroit Publishing Co. reproduced digitally by the Library of Congress, <http://memory.loc.gov/ammem/amhome.html>)

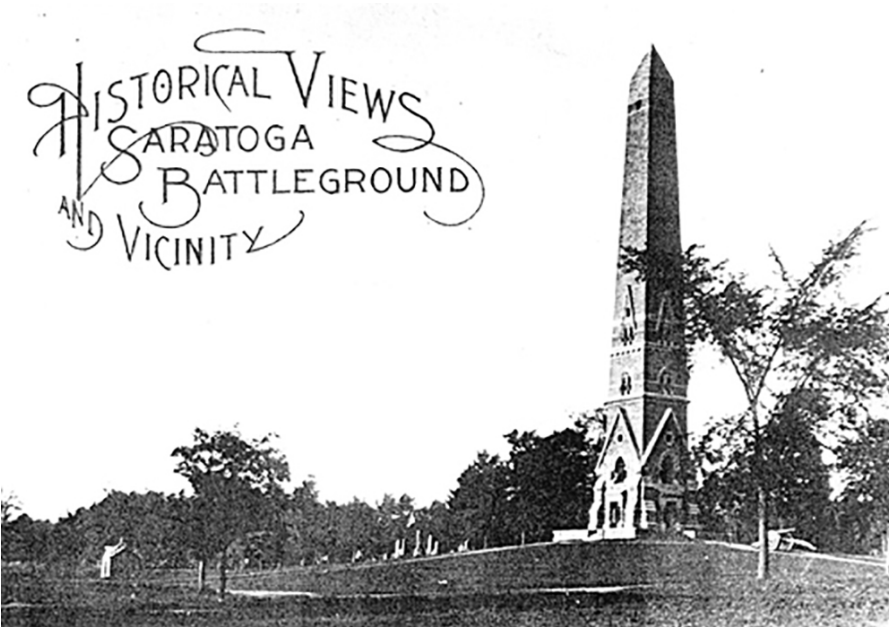
Figure 13. Saratoga Monument with southeast outbuilding, 1912. The cemetery's Battle Hill obelisks are at the center of the background. View is from a point northeast across Burgoyne Street. (Quinn and Bittermann 1992)

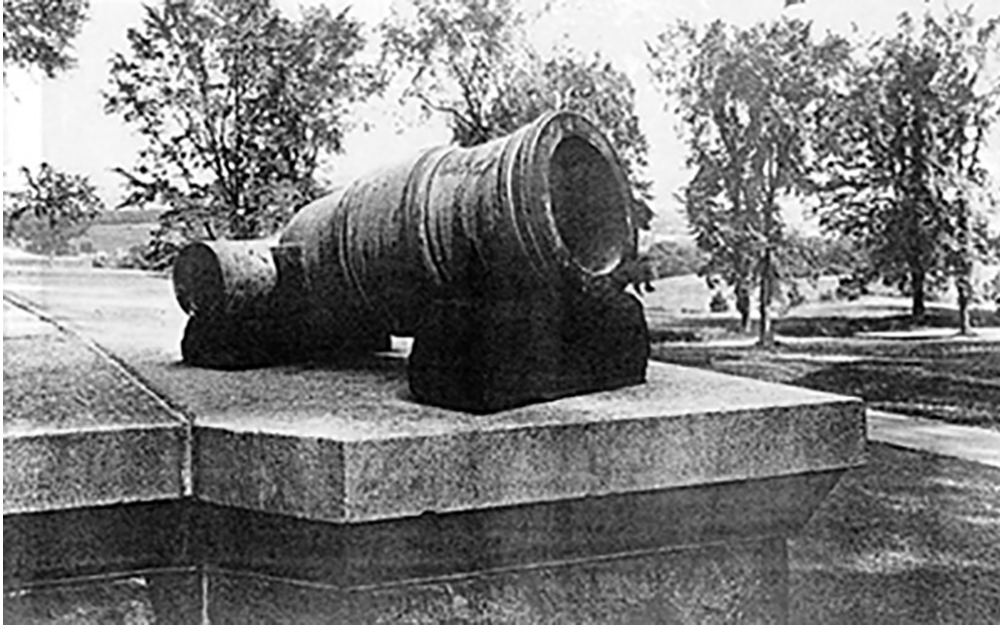
*Figure 16. Cannon on the Monument's base, 1941. In the background is a portion of the elm allee along the eastern segment of the carriage drive. (Quinn and Bittermann 1992)*

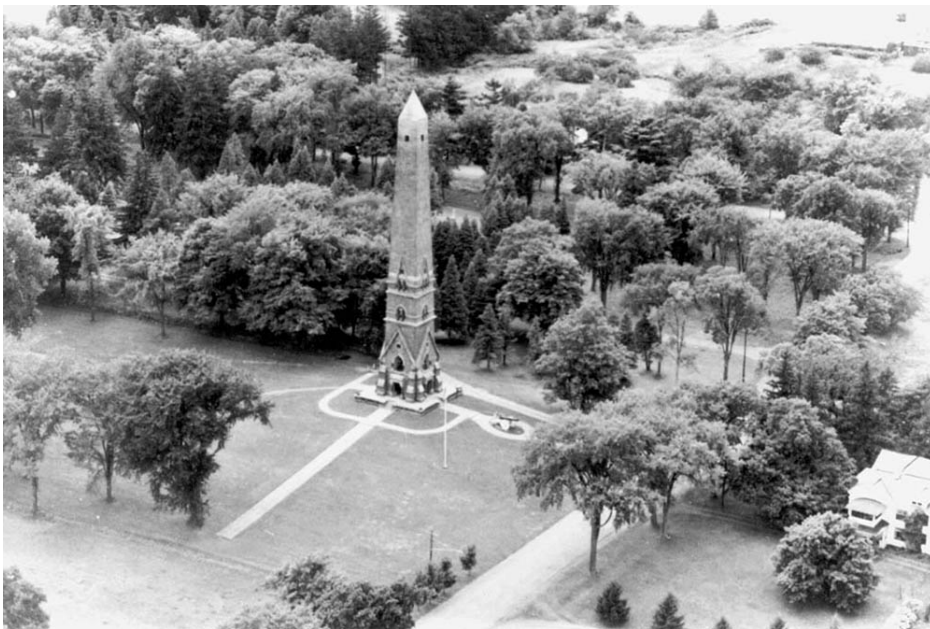
*Figure 17. Saratoga Monument formal landscape, c.1940. (SARA NHP Archives)*

During the 1920s, the site still had close-cropped turf and well-trimmed paths, but the paths were more permanently established. The gravel path that surrounded the north, east, and south sides of the monument was paved with concrete. The northern and eastern walkways were likely paved at this time as well. A wooden slat bench was located in the shade at the southwest corner of the monument. A metal flag pole painted white with a ball finial was installed on the north lawn at the northeast corner of the monument. During the 1920s, the DePeyster cannon was placed on a new white concrete carriage in its spot on the northern path. During the last half of the decade, Saratoga trophy cannons (captured from Burgoyne's forces) were placed on each corner of the base of the monument including two 1776 light three pounder bronze Verbruggen guns, one 1758 bronze W. Bowen mortar, and one 1758 bronze W. Bowen howitzer (Figure 16). These cannons were installed about a decade after US House of Representatives Bill no. 21218 was passed in 1912 approving their loan to the State of New York. By this time, a Civil War cannon (twenty-pounder naval Parrot rifle) on a carriage with a caisson had been placed on the south lawn. An outdoor lighting system consisting of ground-mounted spotlights was installed in 1927 to illuminate the monument for the 150th anniversary of the battles of Saratoga. In 1931 a rest house was built along the western boundary, south of the monument. It was painted white with green trim. In 1937 the obelisk was topped with lead coated copper roofing to prevent water infiltration. A photograph from c.1940 shows the maintained grounds around the monument (Figure 17). (CLI 2009: 42-43)

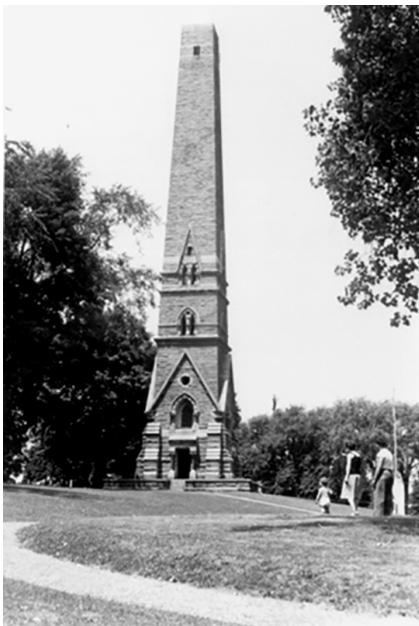
Figure 19. South lawn with s-curve walk around cottonwood mound, 1949. (SARA NHP Archives)

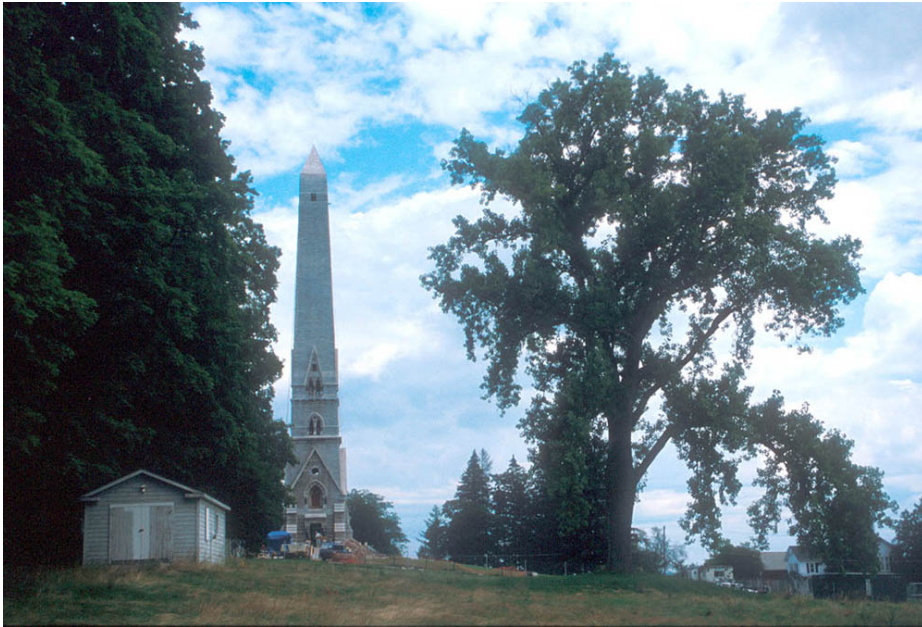
*Figure 20. The 1931 restroom as it appeared in 2000. (OCLP 2000)*

In 2004, the NPS negotiated a lease with the Prospect Hill Cemetery Association for a tract of land north of the cemetery and west of the monument parcel, where it constructed a new entrance road loop parking lot and restroom facility in 2005. The entrance to the parking lot was located along the west edge of the parcel, off of Cemetery Road. This configuration was intended to improve accessibility and sight distances at the intersection with Burgoyne Avenue. The 1981 parking lot east of the monument was removed, but the trace of the carriage road was remains visible. In 2015 the park removed the 1931 restroom south of the monument (Figure 20). (PEPC 528024; PMIS 210751; NR 2004, Sec.7: 20)

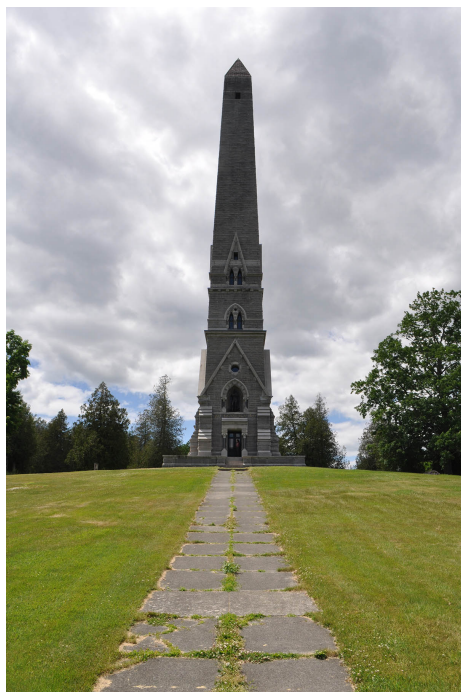
Evaluation:  
The site’s historic topography remains intact today. The land slopes up to the knoll and the monument and the mound on the south lawn remains intact beneath the large tree (Figures 21 and 22). The grades associated with the low bank on the western property line remain, despite the loss of the carriage road.

*Figure 21. Saratoga Monument, view looking west from the east path. (OCLP 2022)*

Today, the geometric-aligned concrete paths and granite steps remain around the monument but are in poor condition and do not meet accessibility standards. The southern S-shaped path and the southern segments of the carriage road remained concealed (Figure 26, see also Figure 21). Archeological evidence remains for these features, while traces of the northern sections of the carriage road that connected to Burgoyne Street are still visible (see Figure 22). The loss of these features has affected the way visitors experience the property. Most visitors now enter the property from the new parking area and walkways to the west rather than directly from Burgoyne Street (Figure 27). As discussed in the Spatial Organization section, visitors are no longer encouraged to experience the entire property, but merely its northwest corner where the monument stands. The changes in the circulation patterns of the property have greatly affected the historic character of the landscape.

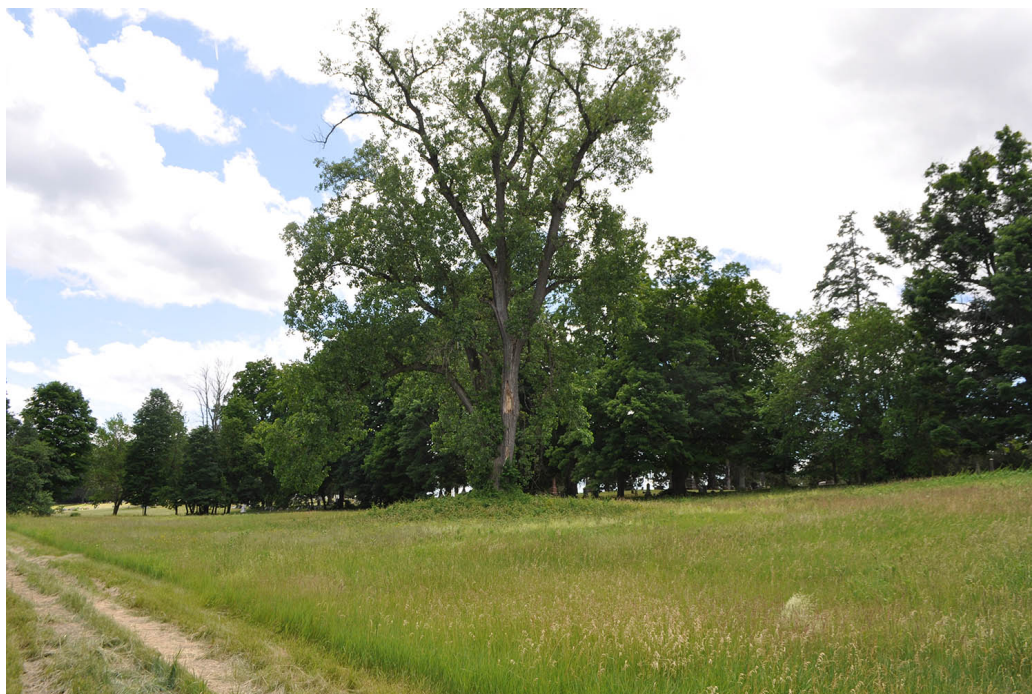
*Figure 22. View looking northwest at the mound surrounding the cottonwood tree on the south lawn. Note the trace of the eastern segment of the carriage road. (OCLP 2022)*

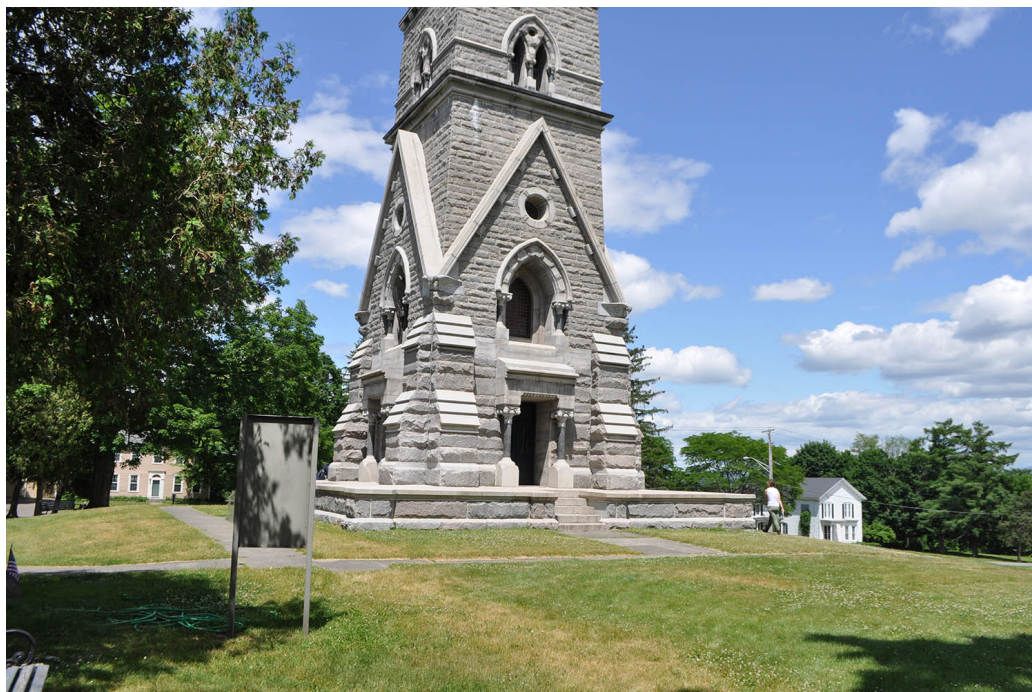
*Figure 23. View looking northeast at walkways around the base of the monument. The worn grass area and asphalt path sit atop the former carriage road. (OCLP 2022)*

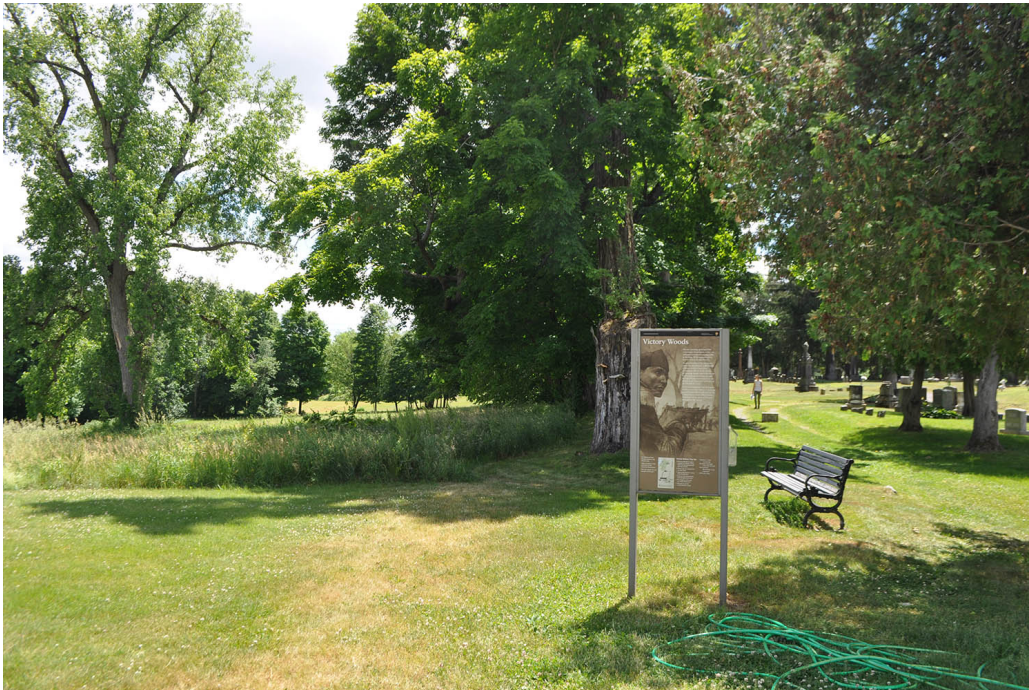
By the 1970s, the allée of American elms had succumbed to Dutch elm disease. The allée was not replanted, and as a result, the character of the formal designed landscape is very different today. The landscape is dominated by maintained lawns and meadows with the single large cottonwood tree (Figure 24). This cottonwood's trunk is about eight feet wide, and the canopy is over 100 feet wide. The southern property edge was sporadically planted with trees during the 1980s and is now a thicket of black oak, honeysuckle, and sumac. A white birch grows in the southeast corner of the lawn. Also during the 1980s, the NPS added some flowers and shrubs to the north lawn fronting Burgoyne Street, but none remains today. The row of large sugar maples that once were part of the allée still survive, although a few have been lost (Figure 25). Clumps of northern white cedars still survive in the cemetery along road and path traces within view of the monument.

*Figure 24. View looking south at lawns and meadows, one of the historic maples, and the historic cottonwood tree (image left). The Prospect Hill Cemetery at image right. (OCLP 2022)*

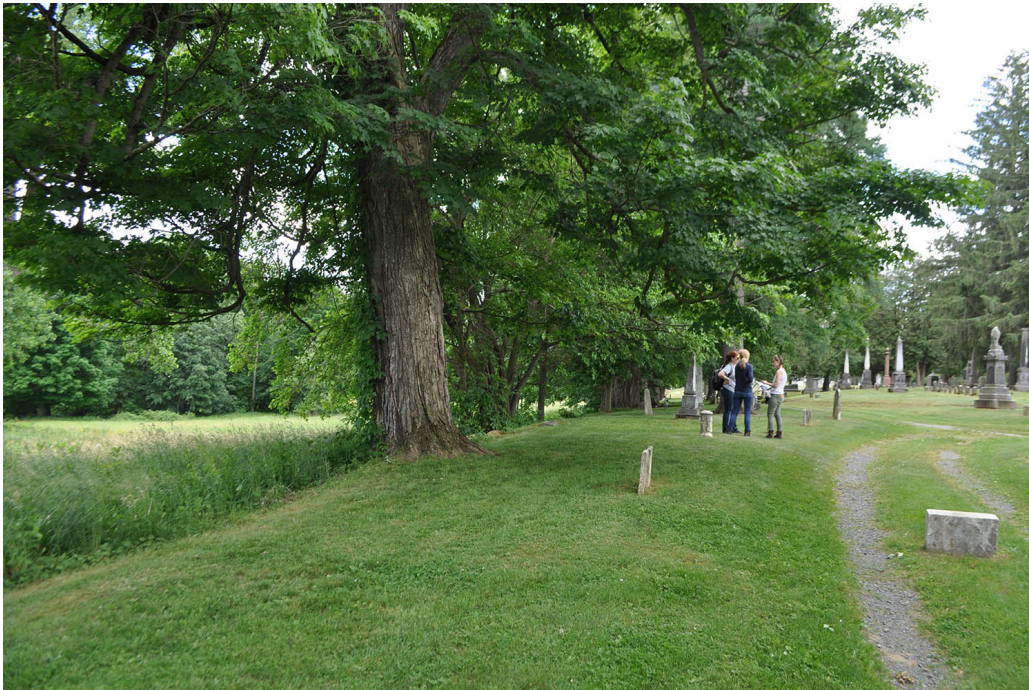
*Figure 25. View looking south at some of the historic maple trees that mark the property line between the site and the Prospect Hill Cemetery. The trees once lined the west edge of the carriage road. (OCLP 2022)*

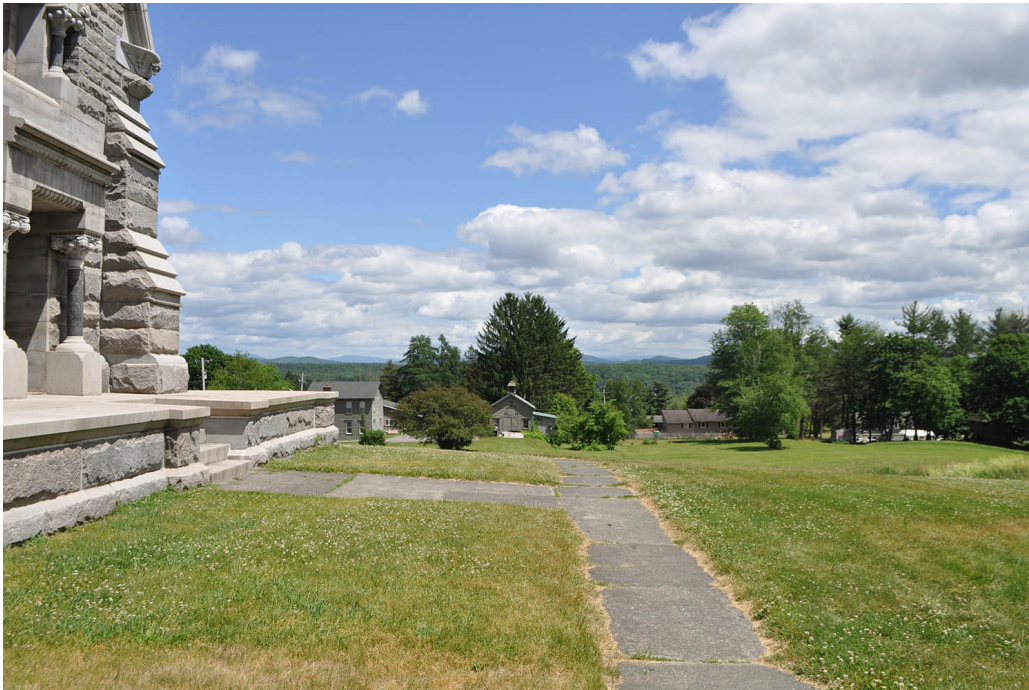
*Figure 26. Historic concrete walks, view looking east from the southwest corner of the monument. (OCLP 2022)*

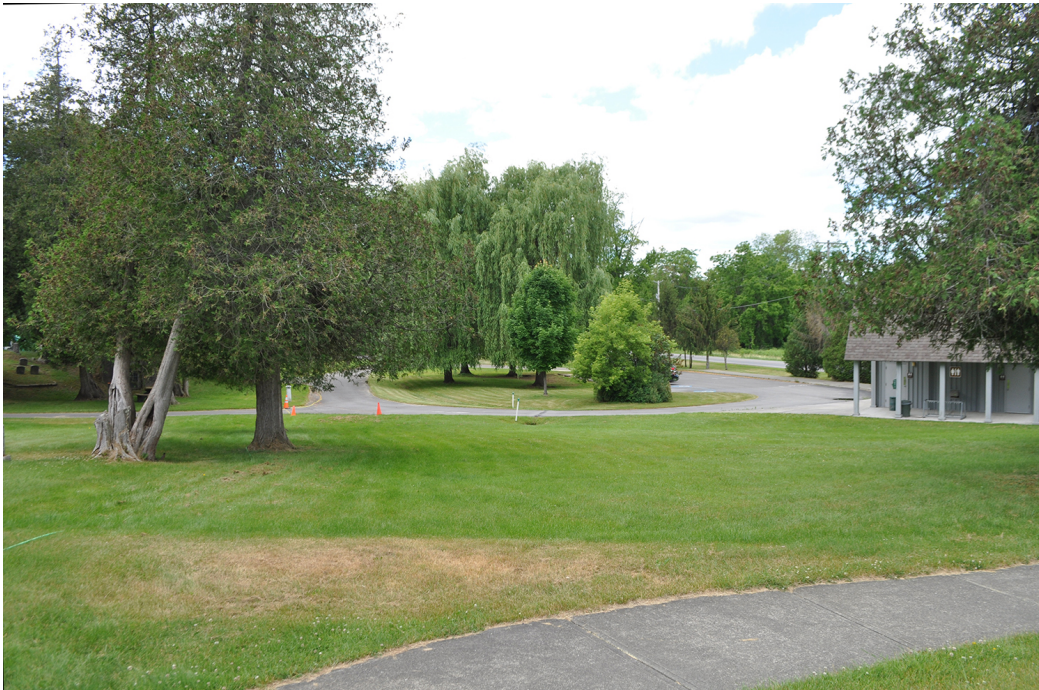
*Figure 27. View looking west at the parking lot, associated walkways, and restroom/shed. (OCLP 2022)*

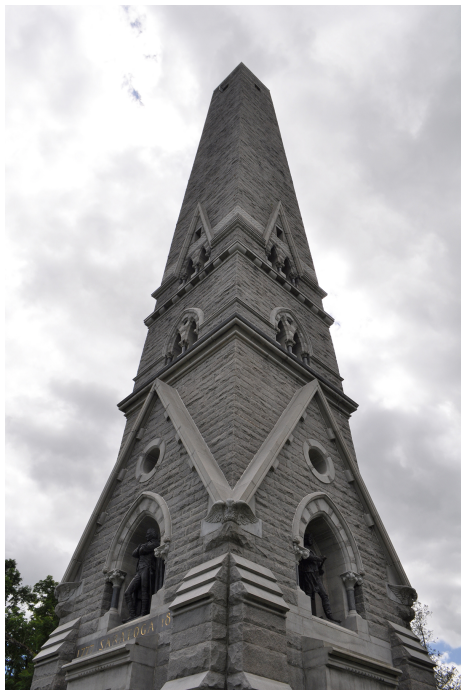
The caretaker's shed was replaced with a frame shed and restroom building in 1931. The newer structure was located along the western boundary, approximately 200 feet behind the monument and alongside or atop the carriage road. It was removed in 2015, around ten years after a new restroom was built on the leased land west of the monument parcel (see Figure 27). The Saratoga Monument was closed several times after the historic period due to safety concerns and rehabilitation projects (1971-1973, 1982). A comprehensive rehabilitation occurred in 1999-2002, but today is in need of repointing (Figure 28). The monument continues to be the most important feature in the landscape.

*Figure 28. Saratoga Monument, as viewed from the southeast. (OCLP 2022)*

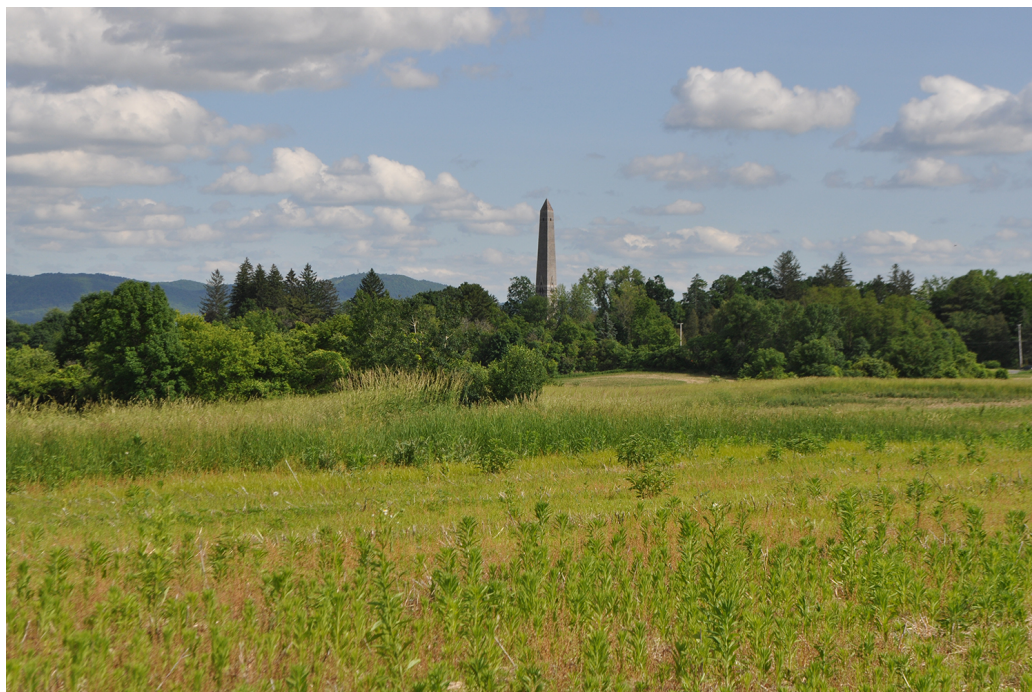
*Figure 29. Saratoga Monument, view looking southeast from around one-half mile to the northwest, on Route 338. (OCLP 2022)*

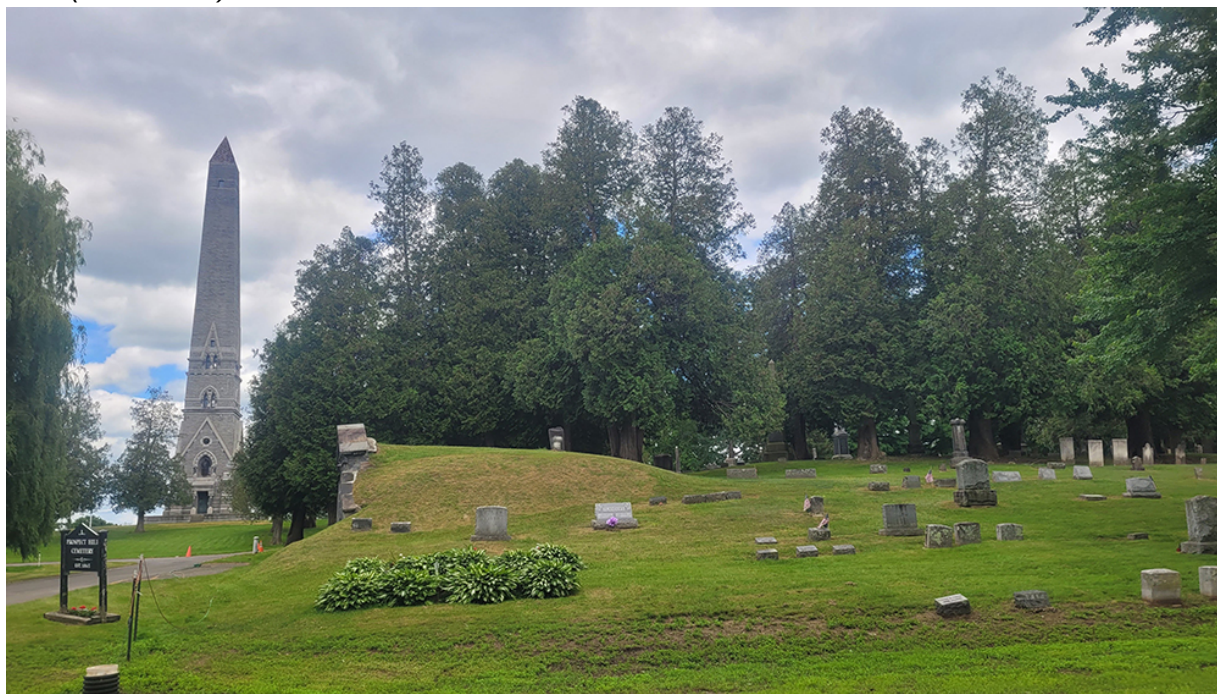
*Figure 30. Saratoga Monument, view looking northeast from the Prospect Hill Cemetery. (OCLP 2022)*
