# Update on Surface-to-groundwater transport of contaminants at Tumacácori National Historical Park: Preliminary results

*James Callegary, Nick Paretti, and  
Kim Beisner, Rose McAndrew*

# Tumacácori National Historical Park

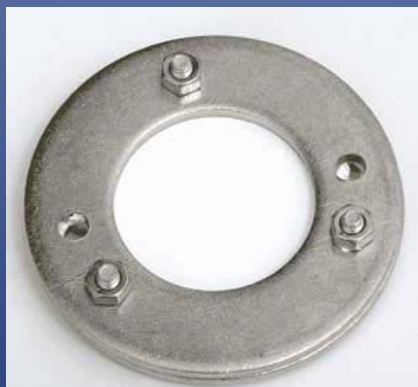
# Polar Organic Chemical Integrative Sampler (POCIS)

- Consists of a solid phase sorbent contained between two sheets of a microporous polyethersulfone membrane
- Used to monitor hydrophilic contaminants
- Compounds include pesticides, prescription and OTC drugs, hormones, personal care products
