## Heiser Spring Restoration Project at Wupatki NM

### PROJECT SUMMARY

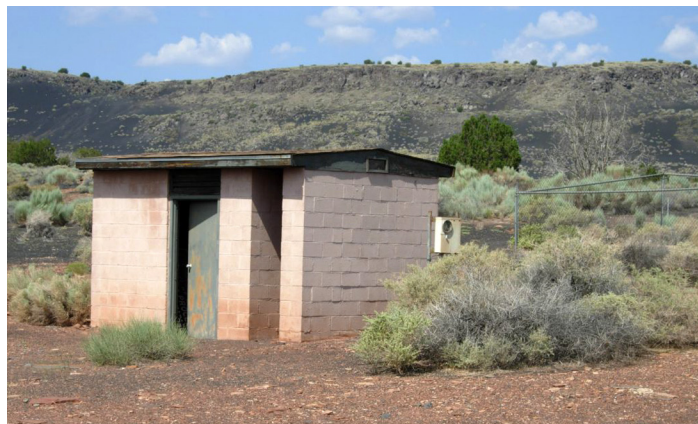
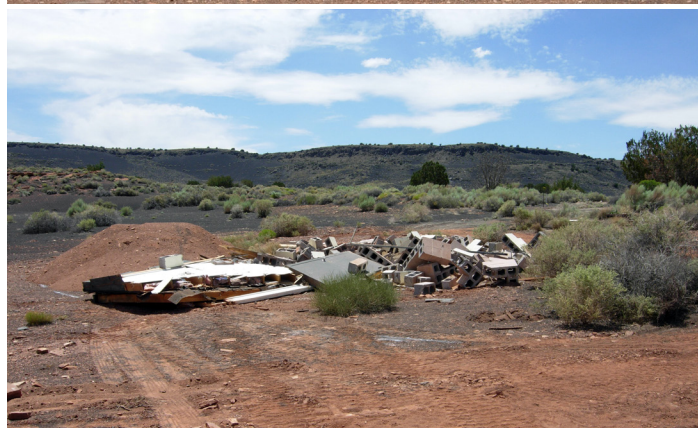
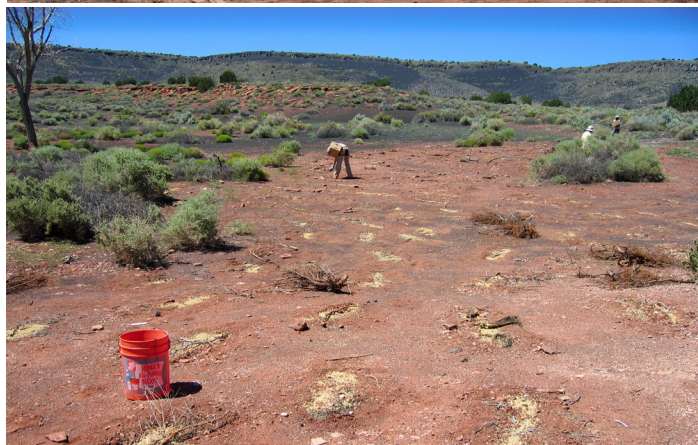
Pumpshack at Heiser Spring, before (top), during demolition and removal (center), and during revegetation efforts (bottom).

- **Remaining structures were demolished and debris removed.** The remaining NPS structures at Heiser Spring, including the springbox, chlorination chamber, cistern, and water pump shed, were demolished and the debris removed from the site. The lower portions of both the springbox and chlorination chamber were documented with photographs, and then abandoned in place in order to minimize possible damage to the water-bearing sandstone unit in which they were built. Native soil was used to backfill.
