## Introduction

Figure 1: Gabions/ Detention Features in Nogales, Sonora (Norman et al. 2010)

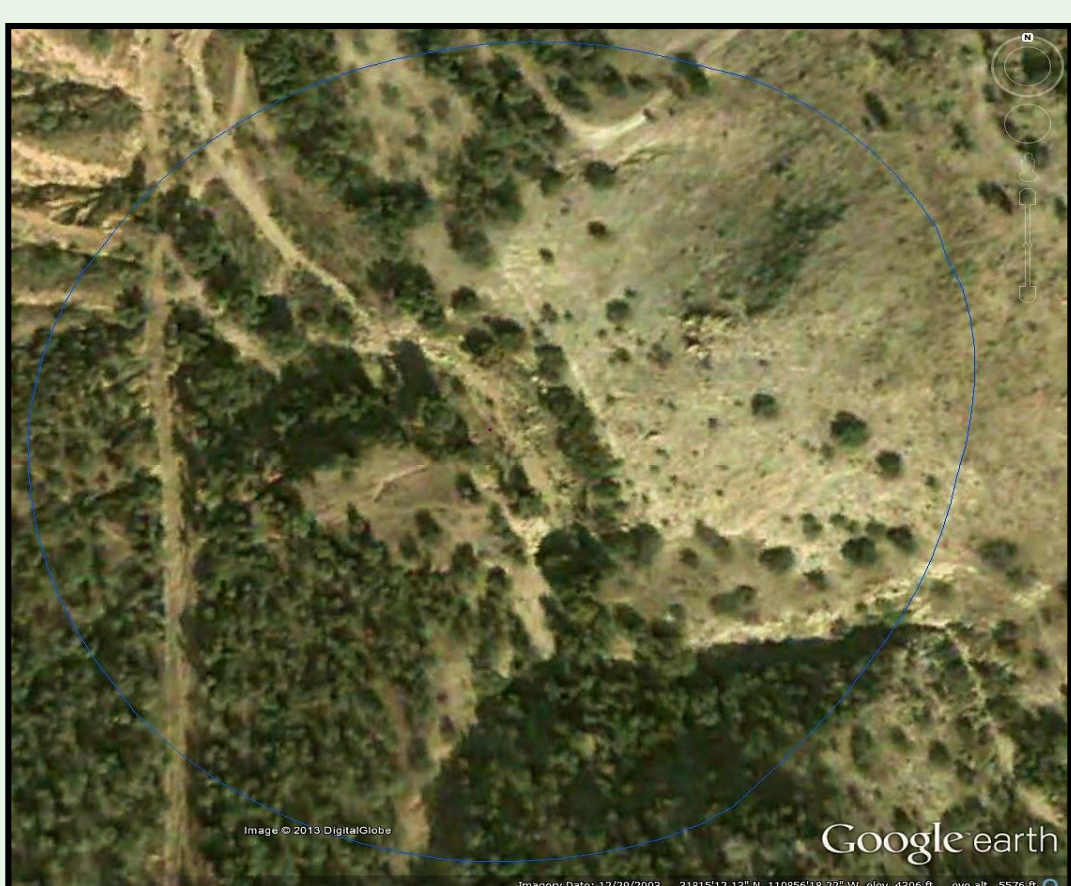
Figure 5. Aerial Photograph depicting vegetation in Capulines on 12.29.2003 (135 m buffer ring shown in blue color).

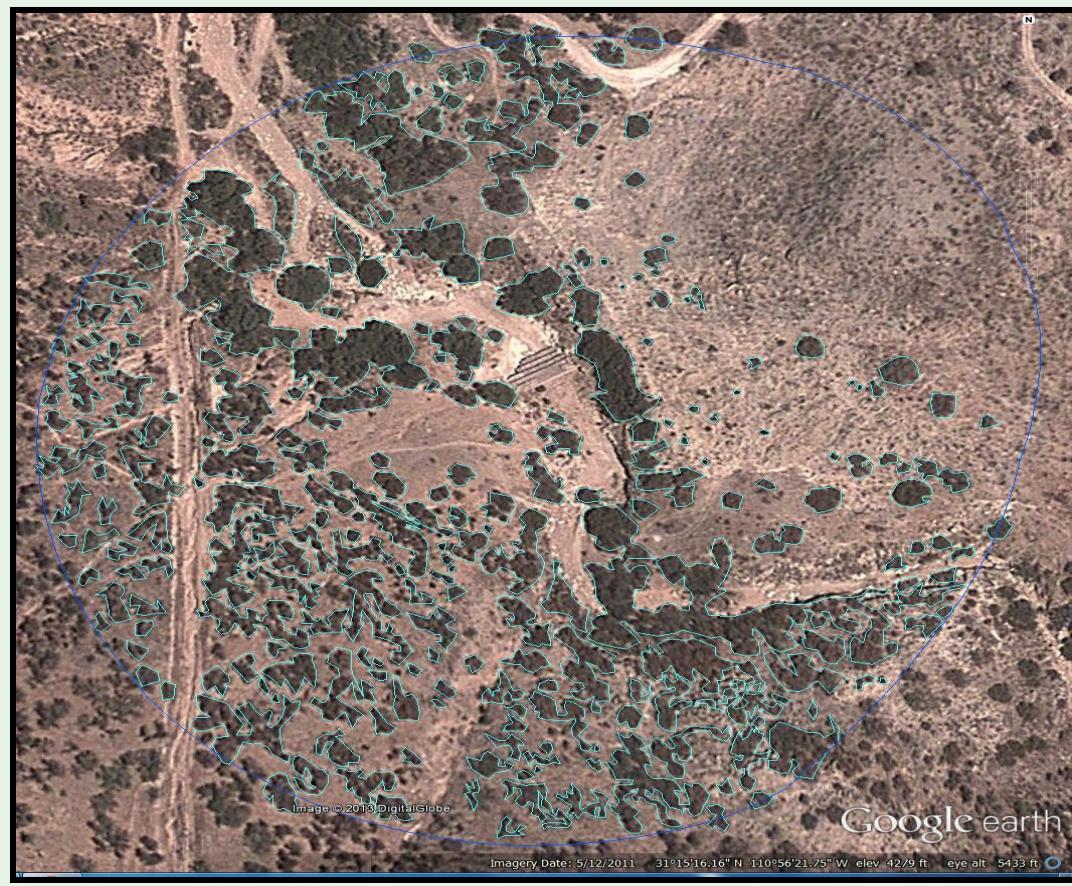
Figure 6. Aerial Photograph of Capulines depicting vegetation in digitized polygons on 5.12.2011 (135 m buffer ring shown in blue color).
