# Hydrologic Evaluation of the Corazon de Tres Rios Del Norte Area

BY  
Frank Postillion, Chief  
Hydrologist  
&  
David Scalero, Principal  
Hydrologist

Pima County Regional  
**FLOOD CONTROL**  
DISTRICT

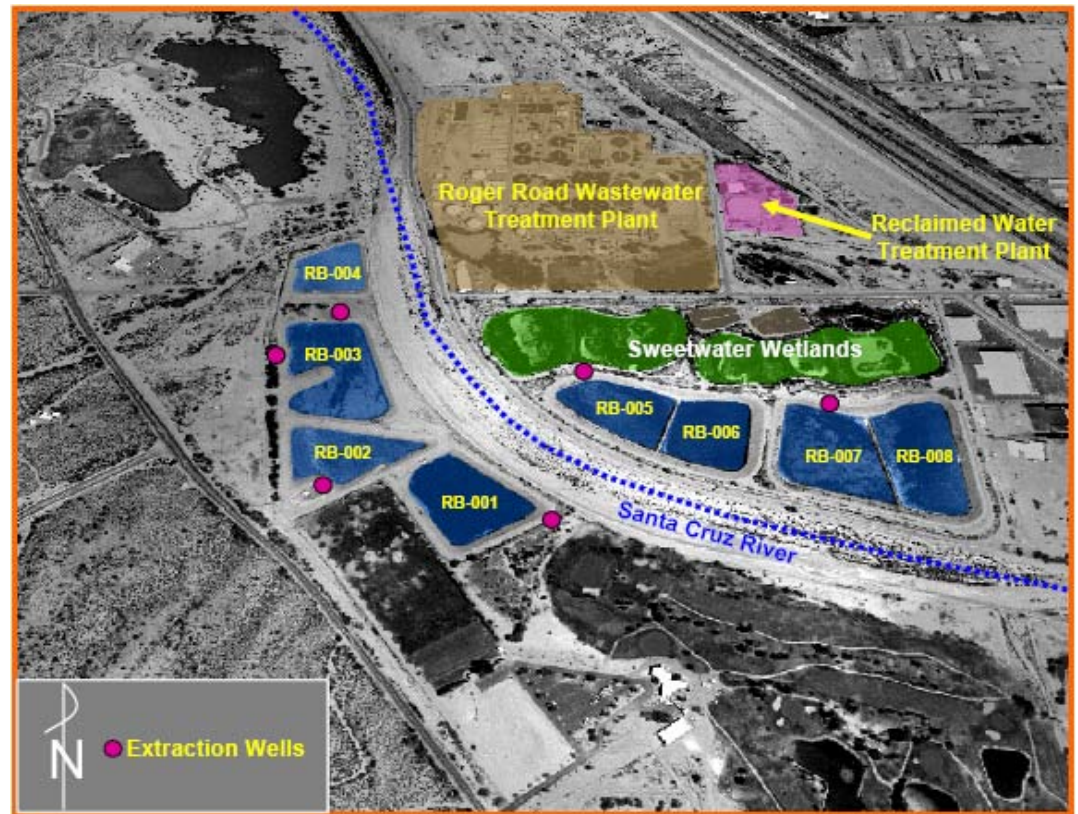
Tucson Water Graphic

- Storm water in SCR, Rillito & CDO
- Treated effluent from Roger Rd. & Ina Rd. Facilities
- Sweetwater → Effluent Recharge Facility

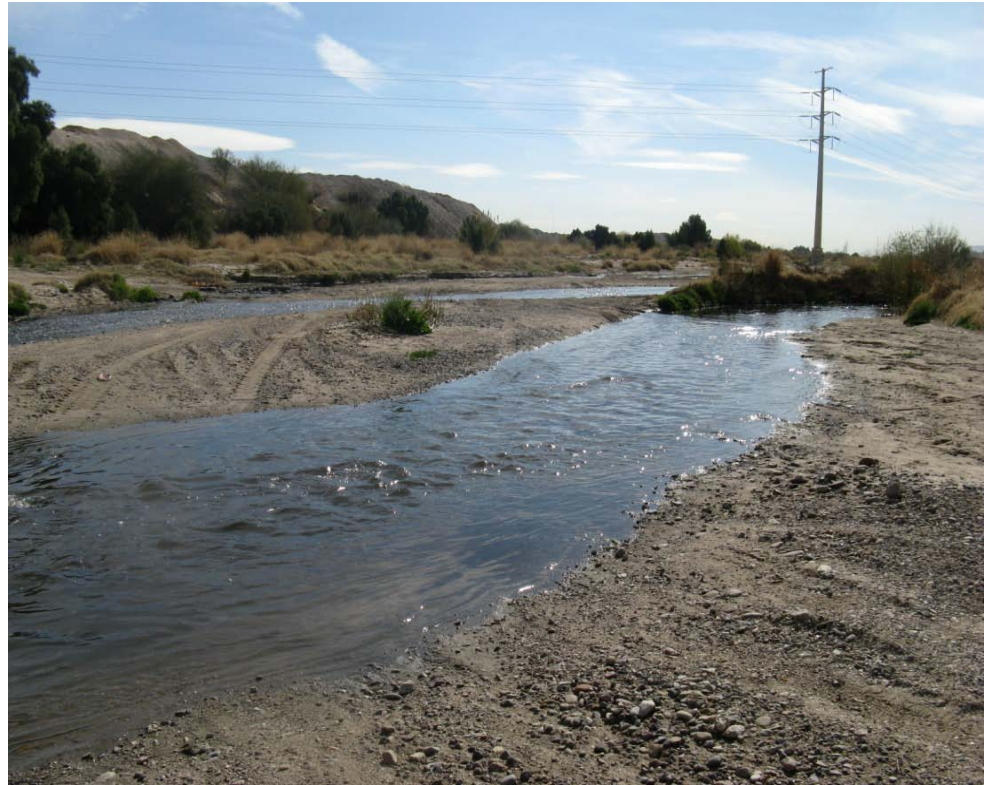
- Recharge rates south of Ina Rd. varied from 0.5 – 5.9 AF/mi/day (3.33 avg.)
- Recharge rates north of Ina Rd. varied from 2.83 – 4.06 AF/mi/day (3.15 avg.)
- Historic recharge rates ranged from 4.4 – 6.7 AF/mi/day (wetter period)
