# Impacts of Flow Diversion on Effluent Infiltration

Santa Cruz River Research Days 2013  
April 15–16, 2013

JACOB PRIETTO<sup>1</sup>

<sup>1</sup> University of Arizona, Department of Hydrology & Water Resources

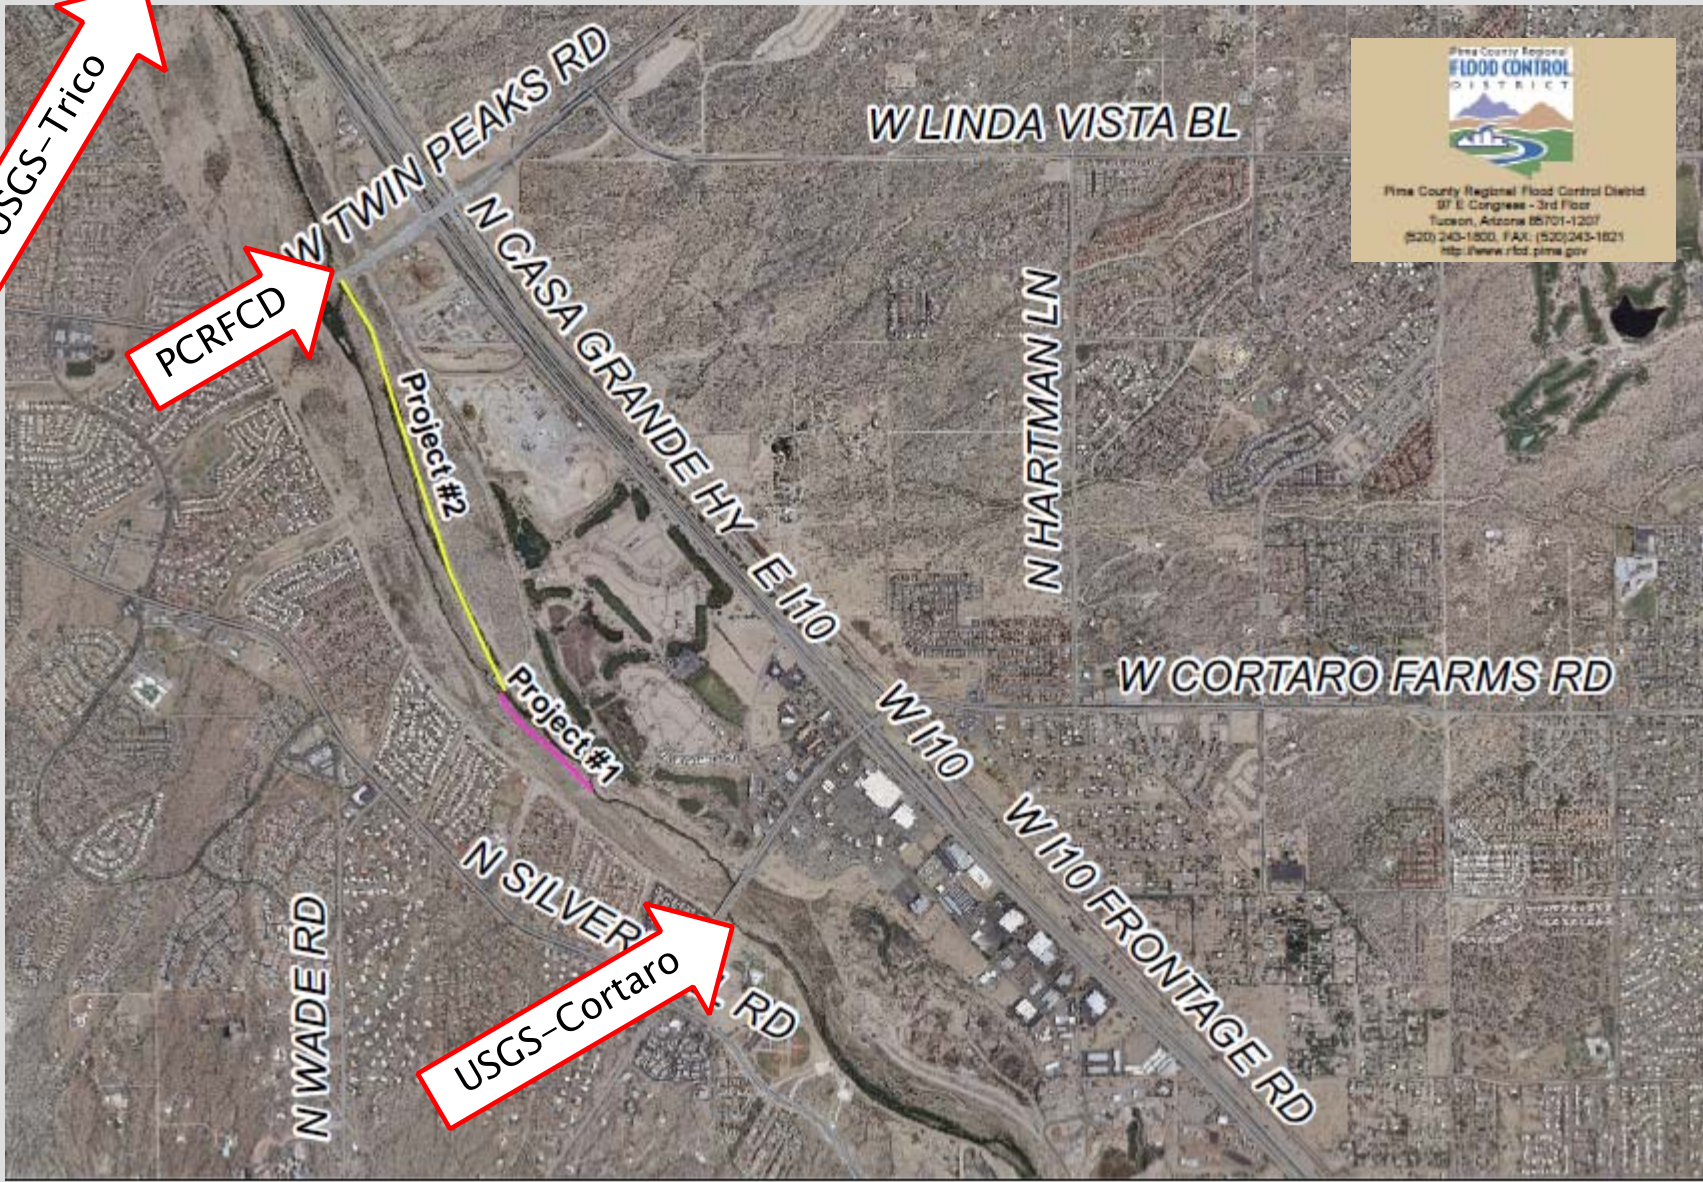
# Map1 RFCD Project Site

- RFCD Project**
- Project #1
  - Project #2

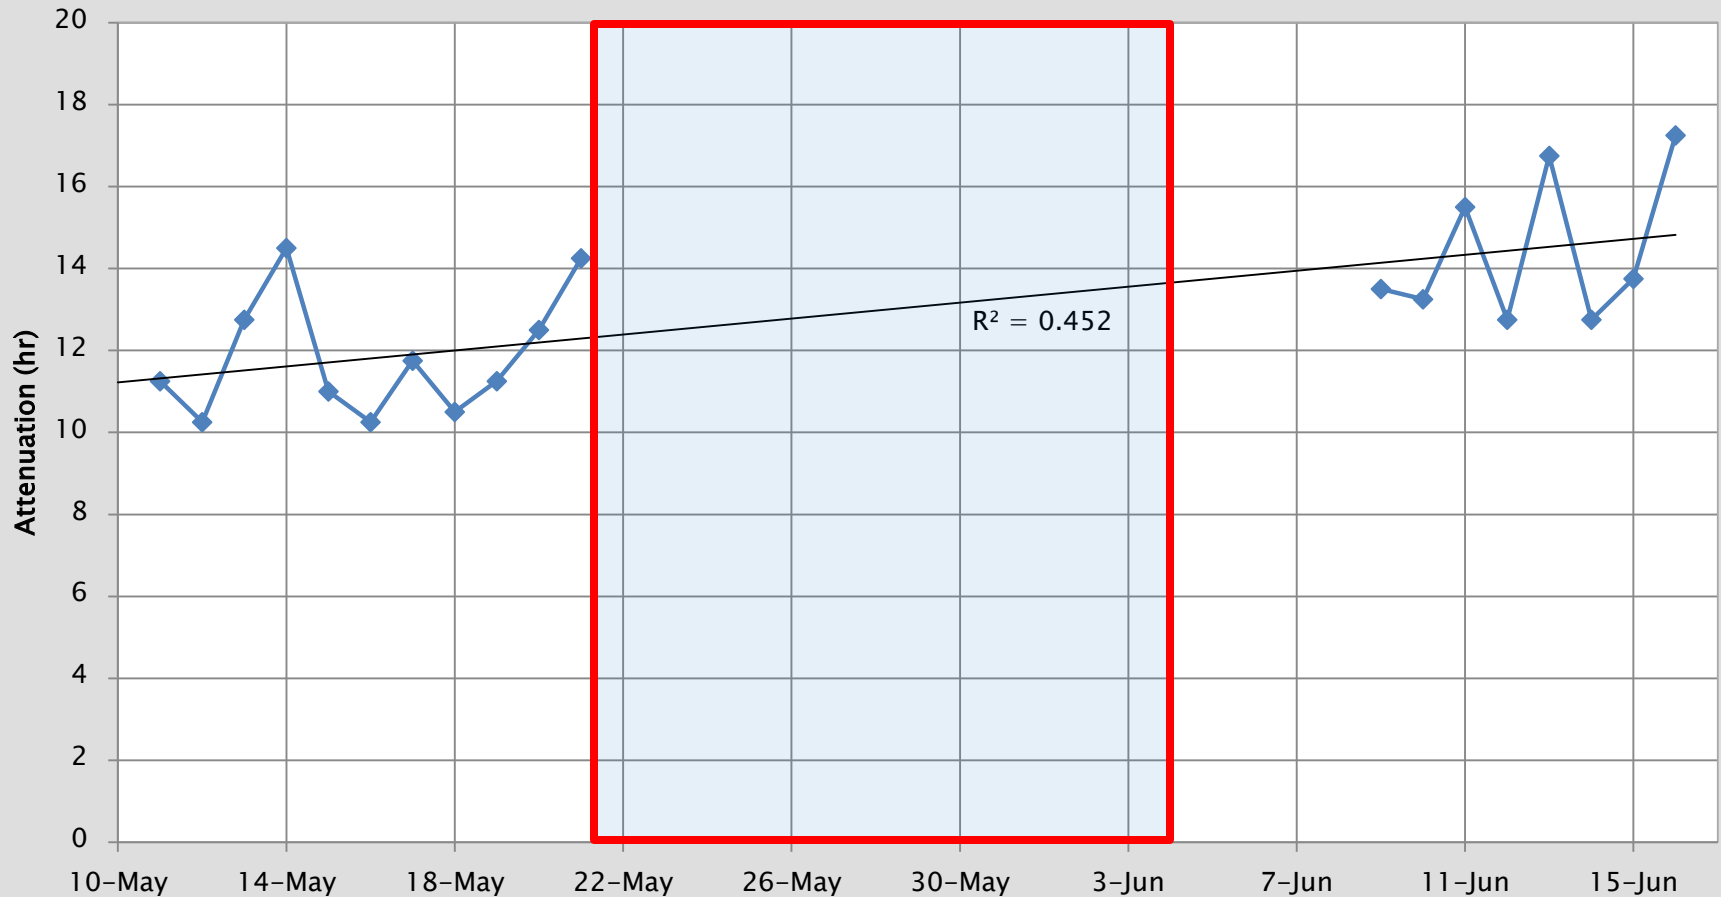
## Peak Discharge Attenuation: Cortaro Road to Trico Road

Distance  $\approx$  16.4 miles

Velocity  $\approx$  1.3 mph (1.9 fps)

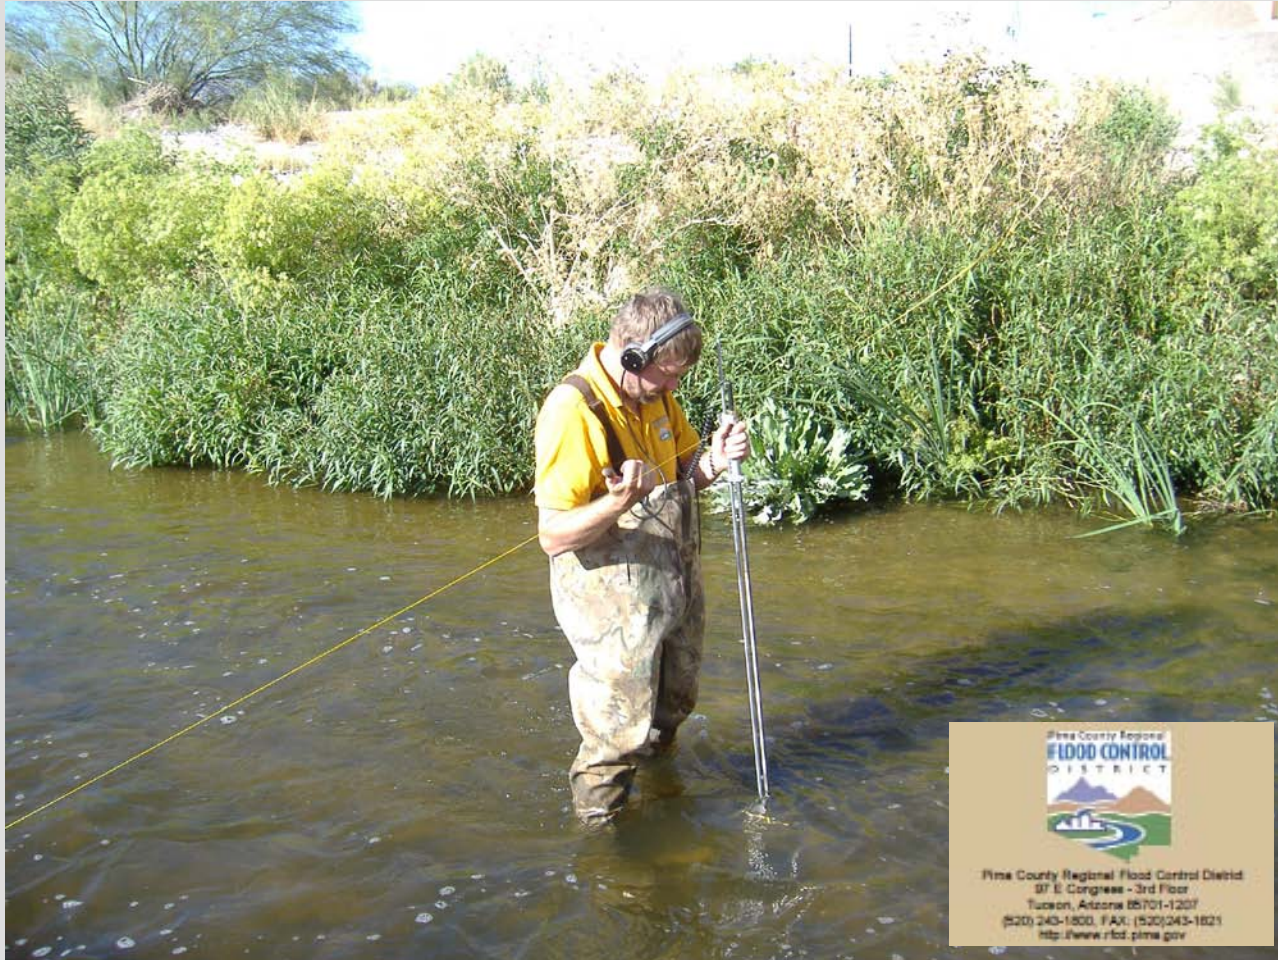
# Streamflow Gauging: Twin Peaks Road

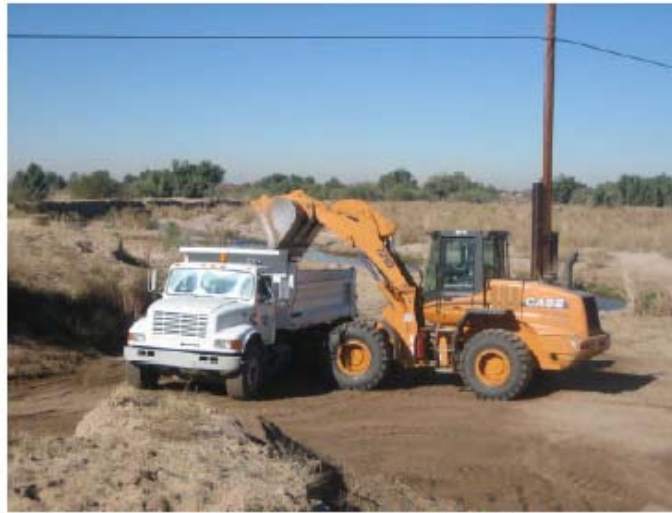
Photo 2. – Removal of Excavated Material during Excavation.

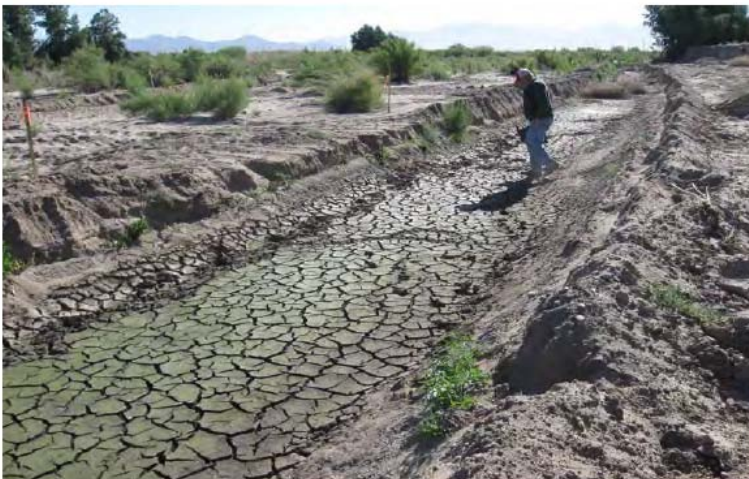
Photo 12. – Mudcracks in Channel 1 after 7 Days of Drying during First Maintenance Event. Brad Despaigne is crossing channel.

- ▶ 4–5x greater after maintenance
- ▶ decreased over time

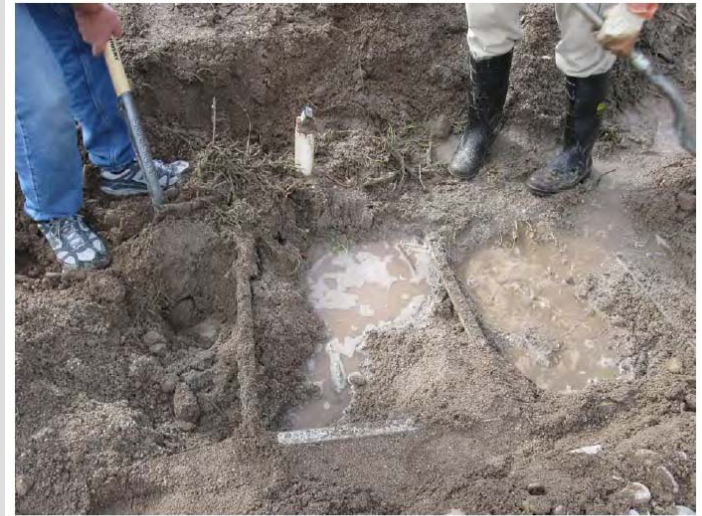
Photo 17. – Buried Upstream Flume after July 5<sup>th</sup> and 6<sup>th</sup> Stormflows.
