# Restoring Salmon and Trout Habitat at East Schooner Creek, Point Reyes National Seashore

**Project Overview:** *As part of the Coastal Watershed Restoration Project, the Seashore replaced existing road-crossing facilities at Mt. Vision Road and Estero Road on East Schooner Creek, a freshwater stream supporting federally threatened steelhead trout.*

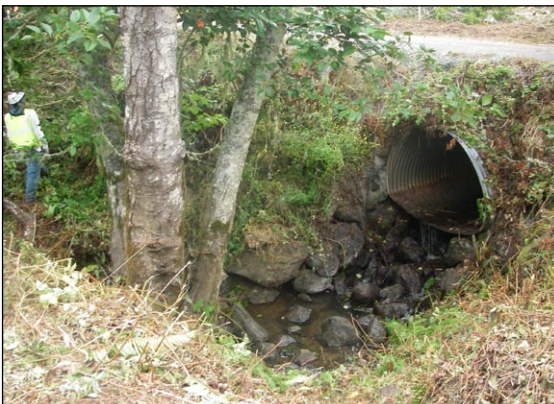
(Left: Before; Right: After) The culvert at Estero Road crossing, before and after replacement. Fish can now pass freely through the bottomless arch culvert, and vegetation is re-establishing.

Work took place in fall 2007, with pumps moving streamflow around the sites. Contractors replaced the old, failing culverts with larger concrete bottomless arch culverts that more than doubled the conveyance capacity of Estero and more than quadrupled that of Mt. Vision. These structures span the channel and maintain a natural streambed bottom that can adjust with changes in the adjacent streambed. The culverts provide fish passage, will easily convey a 100-year flood, and will reduce long-term maintenance. At each site, the project required regrading and reconstruction of the stream corridor upstream and downstream of the project area, providing stable transitions between the altered channel and the existing channel. Contractors created a roughened rock ramp with step-pool structures for this purpose.

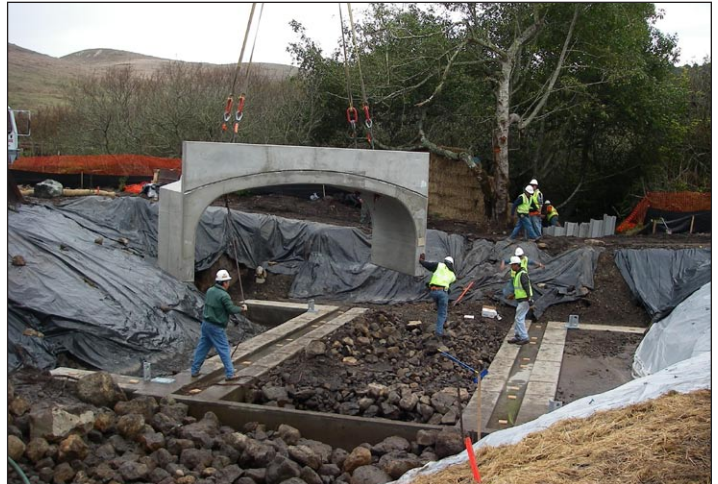
Workers place a piece of the bottomless culvert at the Estero Road crossing.
