Levi Trentham Cabin  
Elkmont Historic District  
Great Smoky Mountains National Park  
**Historic Structure Report**

September 2010

Joseph K. Oppermann–Architect, P.A.

# Historic Structure Report

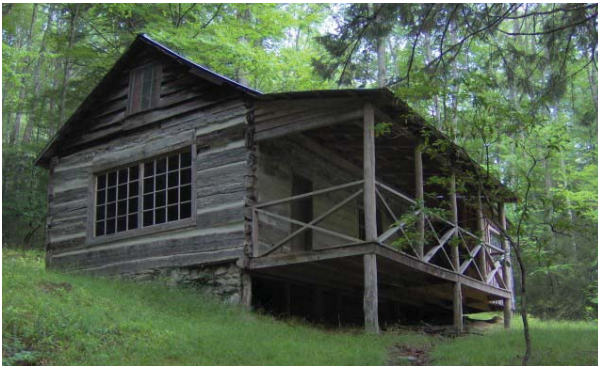
**Figure 2,** Avent Cabin, Elkmont, built by the Ownby family in 1845.

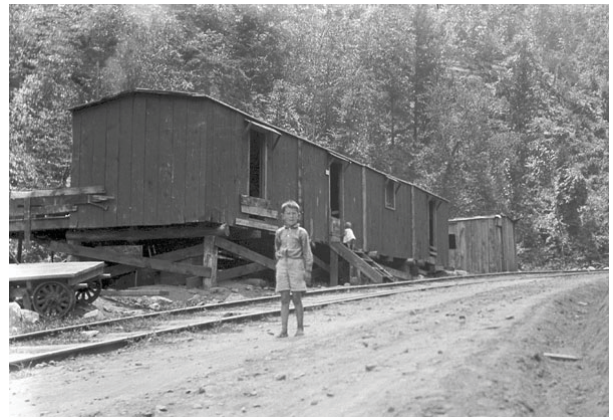
**Figure 3,** Little River Railroad Company set-off houses. (Little River Lumber & Railroad Company Museum)

These structures were assembled at railroad company headquarters and moved by train as railroad construction progressed. Often, several set-off houses were placed in a row to create what was known as a stringtown.

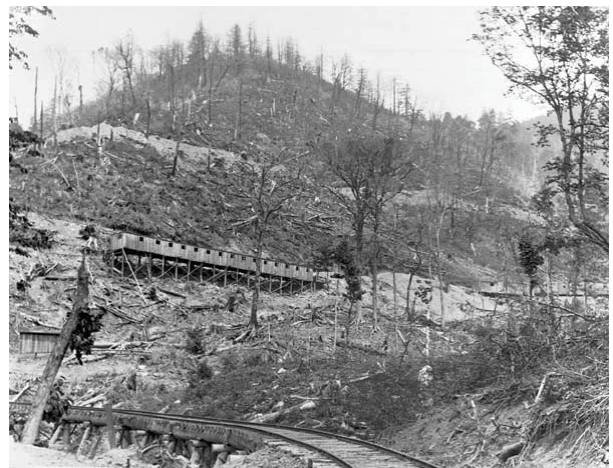
**Figure 5,** “Stringtown” above Elkmont. (Little River Lumber & Railroad Museum)

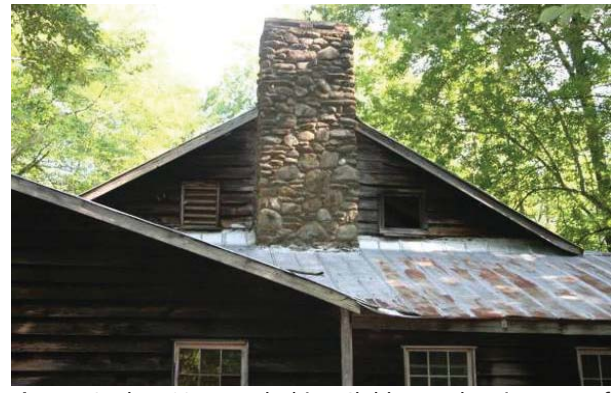
**Figure 12**, The 1934 Appalachian Clubhouse showing uses of natural materials and simple geometric forms.

Whether based on traditional folk designs, the Craftsman style, or a co-mingling of the two, common features are found in the architecture of Elkmont. According to the Thomason report, most buildings are balloon frame construction covered with board-and-batten, weatherboard, or drop siding, and originally had galvanized steel roofs, many later replaced with asphalt shingles. Stone, bricks, and concrete were typically used for chimneys, foundations, and retaining walls, while outdoor living spaces were created with the large porches found on most Elkmont buildings. Wood paneled doors and variations on the casement window are other common features found in the buildings of both club communities. The rustic elements of the exterior are continued on the interior and are evident in the predominance of exposed wood ceilings, walls, and floors.

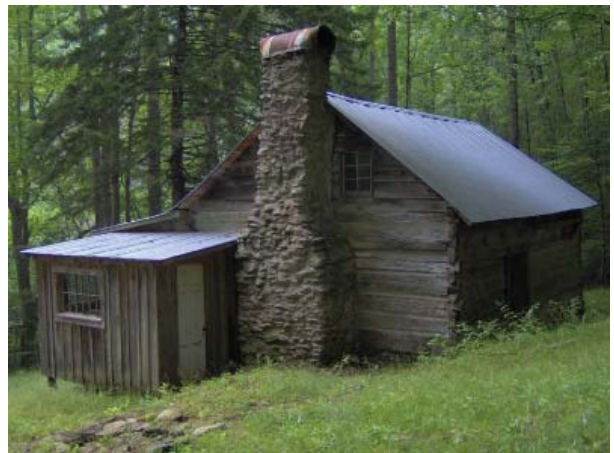
Figure 2, Avent Cabin.

The only other surviving structure in the Elkmont vicinity dating from the mid-nineteenth century is the circa 1845 Avent Cabin, shown below. Built by the Ownby family, this structure was originally part of a farm along Jakes Creek and was surrounded by several barns and other outbuildings.<sup>7</sup> Although the Avent Cabin remains in its original location (near the southernmost point of the Appalachian Club complex), it has been extensively remodeled.<sup>8</sup>

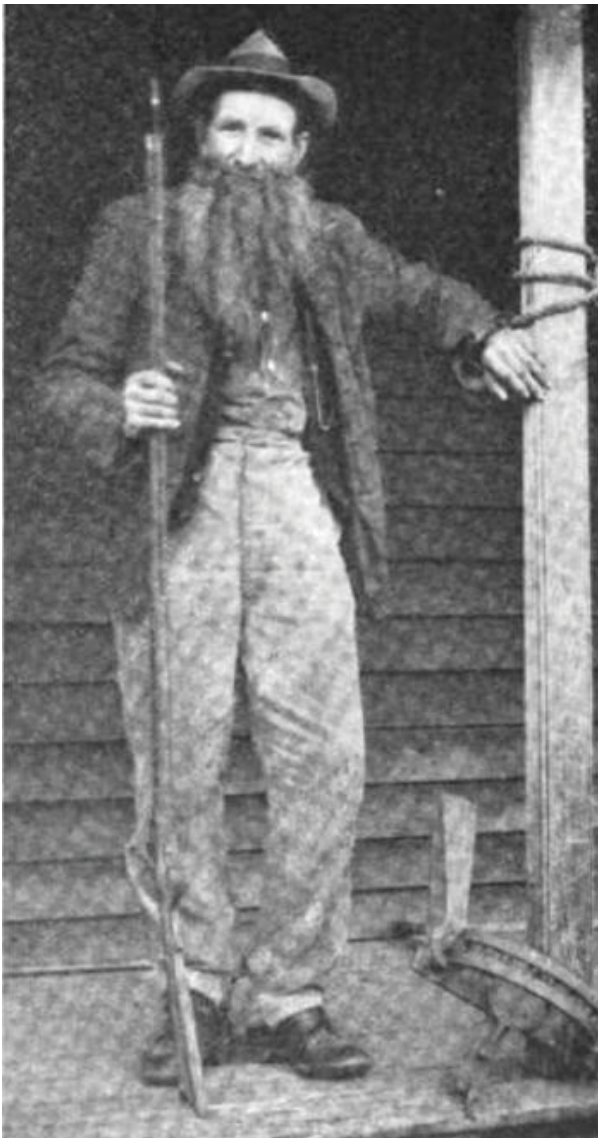
**Figure 5.** Uncle Levi Trentham on a porch, perhaps his own, circa 1909. Note weatherboard siding. (*Field and Stream*, 1909)

with a square support post (see Figure 5). The *Field and Stream* article states, “Uncle Levi’s long porch outside was piled high with the baggage of these brilliantly colored birds of passage, en portage,” referring to the many colorful characters at an early twentieth-century supper at the Trentham Cabin.<sup>17</sup>

Architectural evidence confirms the existence of a porch and siding. Horizontal rows of cut nail holes and some nail fragments are present on the building exterior, indicating removed siding. Five notches are present along what is now the west side of the cabin. These notches are probably pockets for brackets which once supported a porch, presumably the one seen in an early twentieth century photograph (Figure 5).

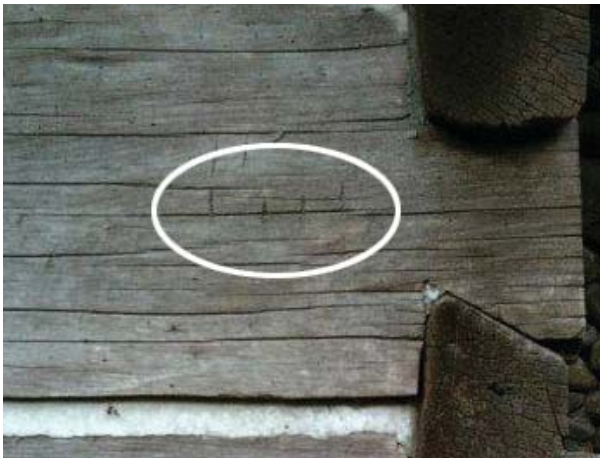
The Levi Trentham Cabin was reassembled behind the Mayo Cabin on a stone foundation. According to descendants of the Mayo family, the unique Roman numeral assigned to each log indicated how the cabin was to be reassembled on its new site in 1932.<sup>23</sup> However, it was a common practice for builders to assign numbers to each log as a method of guiding the sequence of assembly of the pre-cut log members. It is possible that marks created by the original builder later guided reconstruction after relocation. These marks are still visible on the south end of the west side of the cabin.

**Figure 6,** Identifying Roman numerals cut into the Trentham Cabin logs.

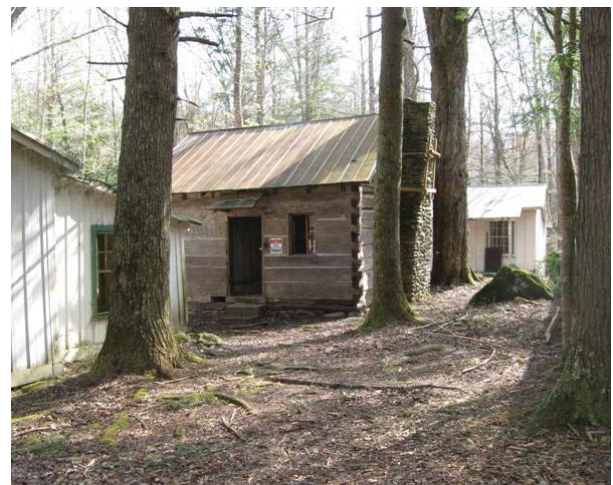
**Figure 2,** View of Trentham Cabin between Mayo Cabin in foreground and Servants' Quarters behind (photo from Diane Flaugh, Cultural Resources Department, NPS).

Due to its location between Mayo Cabin and the Servants' Quarters, Trentham Cabin does not have a paved entrance walkway or any paved outdoor patios like many of the other cabins in the Appalachian Club complex. The cabin's property is tightly bordered on the east and west sides. Another property, known as Galyon Cabin, is located to the south of Trentham Cabin and Addicks Cabin is just ten feet to the north.

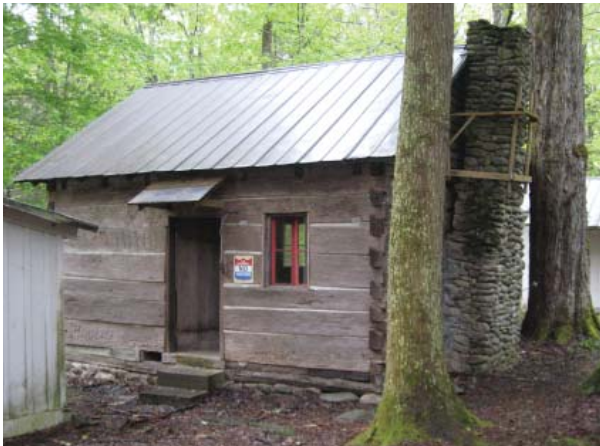
Reportedly, the cabin also had a chimney in its original construction, but when it was moved to its current site it was abandoned. A new river stone chimney was constructed on the south side of the cabin where it stands today.

**Figure 3,** Southwest oblique view of the cabin.

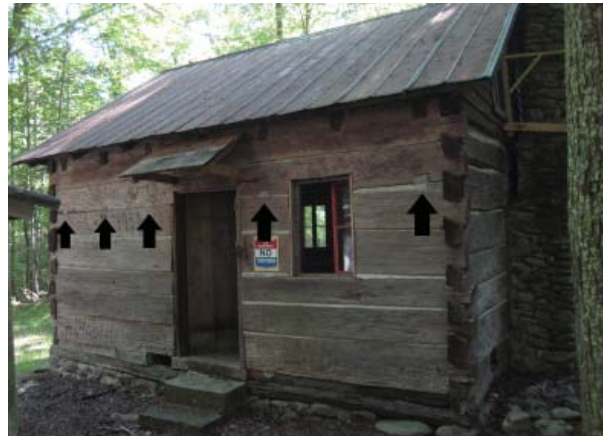
of a previous porch (wall notches for porch roof brackets) and earlier doorway. Typically, the door would be located at the porch and indeed the west doorway has evidence of an earlier design; the logs are notched for a shorter, wider door. And although the east door is notched, this appears to be a twentieth century feature because the door itself is modern, reconstructed with wire nails.

**Figure 4,** Notches on west elevation suggest a previous porch.

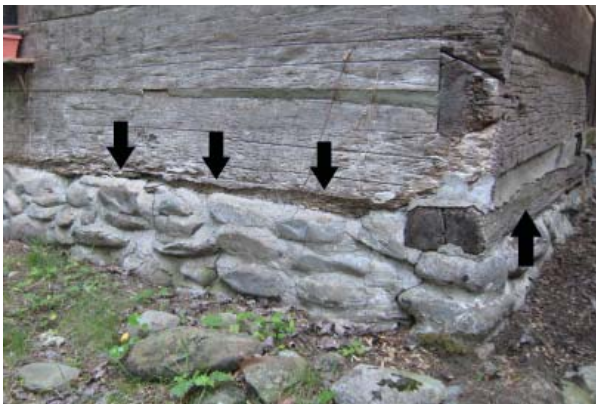
The cabin's log walls are hewn with half-dovetail notching at the corners. The log daubing is a modern mixture, rich in Portland cement, probably in an attempt to increase durability. The gabled roof is covered with 5-V metal roofing and the walls under the gable are finished with weather boards. The roof ridge runs north-south.

**Figure 6,** Northwest corner with unhewn sacrificial bottom log on west elevation (right) and rot in hewn bottom log of north elevation (left).

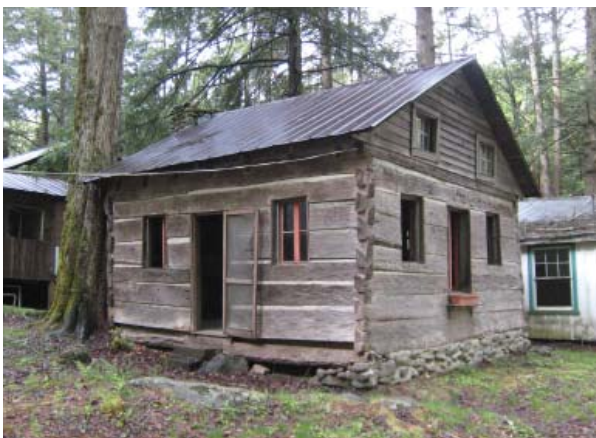
**Figure 7,** Northeast oblique of cabin showing partially collapsed east foundation wall.

The perimeter stone foundation wall has partially collapsed.

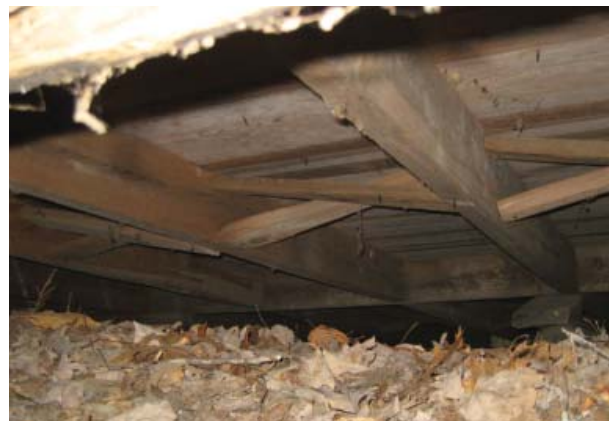
The flooring system is made of wood joists that measure 2" by 6⅛" and are spaced 24" on center. The floor joists run east-west. A floor girder of the same size runs north-south at the center of the room. The finished flooring is made up of 1" thick by 3¼" wide wood boards that run north-south. The underside of the flooring is labeled with the name of the manufacturer, the Bogalusa Lumber Company.

**Figure 8,** Modern conventional floor framing and flooring, both with Bogalusa Sawmill stamp, installed during 1932 reconstruction.

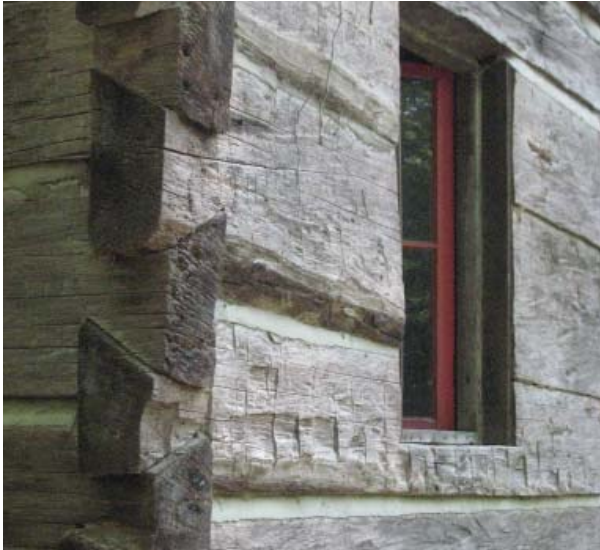
The hewn logs of the cabin are roughly 6" wide and vary in height from 10" to 13". It is thought that the logs are made of poplar. They have half-dovetail notching at the corners and Portland cement rich chinking. The bottom log at the west and west elevation is unhewn and intended to be sacrificial. Close to grade, each will decay more quickly than the upper logs. Therefore, the bottom log is unfinished, expected to be replaced more quickly than the other logs.

Figure 9, Half-dovetail notching at log corners.

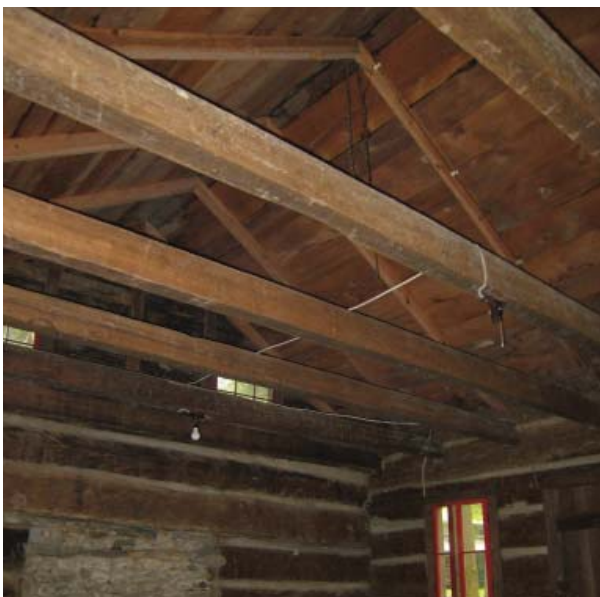
Above the logs, at the gables on the north and south elevations, there are three vertical struts to support the roof framing. Each gable end is finished with weather boards.

Figure 10, View of exposed roof structure.

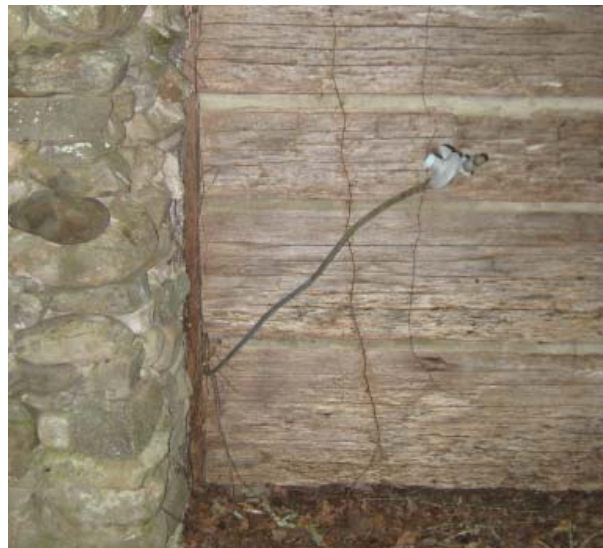
Heating would have been provided by the wood-burning fireplace on the south wall. Additionally, there are remnants of a gas supply line on the south wall, just east of the fireplace. This likely was used for a space heater.

Figure 11, Gas line connection at south wall.

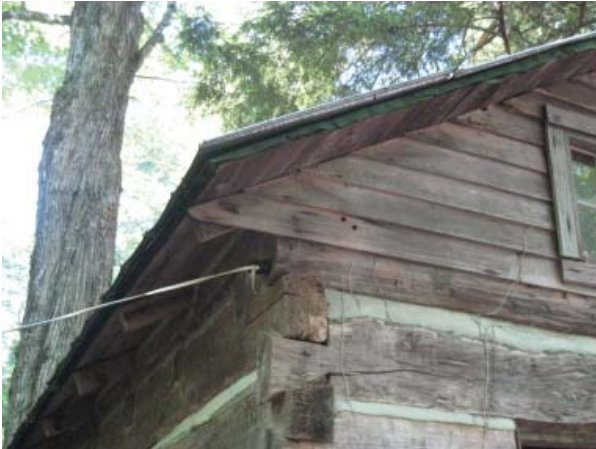
**Figure 12**, An electrical wire connected the Mayo Servants' Quarters to the Trentham Cabin fuse box, which in turn connected to the Mayo Cabin.

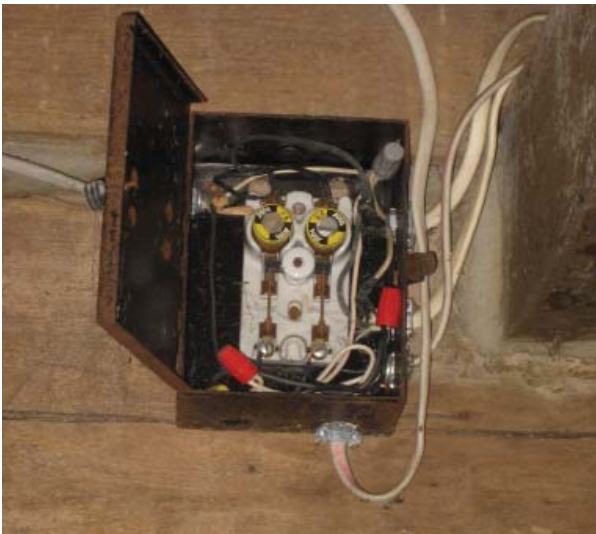
**Figure 13**, Early fuse box on the interior surface of the west wall of Trentham Cabin.

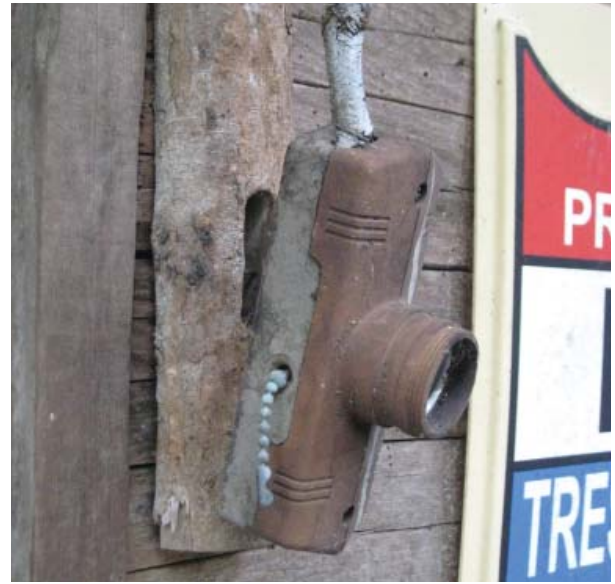
**Figure 14**, Early Bakelite Corporation light fixture mounted to the south side of the front entrance door.

There is one exterior light fixture mounted just south of the front, or west, entrance door. The fixture is made by the Bakelite Corporation, which was popular during the second quarter of the nineteenth century. A similar wooden board that this fixture is mounted to is found on the east elevation, next to the door, but there is no longer a light fixture mounted to it.

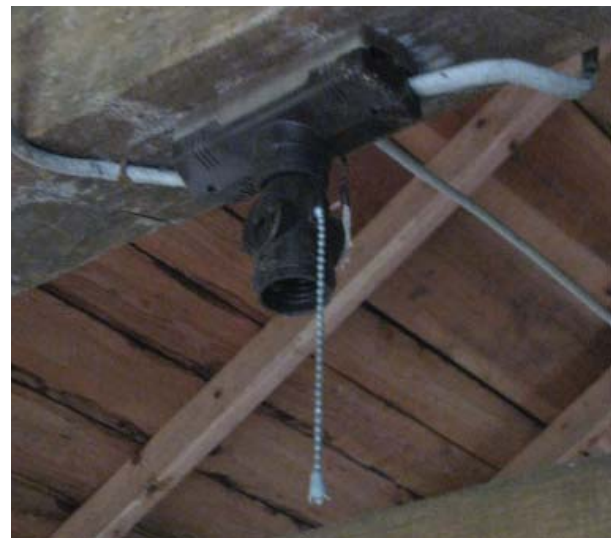
**Figure 15**, Early Bakelite Corporation ceiling-mounted light fixture inside of cabin on bottom of collar beam.

There are two ceiling-mounted light fixtures attached to the underside of the collar ties that date to the 1940s. The fixtures are Bakelite brand bases and they are both missing globes.

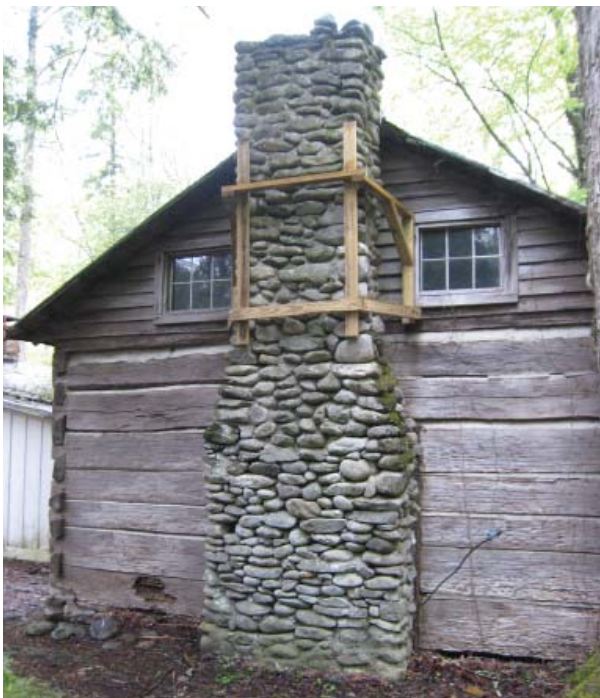
**Figure 16,** River stone chimney on south elevation with recently added frame for support.

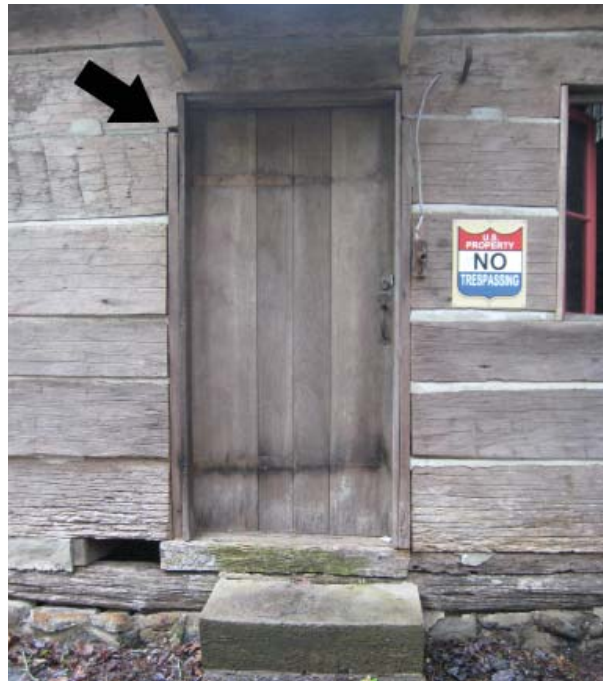
**Figure 17,** West elevation doorway notched for earlier, shorter and wider door.

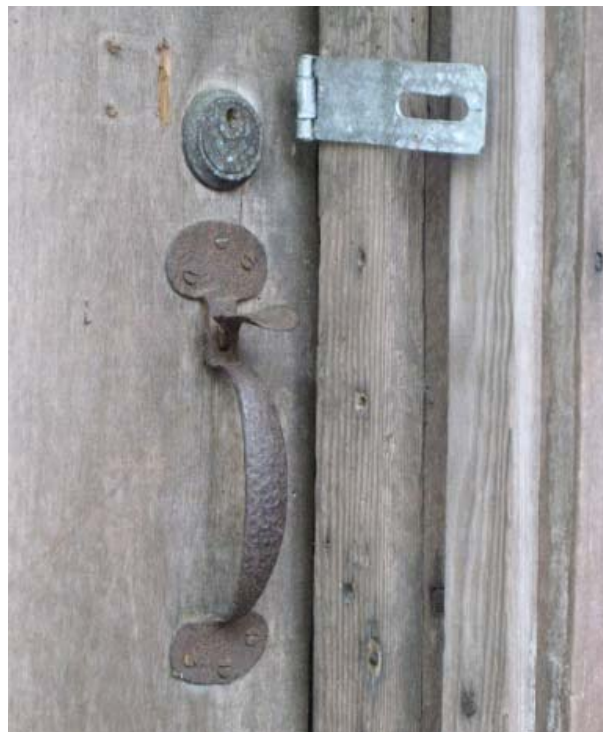
**Figure 18,** Wrought handle at west elevation front door.

There are ghost marks of two 32" long strap hinges on the outside surface of the front door. There currently are two 12" three-knuckle steel barn hinges. The door has a wrought handle but is missing the lock. There is a modern 3½" Yale hardware lock. Outside, just south of the doorway, a hammered metal rod probably held a lantern.

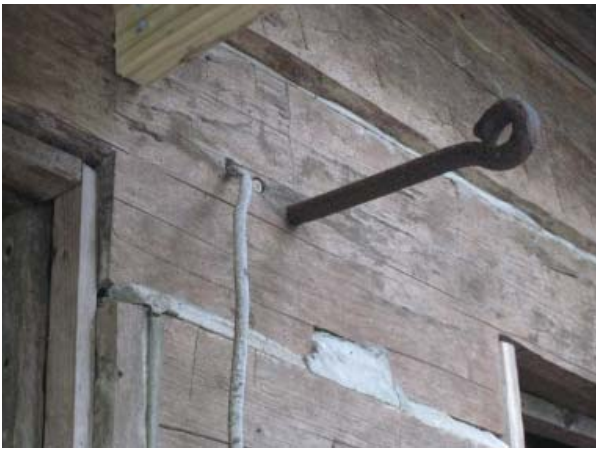
**Figure 19,** Hammered metal rod probably held an exterior lantern.

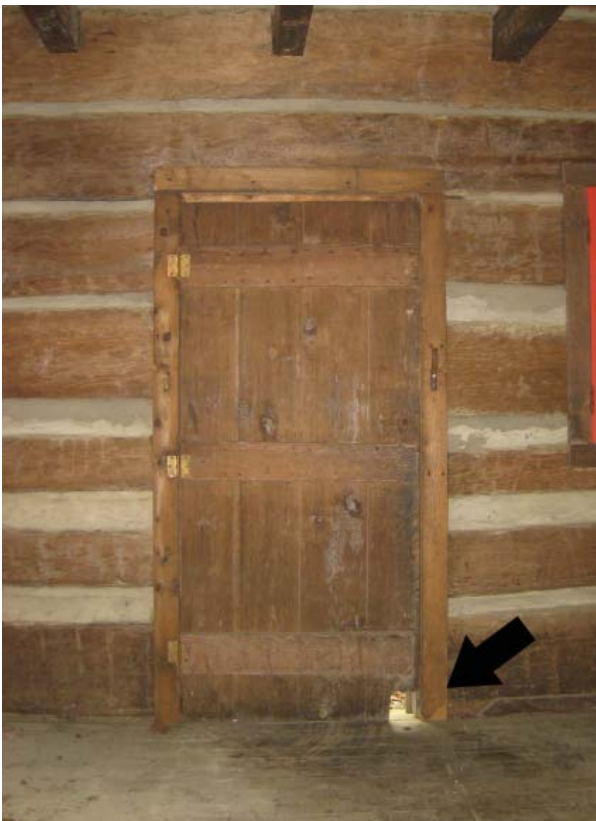
**Figure 20,** Interior side of east entrance door with corner notch for passage by the cat. Door is a 1932 reconstruction.

The back doorway on the east elevation has a two-part screen door and a board-and-batten door. The board-and-batten door is also thought to be made of walnut. It is constructed of square-edged tongue and groove boards and is assembled with cut nails. The door measures 2'-8" wide and 5'-11" tall. It has three 3½" five-knuckle brass-plated butt hinges that are mortised into the door. The door has a wrought handle with a missing lock mechanism and one remaining strap on the south door jamb for a lock bar.

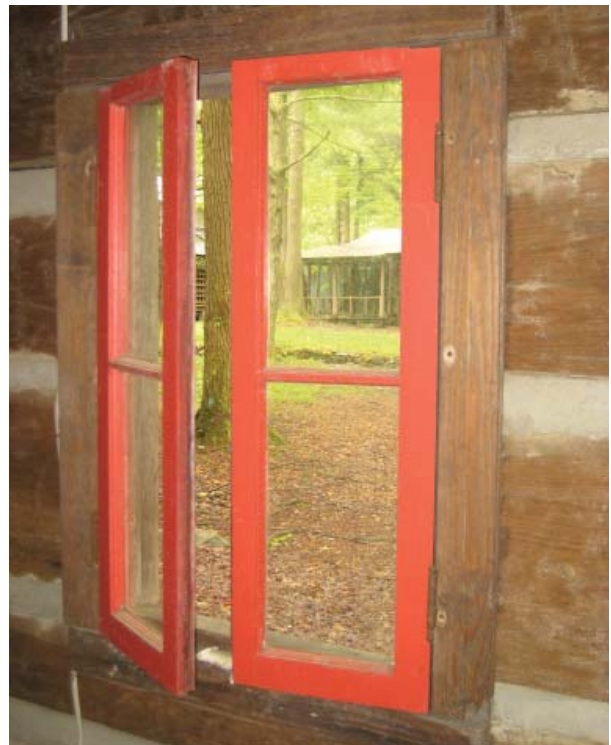
**Figure 22,** Typical paired casement window. Casing constructed in 1932 from floor boards from the Bogalusa Sawmill.

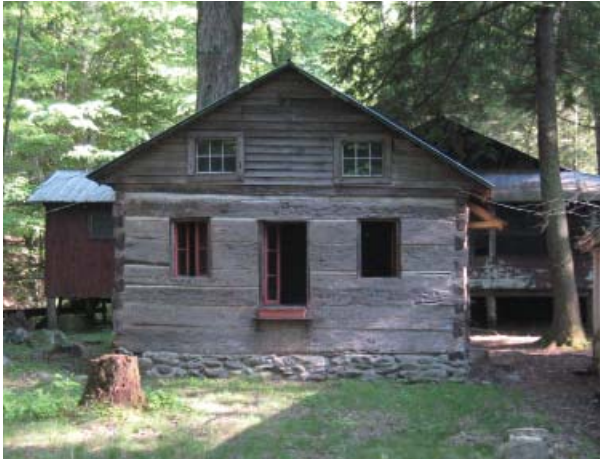
**Figure 23,** All five windows of the north elevation were reportedly added during the 1932 reconstruction. Only one window opening, probably on the west elevation, is original.

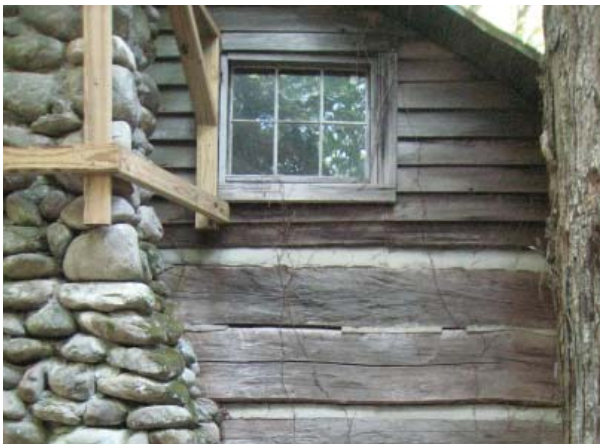
**Figure 24,** Typical side-hinged sash window of gables.

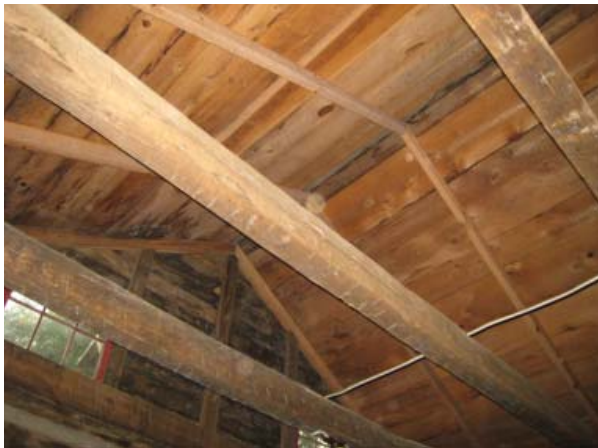
**Figure 26,** Exposed collar ties and roof rafters.

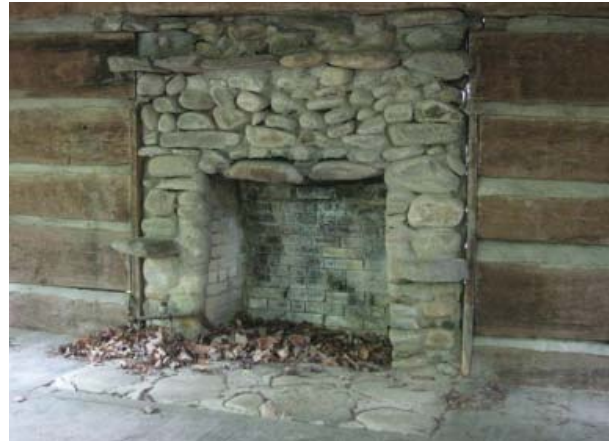
**Figure 27,** River stone fireplace with brick firebox constructed on the south elevation in 1932.

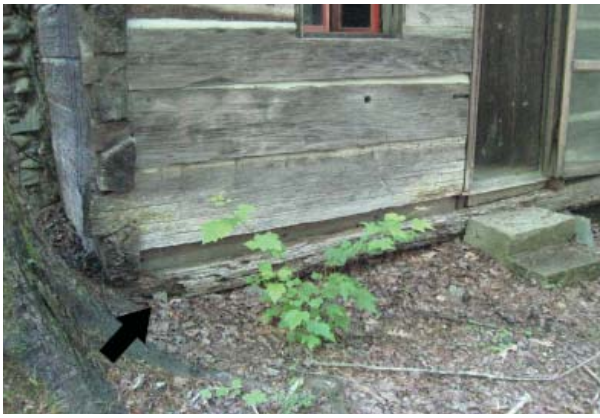
**Figure 28,** Southeast corner exhibiting rot in bottom logs, both south and east elevations.

There is rot in the lower logs, especially along the south elevation and the south ends of the east and west elevation logs where grade is high and rain water pools and is not diverted away from the building.
