## Preliminary Geothermal Analyses of the Area at the Historic Old Faithful Pub, Yellowstone National Park

By  
Henry Heasler, Ph.D., Cheryl Jaworowski, Ph.D. Chelsea Feeney, M.S., Brett Carr, M.S., and  
Duncan Foley, Ph.D.  
Geology Program, Yellowstone Center for Resources  
Yellowstone National Park

24 August 2009

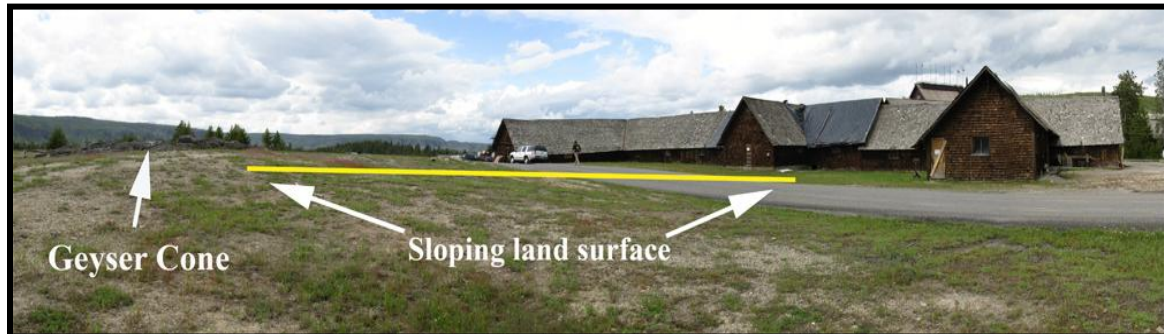
Figure 1. Panoramic view of the historic Old Faithful Pub located near the Old Faithful Inn. Notice the geyser its cone on the left of the photograph and the sloping land surface extending from the geyser cone towards the pub. The sloping land surface is the siliceous sinter apron produced by flowing hydrothermal water. On 22 July 2009, the temperature at 20 inches (51 cm) depth in the geyser cone was 186 °F (85.5 °C). Photograph taken on 26 June 2009, view to the north.

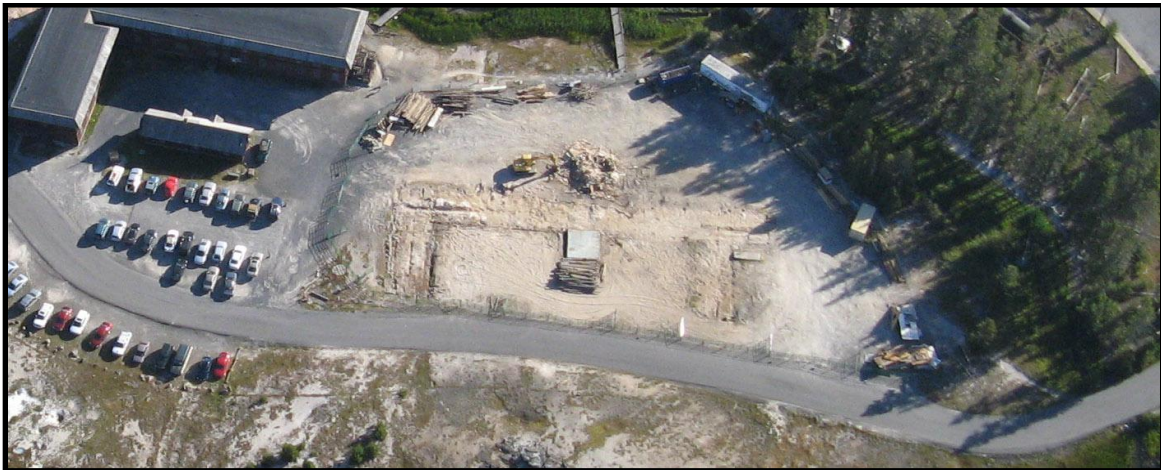
Figure 2. Aerial view of the historic Old Faithful pub taken on 20 August 2009. The complete removal of the building as part of the historic renovation allowed a detailed ground temperature survey. The outline of the former building can be seen in the center of the photograph. View is to the northeast.

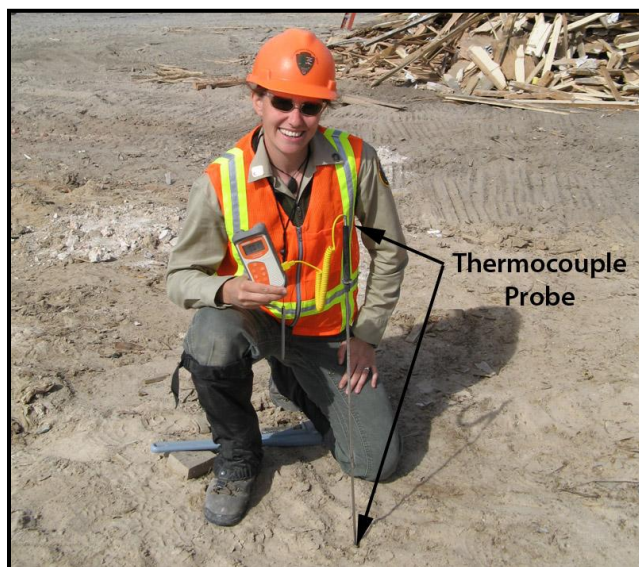
**Figure 11.** The Oakton Acorn thermocouple-thermometer using a type K thermocouple probe that is a hollow ¼ inch (6.4 mm) diameter, stainless-steel tube, 41 inches (104 cm) in length. Photograph was taken in the construction area on 18 August 2009. Chelsea Feeney, Geological Society of America Geocorps volunteer, is measuring temperatures at 10 inches (25 cm) depth.

One effect of high temperatures is the alteration and subsequent softening of the ground. This can be clearly seen in Figure 12. Figure 12 shows locations where the thermocouple probe could be hand-pushed below 30 inches (76 cm) depth. Because the 41 inch (104 cm) length thermocouple probe (Figure 11) is relatively flexible, any penetration of the probe into undisturbed ground means the ground is relatively soft. Thus, Figure 12 maps the area of soft ground resulting from both hydrothermal alteration and the deposition of soft, thermal deposits.

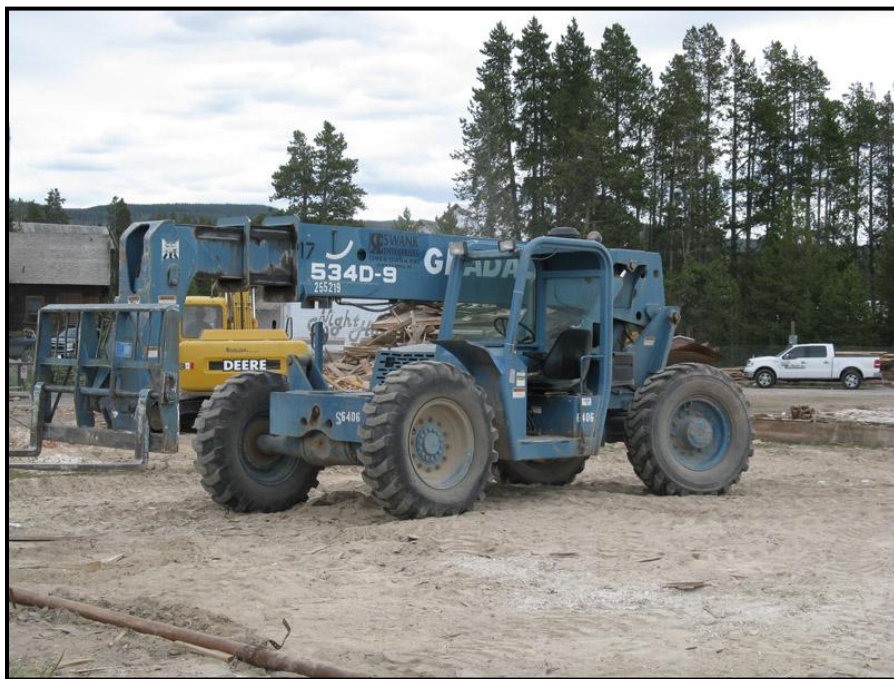
On 18 August 2009, Brent Cotton, Site Superintendent for Swank Enterprises described the equipment breakthrough (Figure 13) on 12 August 2009 at two sites:

“Gradall forklift 534D-9 pulled into existing building location and the rear tire sank into a mud pit, like squeezing, wet, saturated mud. Color of mud was red. And it was hot. Gradall also was empty. Gradall forklift had to be pushed out with an excavator.”

“About 15 to 20 feet to the west, operator was pulling into site with Gradall 534D-9 (empty) and as he was driving in, the ground started to make a wave or move under the tires. The rear tires sank into the mud hole. The mud hole was hot, red, and squishy.”

**Figure 13.** Photograph of fork lift that twice broke the ground surface into active thermal ground on 12 August 2009 between 3 to 3:30 p.m. MDT. Photograph taken 18 August 2009. Location of the two breakthroughs are shown in Figure 8 noted by the 152 °F (67 °C) temperatures outside the northeastern edge of the building.

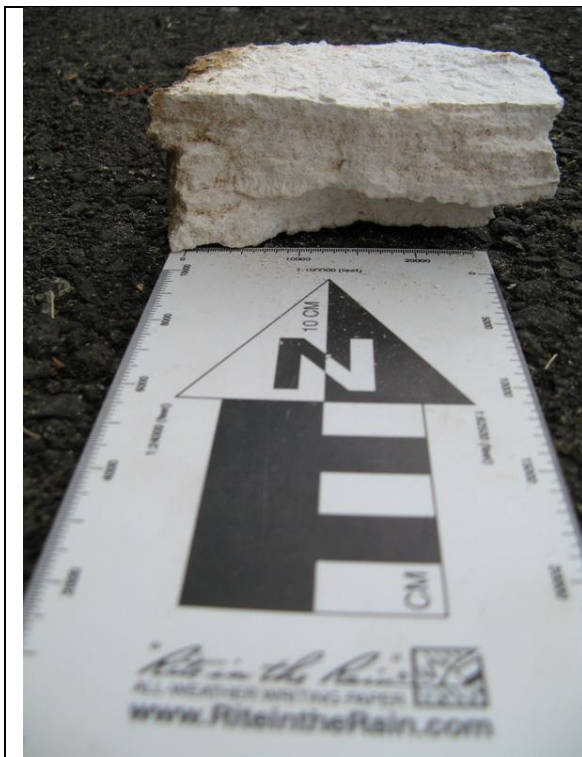
**Figure 14.** Photograph of top layer exposed in a trench. This layered sediment easily breaks by hand.

Examination of excavated rocks and trenches show the following sequence of rocks from top to bottom (0 to 40 inches (0 to 102 cm) or less): (1) a soft, lightweight, layered rock, (2) silica-rich sinter of variable hardness and open spaces and (3) a red-clay layer underneath hard sinter. The top layer (Figure 14) easily can be broken by hand. Construction crushed this layer and spread a fine, light tan or grey powder over the site. This fine powdered sediment limits the maximum surface temperatures recorded by the FLIR camera. The silica-rich sinter (Figure 15) can be made of fragments of sinter cemented together or can be a solid and very hard layer. The hardest layer of sinter occurs just above the red-clay layer (Figure 16). In order to measure a temperature with the flexible temperature probe, this very hard layer had to be penetrated with a steel rod. After penetration of this layer with a rod, the temperature probe could be pushed by hand into the red-clay layer (Figure 17). This same sequence of rocks occurs throughout the entire area of the historic pub.

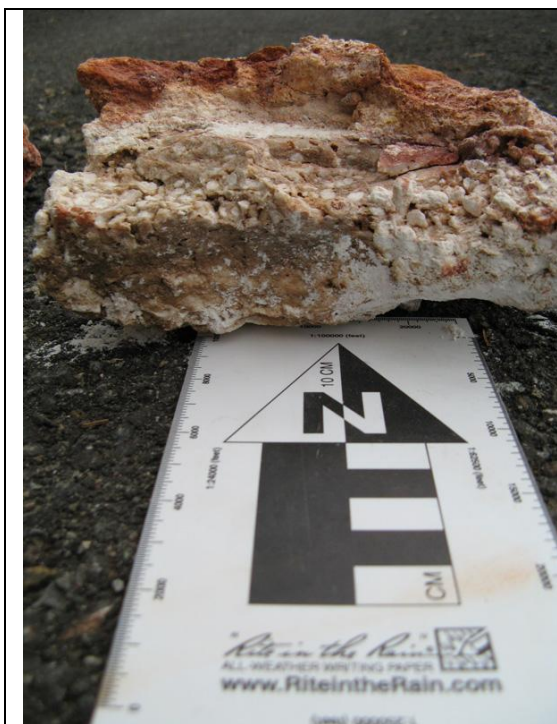
**Figure 16.** Photograph of hard sinter and red-clay layer.
