## Anthropogenic Impacts to the Hydrothermal System within the Old Faithful Area, Yellowstone National Park

By  
Henry P. Heasler and Cheryl Jaworowski  
Yellowstone Center for Resources  
Yellowstone National Park

18 October 2011

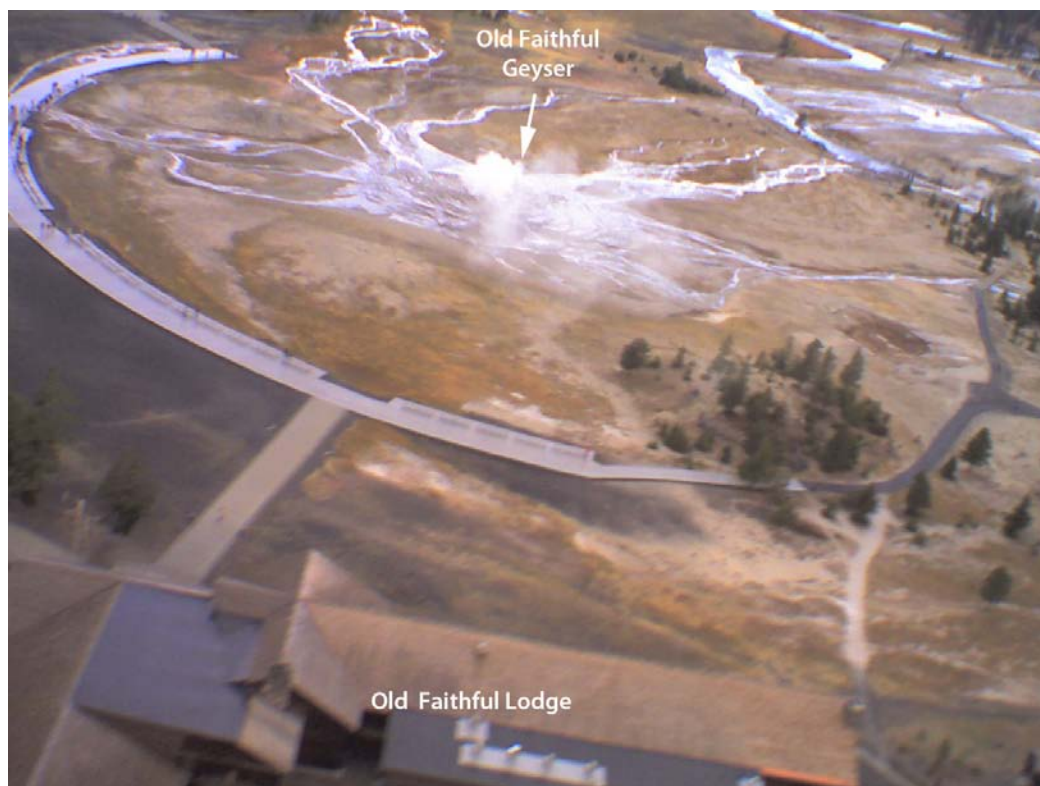
On 10 & 11 May 2004, Carolyn Loren and Beth Taylor (Division of Interpretation, Old Faithful) notified Hank Heasler about an area of steaming ground located between Old Faithful Geyser and the Old Faithful Lodge (Heasler and Jaworowski, 2004). A temperature of 200.7 °F (93.7 °C) was measured at a depth of 2 inches (5 cm) in the area of concern. Jim Knolke, Old Faithful Maintenance Chief in 2004, indicated that the hot area was near a manhole that had been removed for an abandoned sewer line. According to Mr. Knoelke, the sewer line had been abandoned, but not removed, because the ground was too hot for a useable sewer line.

Notice the area of the abandoned sewer line (Area A on Figure 2) in both visible (Figure 3) and daytime thermal infrared (Figure 4). The concentration of heat and temperature by the sewer line is easily visible in the *daytime* thermal infrared image taken on 2 October 2011.

**Figure 3.** Visible, helicopter-oblique photograph taken 2 October 2011. View to the northwest.

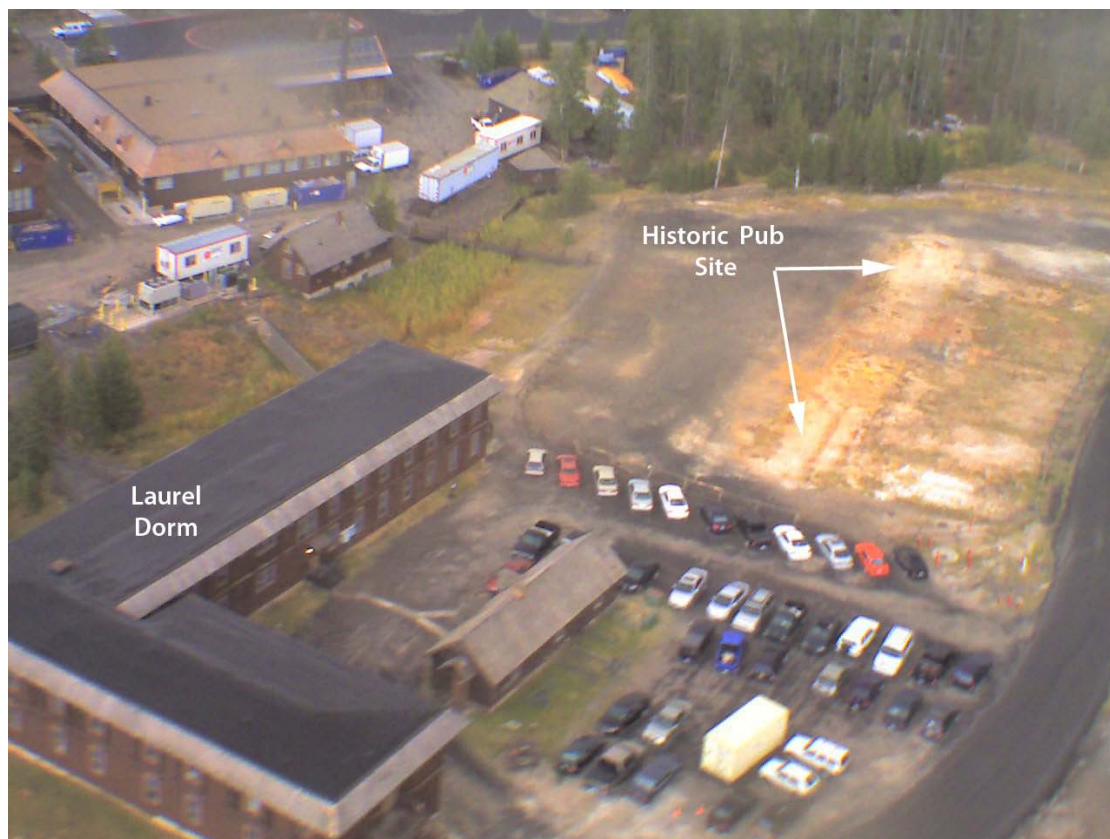
Two reports detail the *active hydrothermal system* that was found at the historic Old Faithful pub (Heasler et al, 2009a, Heasler et al, 2009b). The active hydrothermal system included the following (1) geothermal gases ( >100 ppm hydrogen sulfide and 24.9% carbon dioxide), (2) boiling temperatures at two locations at depths of 30 and 38 inches (76 and 96 cm), and (3) construction equipment, a fork lift, that twice broke the ground surface into the active thermal system on 12 August 2009 between 3 to 3:30 pm MDT.

Both visible (Figure 5) and thermal infrared (Figure 6) show the area of the historic Old Faithful pub (Refer to Area B on Figure 2). Anomalous high temperatures associated with the historic pub infrastructure are visible in the 2 October 2011 daytime thermal infrared image (Figure 6). Figure 6 also indicates a narrow, linear pattern of high temperatures extending from near the historic pub site towards the Old Faithful Inn. These anomalous temperatures were documented in the 2009 YCR reports. This linear pattern is most likely associated with unknown infrastructure.

**Figure 5.** Visible, helicopter-oblique photograph taken 2 October 2011. View to the southeast.

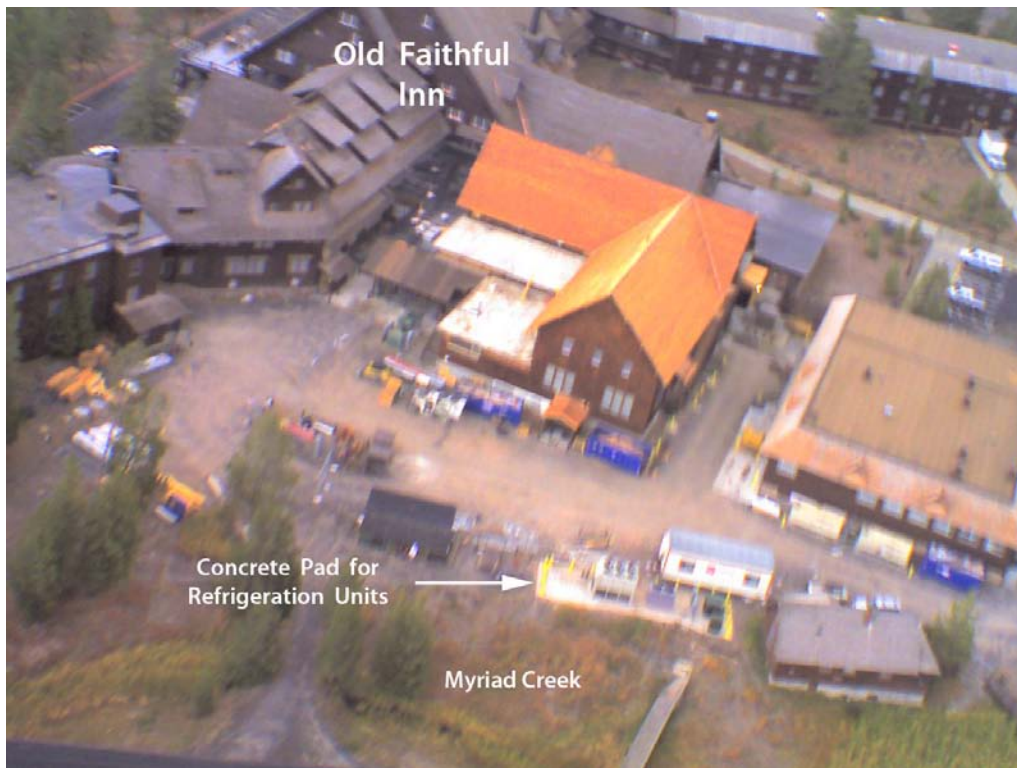
In 2010, a concrete pad was placed for refrigeration units to cool both the Old Faithful kitchen and the food storage area to the south of the kitchen (Refer to Area C on Figure 2 as well as Figures 7 & 8). Trenches for refrigeration pipes were dug and backfilled in spring 2010. The five-foot deep trenches were dug into red-to-white, hydrothermally altered clay that commonly forms a seal to the hydrothermal system in the Old Faithful area (Heasler and Jaworowski, 2010).

**Figure 7.** Visible, helicopter-oblique photograph taken 2 October 2011. View to the east.

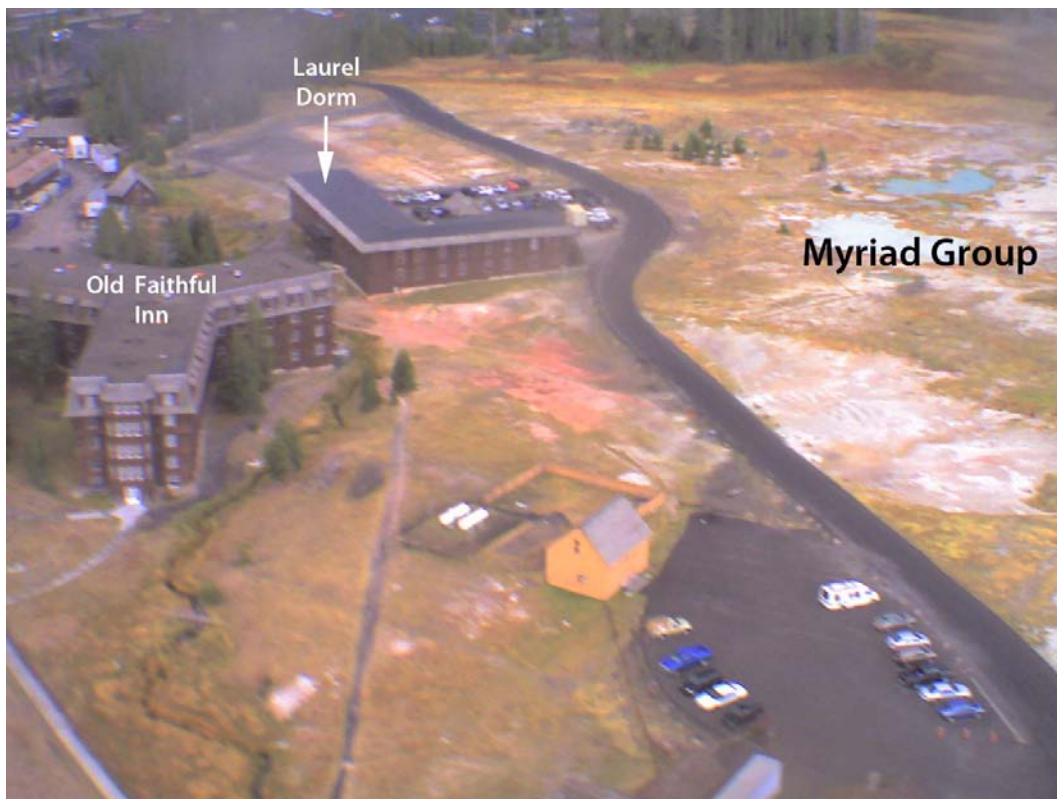
This service road connects the lower Yellowstone General Store and the lower gas station with the west parking lot (Refer to Area D on Figure 2). Figures 9 and 10 show the service road behind the Old Faithful Inn and its location with respect to the *active hydrothermal system of the Myriad Group*. The asphalt of the road traps vapor-transported heat and also greatly decreases the infiltration of surface water.

**Figure 9.** Visible, helicopter-oblique photograph taken 2 October 2011. In the center of the photograph, the red-orange clay left of the road and the pale-white ground to the right of the road outline the surficial extent of the Myriad Group. Compare this visible image with a corresponding thermal infrared image in Figure 10. View to the southeast.

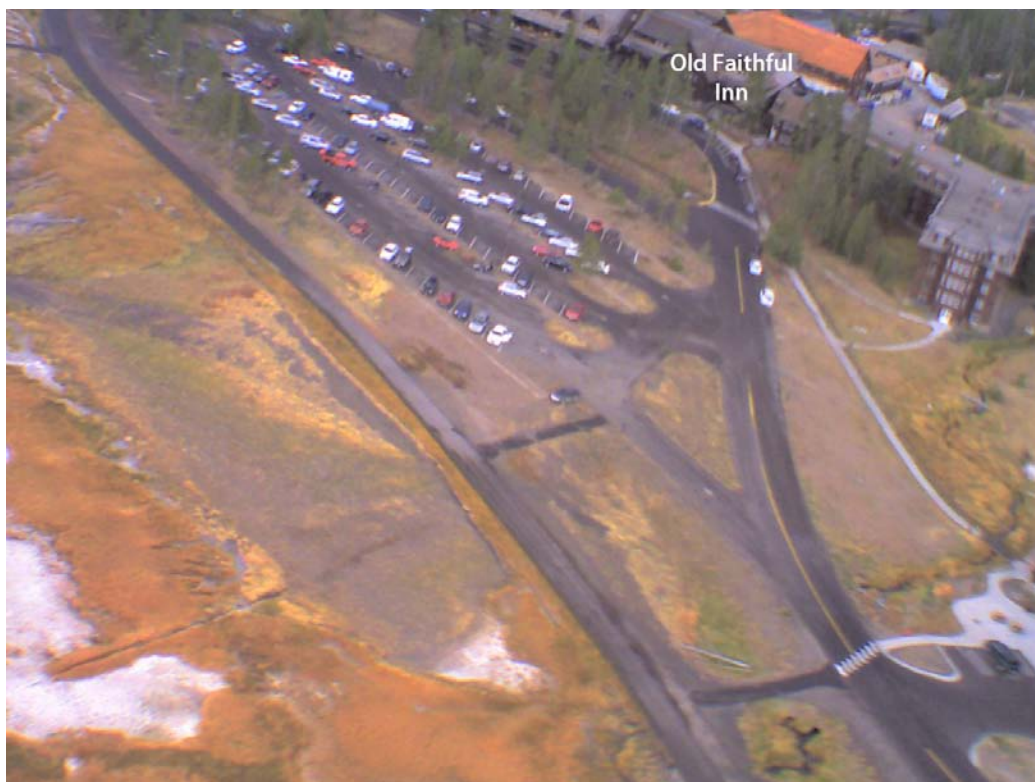
It is not surprising that this snow-free area (Refer to Area E on Figure 2) during the winter emits approximately 300 to 450 kilowatts. Both the visible (Figure 11) and daytime thermal infrared (Figure 12) images show an **active** hydrothermal system near the Old Faithful Inn. In the visible image (Figure 11), golden vegetation on the meadow outlines a hydrothermal area. In the corresponding daytime, thermal infrared image a similar extent of the **active** hydrothermal area can be mapped. The daytime, thermal infrared image shows the high-temperature portion (white, red, yellow and green colors) of a hydrothermal system interacting with anthropogenic activity near the Old Faithful Inn. The hot and colorful thermal area (Figure 12) is of unknown origin. However, the narrow, linear pattern of high temperatures aligned with the edge of a parking area suggests a possible anthropogenic origin.

**Figure 11.** Visible, helicopter-oblique photograph taken 2 October 2011. View to the southeast.
