## Hydrothermal Assessment of Proposed Old Faithful Inn Sewer Line Routes, Yellowstone National Park

By  
Henry Heasler, Cheryl Jaworowski, and Dan Mahony  
Geology Program, Yellowstone Center for Resources  
Yellowstone National Park

17 July 2014

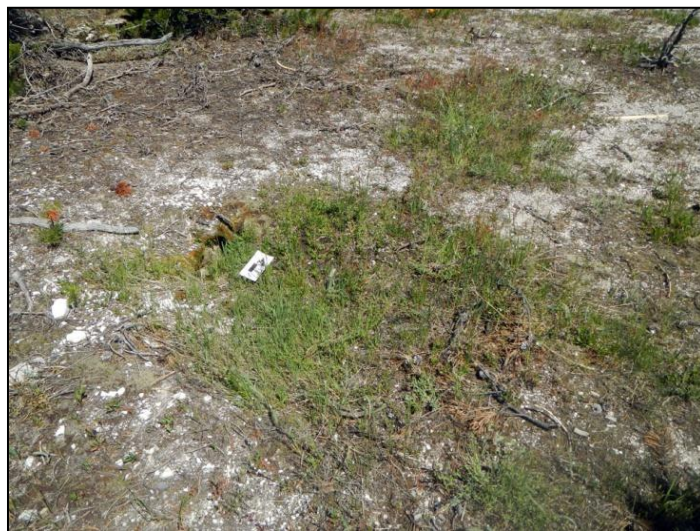
**Figure A1.** Photograph of hydrothermal depressions “A1 and A2” on 2 July 2014. Notice the green depressed areas with vegetation. The black-and-white portion of the north arrow is 10 cm in length.

The gas measurement technique used on 15 May 2014 and 24 June 2014 is not applicable in the area of cavernous ground shown in Figures A1-A4. Caverns and vents form conduits for the collection of hydrothermal gases. Thus, a network of drill holes would not provide reliable values of carbon dioxide concentration.

Also, the temperature measurement technique used on 15 May 2014 and 24 June 2014 is not applicable in the area of cavernous ground shown in Figures A1-A4. The presence of air in the caverns drastically changes the temperature pattern in the ground making the temperatures difficult to interpret.

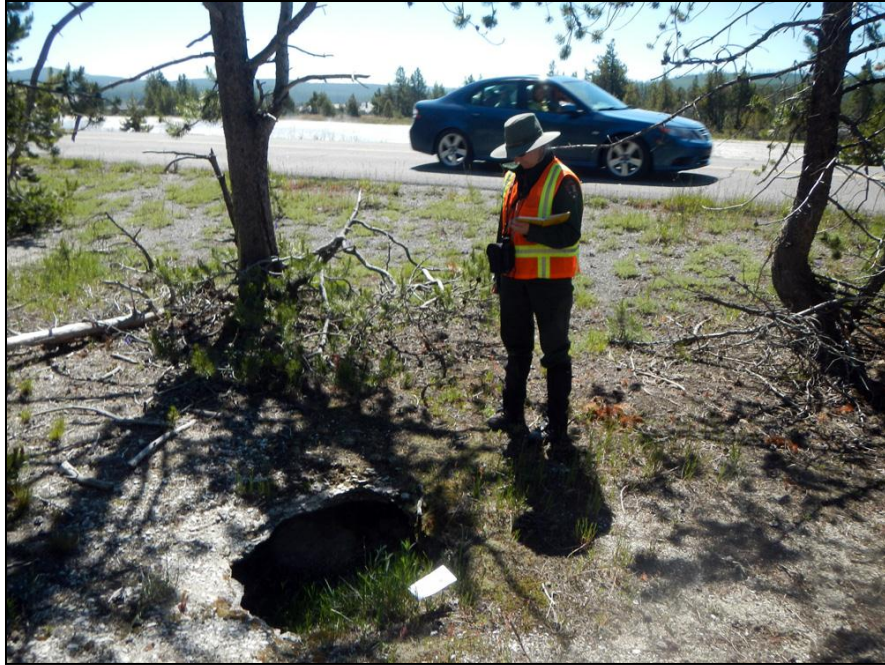
**Figure A2.** Photograph of hydrothermal vent “C”. The two-lane service road is visible in the background. View to the south on 2 July 2014.

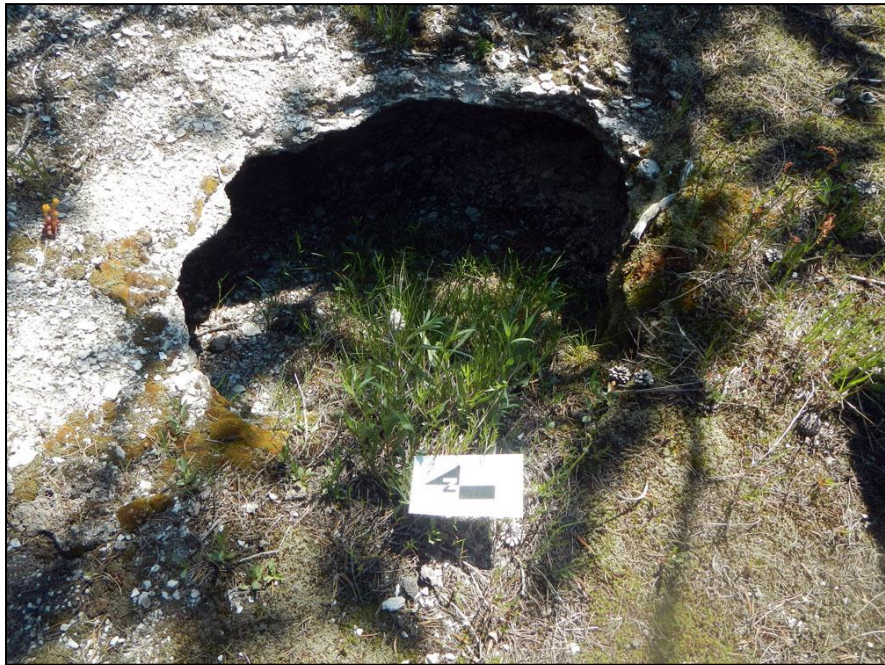
**Figure A3.** Photograph of hydrothermal vent “C” on 2 July 2014. Notice the green vegetation at the mouth of the cavern potentially indicating the presence of water vapor. The black-and-white portion of the north arrow is 10 cm in length.

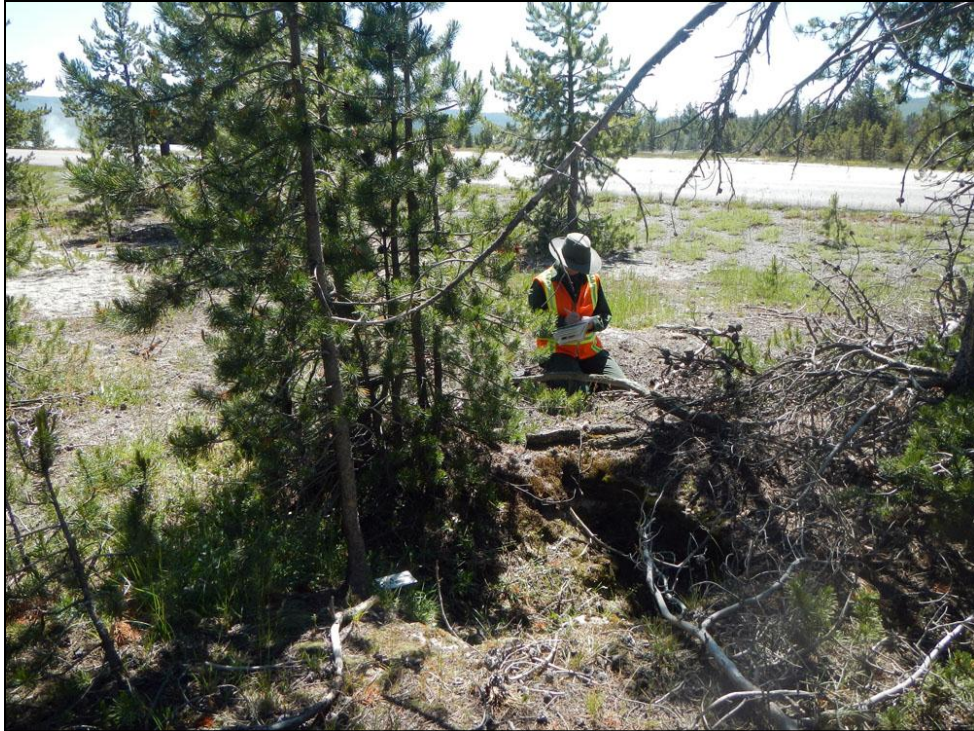
**Figure A4.** Photograph of hydrothermal vent “D”. The two-lane service road is visible in the background. View to the south on 2 July 2014.

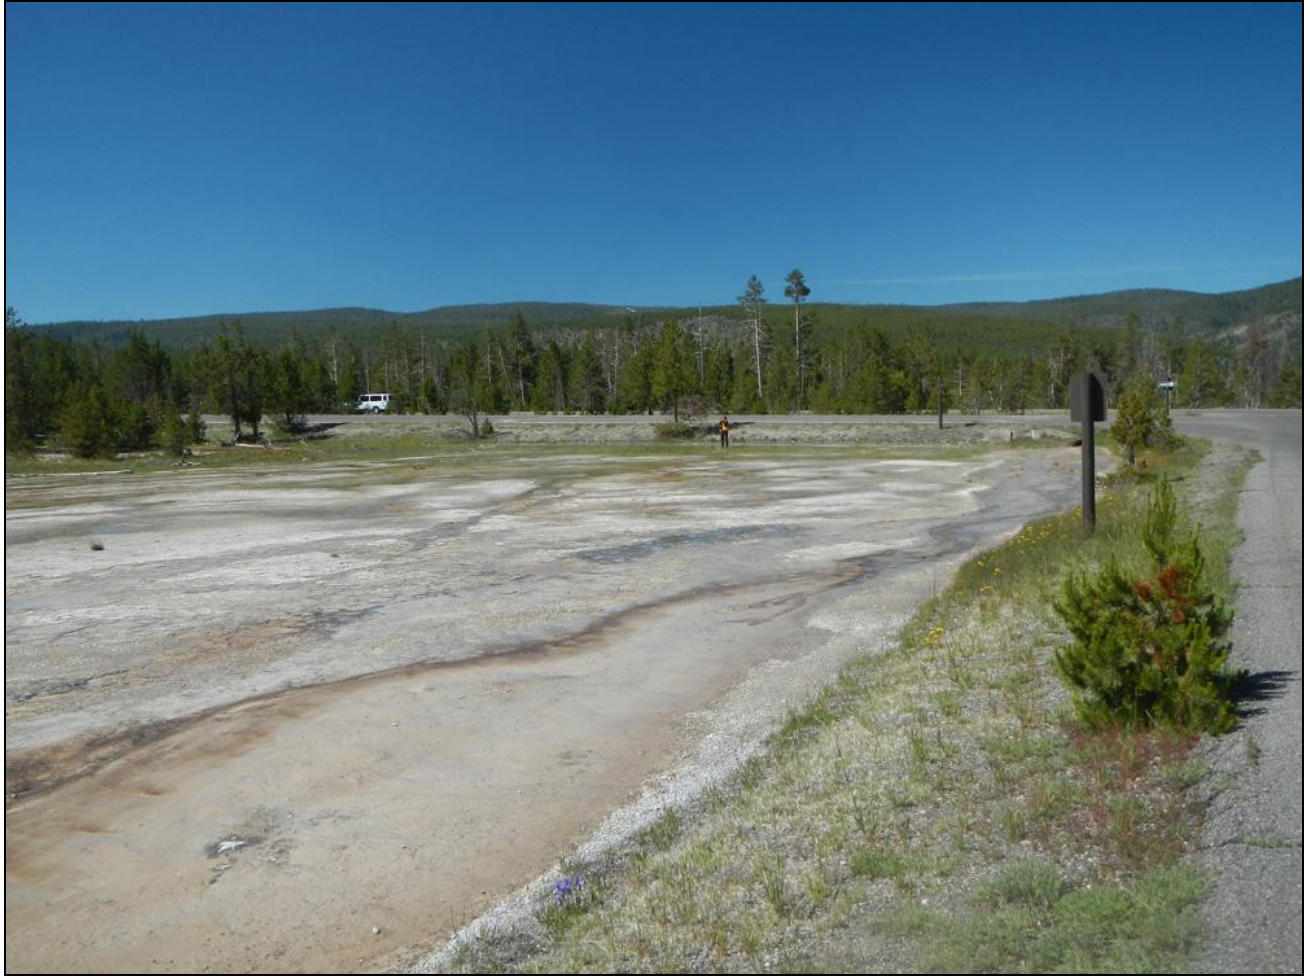
After crossing the two-lane service road, the next portion (approximately 38 m N-S; 24 m E-W) of the alternate sewer line route traverses an area with flowing hydrothermal water. Some hydrothermal water (~15-20 gpm, visual estimate) exits through a culvert while other hydrothermal water stagnates near the road embankment (Figure A5). Various plants grow on the wet, siliceous sinter (Figures A5 and A6).

**Figure A5.** Photograph showing an alternate sewer line route. The alternate route crosses the two-lane service road near the intersection of the two-lane service road with the four-lane road. The YNP staff near the upper center of the photograph is standing near the four-lane road and along the proposed alternate route. Hydrothermal water from the Three Sisters flows towards the culvert and stagnates by the road embankment. View to the west on 2 July 2014.

Yellowstone geologists would not be able to measure temperatures nor hydrothermal gases in the area shown in Figures A5 and A6 due to the presence of water. Water flowing into drilled holes invalidates temperature measurements and precludes the measurement of gases.

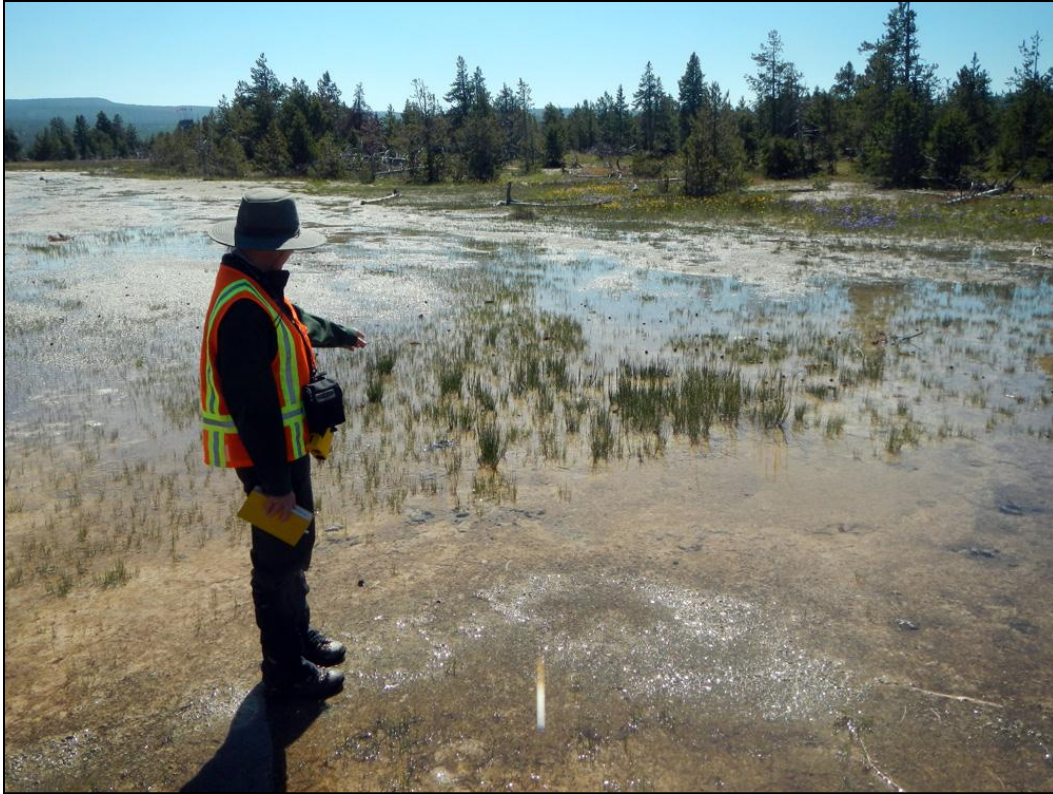
**Figure A6.** Close-up of YNP staff in Figure A5 showing sea arrowgrass (*Triglochin maritima*; Roy Renkin, Yellowstone National Park, 17 July 2014) in bloom and growing on wet, siliceous sinter near the four-lane road embankment. The YNP staff is standing near the proposed route and is pointing in the approximate direction of the alternate sewer line route. View to the south on 2 July 2014.
