August 14, 2007

### **Observations of Duke Power's Right-of-Way Power Line Clearing through the Oconaluftee Area of Great Smoky Mountains National Park**

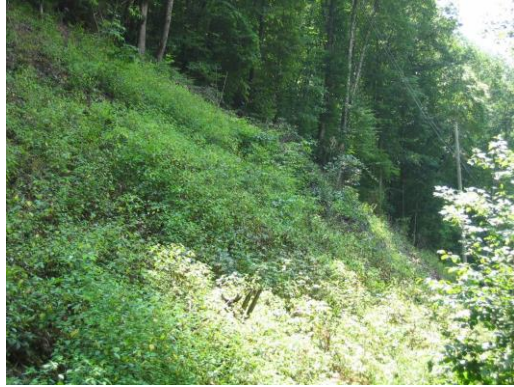
**107-0763**

The entry point for the power line is on Tow String Road heading towards Tow String horse stables. The lines enter the park below the Tow String Community sign (no white and green Park Service boundary signs were observed) and cross the road over a stream. This first site is recorded on the GPS unit as 031. Corresponding photos for this site are labeled 107-0763, 107-0764, 107-0765 (herbicide burn), and 107-0766 (~50m below 107-0765).

- Native jewelweed re-vegetating the area, exotic honeysuckle invading
- Spiders and flying insects observed on rocks and over water
- No aquatic organisms were observed in the water

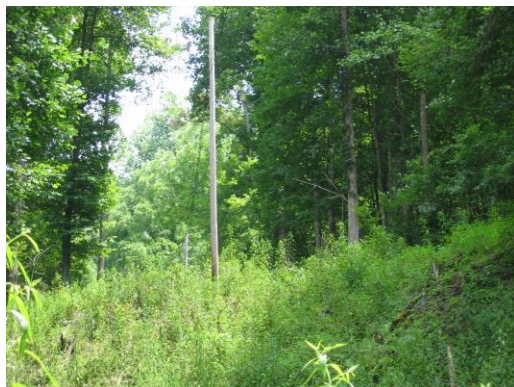
**107-0767**

The lines emerge from the woods into the Tow String barn and horse pasture. This site is recorded on the GPS unit as 032, with corresponding photo 107-0767.

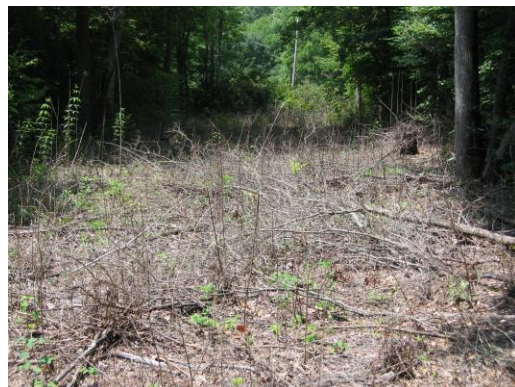
**107-0768**

From the barn, the power lines follow a short right-of-way to parallel the Oconaluftee River and Tow String service road, through the horse camp to the Tow String trailhead. This site is recorded on the GPS unit as 033, with corresponding photo 107-0768 (herbicide burn).

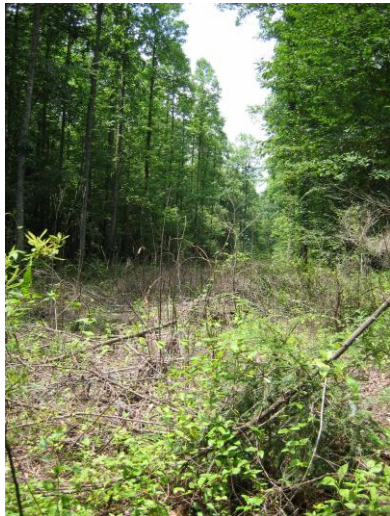
**107-769**

The lines cross the trailhead gate and parallel to the right of the service road (trail) through a large maintained, mowed field. The lines then cross the road into a right-of-way. This site is recorded on the GPS unit as 034, with corresponding photo 107-0769.

- Invasive honeysuckle
- Right-of-way appears heavily sprayed and dead, not much native re-vegetation
- No stream crossings

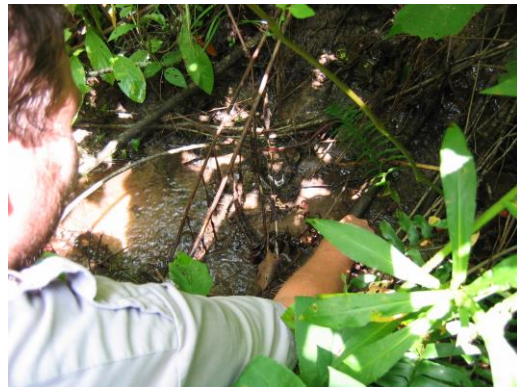
**107-0770**

The right-of-way continues towards the Smokemont water and sewer treatment plant and Smokemont riding stables. Just before the lines reach the sewer plant, they cross a small tributary to the Oconaluftee River, marked directly under the power lines on the GPS unit as site 035, with corresponding photo 107-0770.

- Thick vegetation, not burned and dead, no exotics observed
- No signs of aquatic life observed

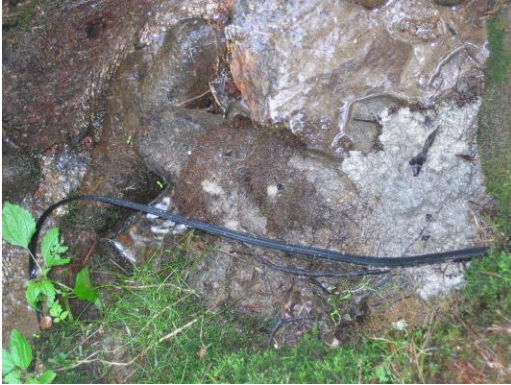
**107-0771**

At Smokemont stables, the lines go behind a house trailer and over a small wetland area. This site is marked on the GPS unit as 036, with corresponding photos 107-0771 and 107-0772.

- Thick vegetation- native jewelweed, etc.
- Wetland rocks very mossy, stoneflies observed

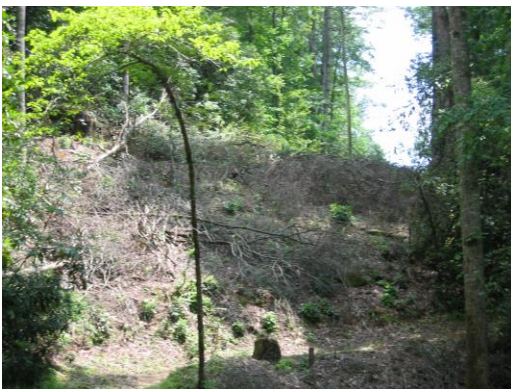
**107-0773**

The lines leave the stables into a sprayed right-of-way through the woods to Smokemont Road at Smokemont Baptist Church. This site is recorded on the GPS unit as site 037, with corresponding photo 107-0773 (dead, burned vegetation).

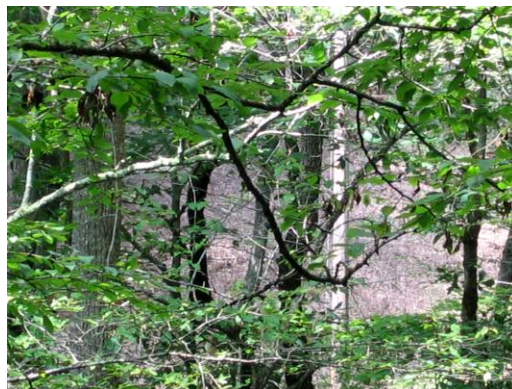
**107-0774**

The lines then follow a horse trail and Smokemont Road to the Smokemont campground at the Bradley Fork trailhead. This site is marked on the GPS unit as 038. Corresponding photo 107-0774 looks up a burned right-of-way to a utility building to the left of the Bradley Fork trail, ~1/8 mile up. Corresponding photo 107-0775 looks the opposite direction, down the burned right-of-way toward the confluence of Bradley Fork and the Oconaluftee River. The lines do not cross the stream here.

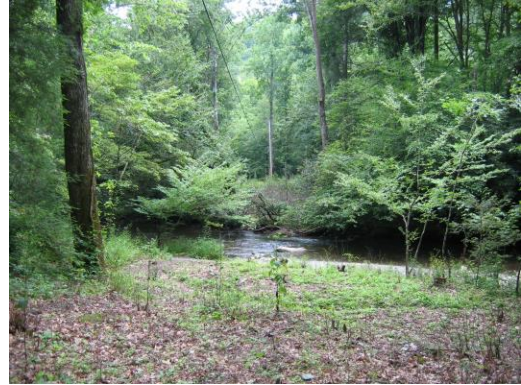
**107-0776**

The power lines do cross Bradley Fork ~300m further downstream towards the confluence, still within Smokemont campground. This site is recorded on the GPS unit as 039, with corresponding photo 107-0776.

- Grasses on stream banks, no honeysuckle or many other exotics observed
- Observed water striders, caddis fly larvae, and crawfish
- Large stream, no fish or salamanders observed- I would recommend spot backpack electro shocking about 50m to either side of the power lines, with emphasis on the downstream side, for further evidence

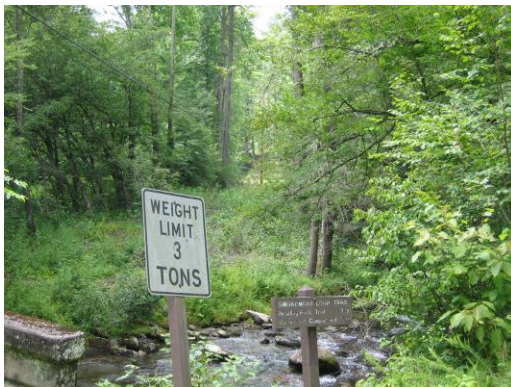
**107-0777**

The lines continue through Smokemont campground, on the opposite side of Bradley Fork, where they are intersected and joined by another set of lines crossing the stream near the confluence with the Oconaluftee River, near the bridge at the Smokemont Loop trailhead. This site is marked on the GPS unit as 040, with corresponding photo 107-0777.

- Lespedeza, grasses, other potential exotics present, though not heavily invading
- A minnow fish was observed

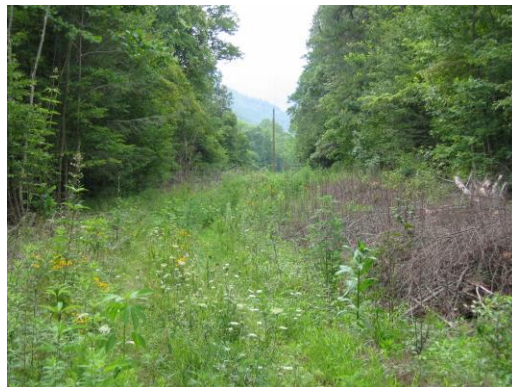
**107-0778**

The lines continue past the bridge, to the right of the Smokemont Loop trail, through a sprayed and burned right-of-way field. The lines cross the trail/service road, and where the Smokemont Loop trail cuts up the ridge to the right, a 4WD service road follows the right-of-way path. The vegetation here is thick re-veg, but shows evidence of past herbicide burning. This site is marked on the GPS unit as 041. Corresponding photo 107-0778 looks up the right-of-way towards Collins Creek while 107-0779 looks down towards Smokemont Loop trailhead. Photo 107-0780 also corresponds with this site.

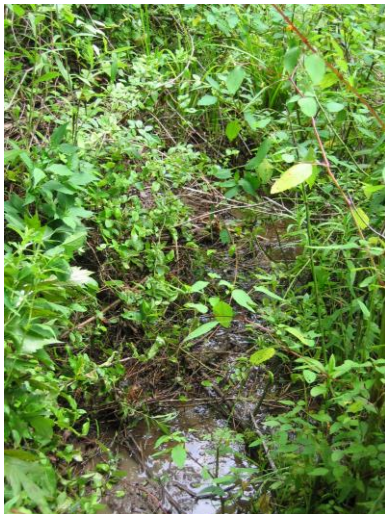
**107-0781**

The lines continue to follow the right-of-way with the 4WD road to where the road becomes impassable at a fallen sycamore, thick vegetation, and rough terrain, ~ 0.75 miles from its crossing of Highway 441. This section was not observed and may contain more potential stream and wetland crossings. At this site, the right-of-way area is thick with vegetation and passes through (is a) wetland habitat, directly under and around the lines, with several bogs occurring ~50m upslope from the lines and ~10m upslope from the right-of-way path. This site is marked on the GPS unit as 042 with corresponding photos 107-0781 (wetland under the lines), 107-0782 (thick vegetation with lines overhead), 107-0783 (Joey surveying wetland habitat for signs of life), and 107-0784 (bog).

- Honeysuckle, multiflora rose observed, along with wetland natives such as reeds (sp?), locust, etc.
- No aquatic life seen in flowing water near or under lines
- 1 small life form (helgramite?) observed in bog

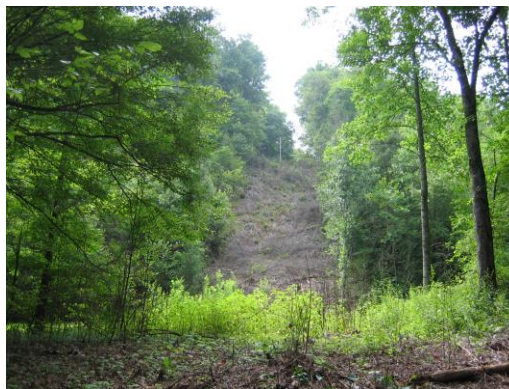
**107-0786**

The lines continue from this point down the right-of-way approximately 0.75 miles where they cross Highway 441 at a paved pull off on the right (heading towards Sugarlands from Oconaluftee VC- we backtracked to this point). At this junction, the lines head down a steep ridge, cross the Oconaluftee River and Highway 441, and continue up another steep ridge on the opposite side of the road towards Collins Creek picnic area. The steep right-of-way heading up the ridges on either side of the road and river is of special concern because it appears to be severely burned by herbicide, and the runoff would head downhill towards the river. This point is marked on the GPS unit as 043, with corresponding photos 107-0785 (looking across river, up the right-of-way towards Smokemont), 107-0786 (looking across road, up the right-of-way towards Collins Creek), and 107-0787 (river with power lines looking up ridge towards Smokemont).

- Clover and grasses observed, nothing invasive, site is disturbed (roadside pull off) and receives heavy visitor traffic
- Large stream- no aquatic life observed either under rocks or in stream approximately 15m to either side of the lines at the crossing
- Because of the potential for heavy herbicide runoff at this site and the lack of aquatic life, I would recommend spot backpack electro shocking ~50m to either side of the lines at the river crossing, with emphasis on the downstream side for further evidence

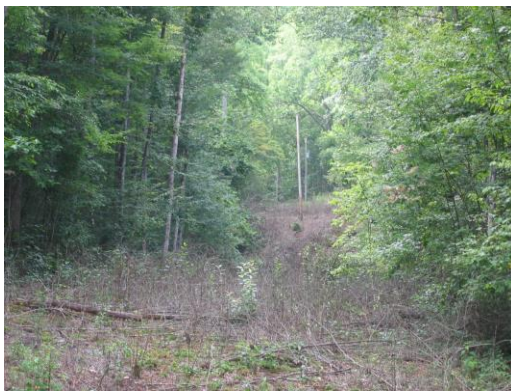
**107-0788**

The lines continue across the road, up the steep but short ridge, and down the other side to Collins Creek picnic area. This right-of-way section is approximately 0.25 miles long and was not observed, though the whole length can be viewed from either end and appears to be severely burned by herbicide with no stream crossings. The other end of this ridge can be viewed from the lower Collins Creek picnic area (where the lines enter the picnic area) and is marked on the GPS unit as 044, with corresponding photos 107-0788 (looking back towards Highway 441) and 107-0789 (looking towards the upper Collins Creek picnic area).

- Some jewelweed and rhododendron re-vegetating the right-of-way, though the area is still mostly dead and burned
