# Water Quality Monitoring for Bright Angel, Garden, Pipe, and Hermit Creeks in Grand Canyon National Park

## *2011–2013 Summary Report*

Natural Resource Data Series NPS/SCPN/NRDS—2016/1220

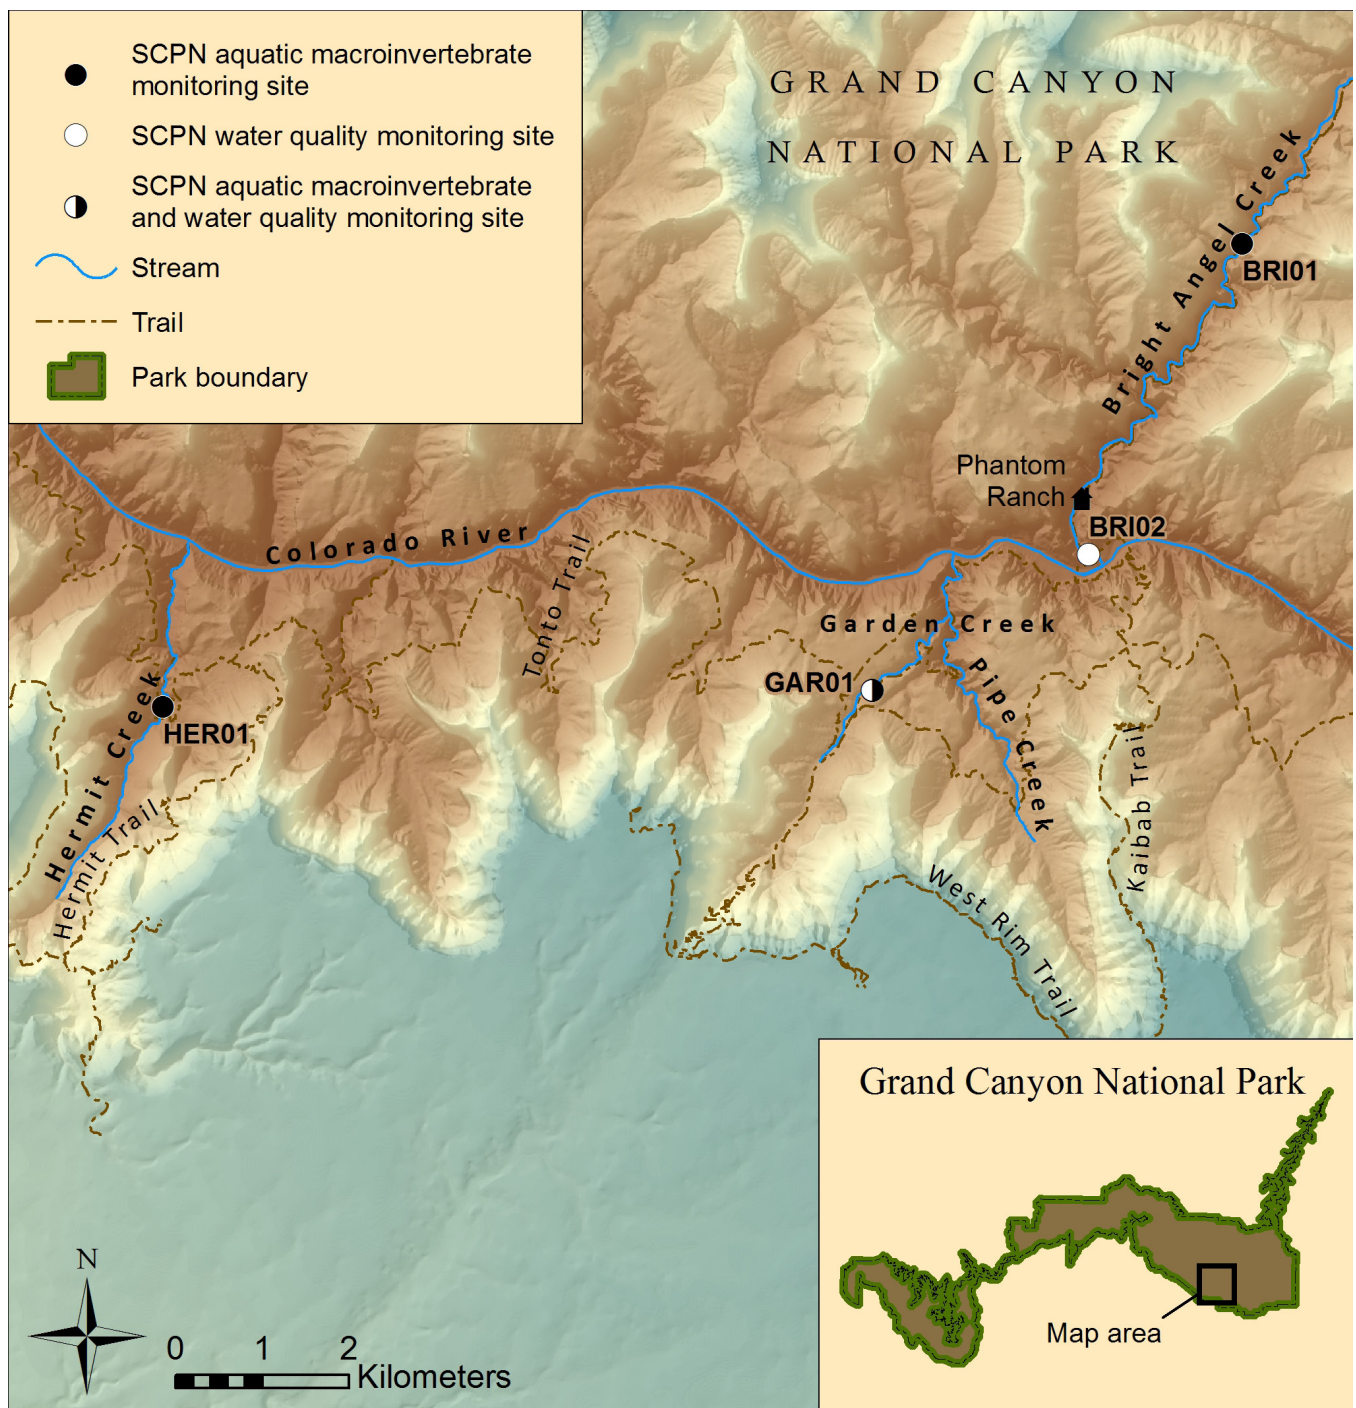
Figure 1. Water quality and aquatic macroinvertebrate monitoring sites on Garden, Bright Angel and Hermit Creeks in Grand Canyon NP.

In 2013 SCPN implemented long-term water quality monitoring on Garden and Bright Angel Creeks in GRCA. Water samples are collected on a quarterly basis at the following sites (Figure 1, Table 1):
