National Park Service  
Cultural Landscapes Inventory  
2005

William Johnson House  
Natchez National Historical Park

## Inventory Unit Summary & Site Plan

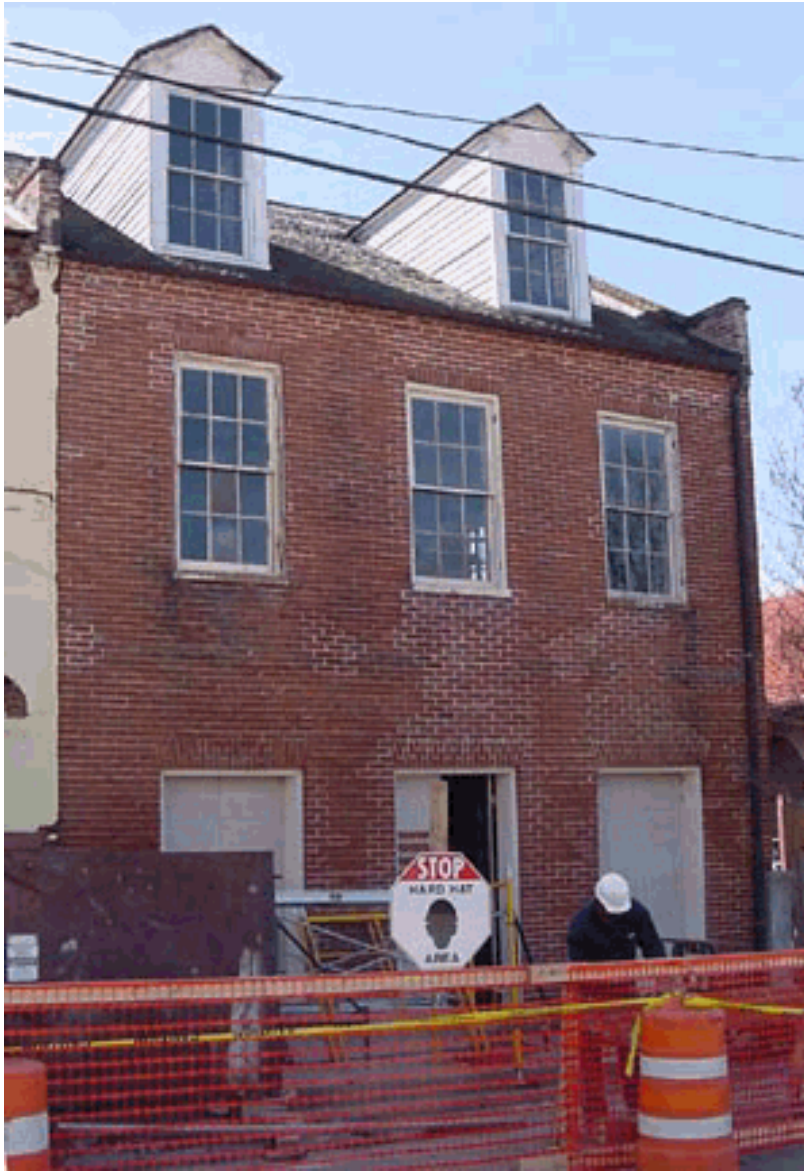
*Figure 8: Front facade of the William Johnson House in January 2003.*

In 1976, the Johnson heirs sold the property to the Preservation Society of Ellicott Hill. The Society commissioned archeology and performed initial stabilization work to prevent further deterioration. A Historic Structures Report for the house was completed in 1979 and restoration work was carried out thereafter. In 1990, the Society sold the Johnson House to the City of Natchez who then donated the property and the adjacent McCallum House to the National Park Service. NPS restored the deteriorated west wall of the house and reframed some first-story windows between 1990 and 1994. Major work also occurred on the 1897 kitchen dependency during this same time period. (Ann Beha and Associates) In 2002-2003, major restoration work was being undertaken on the William Johnson House and major renovation was being performed on the McCallum House in preparation for the site to be opened to the public as an interpretive site. Refer to Figures 8 and 9 for views of the site in January 2003.

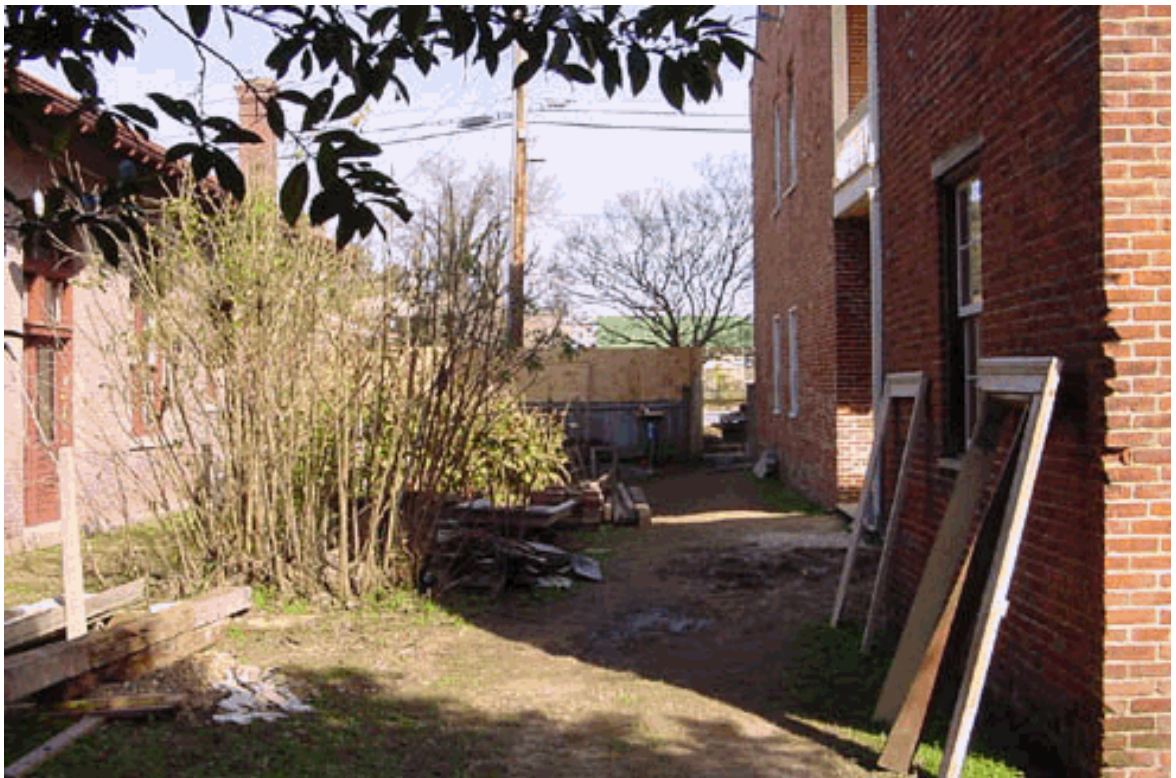
*Figure 9: Side yard looking towards State Street with the west side elevation of the kitchen dependency in foreground.*

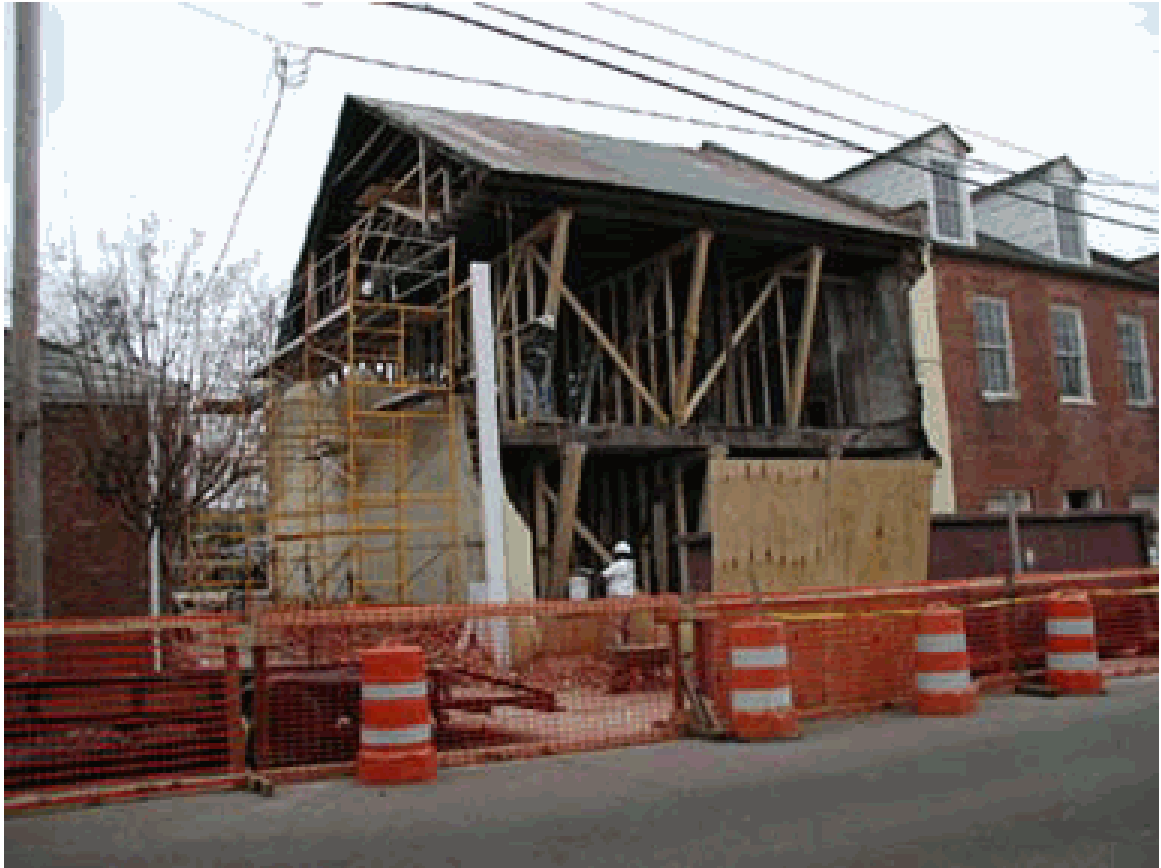
*Figure 10: North front facade of the McCallum House during renovation (January 2003).*

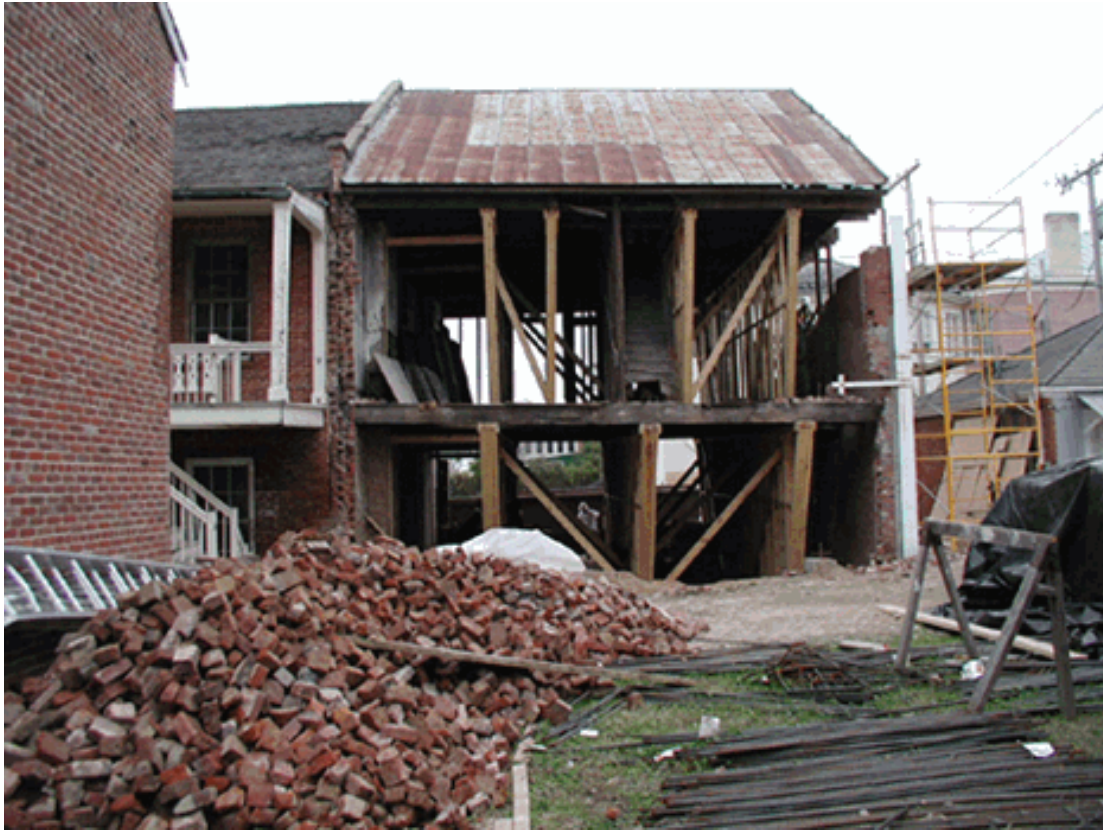
*Figure 11: South rear facade of the McCallum House during renovation (January 2003).*

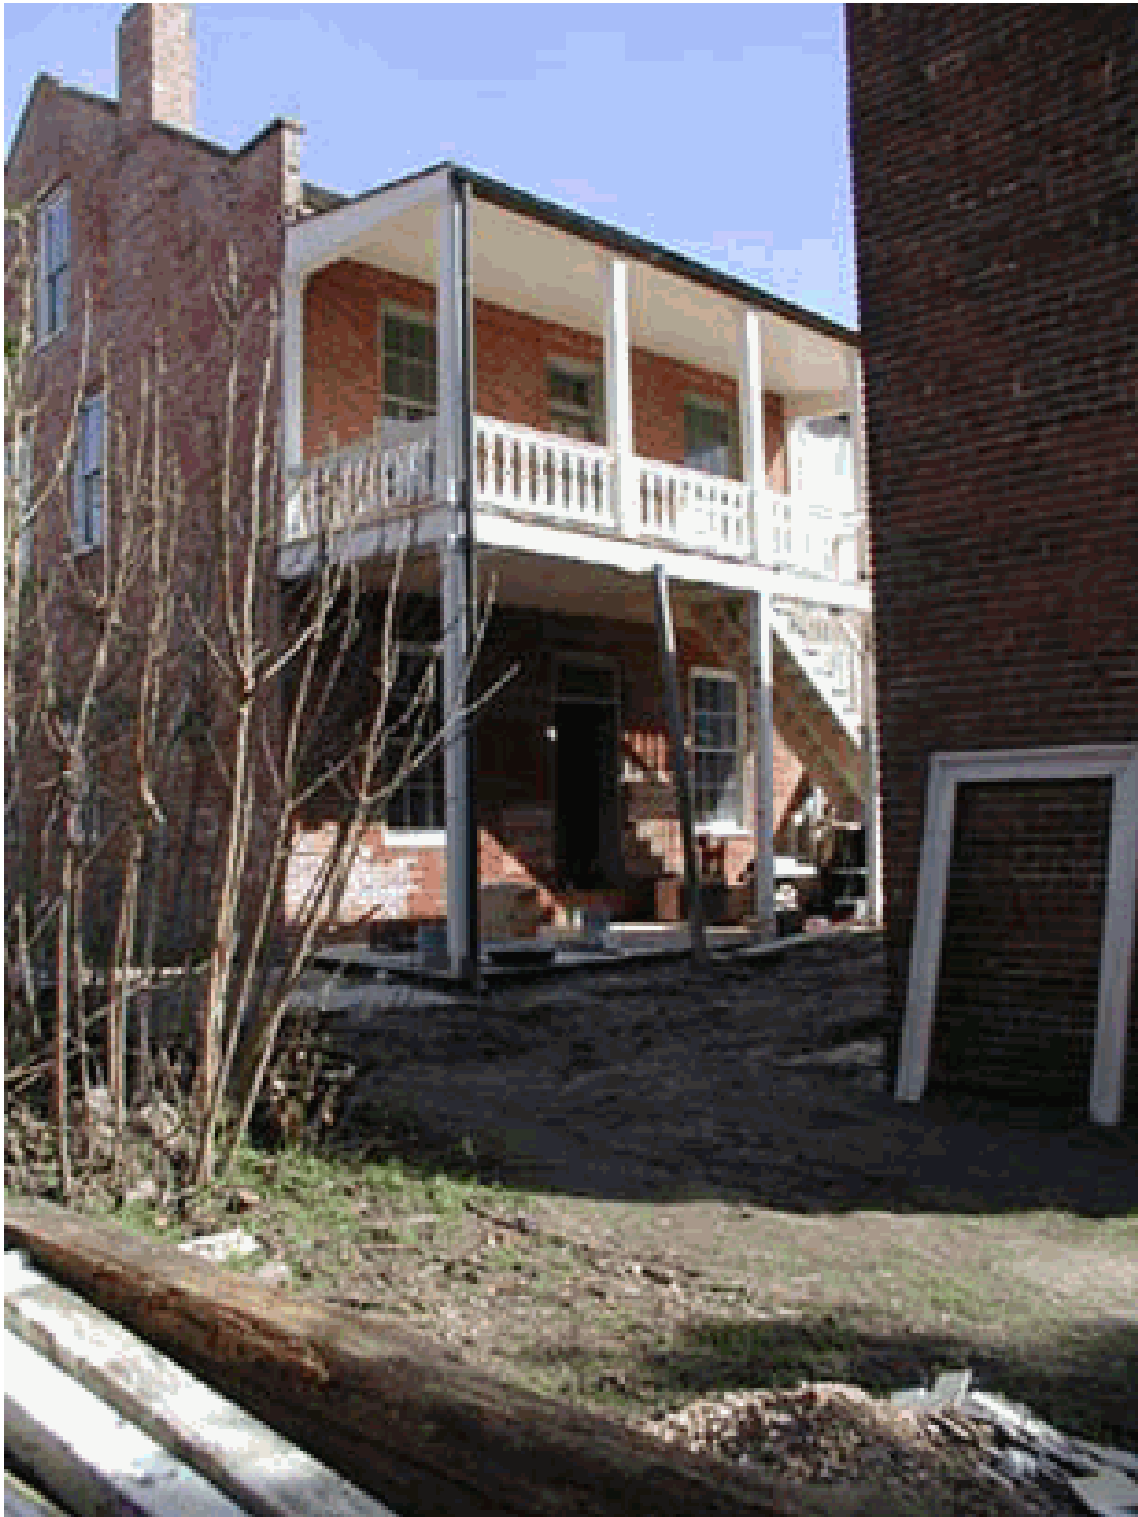
*Figure 13: Rear porch of the William Johnson House.*

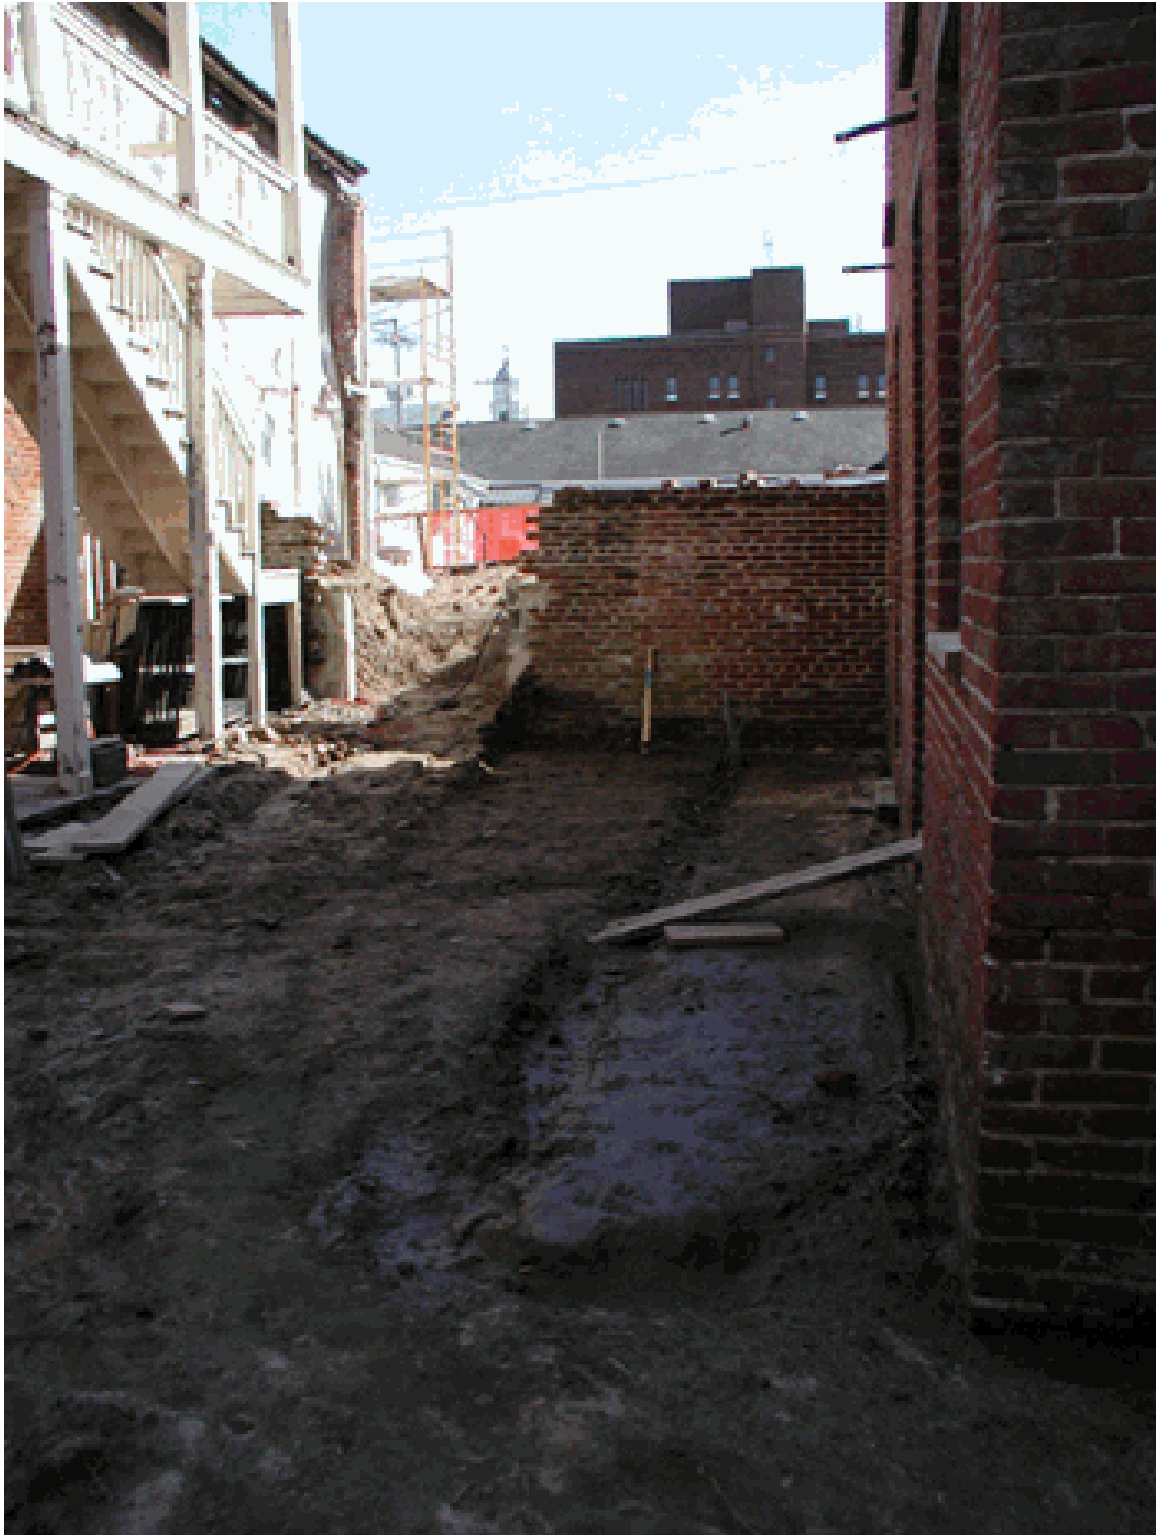
*Figure 14: Retaining wall located in the east side yard.*

William Johnson's diary provides much in the way of documentation for the land use. Archaeological work has uncovered a wealth of artifacts to support these activities. (Atkinson). Johnson's diary documents the construction of a hen house, a corn house, a wash house, a carriage house, two subterranean brick cisterns, a cistern house, three small sheds, a replacement shed, a "back building" (kitchen dependency) and numerous animal pens. He also mentions the construction of several different types of fences, laying brick pavement, and digging a gutter. (Hogan and Davis, eds.) Through archeological investigation, evidence of several privies, a cistern, outbuildings, and brick and glass bottle edging materials for gardens and walkways has been located on the property. Existing above ground structures include a brick retaining wall on the east property line between the two main buildings and extending south beyond the kitchen; a gated wooden fence (removed in 2003 and rebuilt in 2004); and the recently refurbished two-story wooden porch at the rear of the William Johnson House. Further investigation of the retaining wall would be necessary in order to date it.

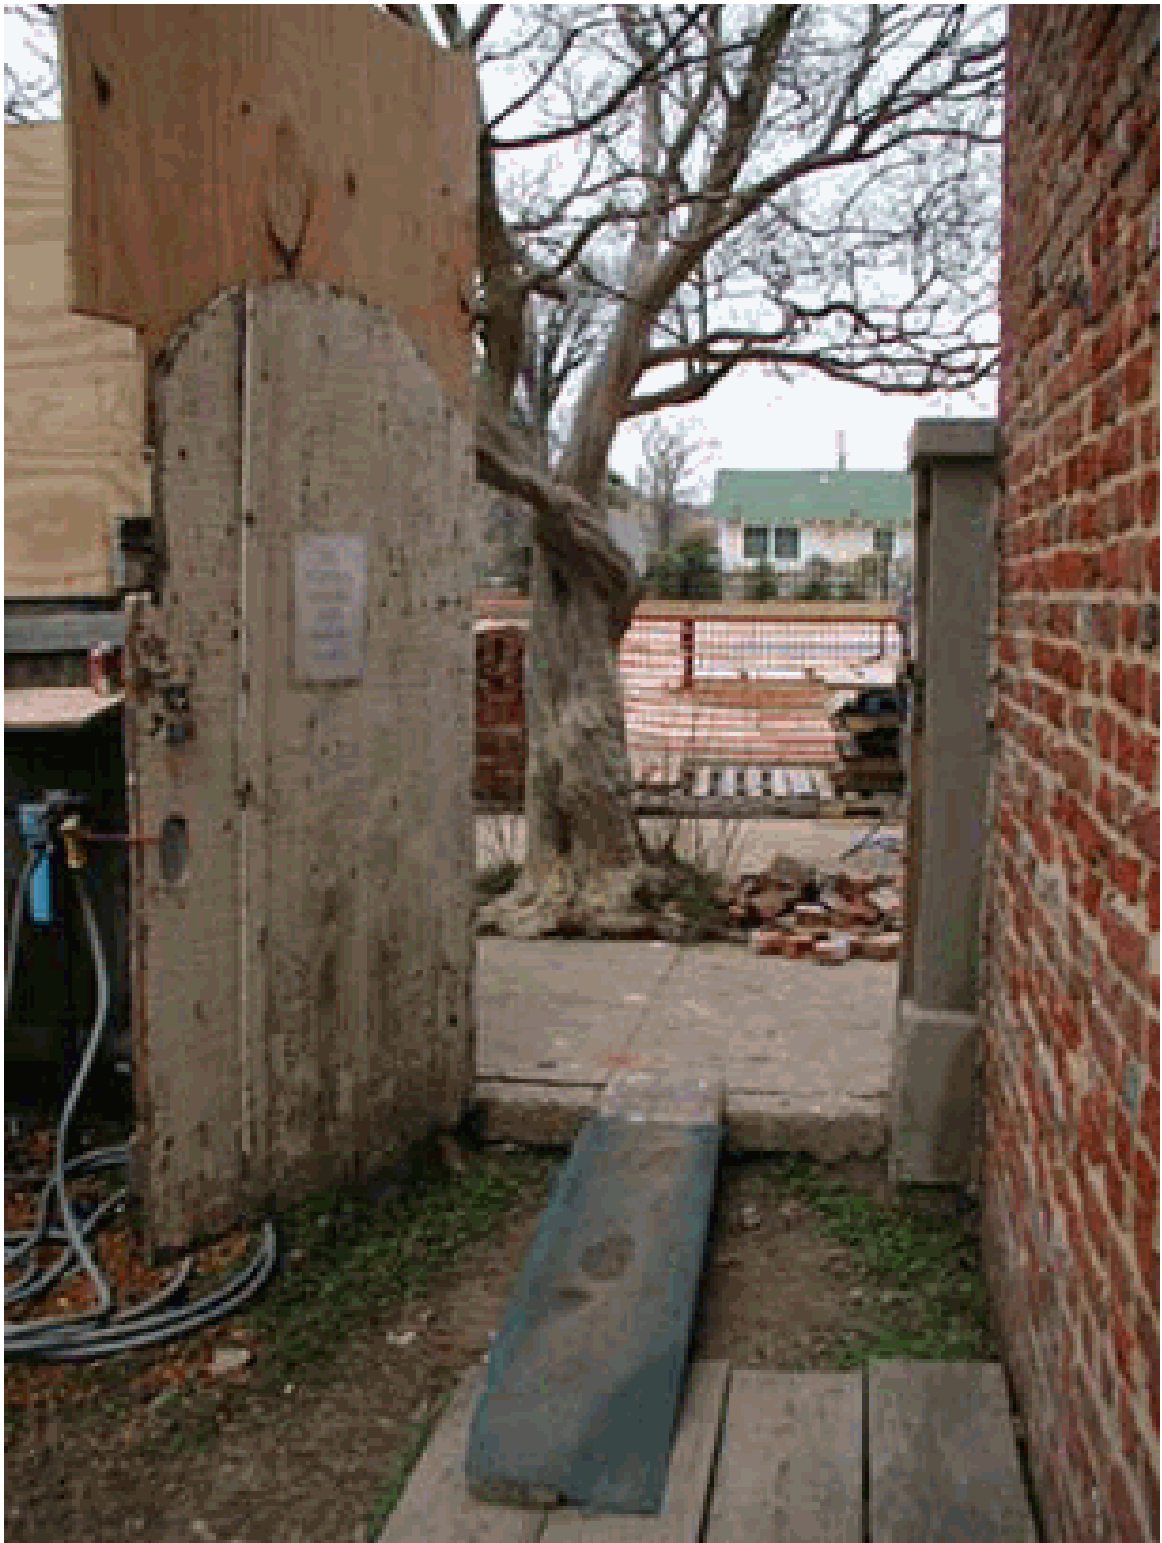
*Figure 15: Gate door, possibly dating to the early twentieth century.*

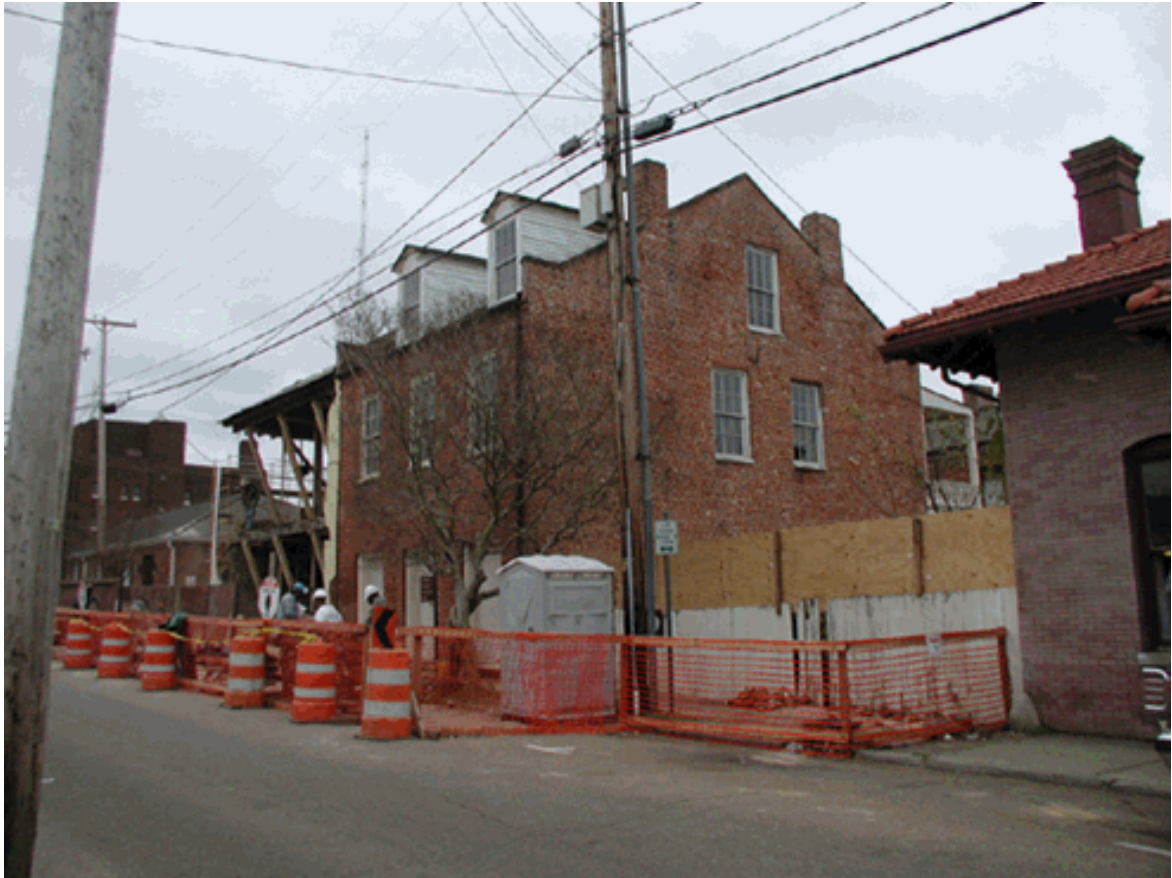
*Figure 16: Vertical board fence enclosing west side yard.*

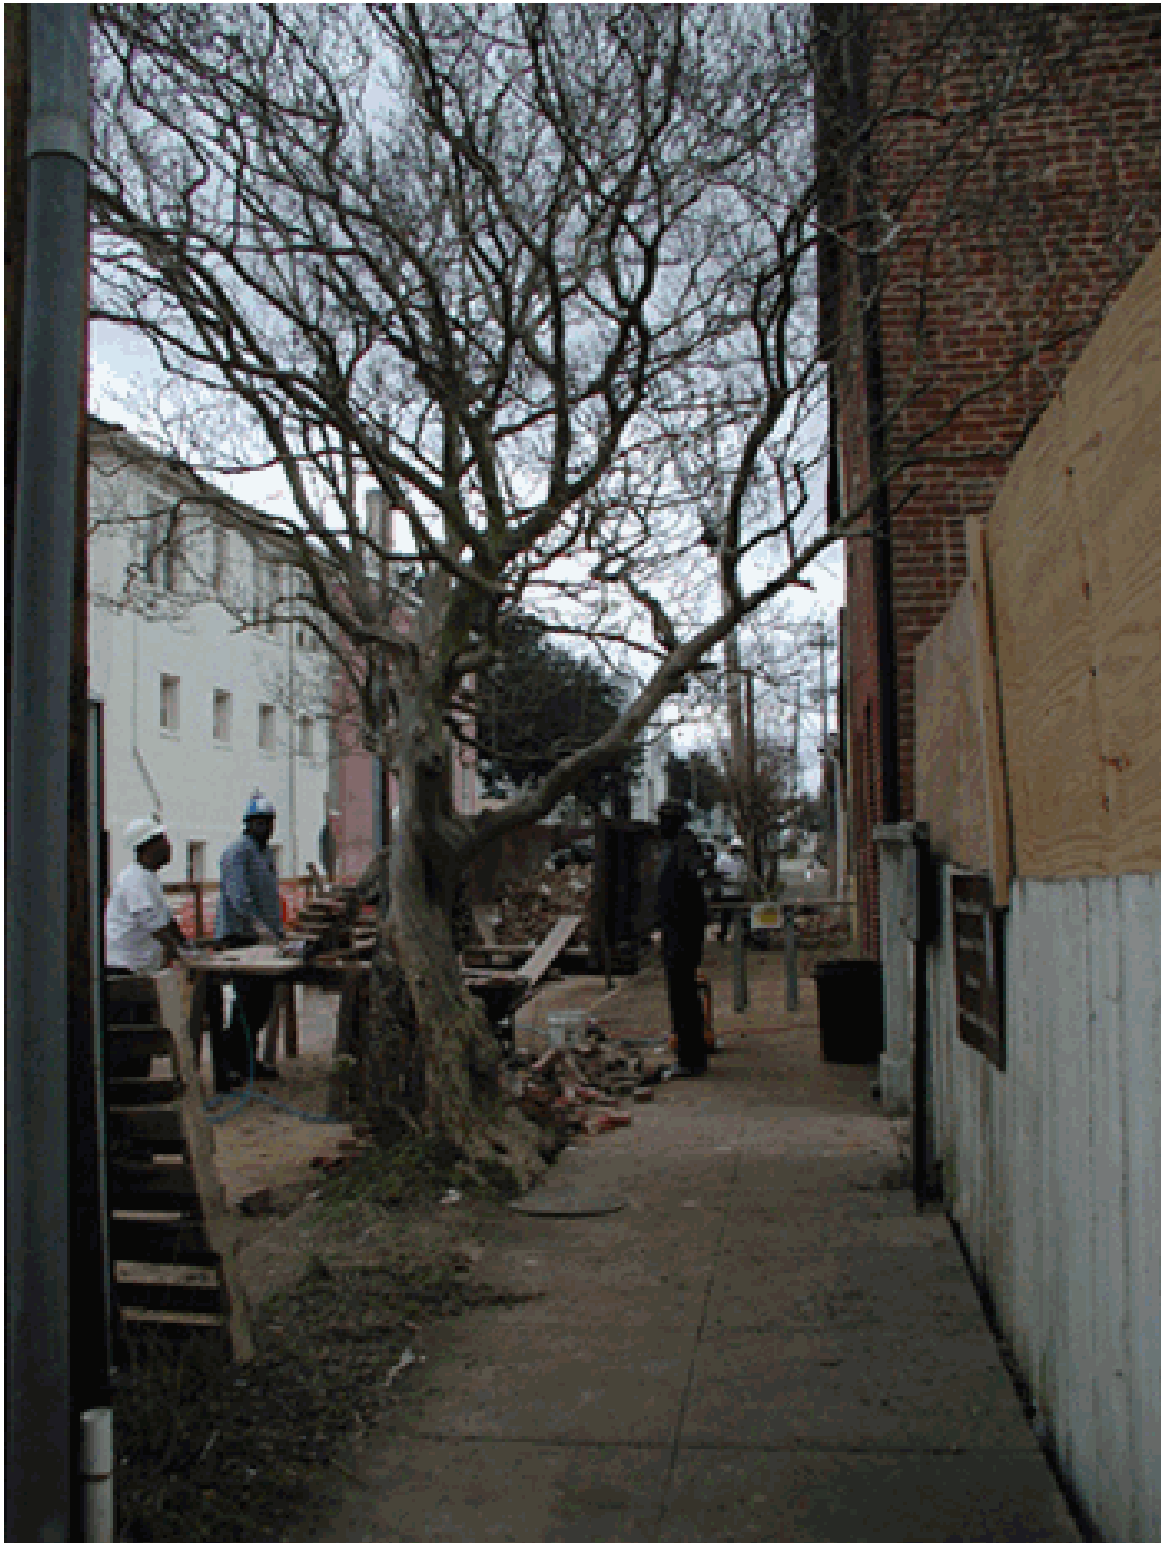
The site contains very little in the way of plant material. A large Crape Myrtle tree, Figure 18, is present on State Street just outside the fence gate, growing in a 3' x 4.5' (144 SF) planting strip at the back of the curb in a concrete sidewalk zone. Inside the fenced yard, running parallel along the side of the depot building, are several clumps of Canna Lilies and one fig clump, see Figure 19. This fig clump, or an ancestor to it has been in this location since at least the 1920s if not earlier. (Mary Louise Miller interview) Near the corner of the dependency building is a rather dense 12" twin-trunk Devilwood (*Osmanthus americanus*), Figure 20. This 'tree' probably started out as a shrub and has matured to a much larger form. At the time of the site visit/assessment this plant was loaded with dark fruit and attracted numerous birds. Beyond the Devilwood is a 12" Elm tree (*Ulmus americana*), and at the very back of the property are two Paper Mulberry trees with 20" and 24" caliper trunks, seen in Figure 21. The Devilwood and Elm trees are shown just outside the west side property boundary, the two Mulberry trees are either just inside or on the south property line. The balance of open space is lawn in poor condition.

*Figure 18: Crape Myrtle tree on State Street.*

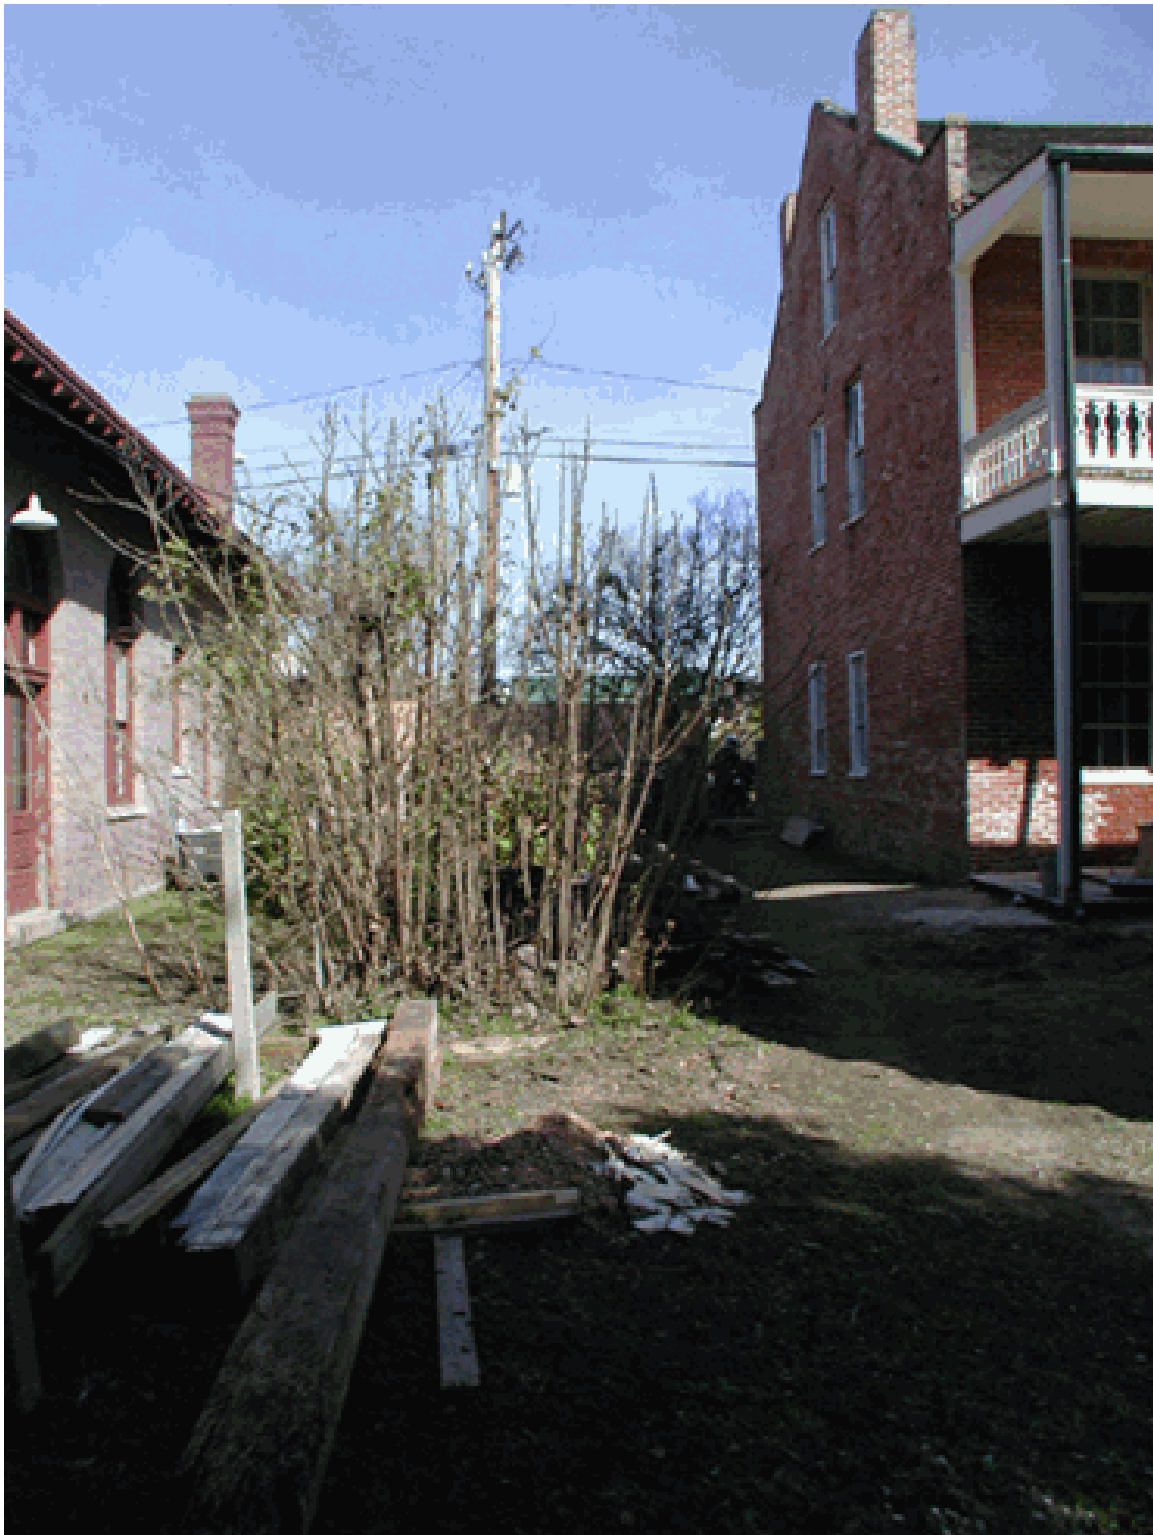
*Figure 19: Canna Lilies and fig clump in west side yard.*

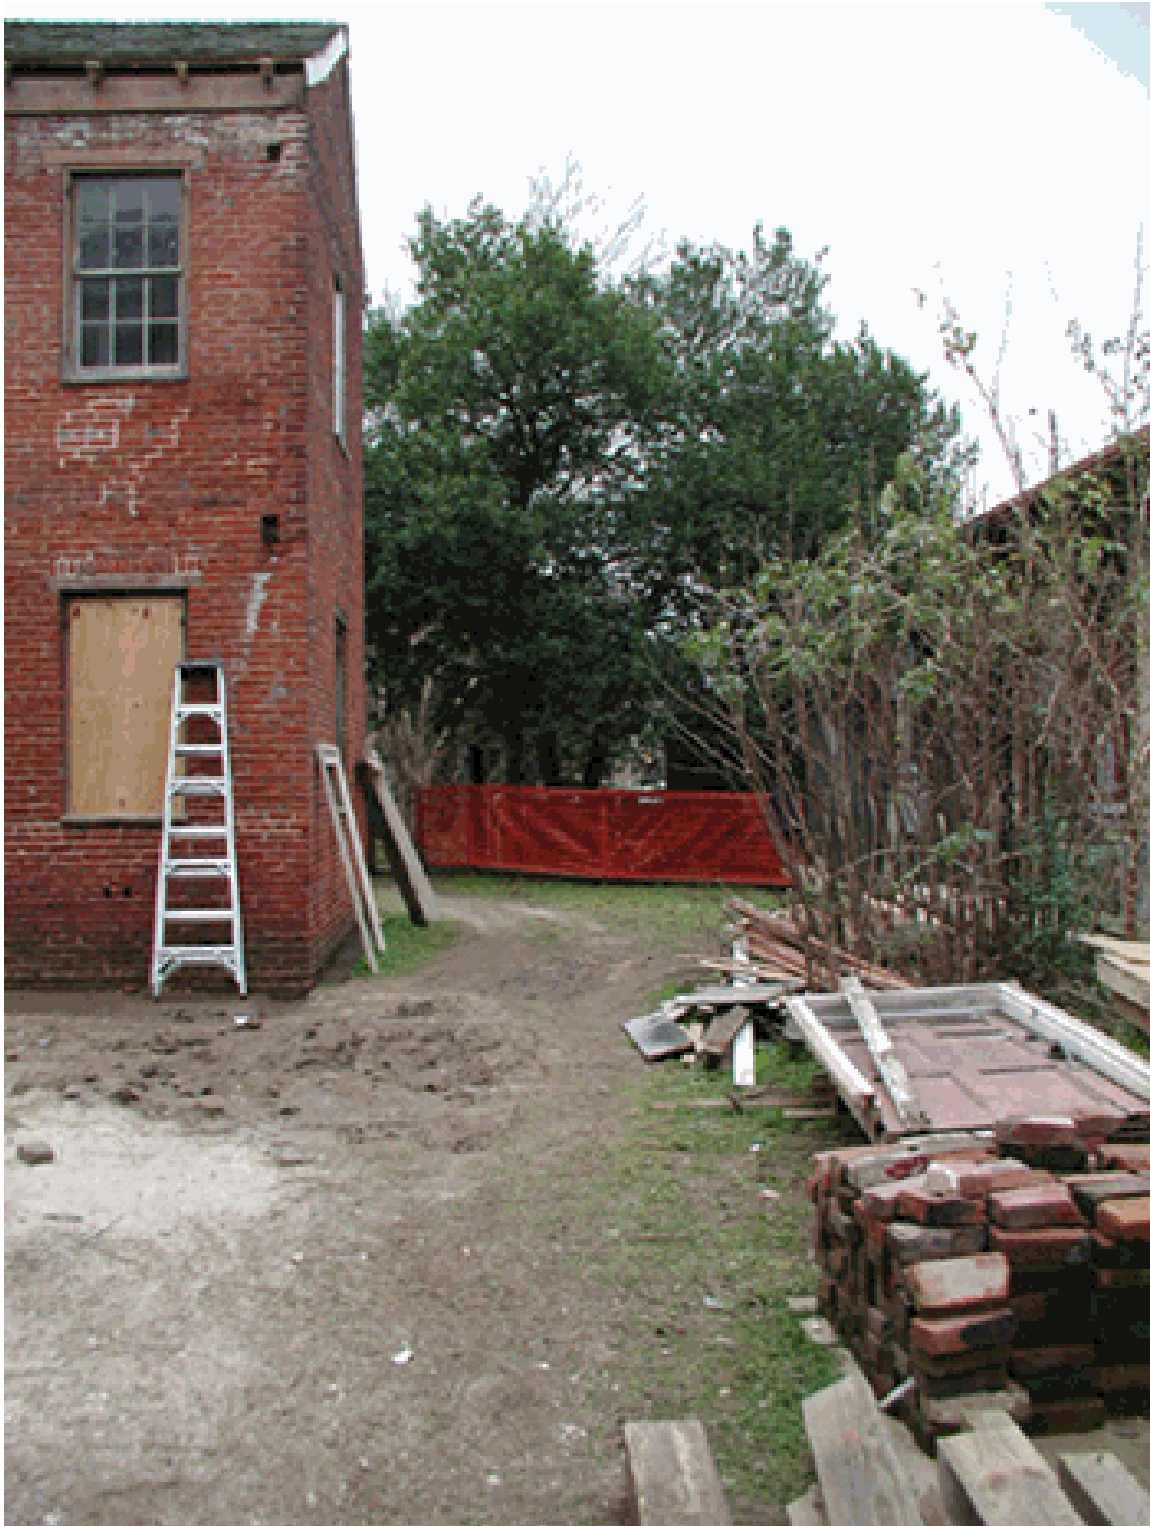
*Figure 20: Devilwood in southwest rear yard.*

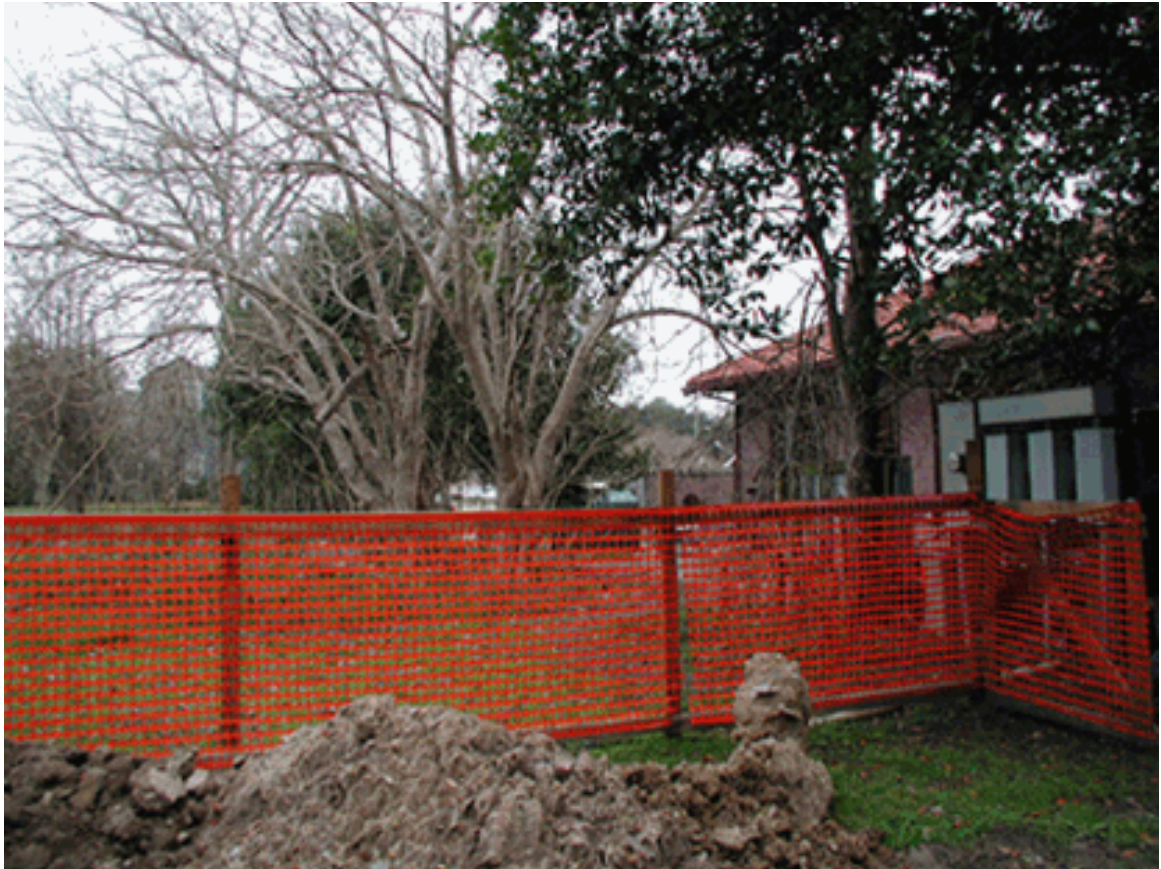
*Figure 21: Paper Mulberry trees in rear yard.*
