National Park Service  
Cultural Landscapes Inventory  
2011

Vicksburg National Cemetery  
Vicksburg National Military Park

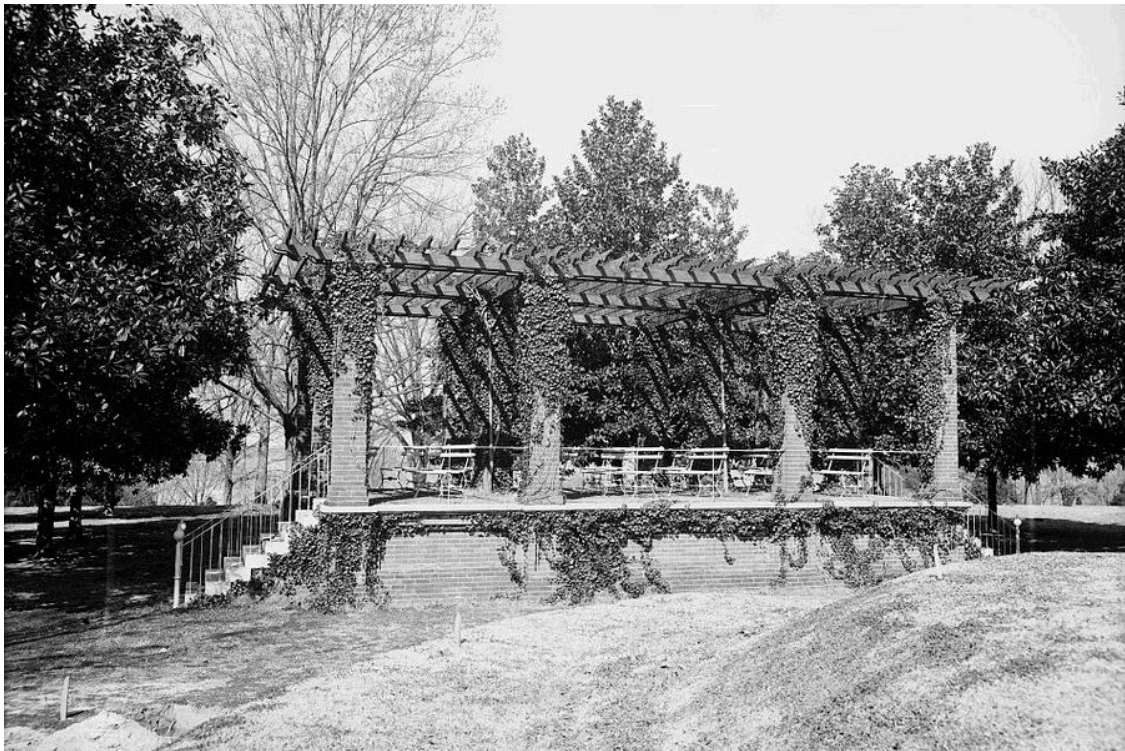
*The rostrum, 1906. Source: Vicksburg National Military Park.*

In 1879, a brick rostrum was constructed adjacent to the flagstaff (Figure 6). The rostrum, similar to those in other national cemeteries, was an open brick structure with two sets of stairs, and covered by a wood pergola. The platform of the rostrum served as a setting for speeches and memorial events. In the same year, a new entrance arch and roadway were constructed near the southwest corner of the cemetery (Figure 7). The entrance arch, built at a cost of \$7,000, was 36 feet 6 inches tall with a 20 foot tall opening. The arch was constructed of rusticated limestone with a pair of Doric columns flanking the portal on each side. The entablature is inscribed, “Here Rest In Peace 16,600 Citizens Who Died for Their Country in the Years 1861–1865.”

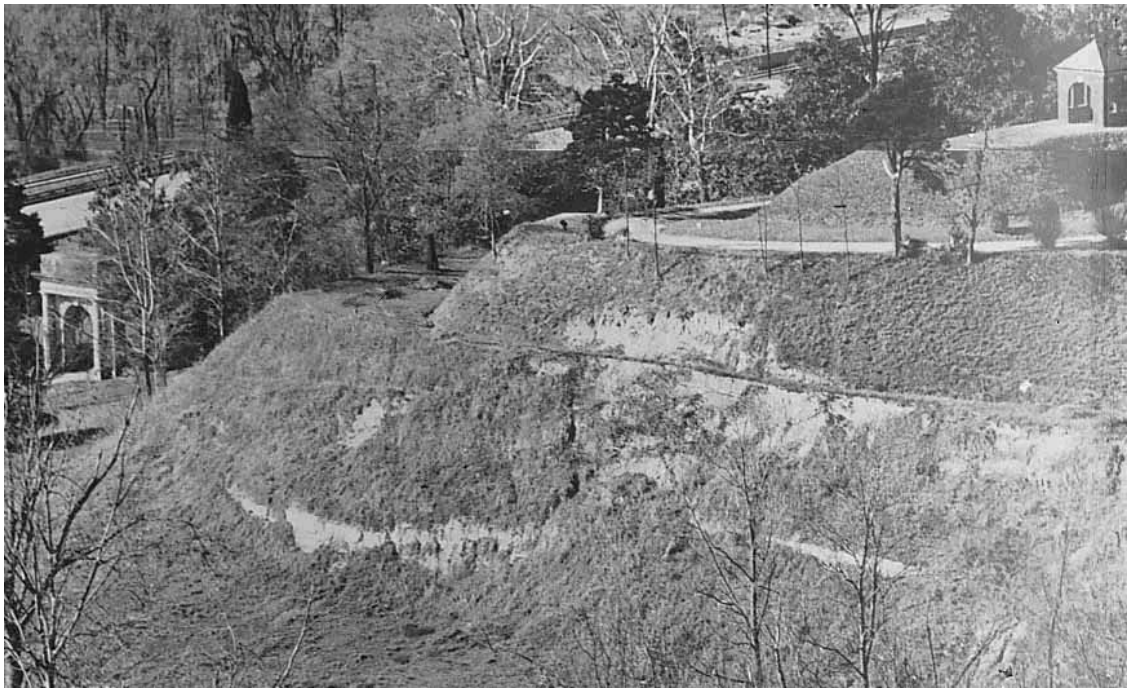
*Mint Spring Bluff after 1931. Source: Vicksburg National Military Park.*

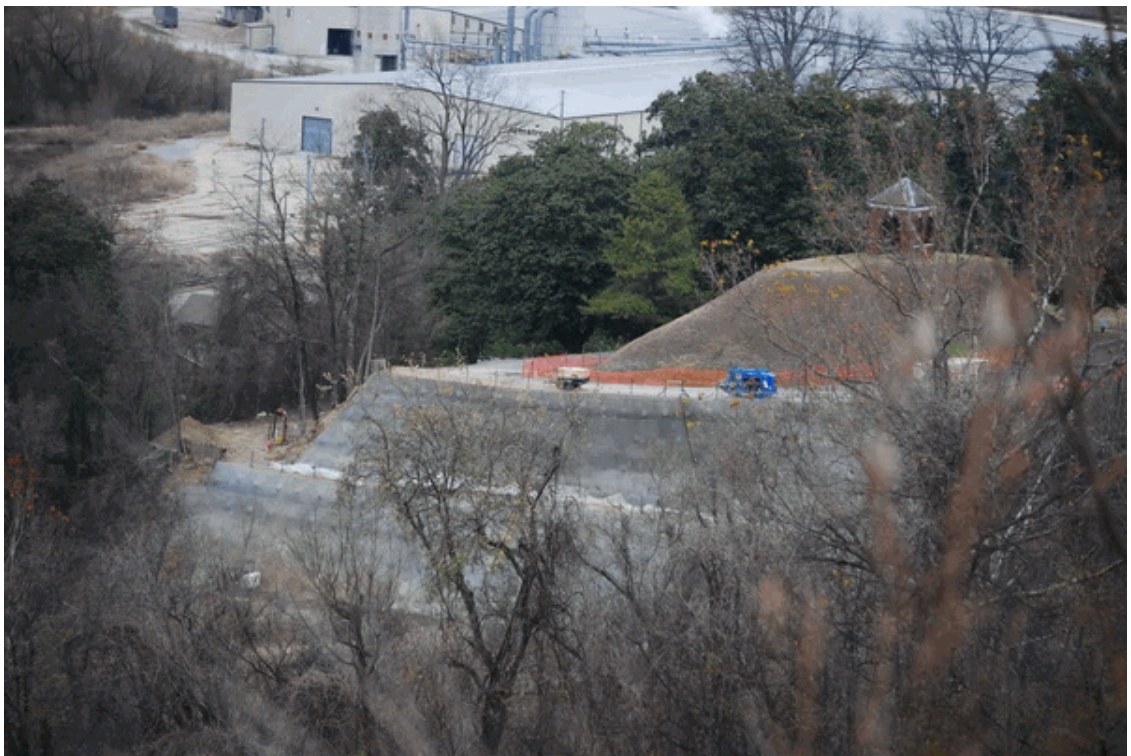
*Stabilization work at the bluff above Mint Spring was completed in 2011. Source: Vicksburg National Military Park, 2011.*

In 2010–2011, the bluff south of the tour road above Mint Spring Bayou was stabilized (Figure 14). A chain link fence was erected at the top of the bluff for safety purposes. At completion of the work, twenty firethorn (*Pyracantha* sp.), shrubs were planted along the top of the bluff.

Mint Spring Bluff, which forms the southwestern border of the cemetery and is adjacent to Mint Spring Bayou, is continuously threatened by severe erosion. Heavy rains over many years eroded the bluff and endangered the cemetery road. The lower road eventually sloughed toward Mint Spring Bayou and severely damaged the original cemetery wall, sections of which have collapsed into the waterway. To alleviate much of this problem, the Mint Spring Bluff Stabilization Project was begun in June 2010, and the work was completed in early 2011.
