National Park Service  
Cultural Landscapes Inventory  
2014

Flat Top and Fallingwater Cascades Trailheads  
Blue Ridge Parkway - Ridge District

## Inventory Unit Summary & Site Plan

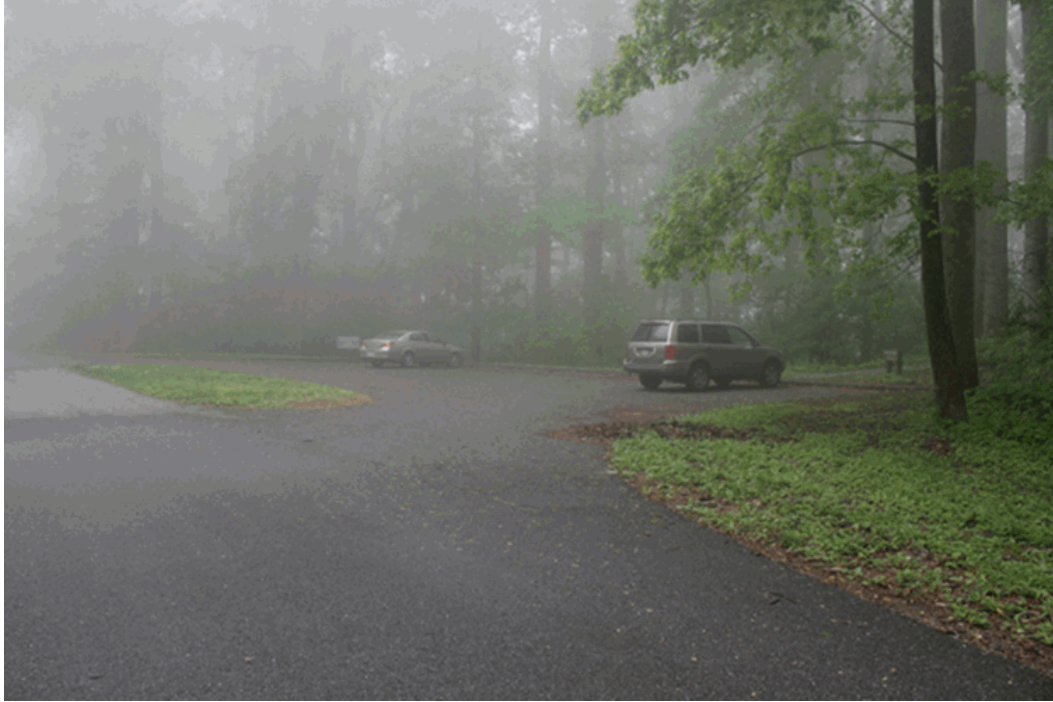
*FIGURE 14. Flat Top Trail parking area. The grass strip separating the parking area from the parkway is a distinguishing feature of the Blue Ridge Parkway crescent-type overlook (2012 Peaks of Otter Cultural Landscape Report).*

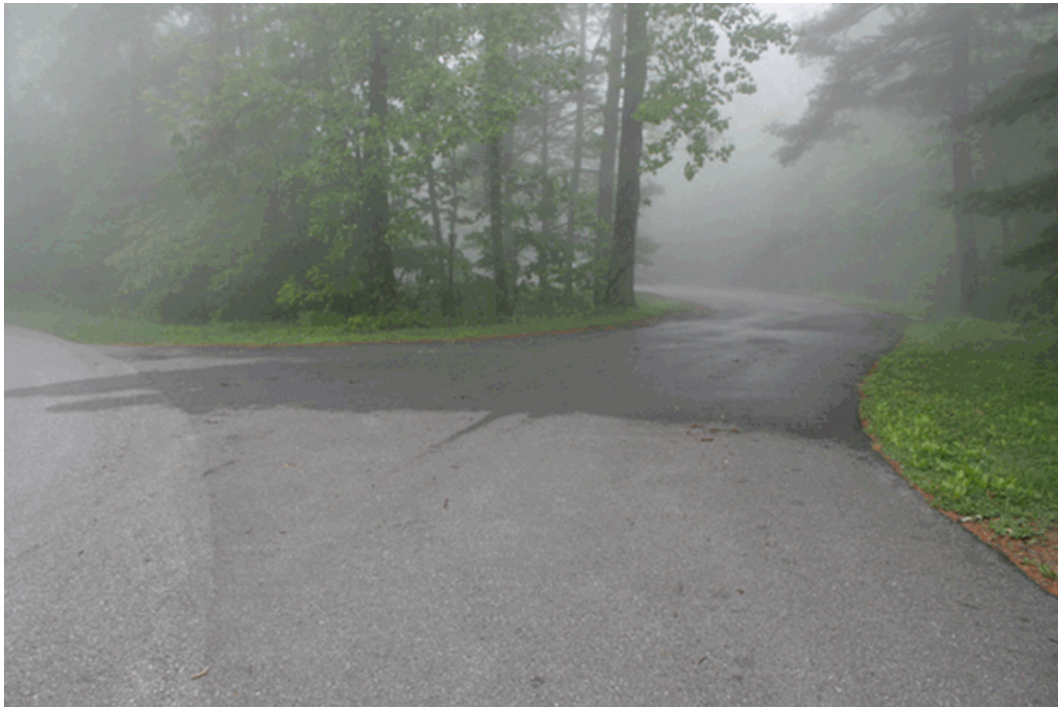
*FIGURE 15. Fallingwater Cascades parking area entrance. This was the only access to the parking area prior to the addition of the exit drive (2012 Peaks of Otter Cultural Landscape Report).*

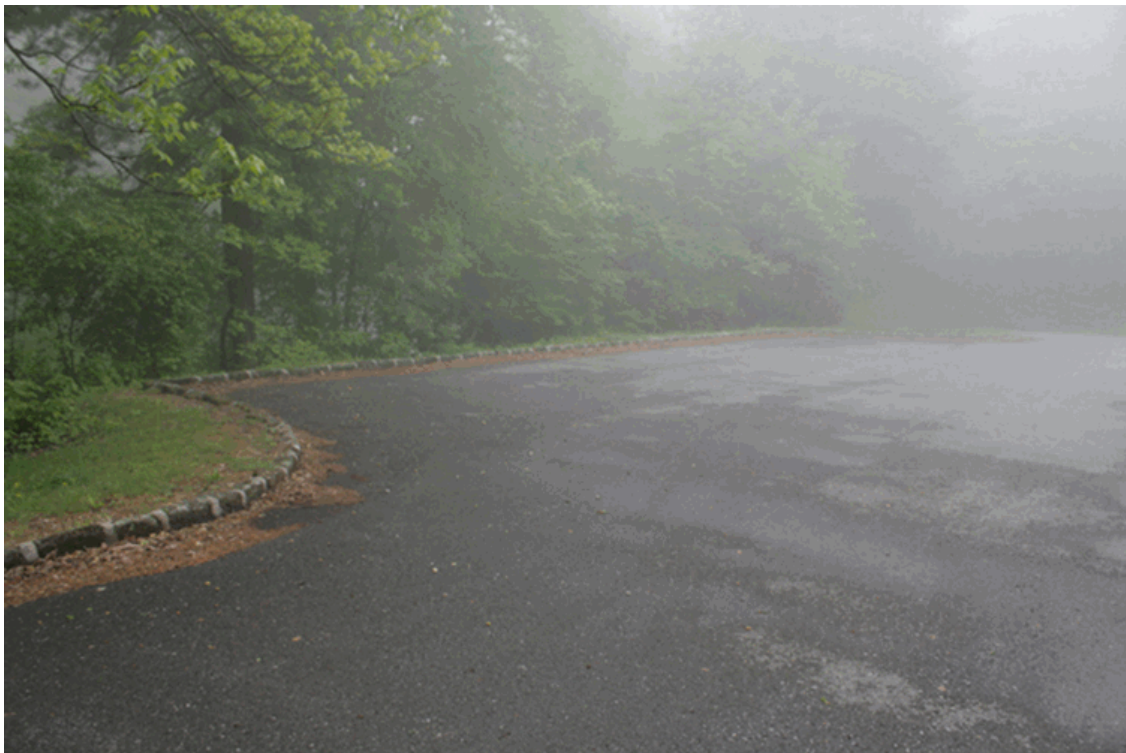
*FIGURE 16. Fallingwater Cascades parking area. In its original dead-in configuration, the exit drive in the distance did not exist (2012 Peaks of Otter Cultural Landscape Report).*

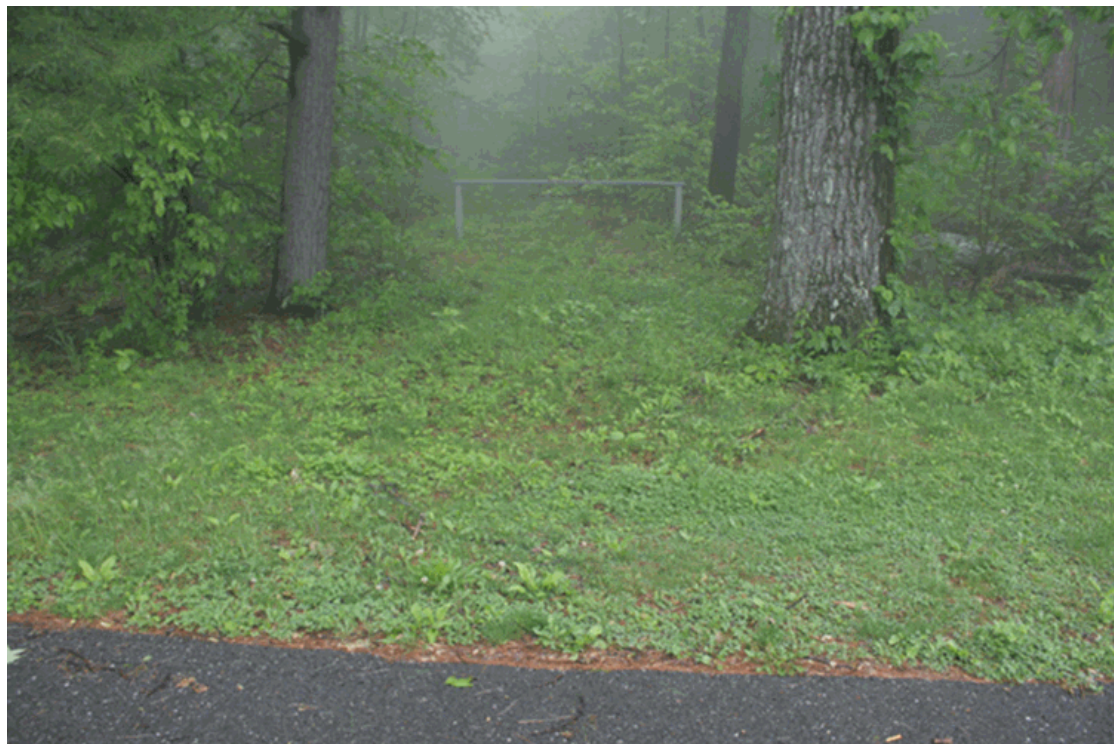
*FIGURE 17. A U.S. Forest Service fire road leads north from the Fallingwater Cascades parking area (2012 Peaks of Otter Cultural Landscape Report).*

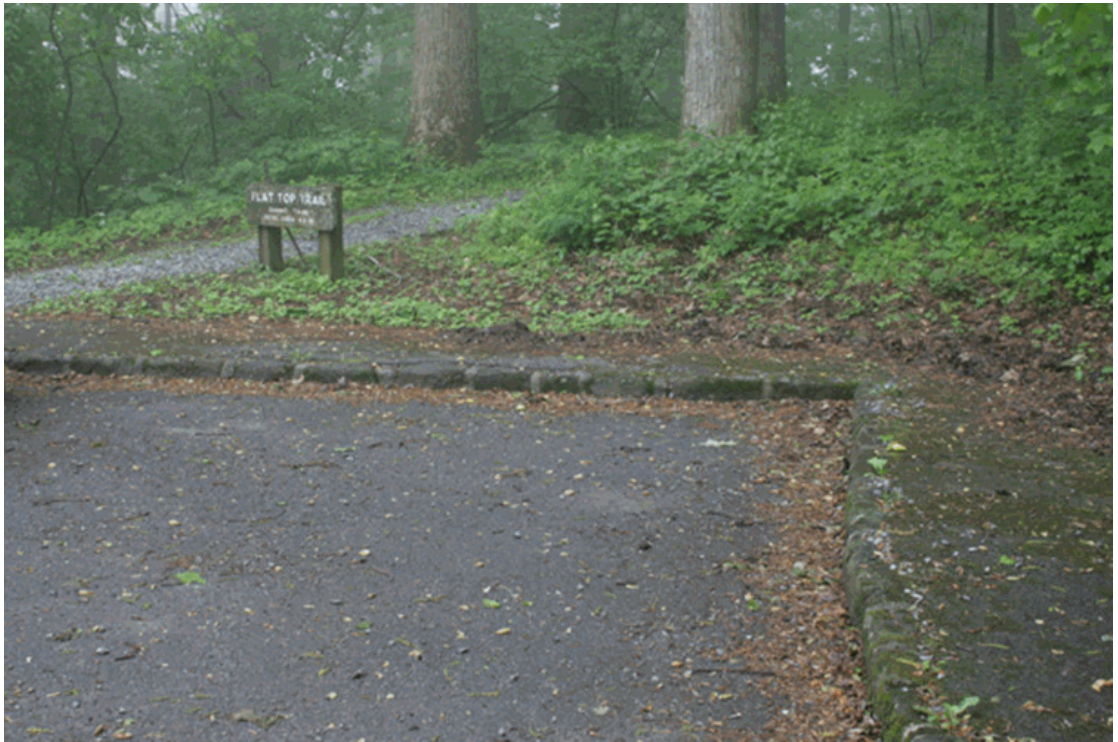
In the Fallingwater Cascades parking area, an asphalt path runs along the west edge of the divided parking bay. Mortared fieldstone curbing divides the path from the parking area. The path and edging exhibit some lichen growth but are generally in good condition. Asphalt spurs lead from the southwest end of the path down a short slope to the Fallingwater Cascades Trail, which is composed of a mix of hard-packed earth and gravel. This trail extends beyond the limits of the Blue Ridge Parkway reservation into U.S. Forest Service land associated with the Jefferson National Forest. Spurs of the trail lead to the Fallingwater Cascades along Fallingwater Creek and to the Flat Top Trail parking area and trail beyond. A social trail is located south of the asphalt access paths, leading from the parking lot to the Flat Top Trail branch.

*FIGURE 18. The asphalt sidewalk along the edge of the parking area at the Flat Top Trail parking area (2012 Peaks of Otter Cultural Landscape Report).*

| <b>Impact Description:</b> | Portions of the asphalt sidewalks at both the Fallingwater Cascades parking area and the Flat Top Trail parking area are broken and cracked. |

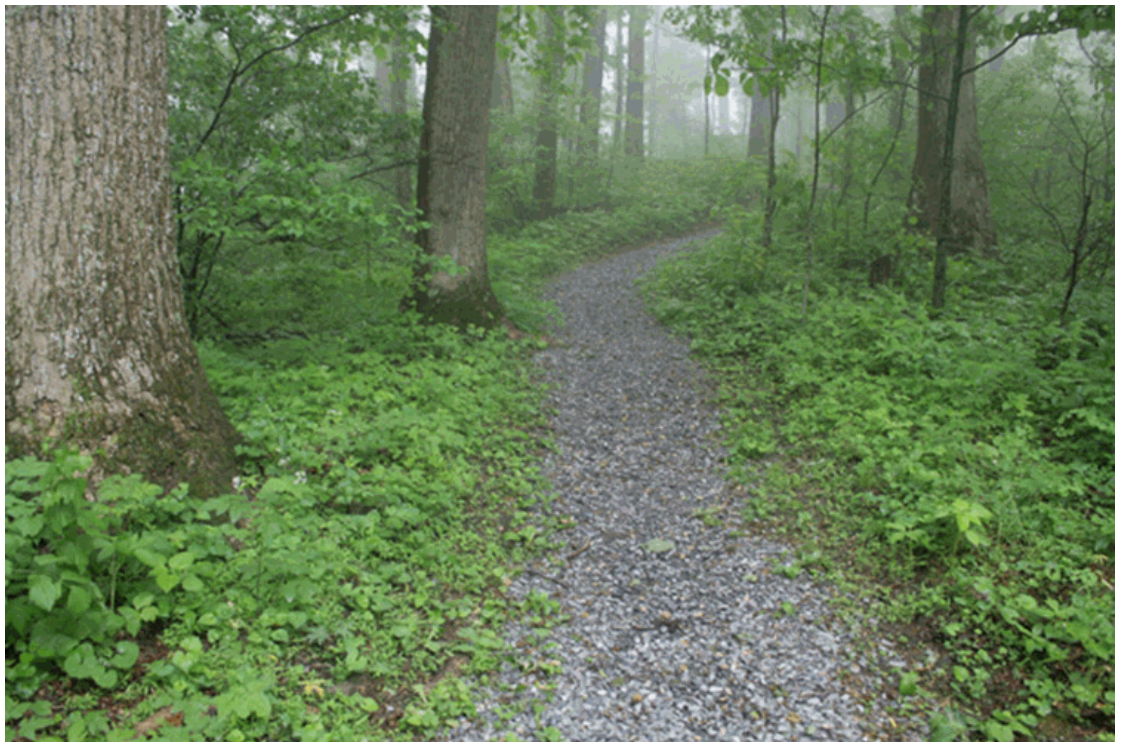
*FIGURE 19. The gravel trailhead of the Flat Top Trail (2012 Peaks of Otter Cultural Landscape Report).*

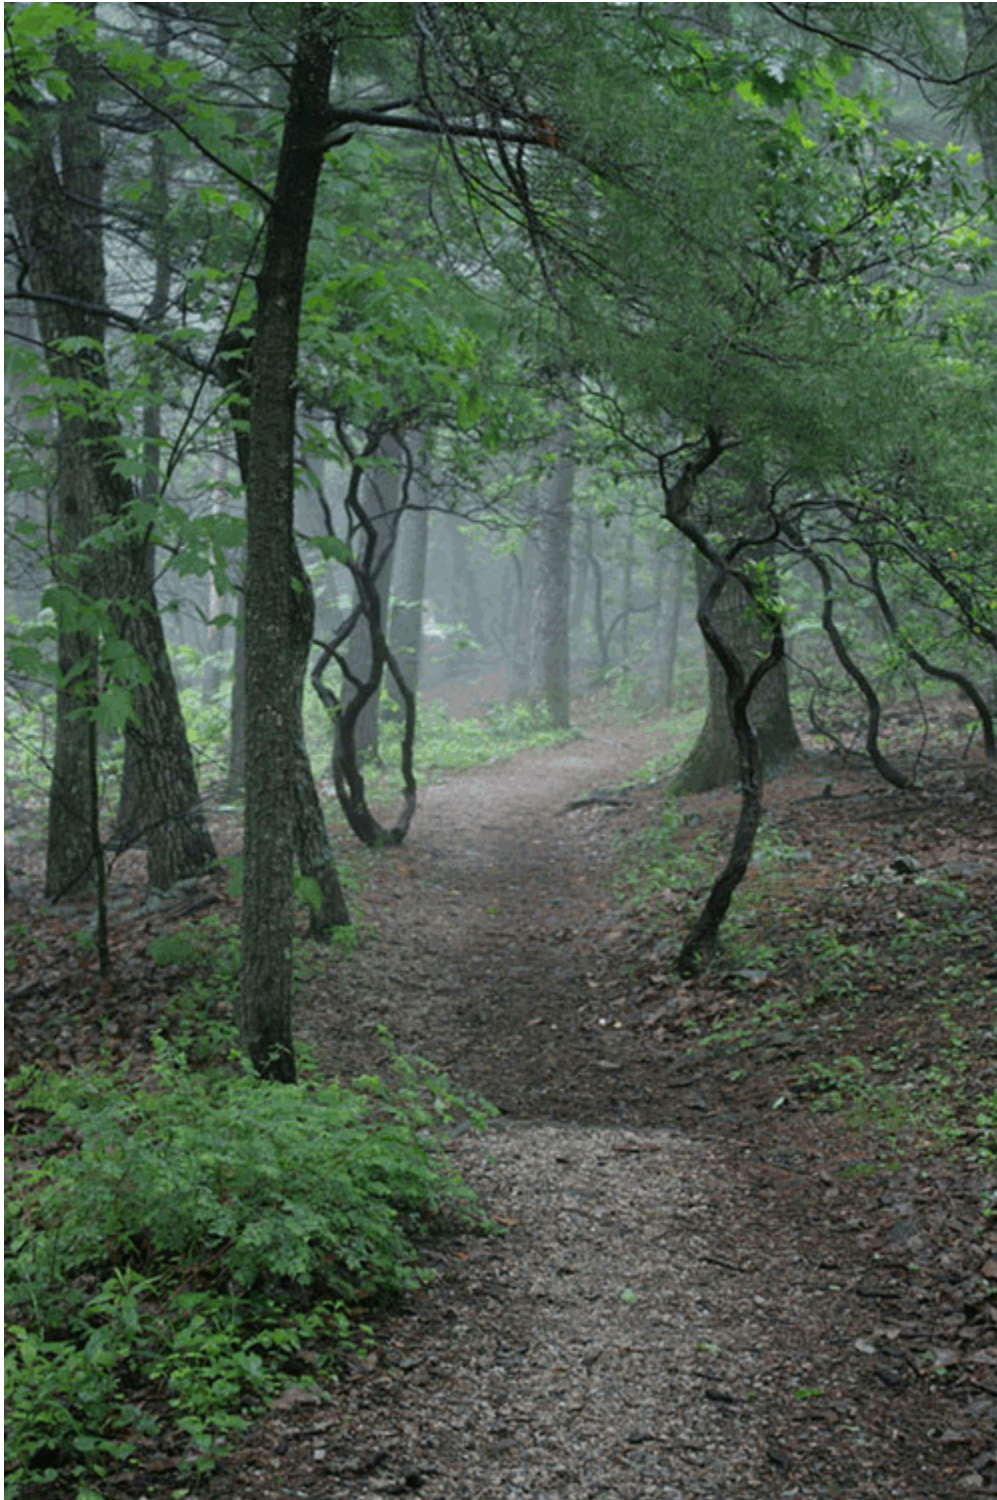
*FIGURE 20. The Fallingwater Cascades Trail is surfaced with gravel and hard-packed earth (2012 Peaks of Otter Cultural Landscape Report).*

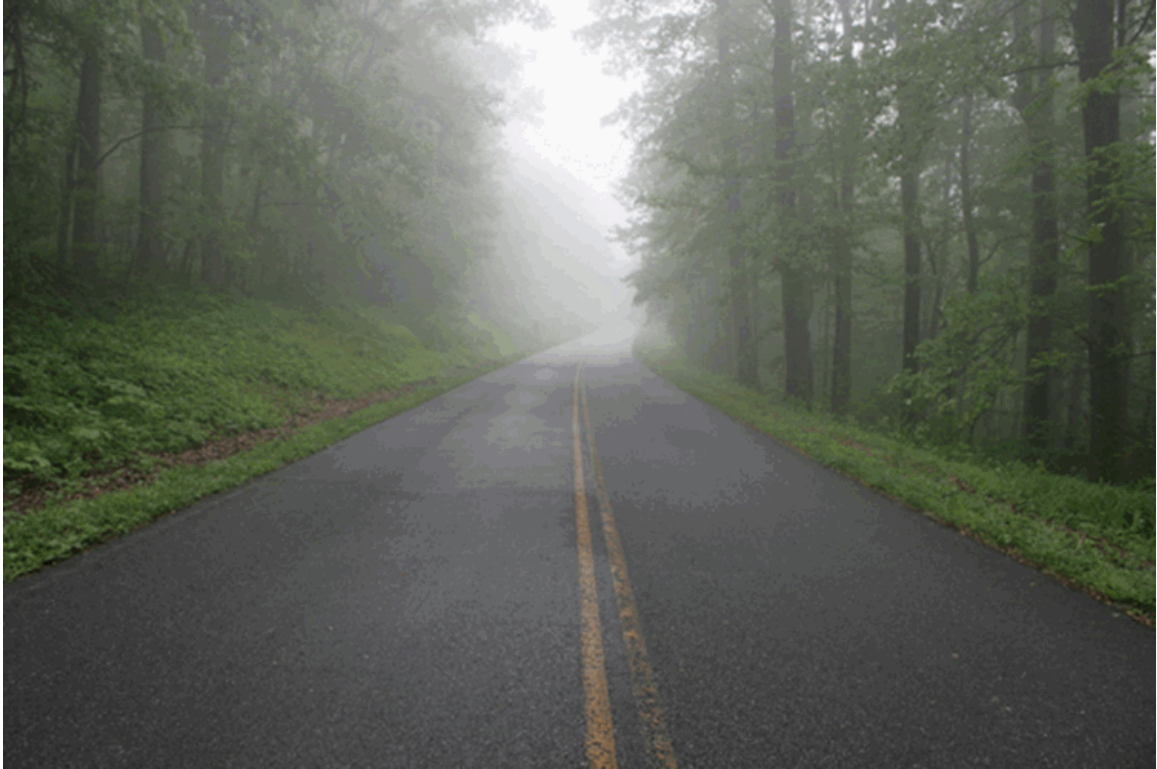
*FIGURE 21. Directed views along the parkway at the Flat Top Trail Parking Area (2012 Peaks of Otter Cultural Landscape Report).*

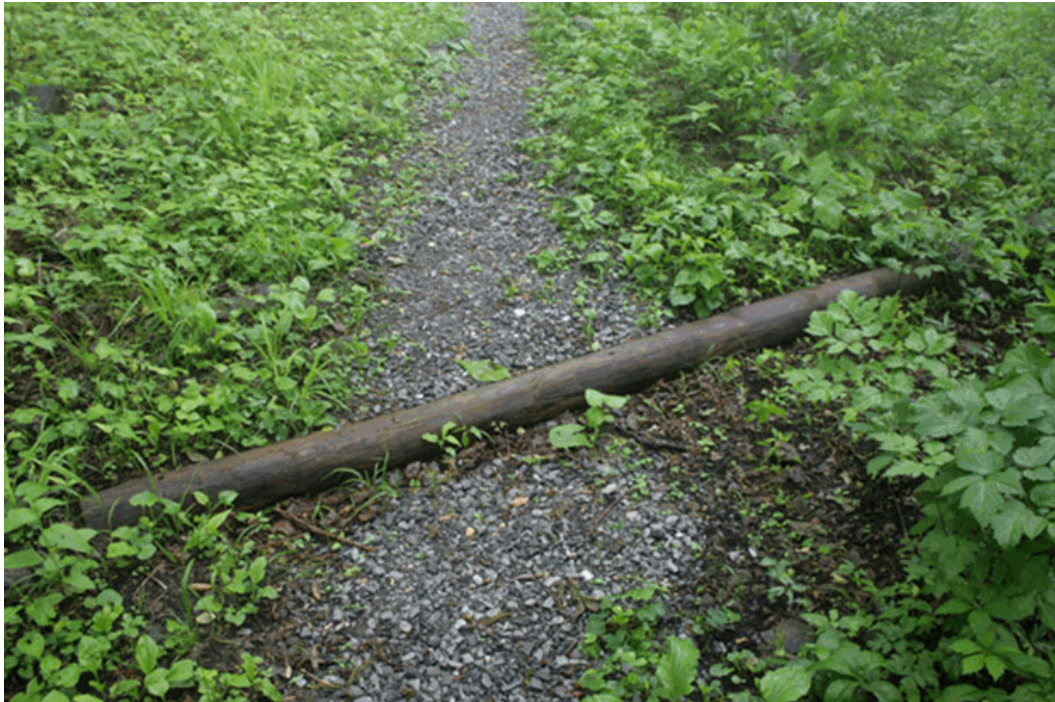
There are no light features associated with this component landscape. Storm water management features located in this component landscape are the wood waterbars incorporated into the trails to prevent erosion due to storm water runoff, at least one stone culvert beneath the parkway just north of the Fallingwater Cascades parking area, and at least three other culverts under the parkway. The waterbars are partially embedded into the surface of the trail, and set across the trail at an angle to divert runoff. The stone culvert appears to be the piped culvert with stone headwall type found throughout the developed area that has an associated drop inlet. The other three culvert types are not specified in the 2012 Peaks of Otter Cultural Landscape Report.

*FIGURE 22. Waterbars are incorporated into the trails to direct the flow of storm water runoff (2012 Peaks of Otter Cultural Landscape Report).*

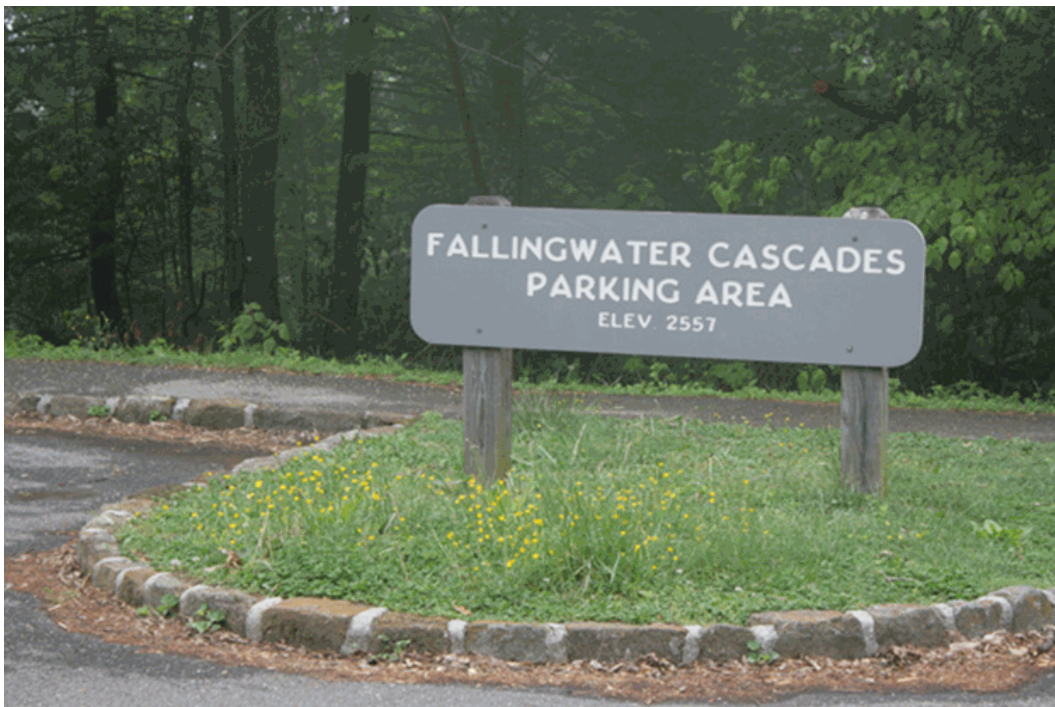
*FIGURE 23. The parking bays are divided by a stone-edged island, containing signage replaced sometime since the period of significance (2012 Peaks of Otter Cultural Landscape Report).*
