# Upper Columbia Basin Network Integrated Water Quality Annual Report 2015

*City of Rocks National Reserve (CIRO)*

*Castle Rocks State Park (CRSP)*

Natural Resource Report NPS/UCBN/NRR—2016/1272

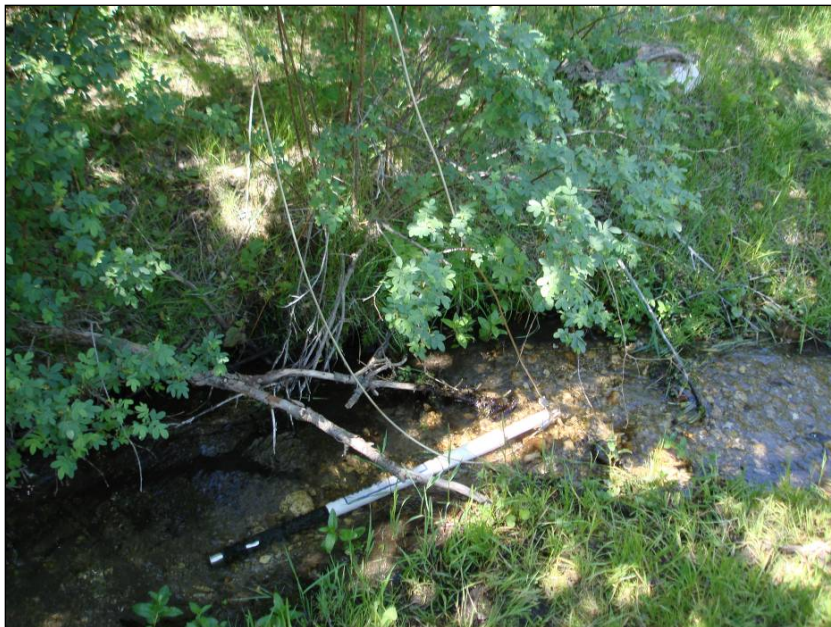
**Figure 2.** North Circle Creek water quality monitoring station #01, approximately 15 m upstream from the intersection of Stripe Rock trail with North Fork Circle Creek trail.

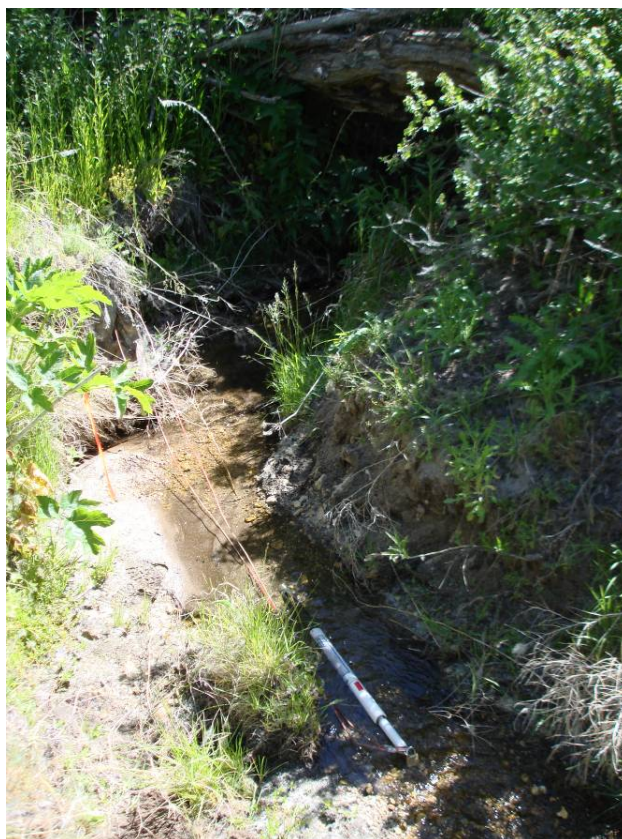
**Figure 3.** South Circle Creek water quality monitoring station #01, approximately 15 m downstream of Box Top trail.

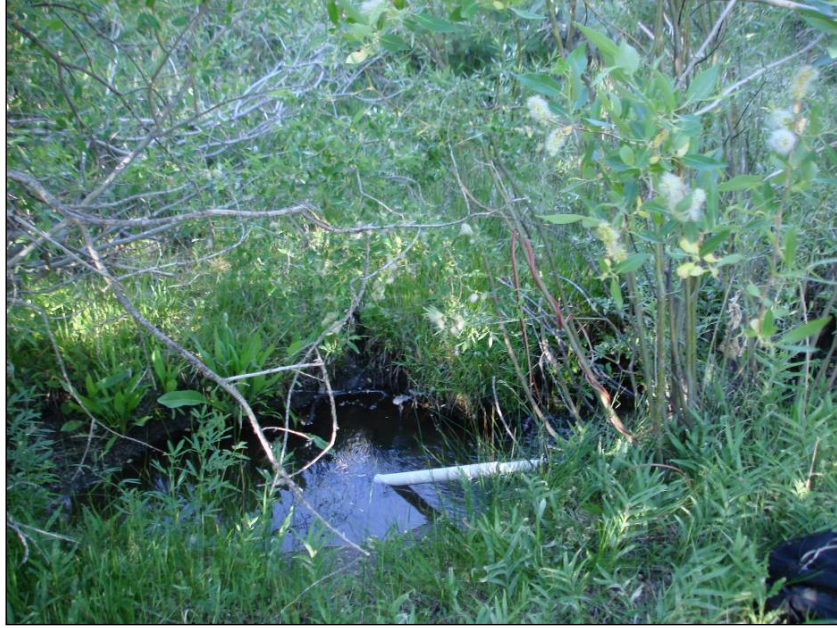
**Figure 4.** Main Circle Creek water quality monitoring station #01, approximately 150 m downstream of City of Rocks road.

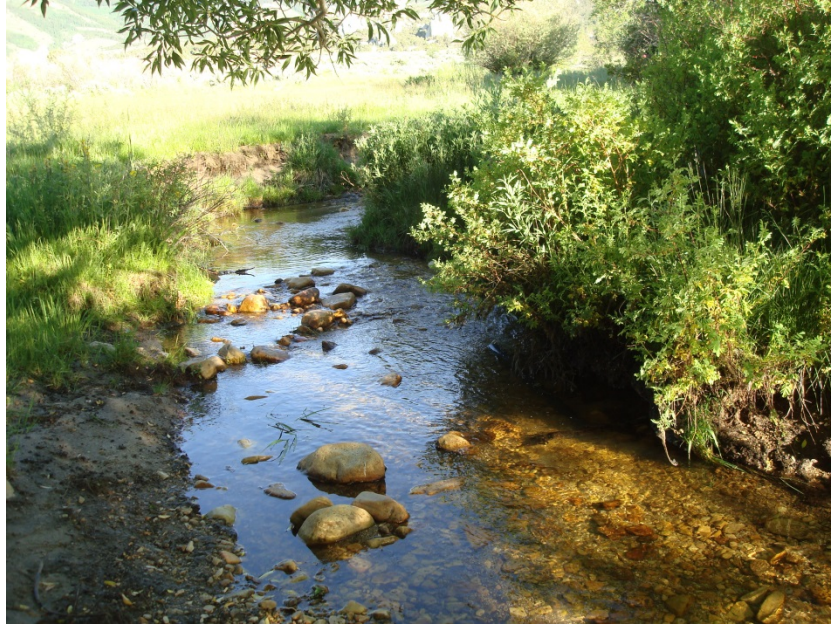
The Hydrolab was deployed in Almo Creek in a location that provided adequate water depth and surface flow in mid-June. The monitoring location is noted in Figures 8 and 9, and Appendix A. The location was the same as in 2012. The macroinvertebrate sample reaches along Almo Creek coincide with the stream channel characteristics and riparian condition monitoring reaches (see Appendix C for GPS waypoints).

**Figure 8.** Almo Creek looking upstream towards water quality monitoring station #01.
