# Upper Columbia Basin Network Stream Channel Characteristics and Riparian Condition Annual Report 2015

*City of Rocks National Reserve (CIRO)*

*Castle Rocks State Park (CRSP)*

Natural Resource Data Series NPS/UCBN/NRDS—2016/1046

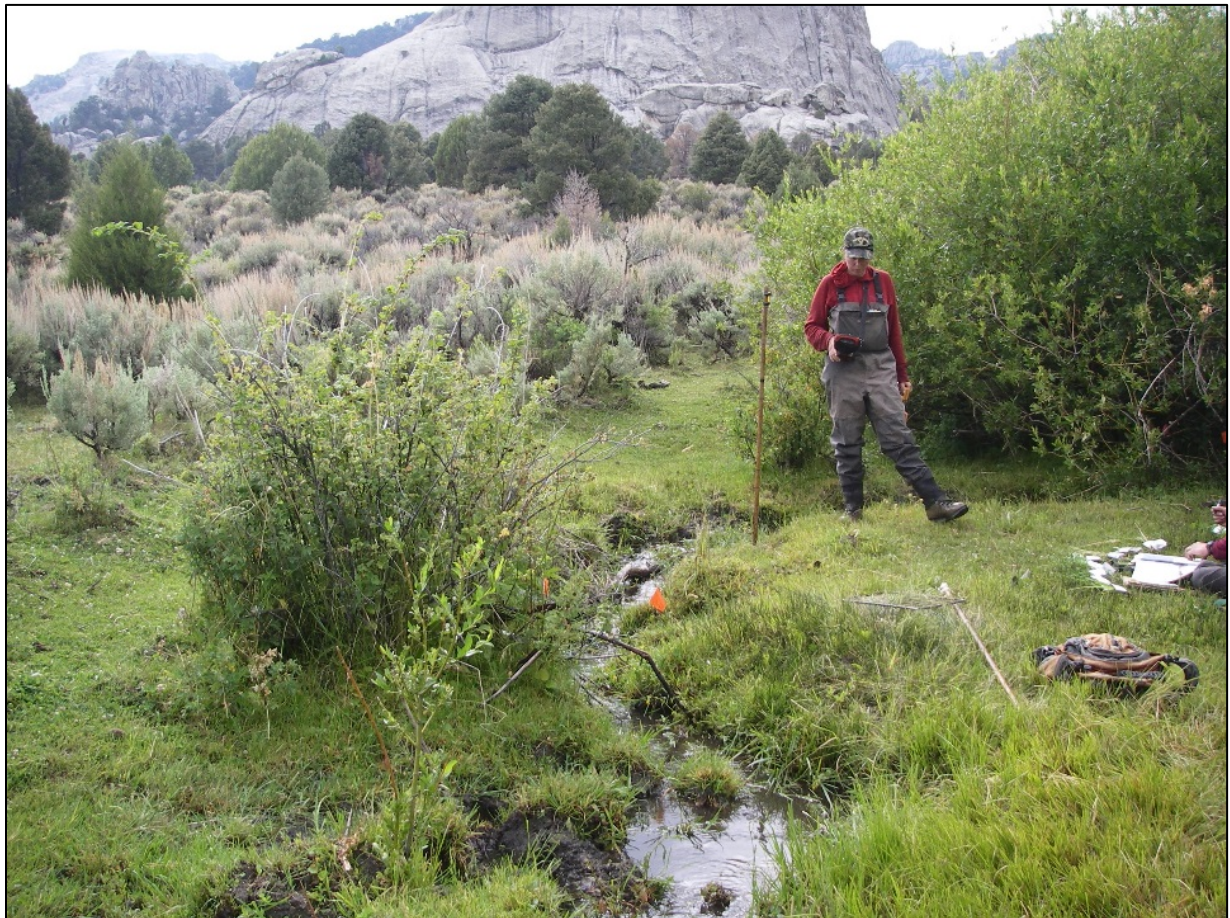
North Fork Circle Creek stream channel characteristics reach overview- SiteID: 3221, SiteName: 524-10-I, July 2012, City of Rocks National Reserve.

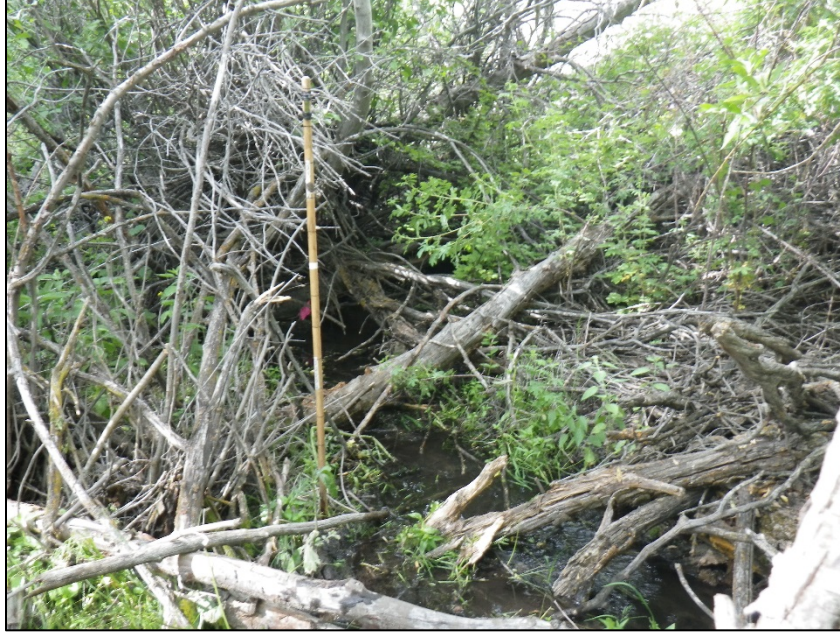
**Figure 2.** North Fork Circle Creek, SiteID: 3220, SiteName: 524-09-I.

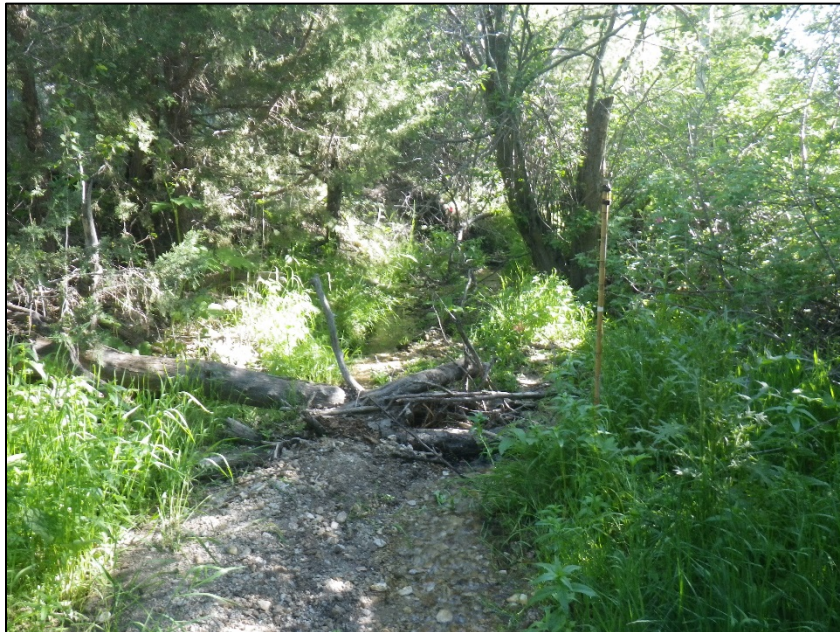
**Figure 3.** South Fork Circle Creek, SiteID: 3222, SiteName: 524-11-I.

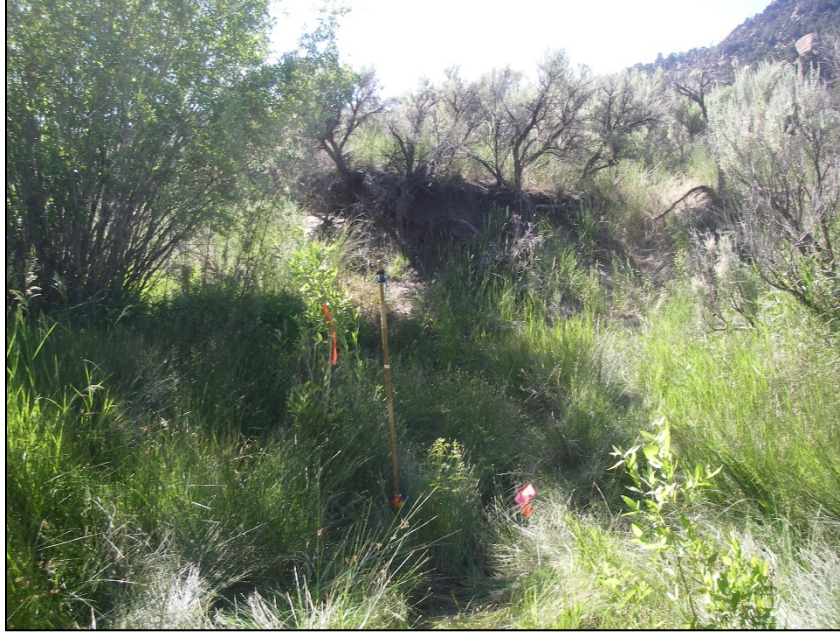
**Figure 4.** Main Circle Creek, SiteID: 3226, SiteName: 524-14-I.

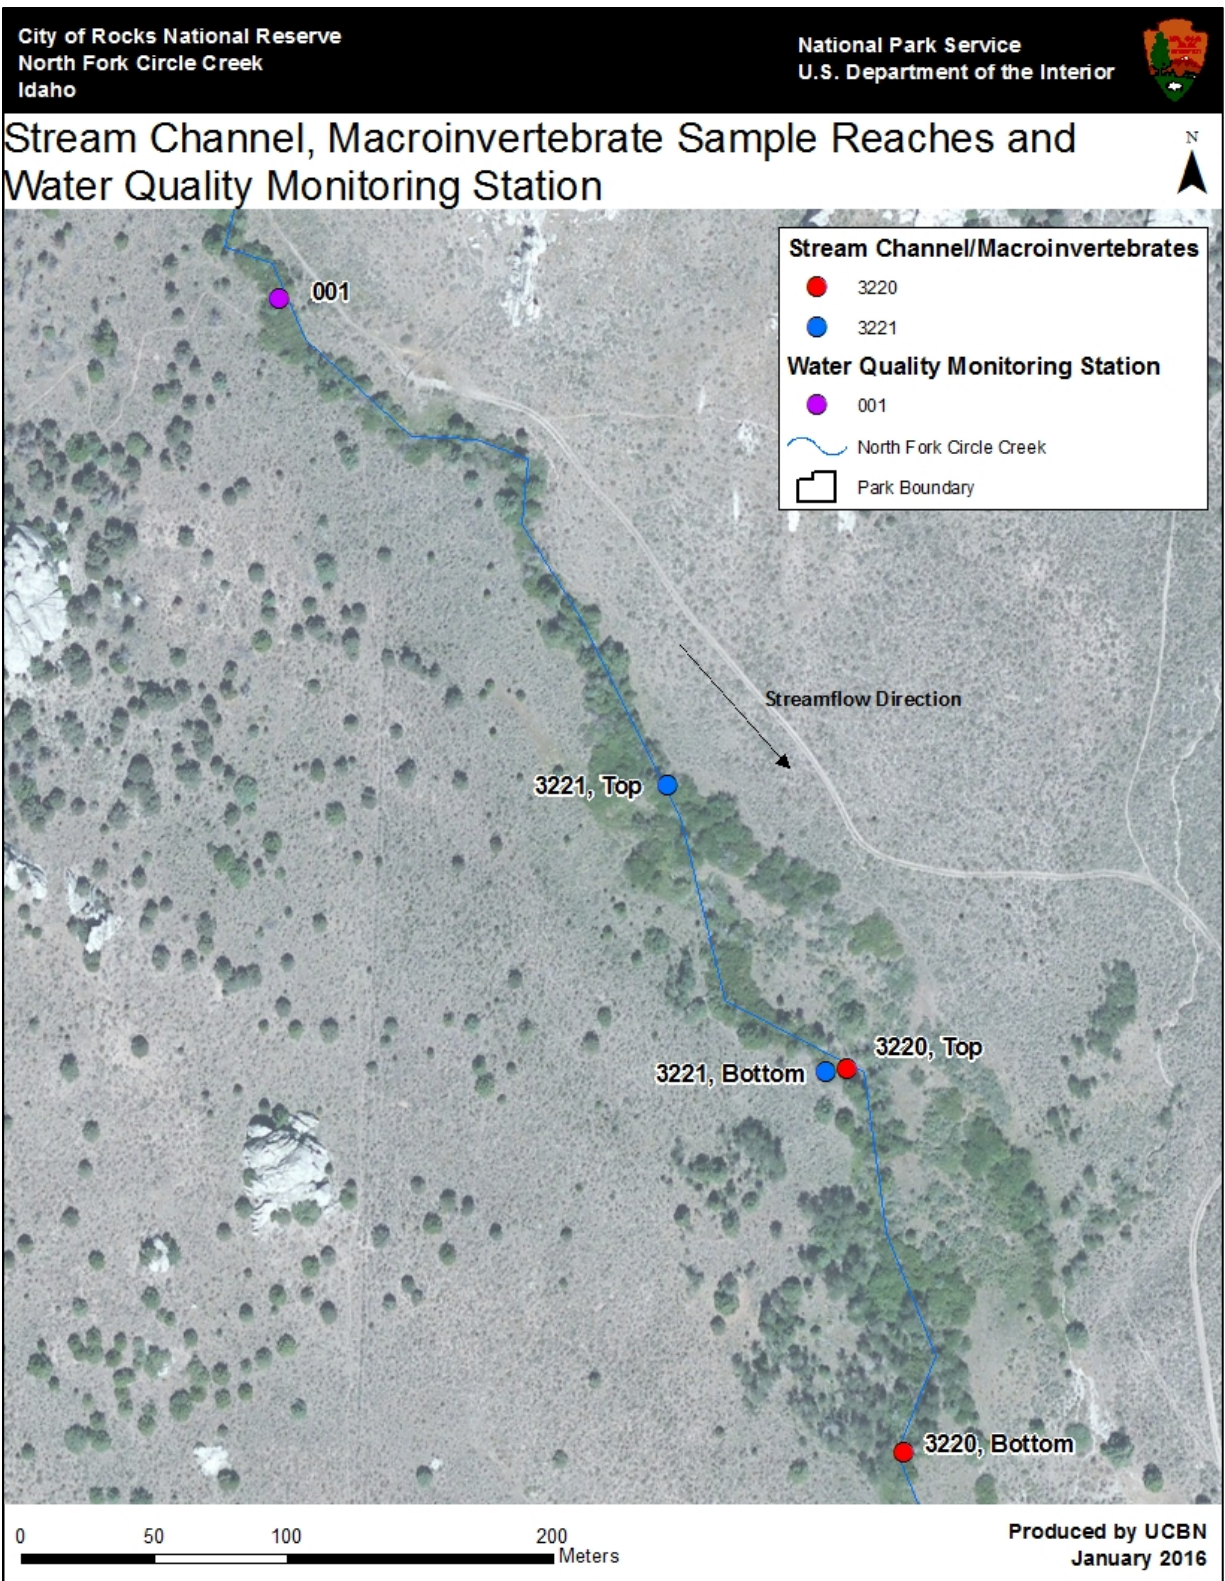
**Figure 5.** Top and bottom of stream channel characteristic and riparian condition monitoring sites on North Fork Circle Creek 2015.

Monitoring included 6 total sample sites, with 2 on sites on each of the North Fork, South Fork, and Main Circle Creeks (Figures 2-7). The most downstream sample sites were established starting from the first suitable pool tail upstream from the park boundary. The subsequent site was established at the first suitable pool tail upstream of the first site. Both stream channel characteristics and riparian condition were evaluated at each of the 6 locations.

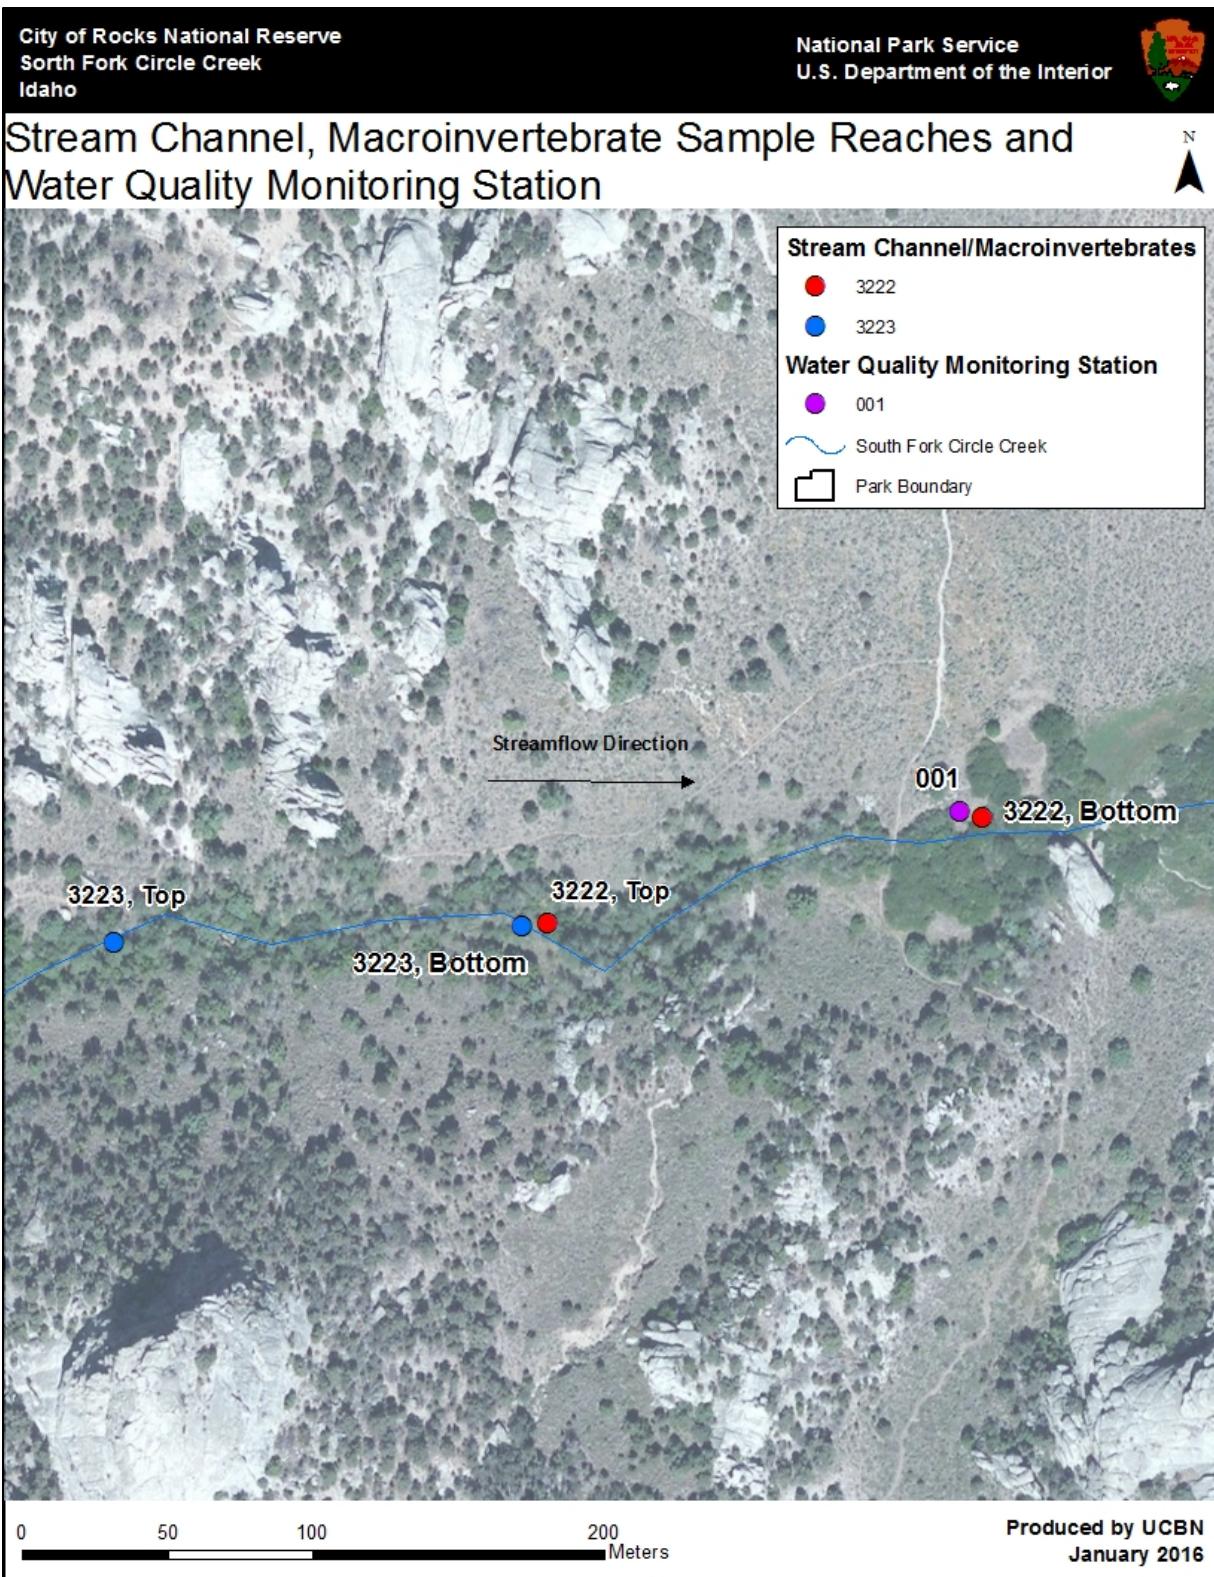
**Figure 6.** Top and bottom of stream channel characteristic and riparian condition monitoring sites on South Fork Circle Creek 2015.

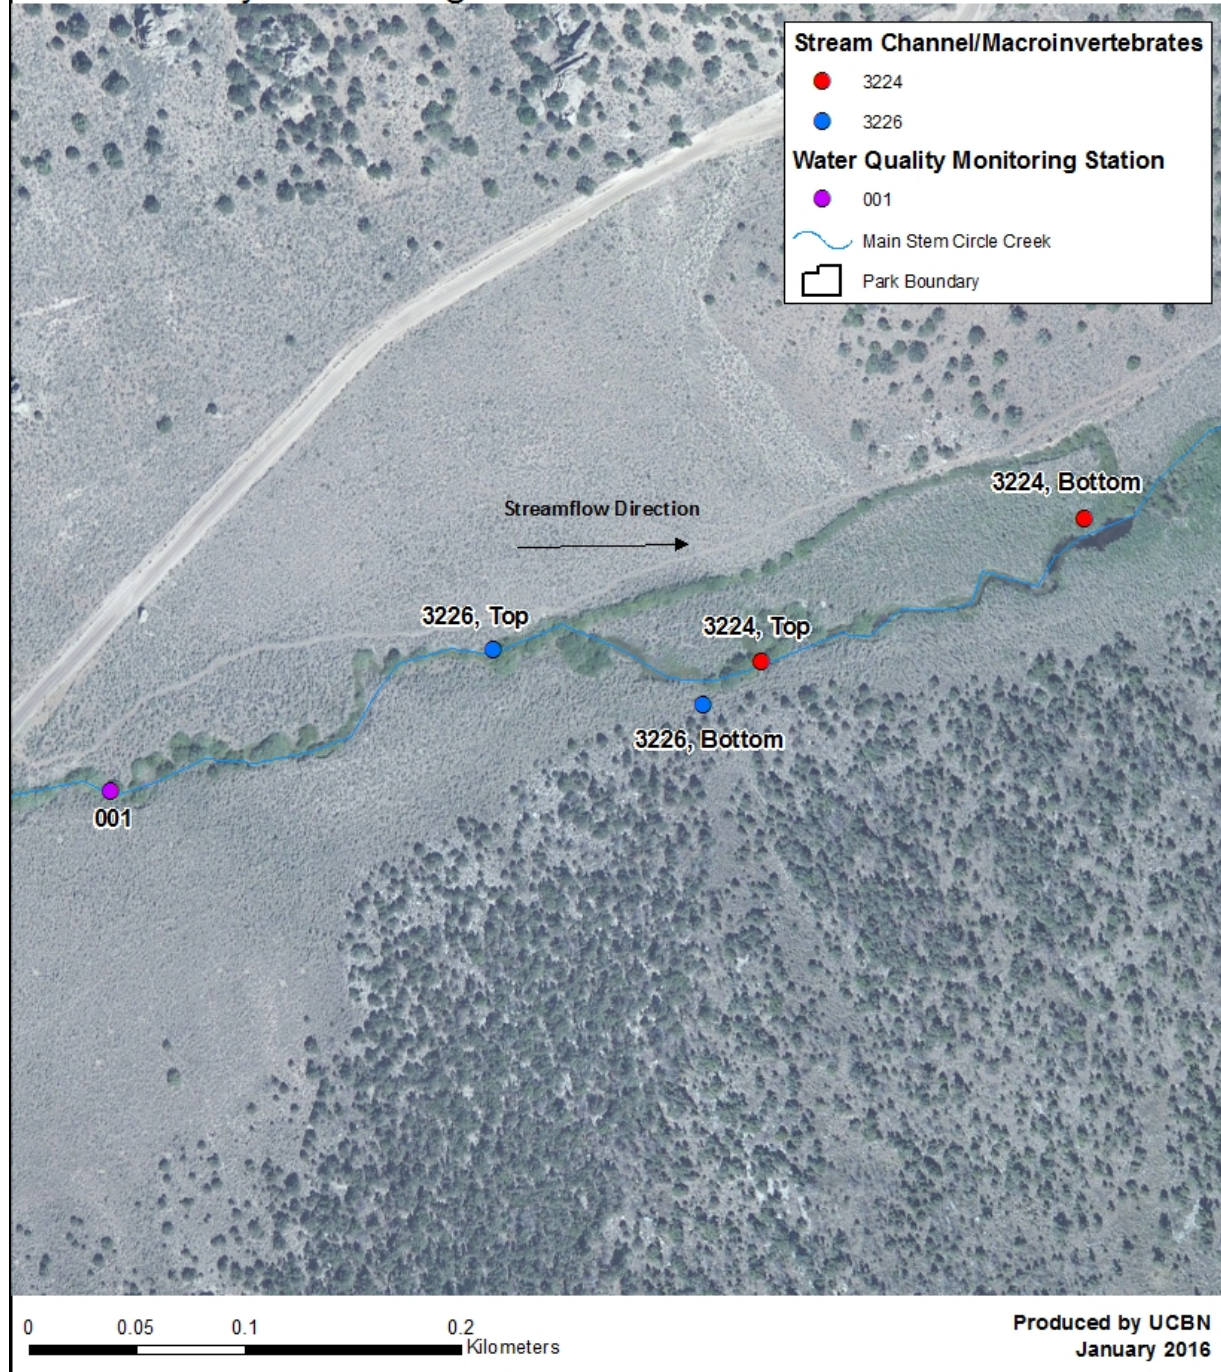
**Figure 7.** Top and bottom of stream channel characteristic and riparian condition monitoring sites on Circle Creek 2015.

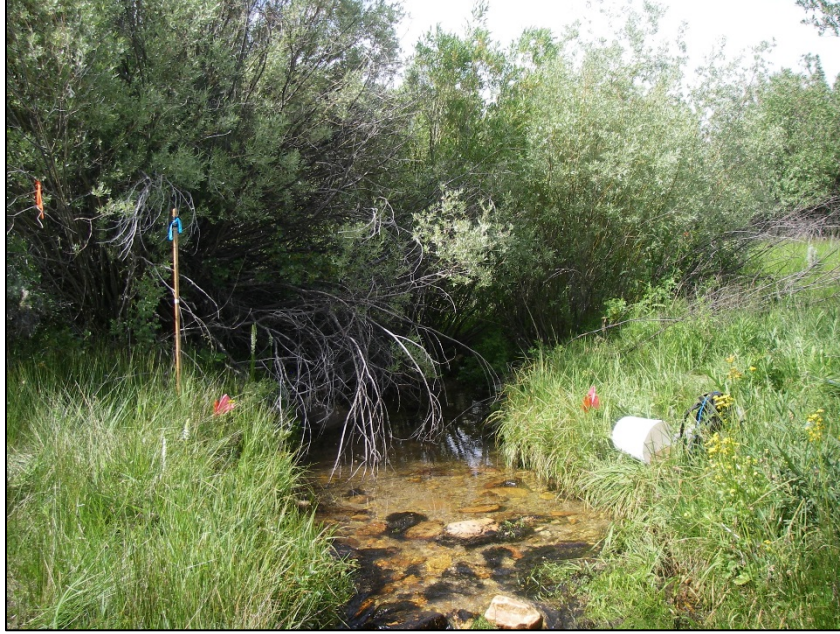
**Figure 8.** Almo Creek, SiteID: 3218, SiteName: 524-07-I.

Sample site/reach selection differed from normal selection in that one site was placed within the fenced wetland area the other outside (Figures 8 and 9). Within each of these areas, sites were established by moving upstream until the first suitable pool tail was encountered. Both stream channel characteristics and riparian condition were evaluated at each site.

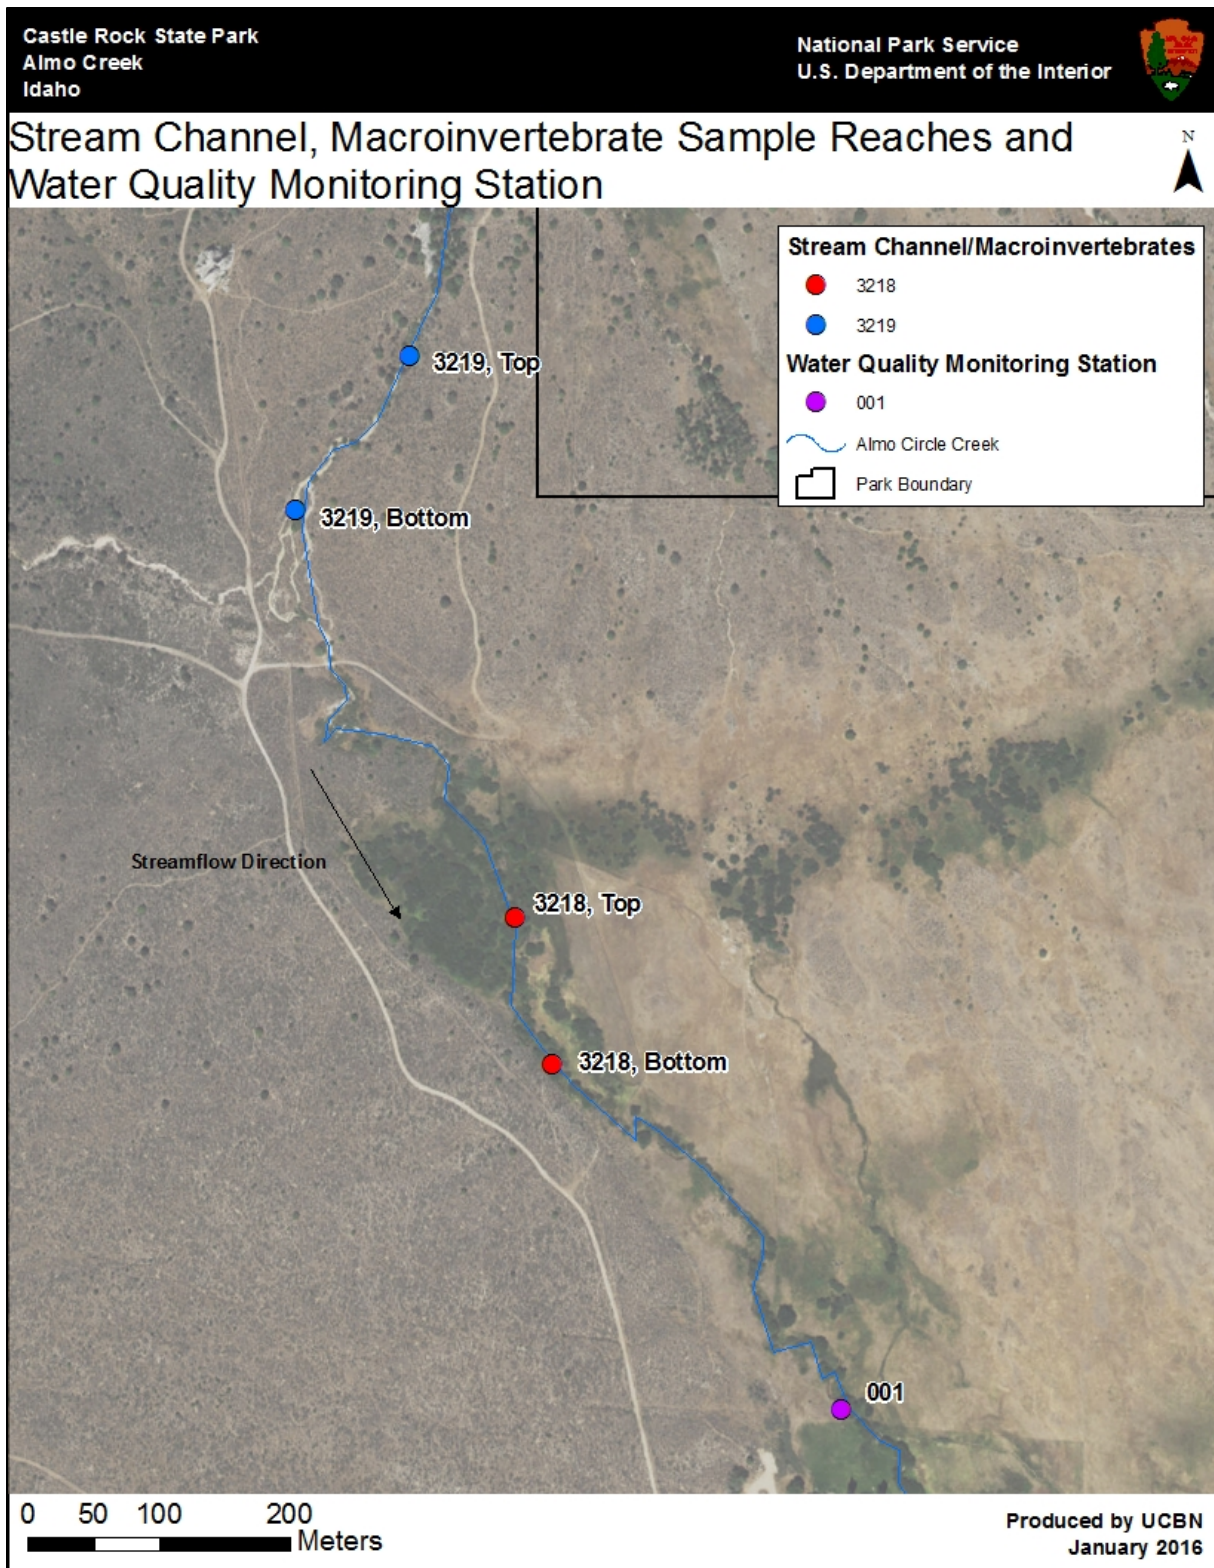
**Figure 9.** Top and bottom of stream channel characteristic and riparian condition monitoring sites on Almo Creek 2015.
