# Assessment of Estuarine Water Quality at Cape Hatteras and Cape Lookout National Seashores

## *2015 Data Summary*

Natural Resource Data Series NPS/SECN/NRDS—2016/1056

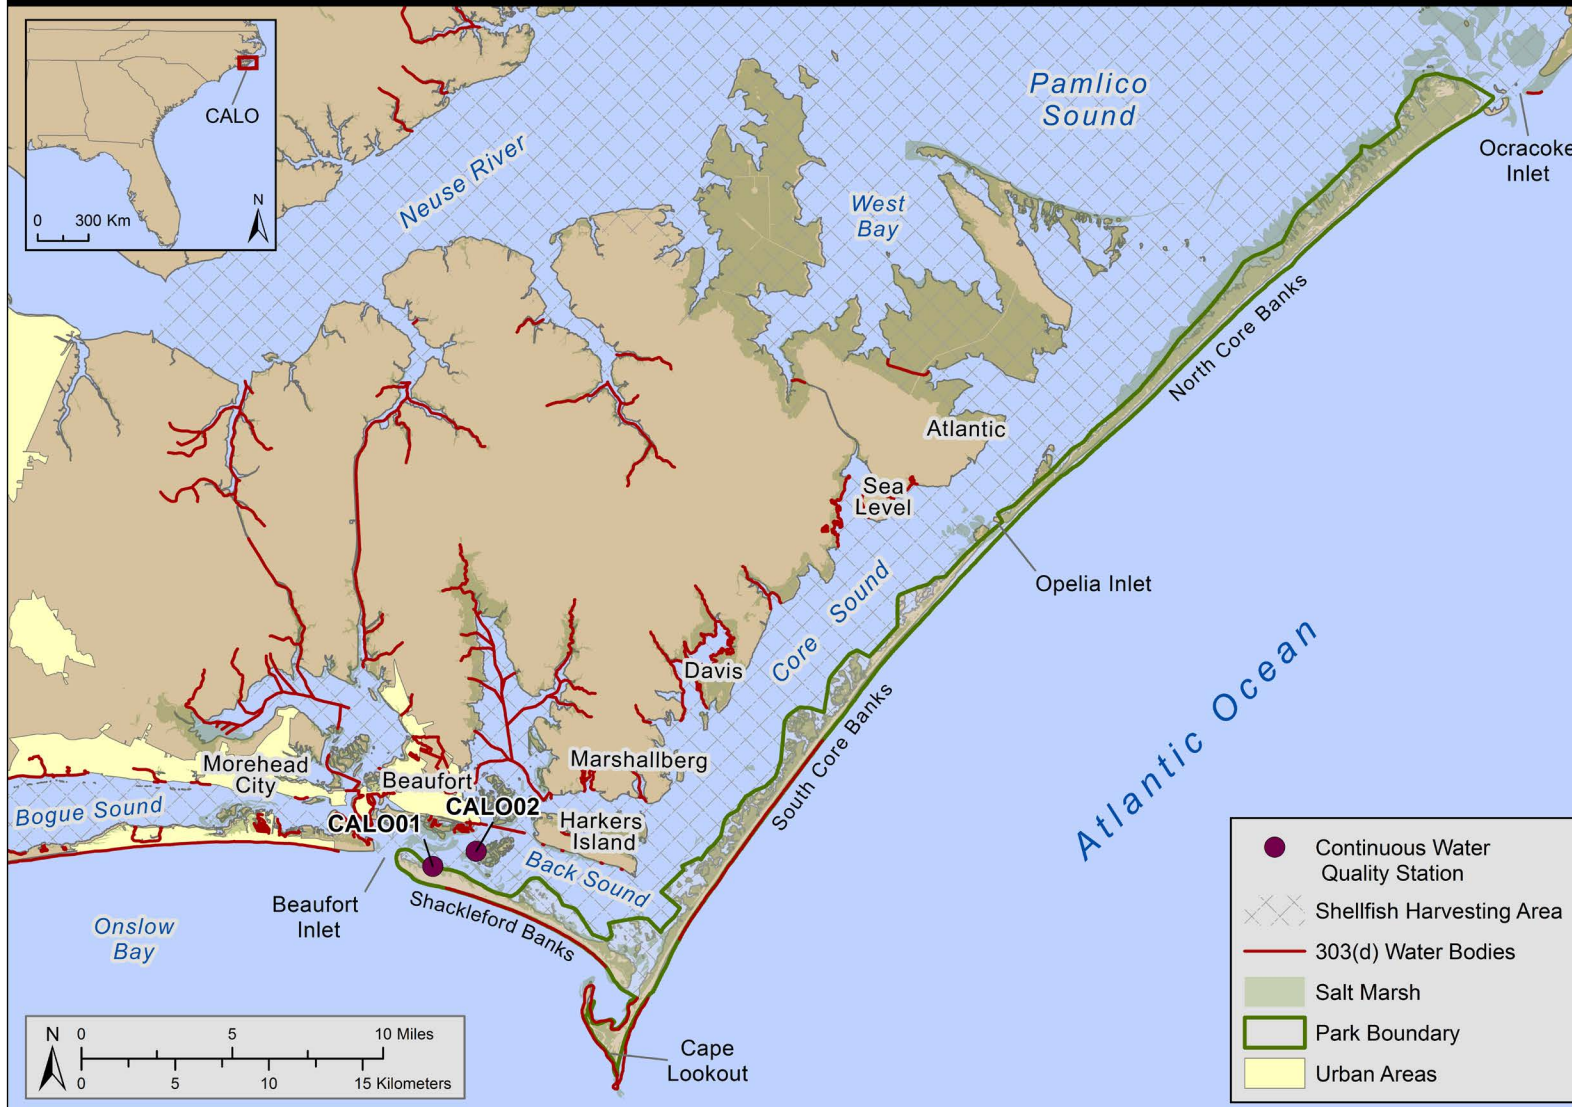
# Cape Lookout National Seashore Significant Waters Map

**Figure 2.** Map of Cape Lookout National Seashore in 2015, showing the location of the SECN fixed water–quality monitoring stations. The map also indicates areas of salt marsh (USFWS 2016), urbanization (US Census Bureau 2016), 303(d) listed water bodies (EPA 2016), and areas designated as having special uses or restrictions (NC OneMap 2016).

Cape Lookout National Seashore includes approximately 24,500 acres of land and is composed of two main islands—Core Banks and Shackleford Banks (Figure 2). Cape Lookout National Seashore was authorized in 1966 and transferred to the National Park Service in 1976. Presently, its two main islands are solely used for recreational purposes. Shackleford Banks has no vehicle traffic and human use of the island consists of sport fishing, swimming, surfing, hiking, camping, and nature study. Core Banks supports these same activities, but vehicle traffic is permitted along the beaches, and there are some dirt roads in the interior of the islands.
