# Stream discharge monitoring in seven watersheds on Mt. Desert Island, ME

## 7 New Discharge Monitoring Stations:

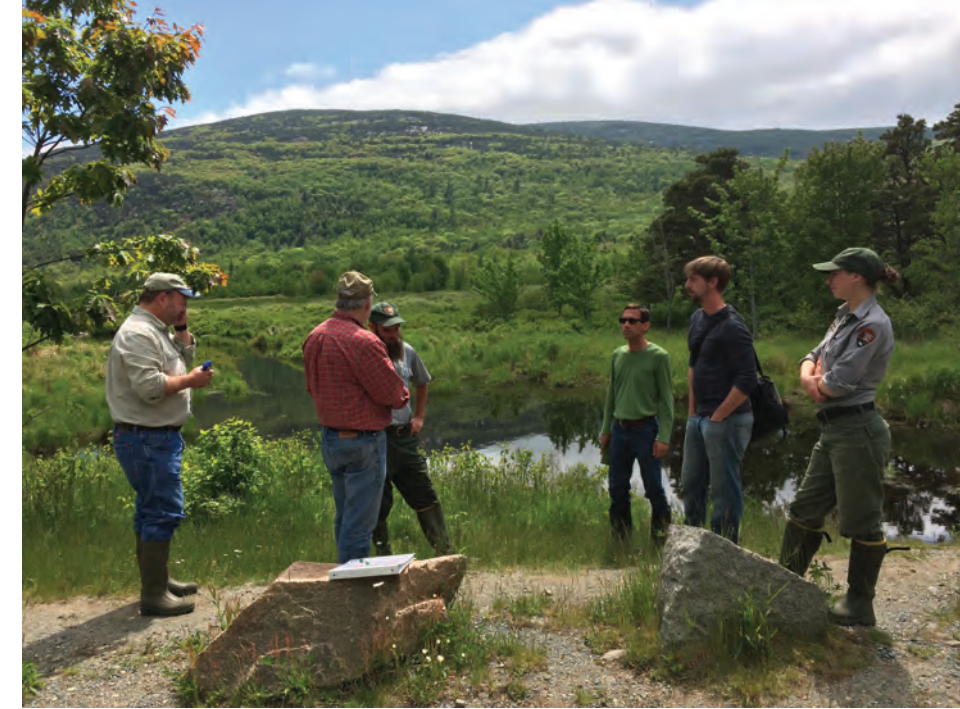
This project is a collaborative effort between ANP, FOA and COA initiated by COA student, Will Minogue. We chose gage sites that align with our collective goals (Cromwell Brook at Park Look Rd Site; photo S. Hall).

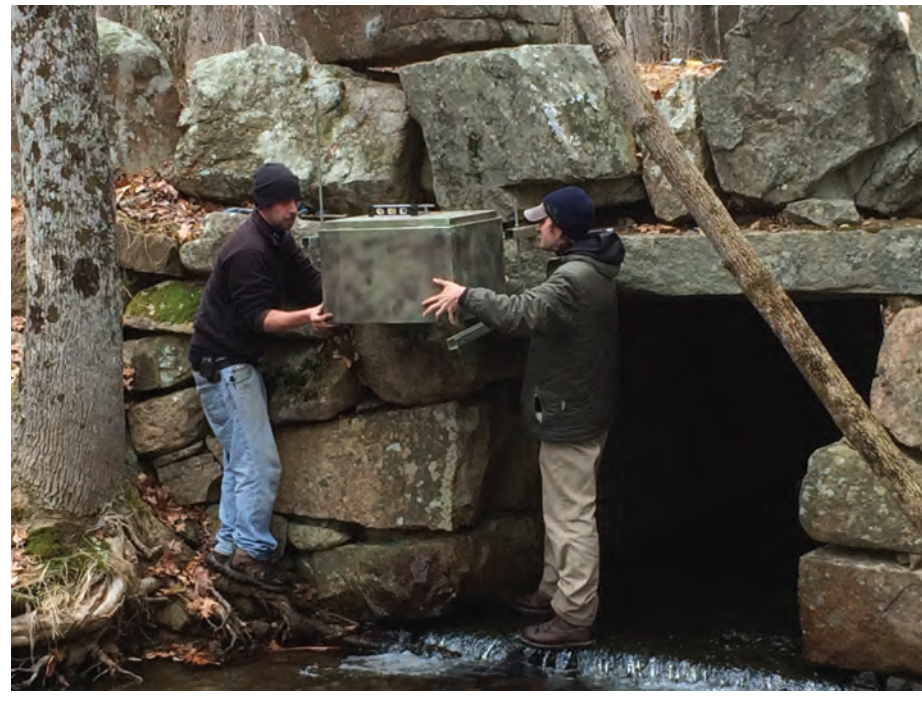
Each site was equipped with a camouflage box containing the gaging equipment donated by the USGS Water Science Center, Tampa, FL (Cromwell at Sieur de Monts Site; photo S. Hall).

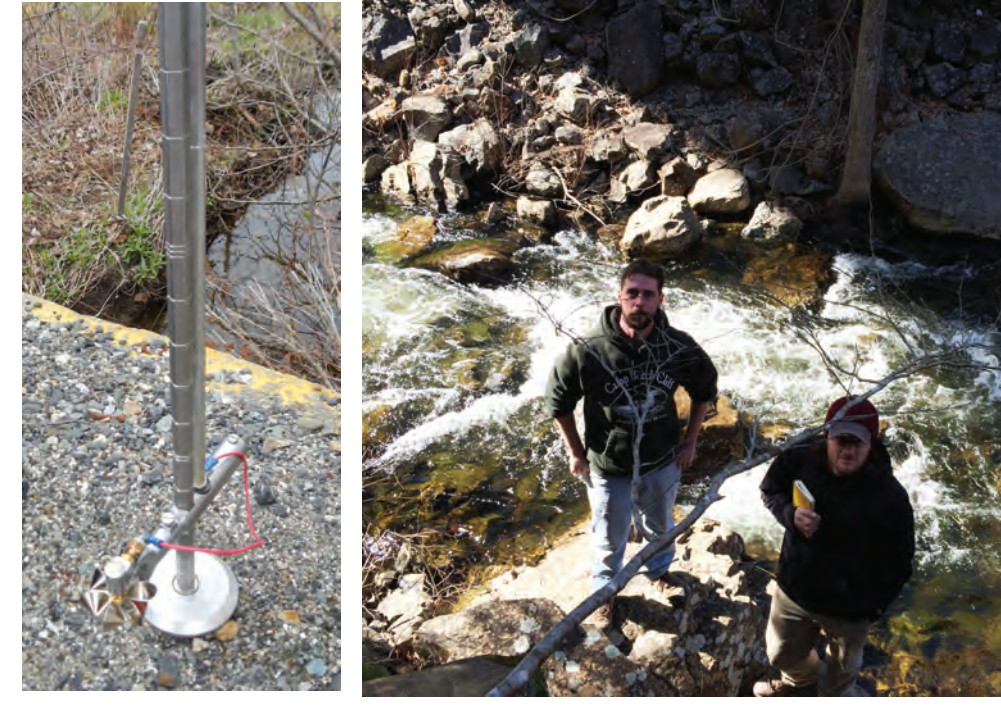
During April and May, discharge measurements were made weekly on each stream in order to establish a rating curve (see below) relating stage height to discharge (photos by A. Wolf and S. Hall).

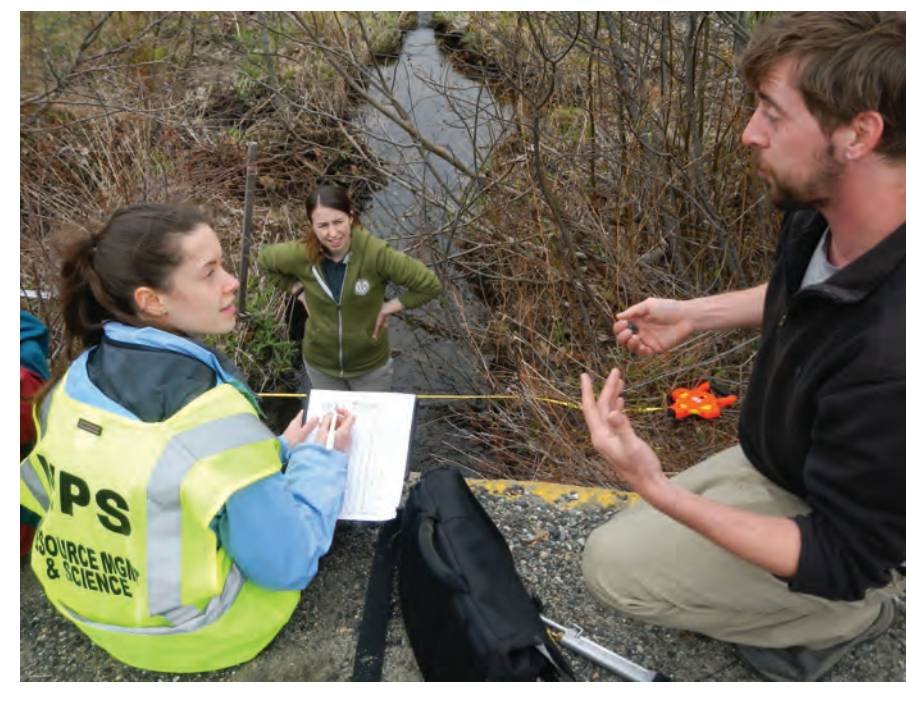
Students were instructed how to measure discharge in order to prepare for long-term data collection and care of the sites. (photo C. McCarthy-Edwards).

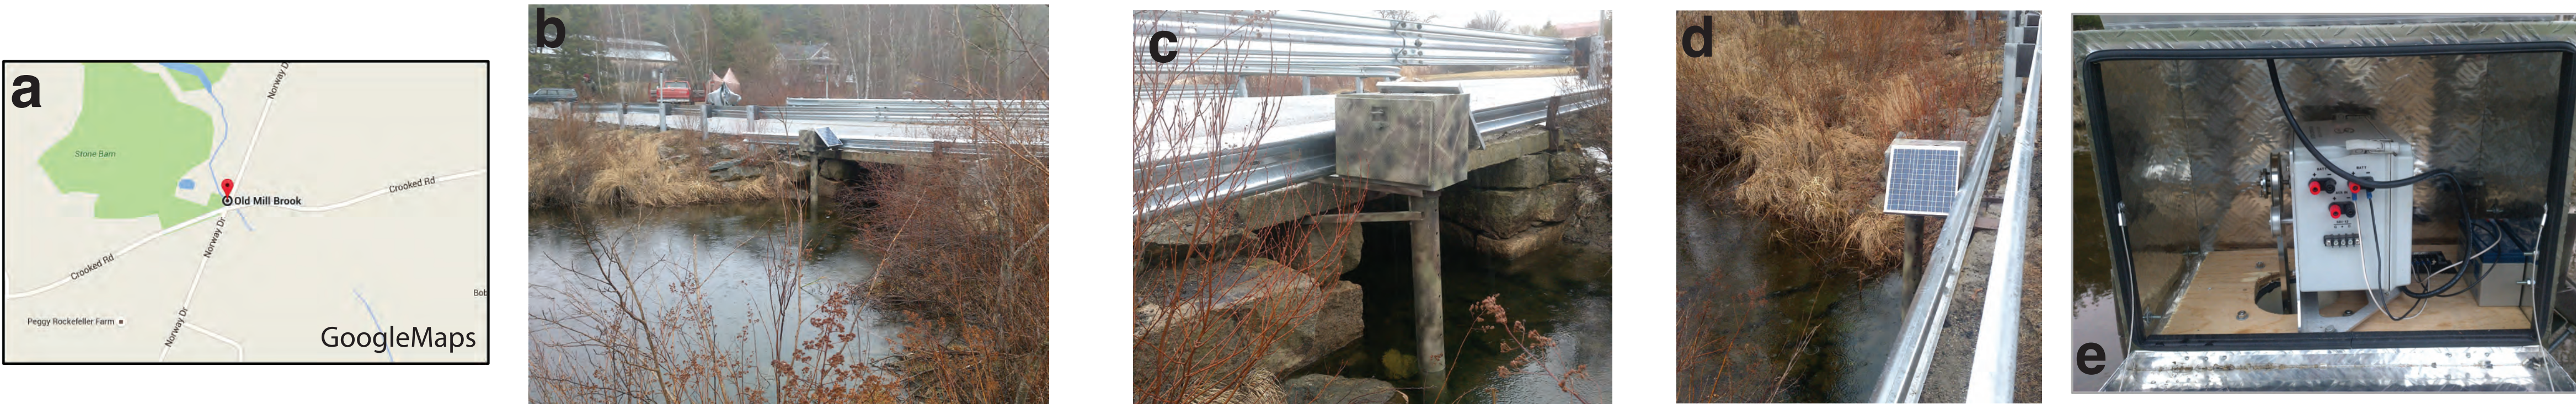
At the corner of Crooked Rd and Norway Dr (a), the camphage box blends in well with the bridge stone (b). This site is of interest to COA because it is adjacent to the COA-run farm. It is also a major tributary to Northeast Creek (photo by W. Minogue)

Equipment is mounted to the side of the bridge at a stream culvert. A camouflage pvc pipe (c) protects the tape and stills the water. A solar panel (d) fixed to the side of the aluminum box provides power to the instrument. Inside the box, is a battery, regulator, and data logger attached to the tape (e; photos by W. Minogue).

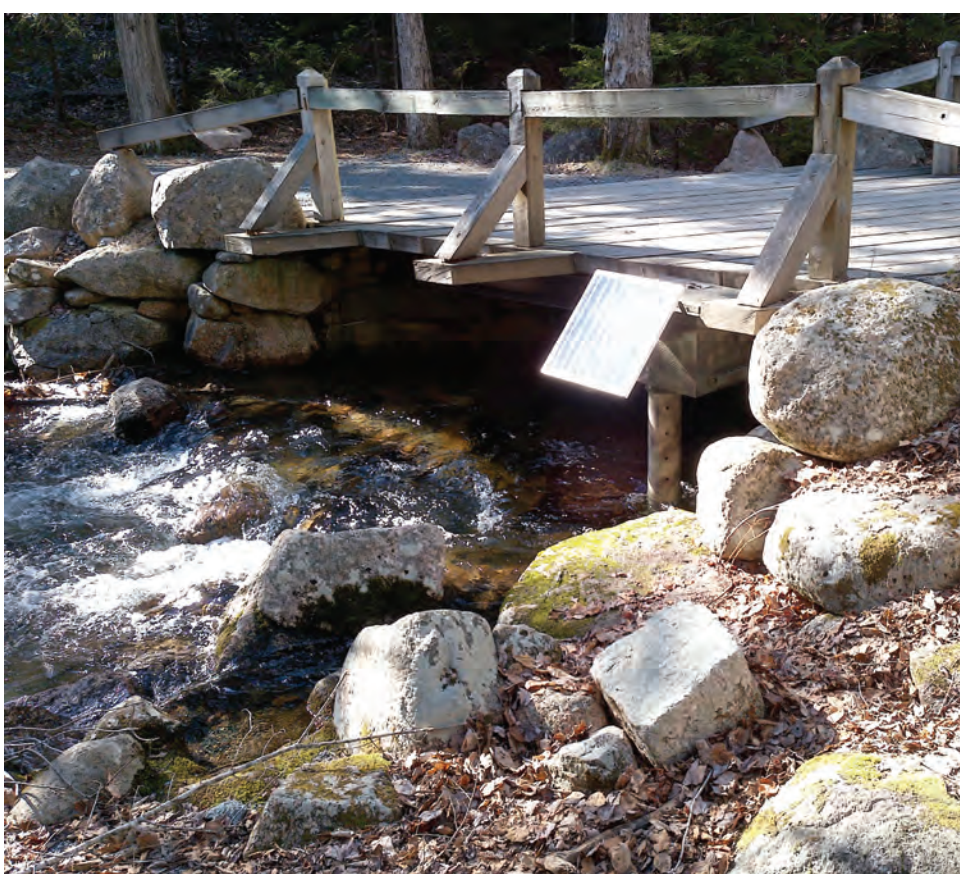
Jordan Stream Gage, downstream from lake (photo W. Minogue)

Jordan Stream originates at the dam outlet of Joran Pond. When lake levels are low, very little water can pass over the top of the dam resulting in low or no flow in the stream. Supplementing discharge measurements, ANP staff regularly collect field parameters and water samples (nutrients) at this site. The Jordan Pond Buoy collects and reports water quality and weather data in 15 min increments as well.

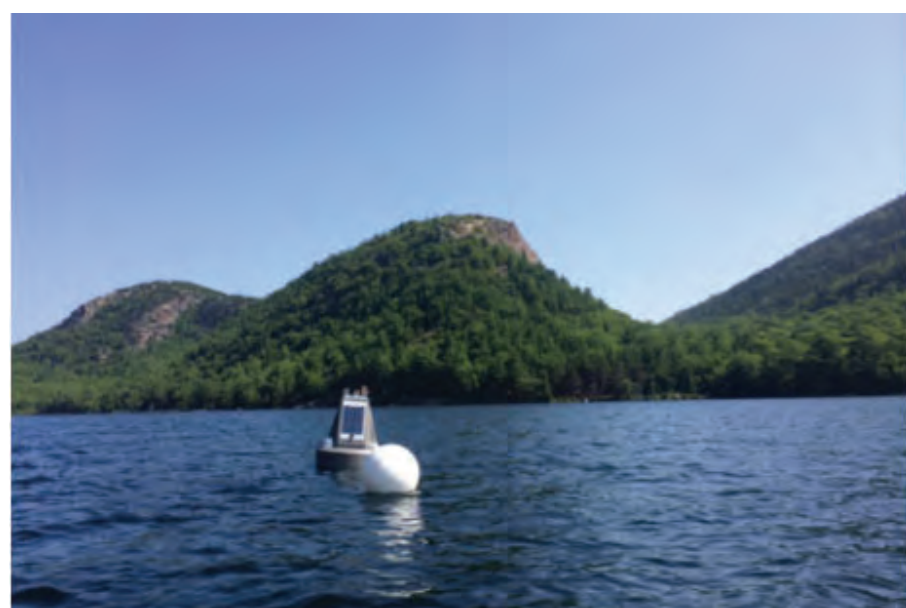
Jordan Pond Buoy (<http://www.jpbuoy.com/>)
