# Summary Report

## Watershed Restoration Project 07-02:

### Removal of the A120 road – 07-02; Removal of a portion of the A130 East/A100 North roads – 07-02A,

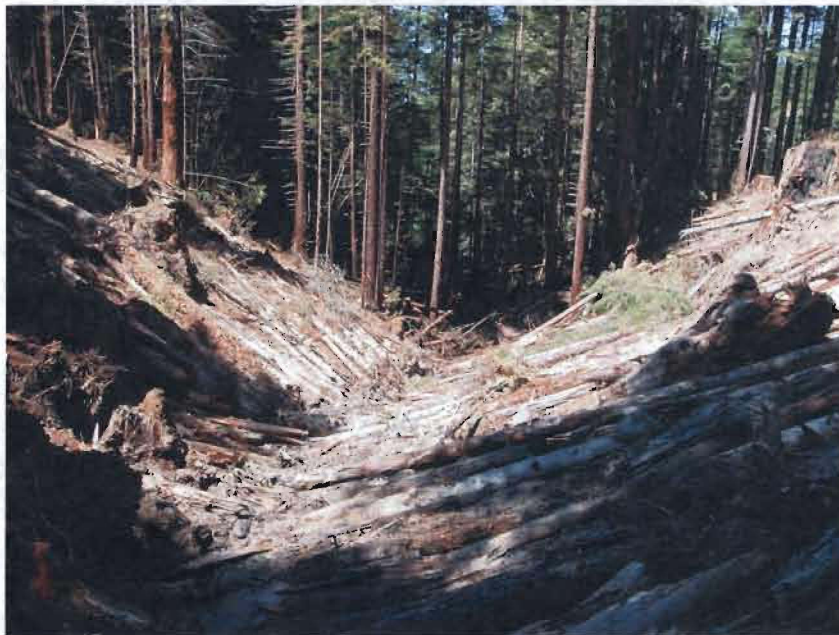
RX-1 changed excavator operators after about 30% done. A total of 2,774 cubic yards of material was excavated from this crossing. The final configuration was left with a log spanning the channel near the top of the excavation.

RX-1; Looking downstream.

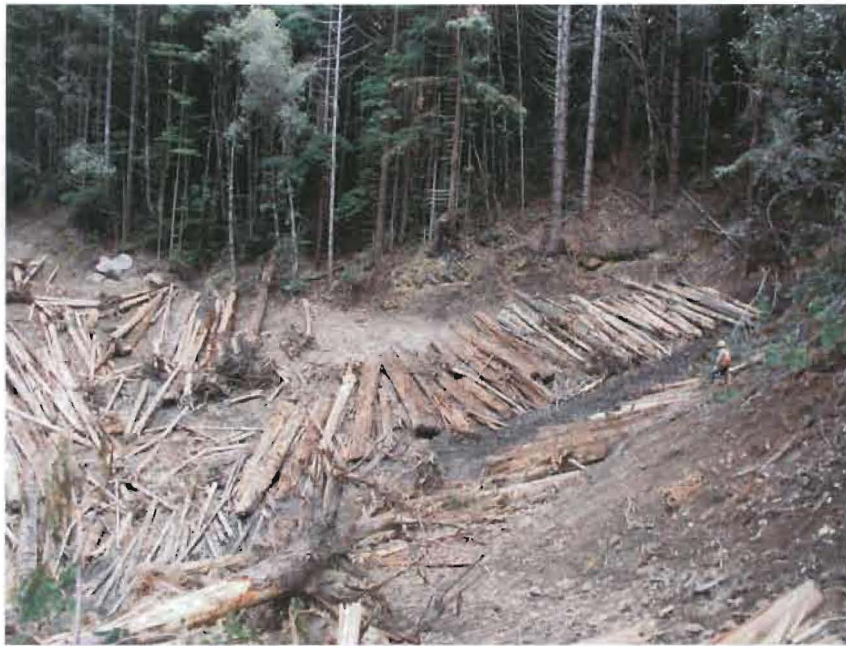
RX-2 had 2 different excavator operators. Paul established the bottom of the excavation, then Jerry cut his teeth on the remainder of this excavation. Spring at right bank was given a depression to flow to channel axis. Lots of springs on this crossing – 3 on right bank and one left of top. Small amount of fill placed on left bank, near top, in order to slope the flat spot above the mulch.

RX-2; Looking towards right bank.

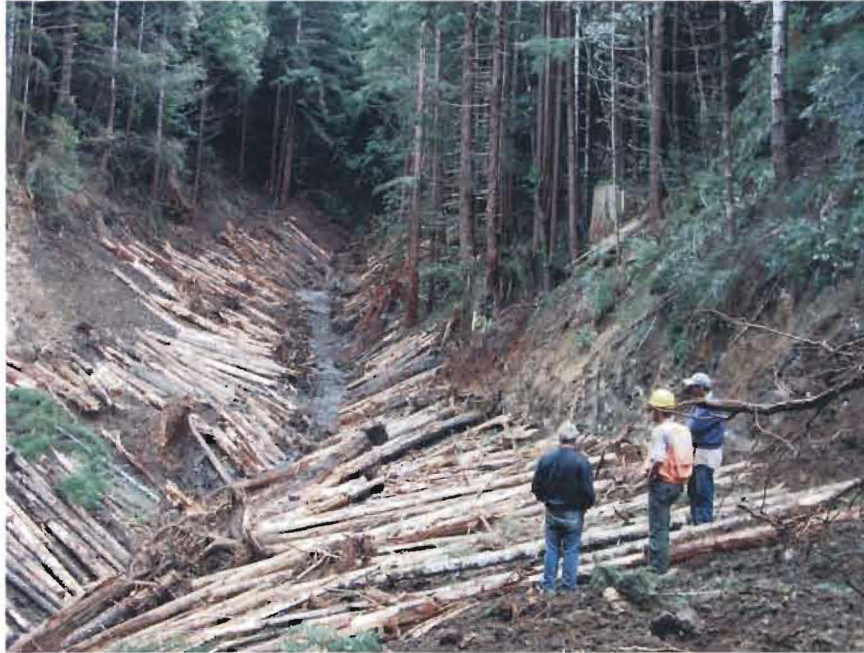
RX-3 was the largest crossing of the project with 6,025 cubic yards excavated. Skid road along right bank, upstream of A120 was removed up to major break in slope, approximately 250 feet.

The bottom of the excavation was not straight-forward, because a Large-wood/chunk trash pile extended beyond a reasonable reach for the excavator. The D-8K dozer and a choker were used to remove a large root wad and old growth chunks from the axis of the channel at the designed bottom in order to leave the channel flowing freely onto existing (post-logging) gravels below the excavation.

The left bank kept moving left as more and more chunks were uncovered. Humboldt logs were not layed parallel in this fill, but were jack-strawed such that subsurface flow was dispersed and deflected (instead of concentrated) along the logs. This resulted in fill saturation higher in the prism than would normally be expected: excessive moisture differential was paid for this work item.

RX-3; Looking upstream, from left bank.  
Upper left portion of photo is skid road along right bank.

One technical problem with this excavation was how to remove the skid road from the right bank of the channel, upstream of the A120, while needing to exit the site via the A120 along the left bank. As the excavation progressed upstream, a temporary crossing was installed from the cutbank of the A120 (on the left bank) to the skid road upstream of the A120 (on the right bank). This temporary crossing provided an exit path that the excavator could remove from a position on the left bank approach of the A120, after the skid road had been removed.
