# Summary Report

## Watershed Restoration Project 08-02: Removal of a portion of the A400 road – 08-02A; (Removal of a portion of the A141 road – 08-02B); Removal of portions of the A100 and A140 roads – 08-02C;

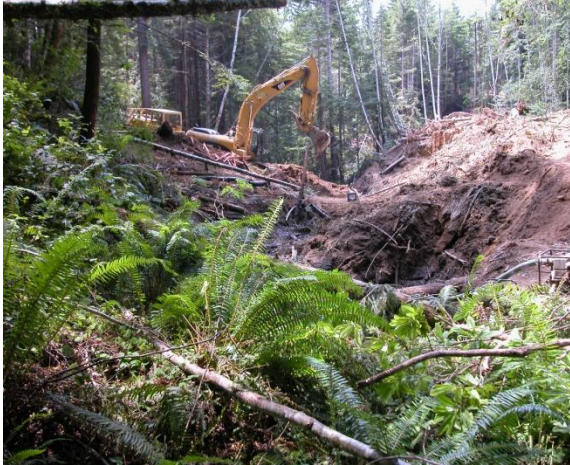
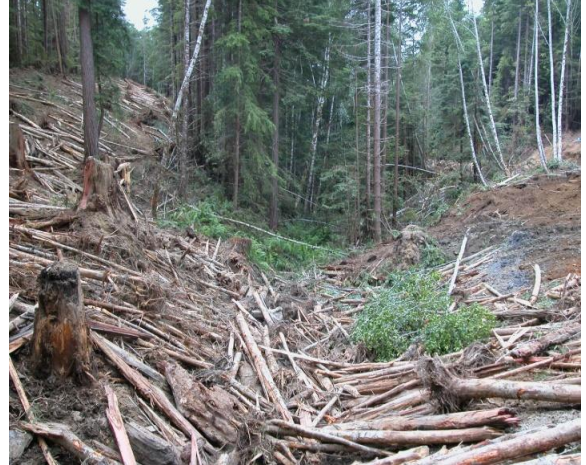
LDS

Work Item #10 was a collapsing Humboldt crossing that was part of a landing (work item #11) built near the confluence of two streams (work items #10 and 12). Here the A400 crosses the northern, blue-line, branch of the Middle Fork Lost Man Creek (MFLMC). Due to the persistent (late season) excessive moisture at these sites, production was low and cost of excavation was well above the design estimates. Original design was for a volume of 3,366 yd<sup>3</sup> at a cost of \$27,635, but final volume was 4,891 yd<sup>3</sup> at a cost of \$71,638. The increase was mostly attributable to much longer push differentials, as well as a failure to budget for excessive moisture and flow diversion expenses.

A few very long, old growth logs were pulled from the bottom of this excavation. Good video exists for the excavation of the landing complex.

Original design called for utilizing work item #11 for storage of the fill spoils from this excavation. Site conditions changed once work item #11 was opened, however, and because of the significant spring flow coming from the base of the cutbank it was decided to spoil fill elsewhere. As much as possible (3,133 yd<sup>3</sup>) was pushed to the distant fillsite #3 before access to that side of the creek had to be eliminated. This necessitated the opening of an alternate local fillsite, work item #20 (Figure 3), which was also used for spoils from stream crossing work items #12 and #20.

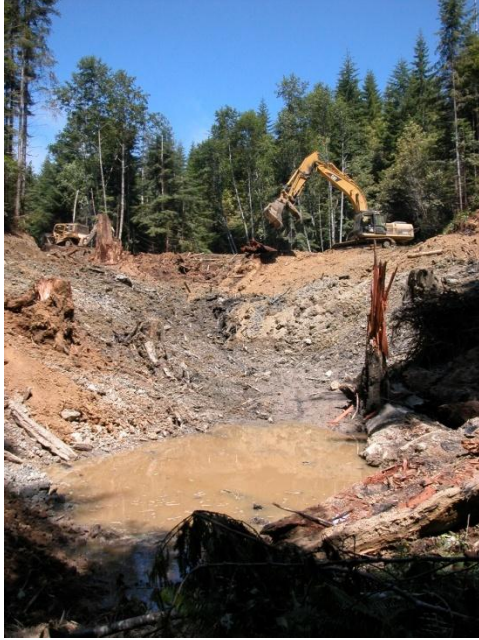
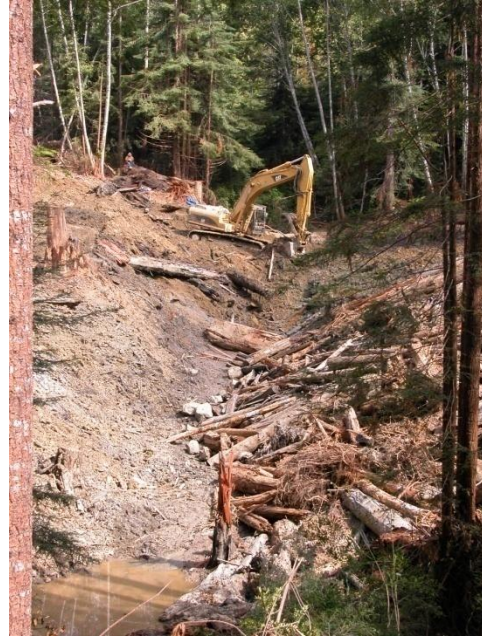
LUS 7.25.08

Work Item #12 was 240 ft. of buried channel that was beneath 20 ft. of collapsing fill and large wood at the downstream end. The upstream 90 ft. of the excavation was fine sediment deposition (up to 12 ft. deep) behind large, jack-straw, woody debris that appeared to be culls pushed off the landing. The excavation was designed to move 3,701 yd<sup>3</sup>, but actually excavated 8,576 yd<sup>3</sup>. Moreover the spring flow coming from every direction, coupled with the weakly consolidated sand (bedrock and fill) complicated the excavation and the push to the fillsite. Consequently the cost of this site increased from a design of \$36,751 to an actual cost of \$92,568.

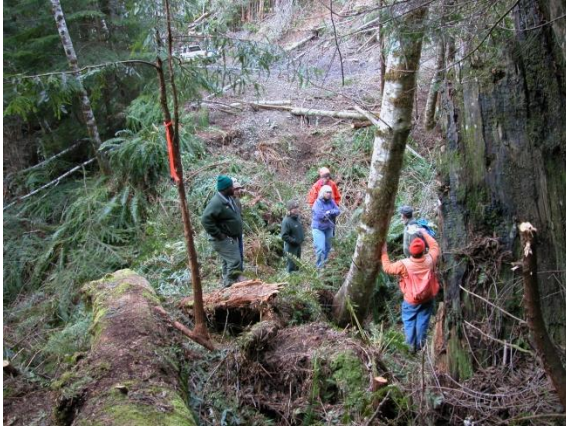
Work Item #16 (RX-7) was a collapsing log stringer bridge prior to A400 road removal efforts began. The collapsed logs and fill had caused sediment aggradation immediately upstream of the crossing. Stream profile and cross sectional surveys estimated that the depth of this aggradation was in excess of eight feet. The designed excavation was to be 2,193 yd<sup>3</sup>, but only 1,241 yd<sup>3</sup> was excavated prior to moving to work unit 08-02C.

RX-6 prior to excavation.

As part of the road opening and improvement to gain access to the first work items, the log stringers were removed and a temporary culvert was installed. The culvert was at approximately the top of the aggraded wedge, or at the existing channel surface. A small (1 yd<sup>3</sup>) settling pond was dug at the culvert inlet. During this process it was discovered that there had been a more traditional Humboldt crossing (logs parallel to flow) prior to bridge installation. The culvert was placed on top of the Humboldt logs and backfilled. The sideslopes of the crossing were excavated back to a gradient that would be drivable.

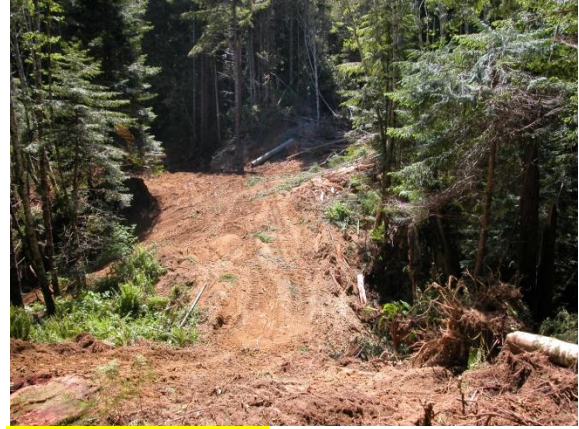
RX-6 partial excavation.

Due to the need to move to a T&E restricted work unit (08-02C) on September 15<sup>th</sup>, no additional excavation outside of the bridge corridor was undertaken on this work item. Instead, the crossing was winterized by pulling the temporary culvert, cleaning the dirt from on top of the Humboldt logs, excavating the sideslopes back to a 1:1 gradient, and mulching the sideslopes with vegetation disturbed during road opening. It is anticipated that this crossing will be completely excavated in the summer of 2009.

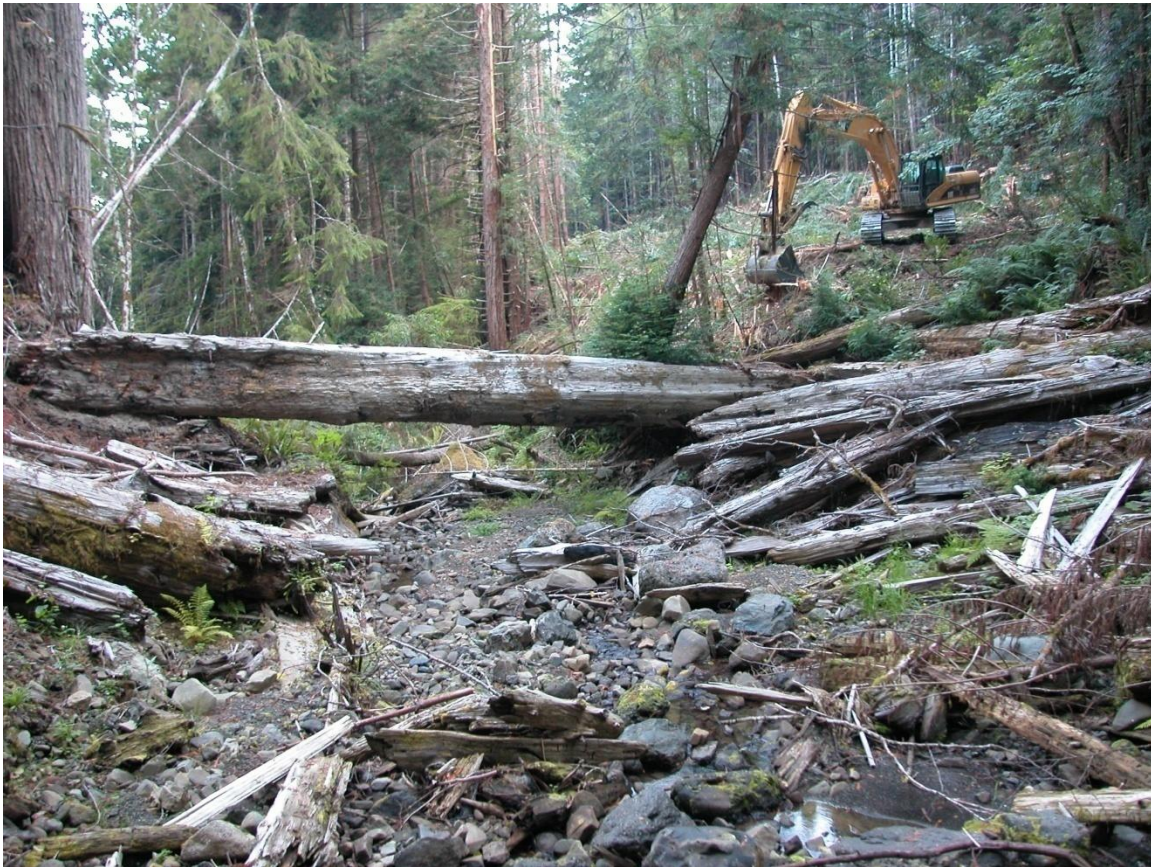
Another EOS treatment of interest is work item #39, which is located closest to the South Fork Lost Man Creek (SFLMC). This treatment begins where the A100 road log stringer bridge used to cross SFLMC: see photo below.

South Fork Lost Man Creek at former A100 crossing. Unit 08-02C, work item #39 at excavator. Pre-treat.
