# Summary Report

## Watershed Restoration Project 09-03:

A300 – 0903a  
A160 – 0903b

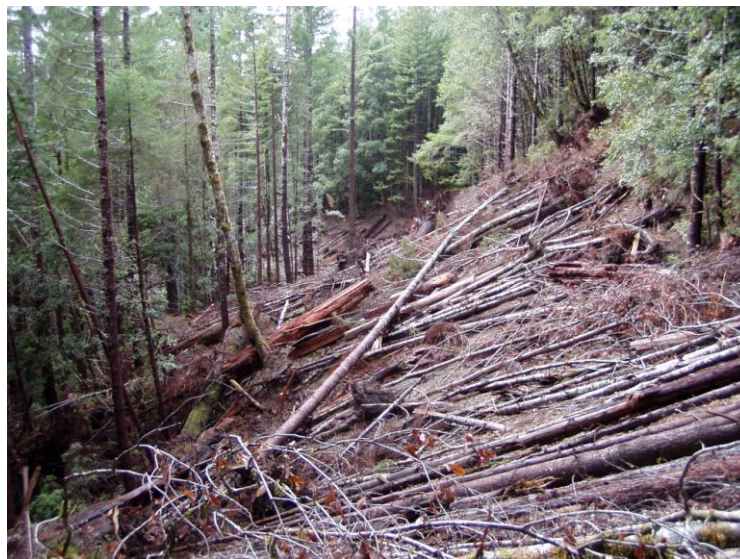
Image shows upper headwater swales following landform restoration. Photo was taken from Holter Ridge Road, looking down the previous A300 road alignment.

Road fill excavations produced no surprises during this portion of the project. Some work item volumes varied within normal ranges. The miscellaneous work included end hauling and addressing some drainage issues with access roads. There is also an immeasurable safety benefit regarding the removal of the A300. During reconnaissance of the A300 following the 1997 storm, one of the inventory volunteers took a nasty spill while traveling down the upper portion of the road. Then again in the early 2000's while preparing for the Line Item Construction package #355, one of the park project geologists had a similar experience. Not too long after that, a pair of rehab technicians got hopelessly stuck in a rut on that same portion of road.

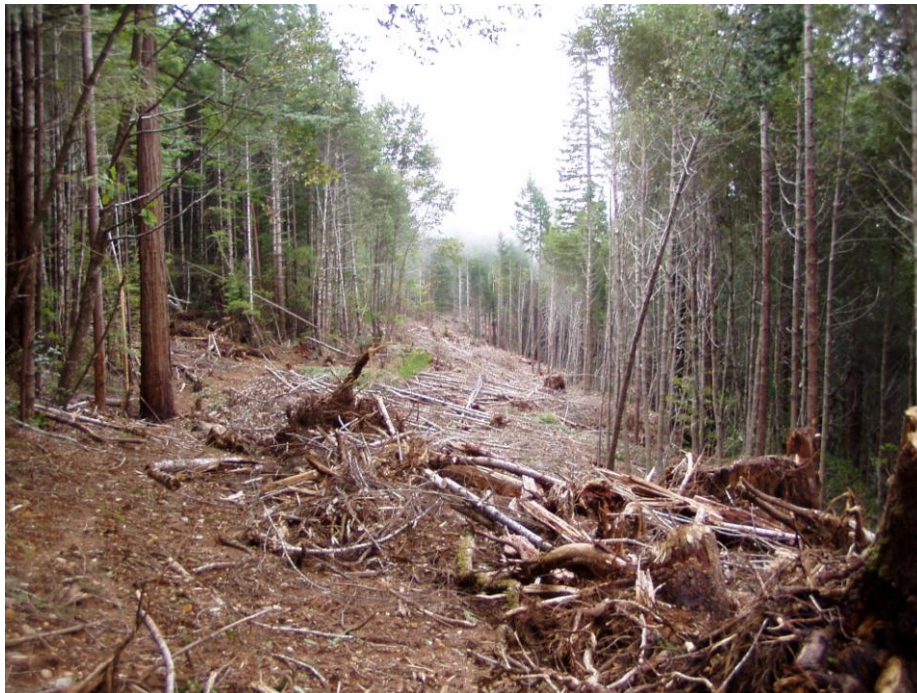
This photo was taken looking south along the A160 from the junction with the A150 and what is now called Lost Ridge Road.

The portion of the A160 from the junction of the A150 to the junction of the A170 was logged out prior to road removal. As part of the forest restoration project going on in the area, 'right of way' trees were logged and removed. All limbs and tops were left for use as mulch on the finished slopes. The photo of the A160 shows more than enough mulch to meet the guidelines for the area.
