National Park Service  
Cultural Landscapes Inventory  
2016

Camp Greentop  
Catoctin Mountain Park

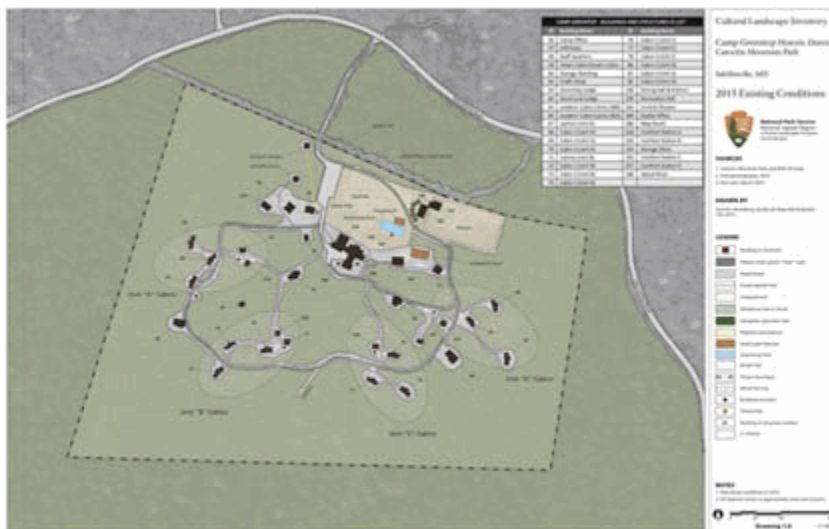
### Site Plan

*As part of Catoctin Mountain Park (formerly Catoctin Recreational Demonstration Area), the Camp Greentop landscape encompasses approximately 52 acre (NCR).*

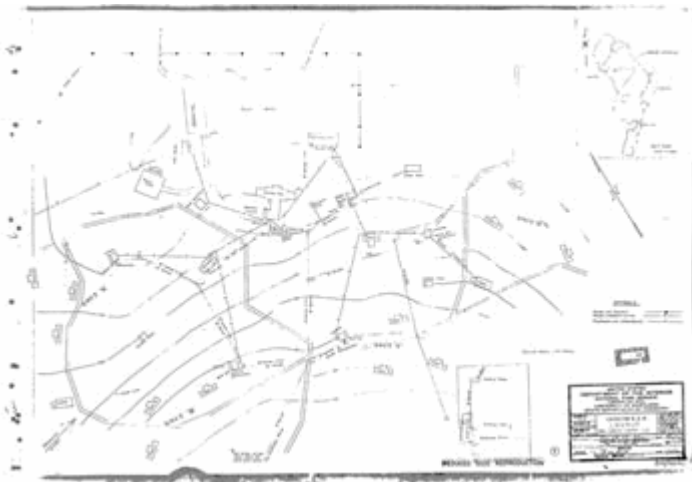
*Camp Greentop layout plan, 1938 (841-9007C, CATO TIC Files).*

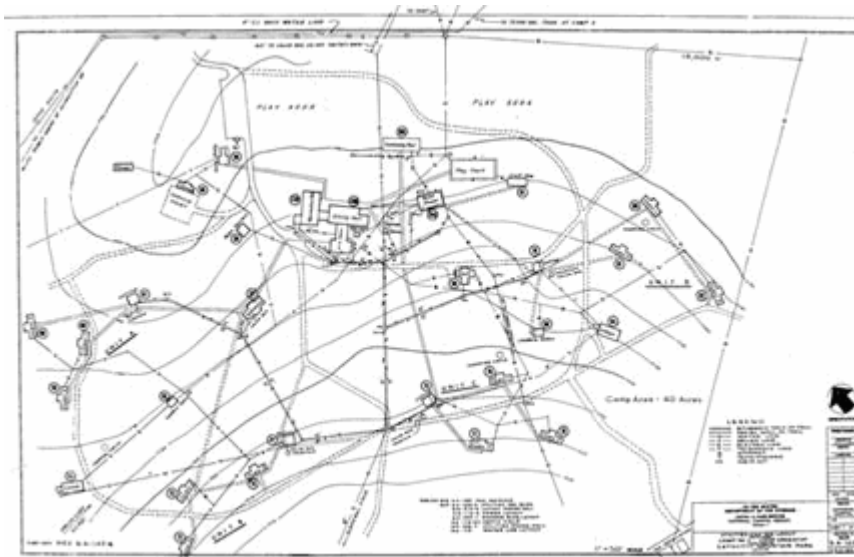
*Camp Greentop utilities and general layout plan, 1967 (841-80338, CATO TIC files).*

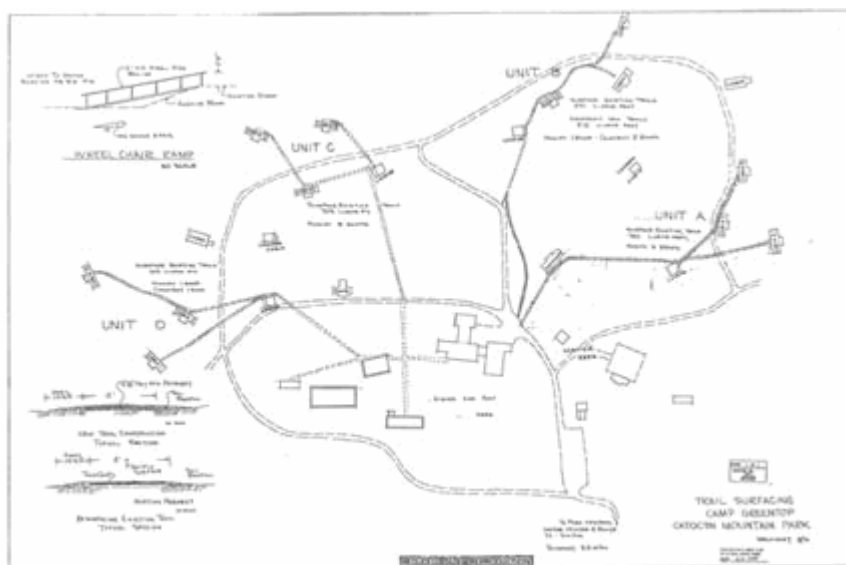
*Trail surfacing plan at Camp Greentop, 1976 (841-80408, CATO TIC files).*

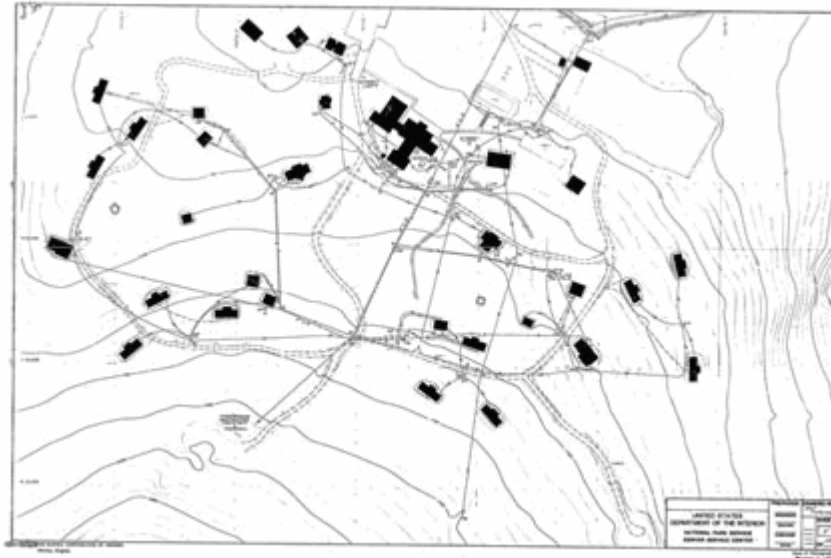
*Camp Greentop site layout, 1982 (841-41022, CATO TIC files).*

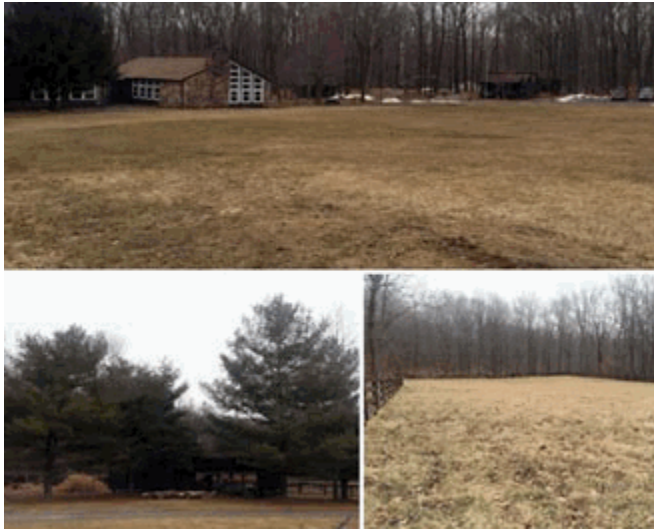
*Vegetation in Camp Greentop includes a playfield (top), a non-contributing white pine visual screen (bottom left), and horse pasture (bottom right). (NCR)*

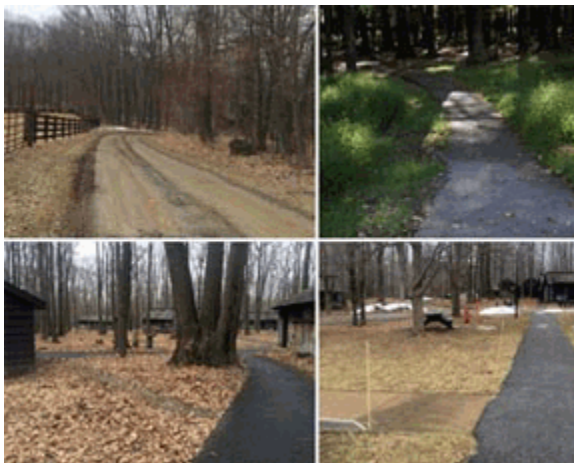
*Camp Greentop current circulation patterns: main gravel loop road (top left), asphalt surfaced pedestrian trail (top right), social trail between cabins (bottom left), and concrete sidewalk to recreation hall (bottom right). (NCR)*

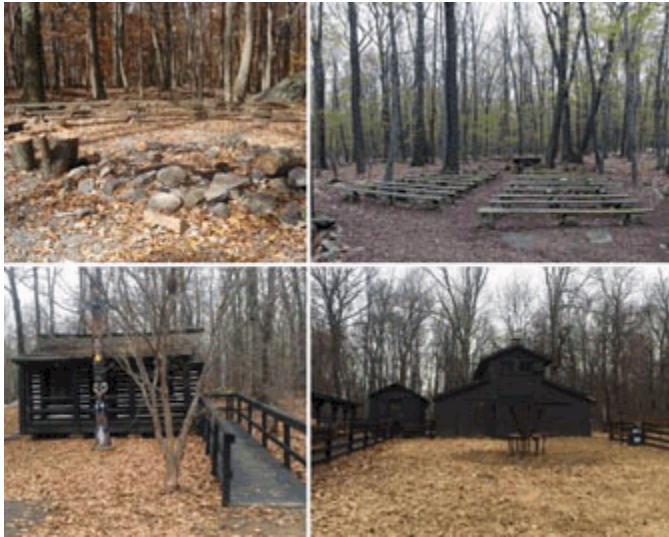
*Buildings and structures: campfire circle (top left), outdoor chapel (top right), camp office building (bottom left), and Non-contributing horse stable and tack room (bottom right). (NCR)*

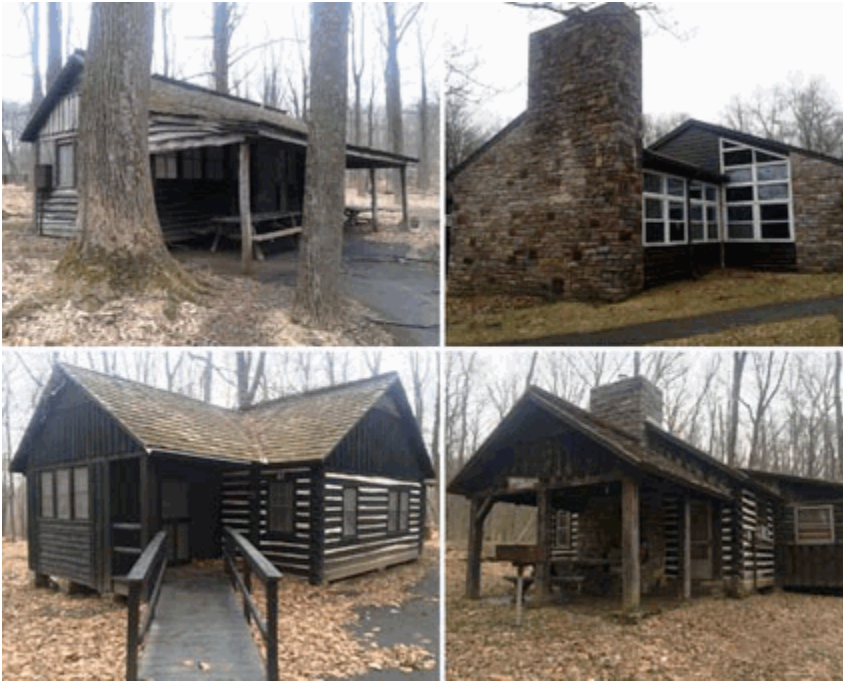
*Buildings and structures: Crafts shop (top left), non-contributing dining hall (top right), infirmary building (bottom left), and Good Luck Lodge (bottom right). (NCR)*

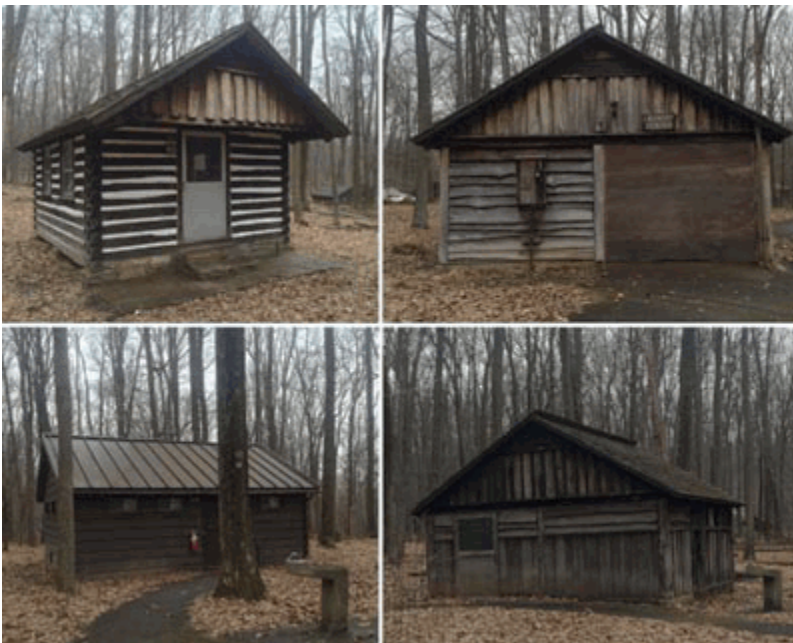
*Buildings and structures: leader's cabin (top left), unit "A" latrine and laundry building (top right), non-contributing unit "A" comfort station (bottom left), and unit "B" latrine (bottom right). (NCR)*

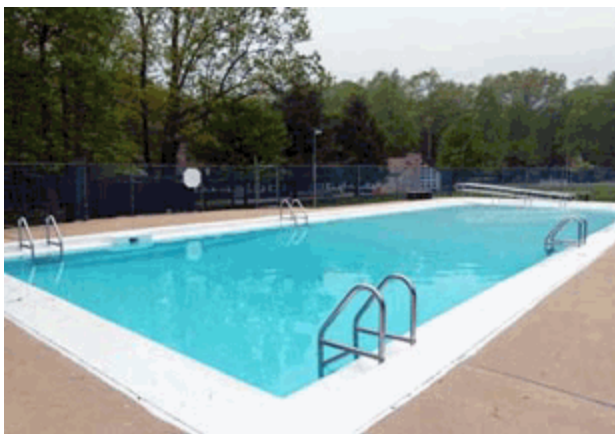
*Swimming pool with wheel-chair access located within Greentop's playfield. (NCR)*

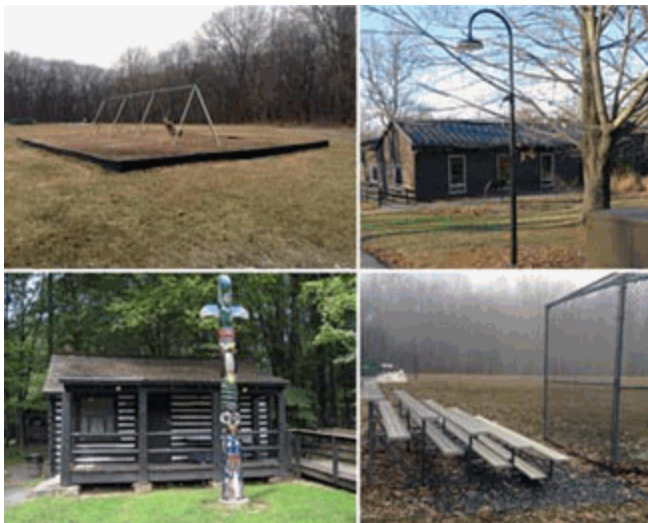
*Small-scale: swing-set playground (top left), light fixtures (top right), totem pole (bottom left), baseball cage and bleachers (bottom right). (NCR)*

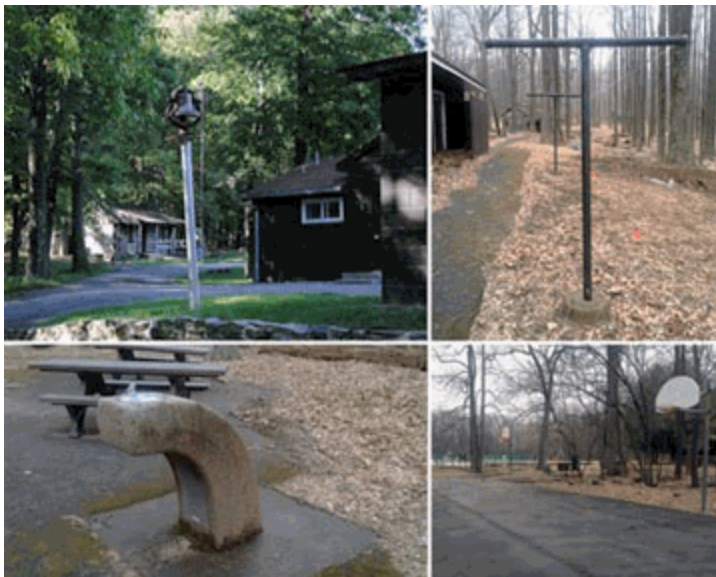
*Small-scale features: dinner bell outside dining hall (top left), clothesline outside wash house (top right), drinking fountains (bottom left), athletic court with basketball hoops (bottom right).*

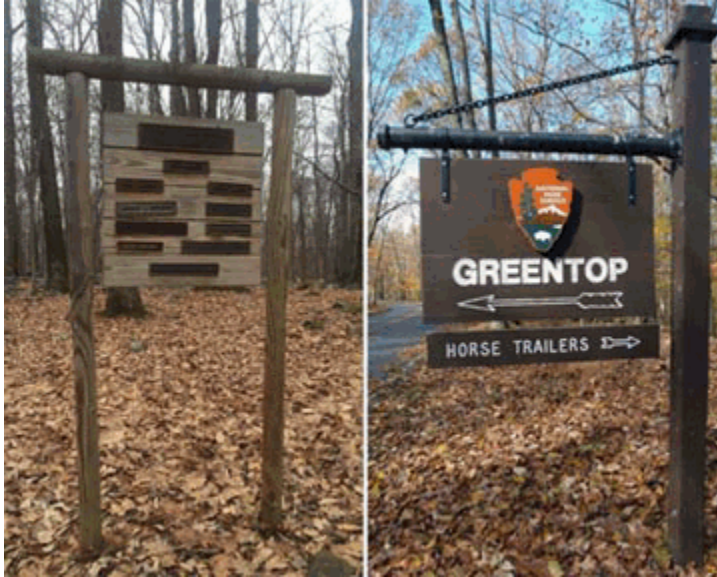
*Small-scale features at Camp Greentop include signage: signage at the outdoor chapel (left), and way-finding signage at the camp entrance along Park Central Road (right). (NCR)*
