National Park Service  
Cultural Landscapes Inventory  
2012

Newcomer Farmstead  
Antietam National Battlefield

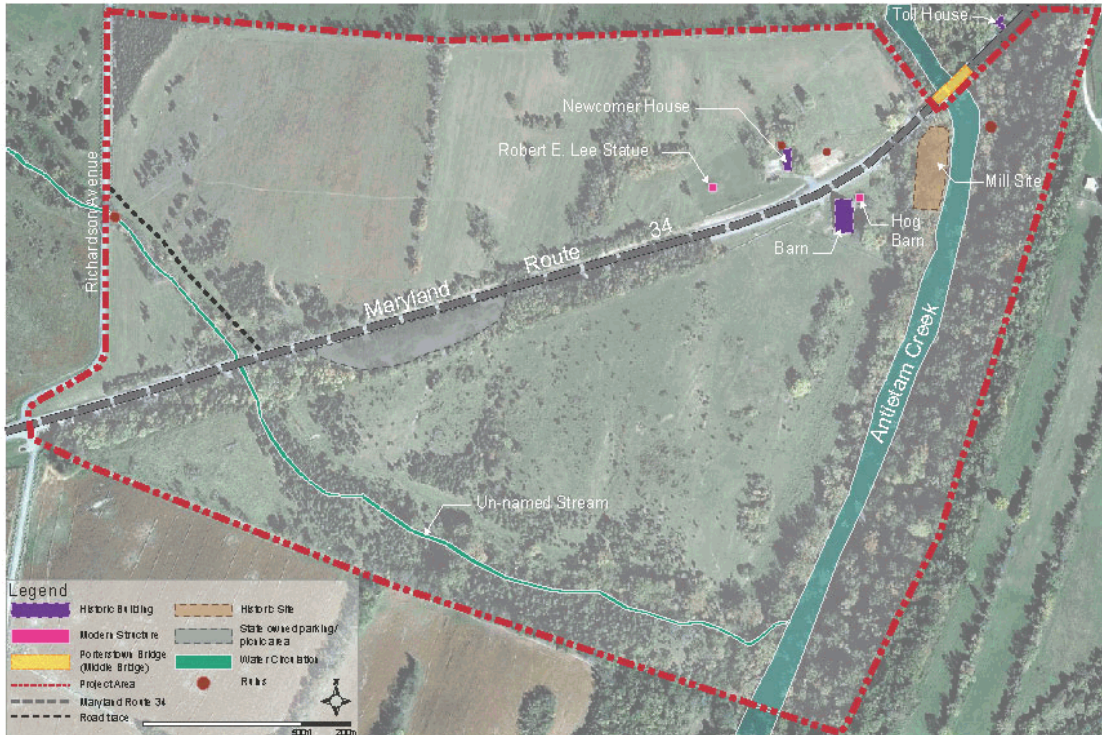
### Site Plan

*Note: Small Scale features are not shown on this map. See the A&E section for a description of their locations.*

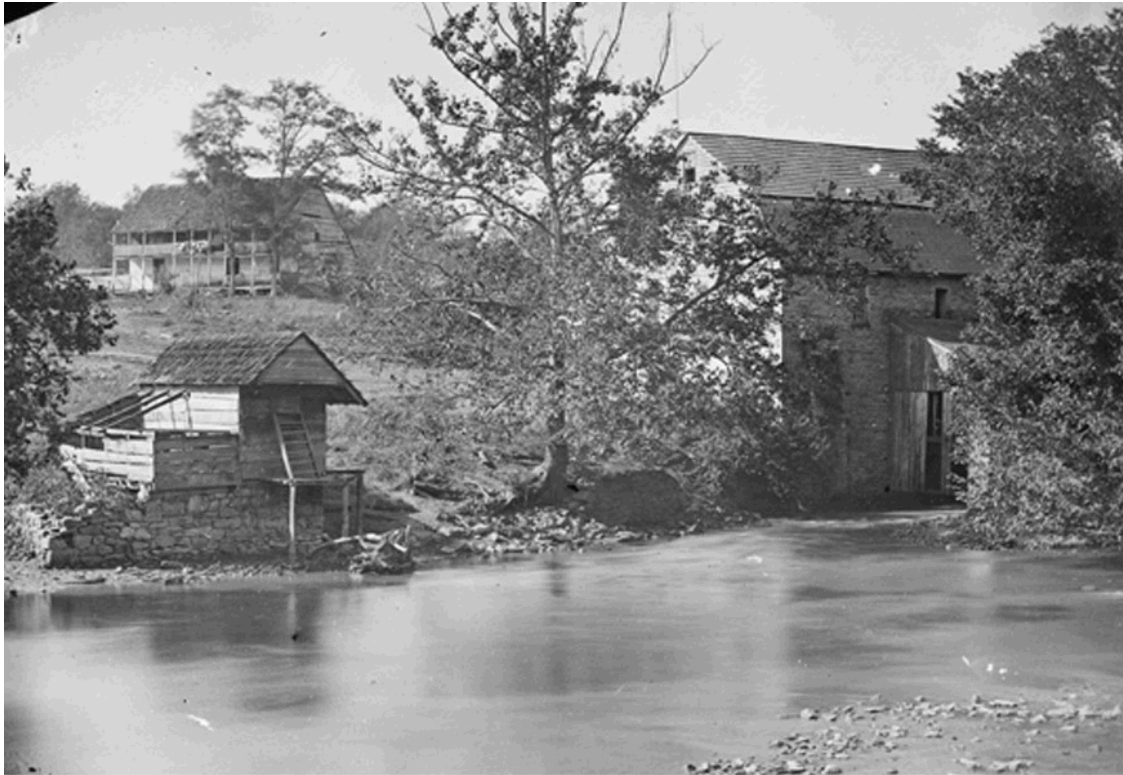
*View of Orendorff House ( left-rear), and on the creek from left to right; an outbuilding  
and the Newcomer Mill (LoC, Alexander Gardner 1862)*

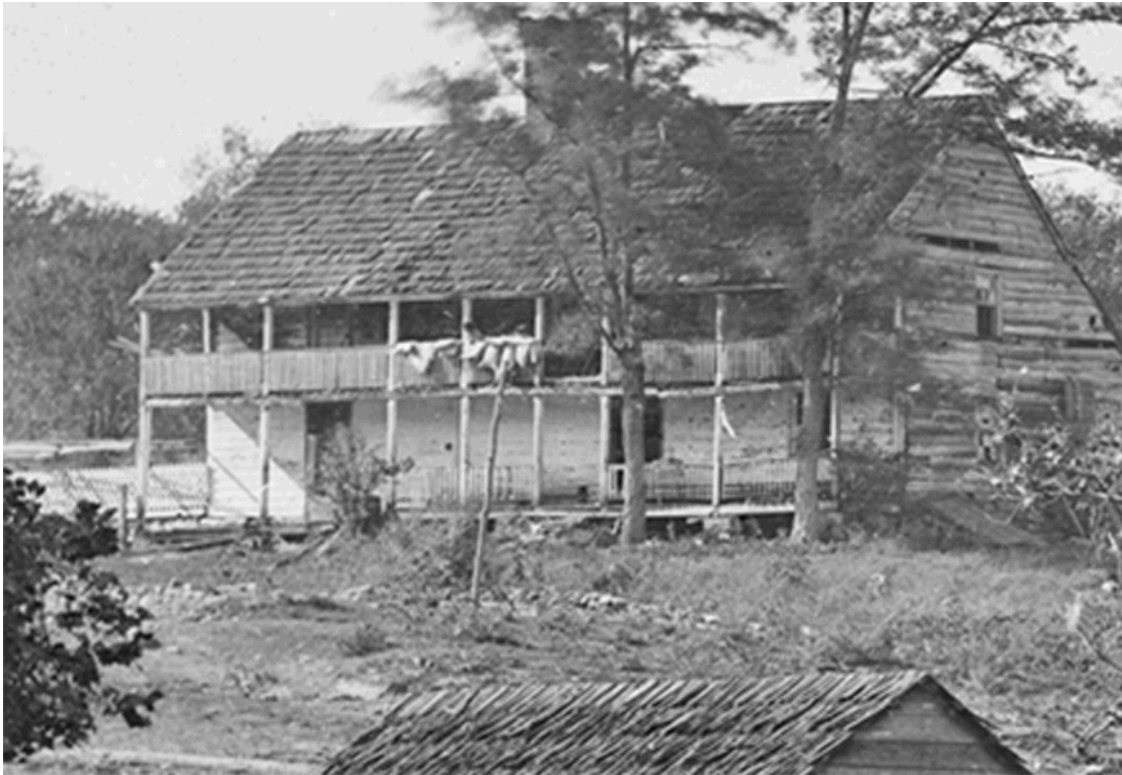
*Orendorff House [Zoom of previous photo] Note the stone retaining wall located just in front of the porch. This remains as an extant small scale feature. (LoC Alexander Gardener 1862)*

Another small scale feature that remains extant is a section of a stone retaining wall located just in front (south) of the Orendorff House foundation ruins. This retaining wall is visible in the 1862 Gardner photo that shows the old house.

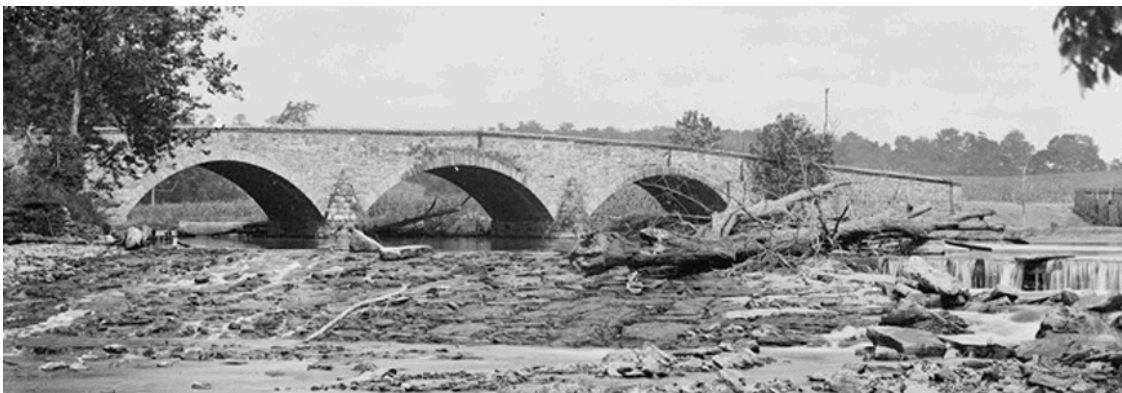
*Middle Bridge looking upstream. Note the dam on the right, which appears to be damaged. (LoC, Aexander Gardner 1862)*

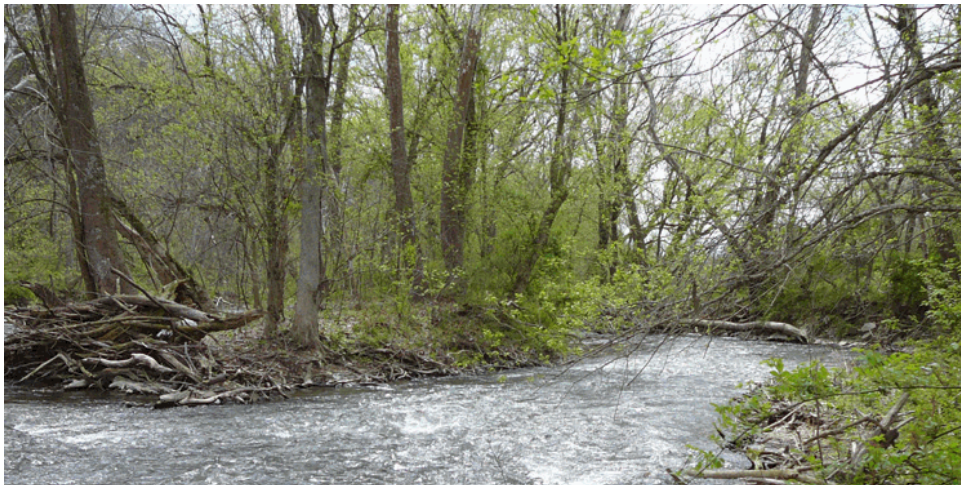
*View of Antietam Creek, looking downstream. The grist mill was located on the right bank and the sawmill was located on the island to the left, which was created by the mill race.  
2012 (NCR/CLP)*

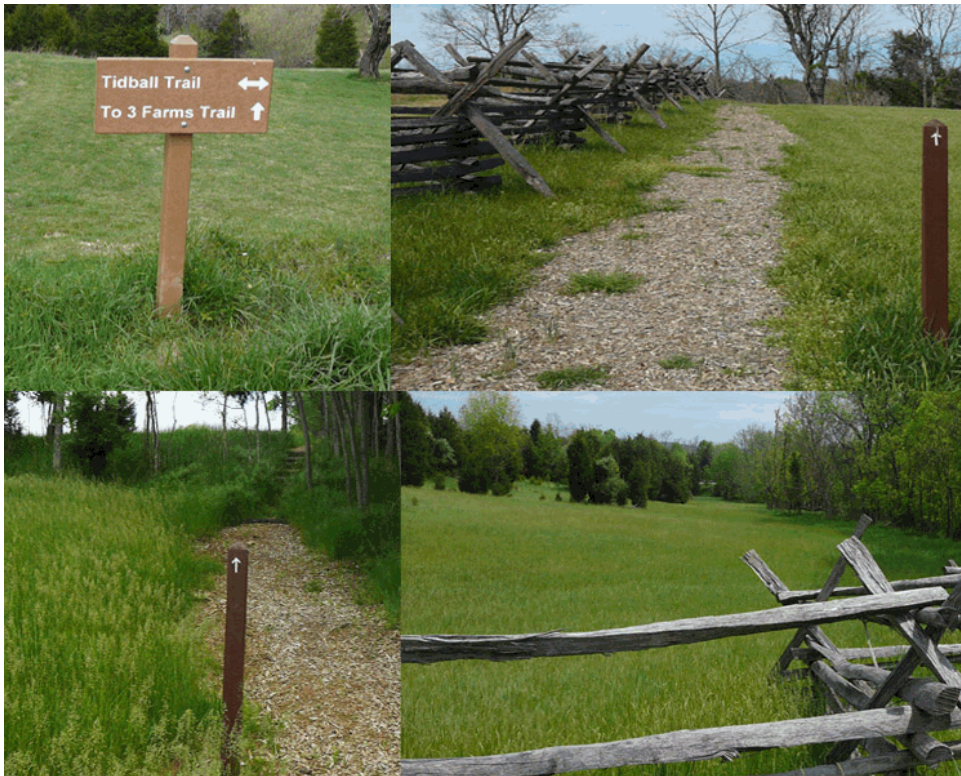
*Clockwise from top left:  
Trail sign for Tidball Trail, Tidball Trail, trail marker and worm fence, worm fence and  
Sunken Road Trace, Tidball Trail, marker and steps*

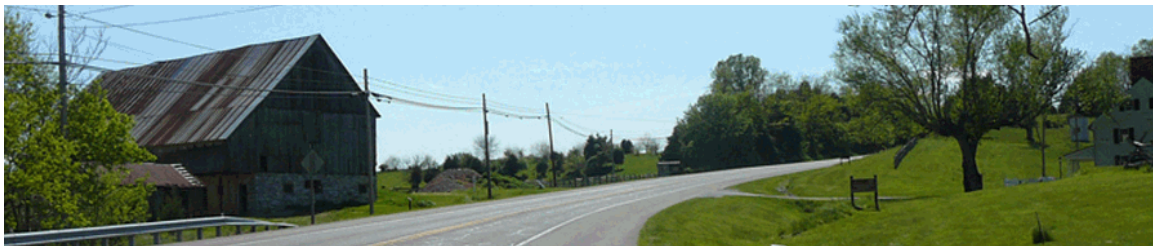
*View looking west along MD Route 34. 2012 (NCR/CLP)*

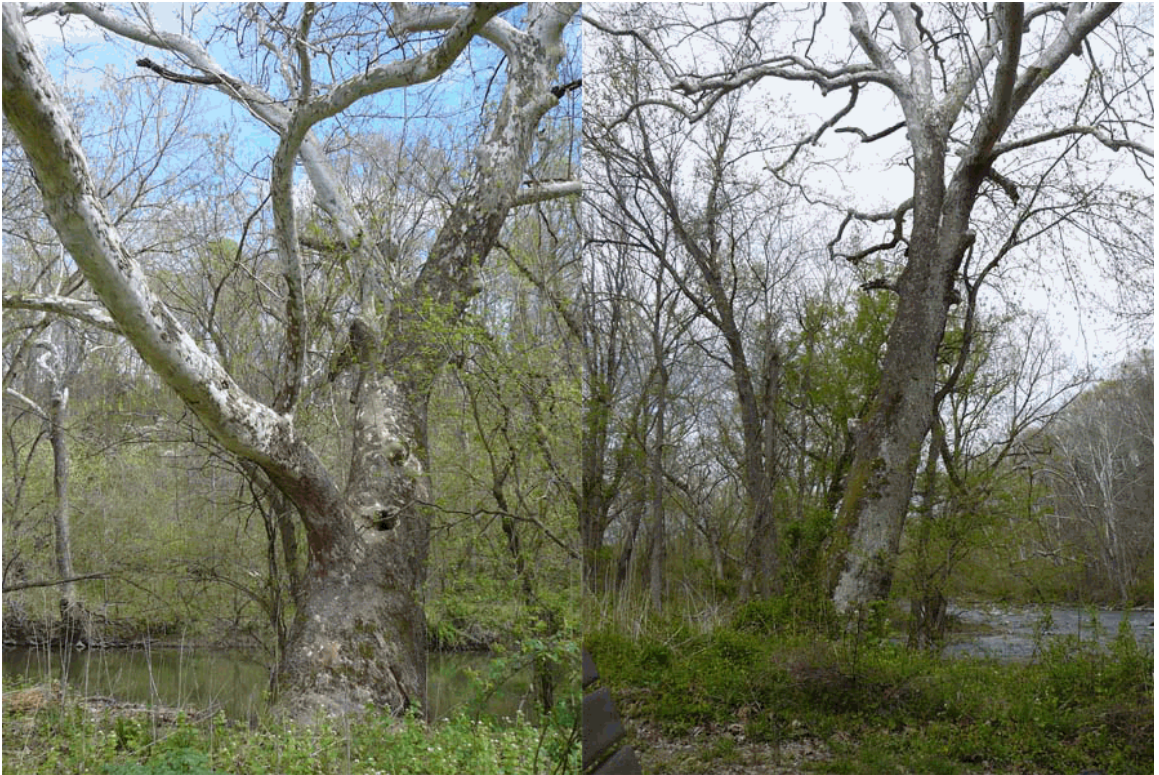
*Sycamore Trees along Antietam Creek  
2012 (NCR/CLP)*

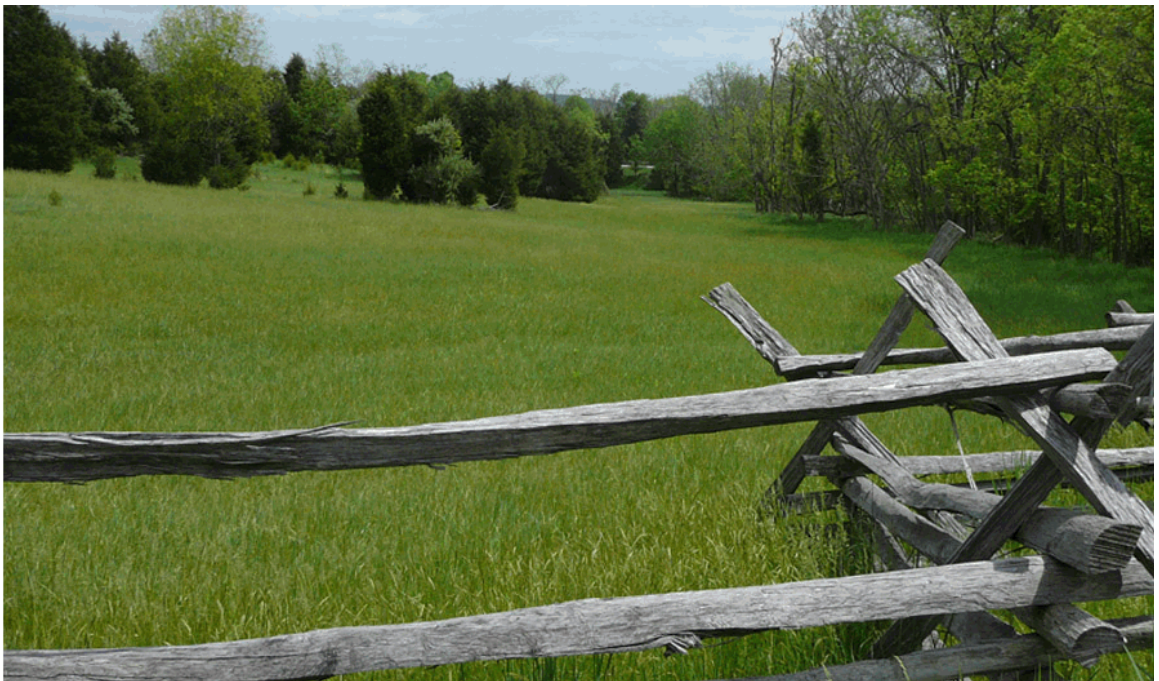
*Looking south from Richardson Road, along the Sunken Road Trace. Note the cedar trees to the left and the woody vegetation along the unnamed stream on the right.*  
2012(NCR/CLP)

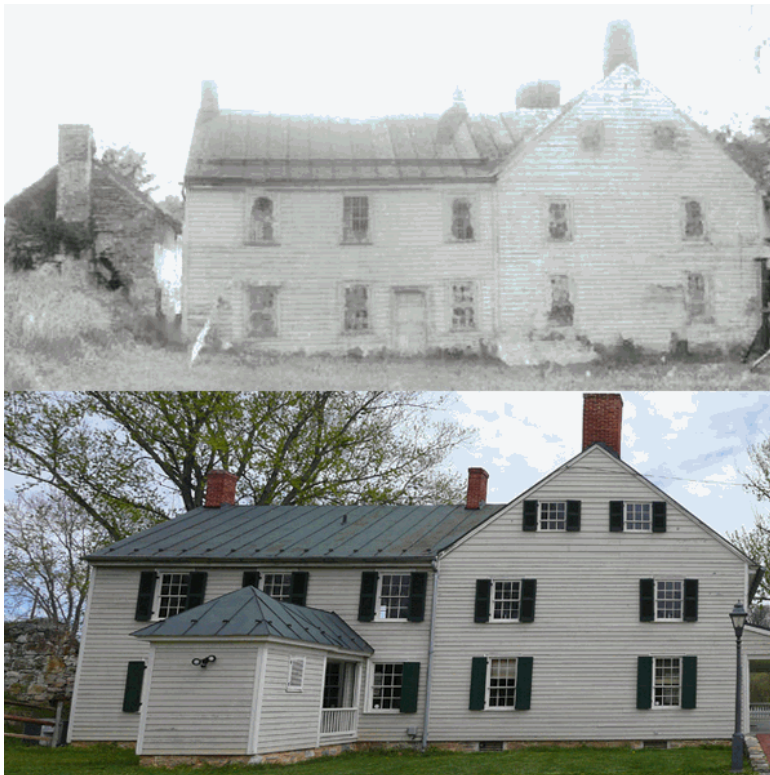
*Top: Newcomer House and out kitchen 1975  
(MHT NR nomination)  
Bottom: Newcomer House and out kitchen ruin  
2012 (NCR/CLP)  
West Elevation*

Currently all that is left is the lower part of the chimney and a portion of the west elevation wall and foundation. A few scattered foundation stones can also be seen.

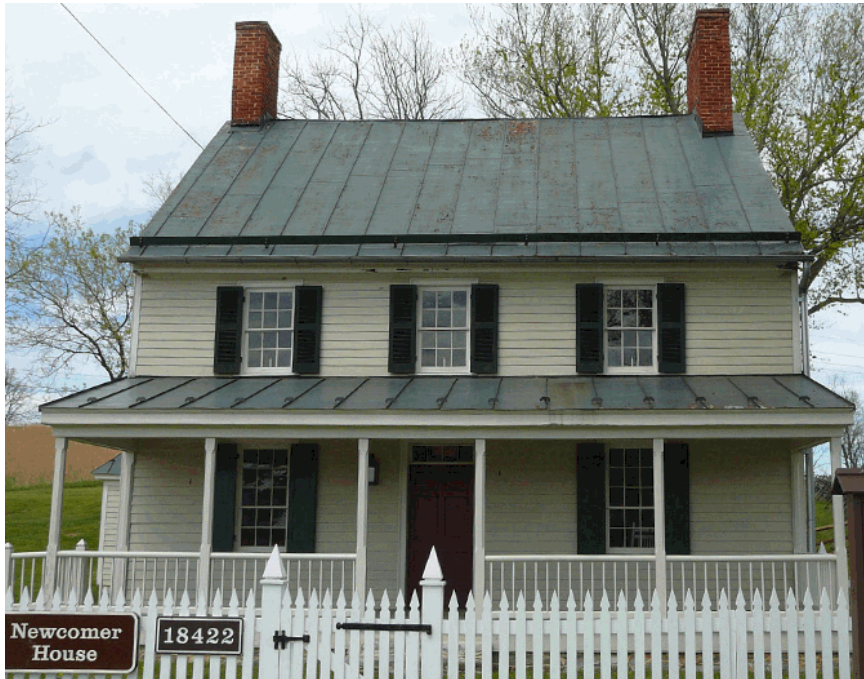
*Newcomer House, Front elevation  
2012 (NCR/CLP)*

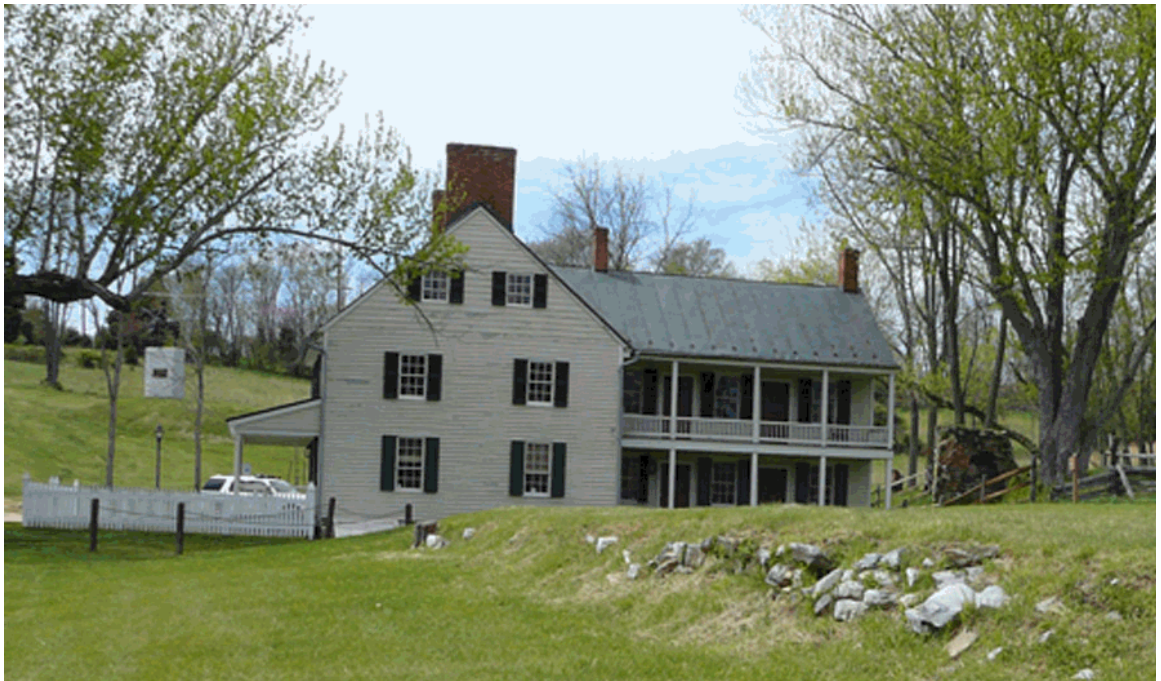
*Newcomer House, east side elevation with the out kitchen ruins to the right. The Oreendorff House foundation ruins are in the foreground [ See the 1862 photo of the house in the history section]. 2012 (NCR/CLP)*

All that remains of the Orendorff House is the stone foundation of the front elevation of the structure. It runs from east to west and is about 50 feet long.

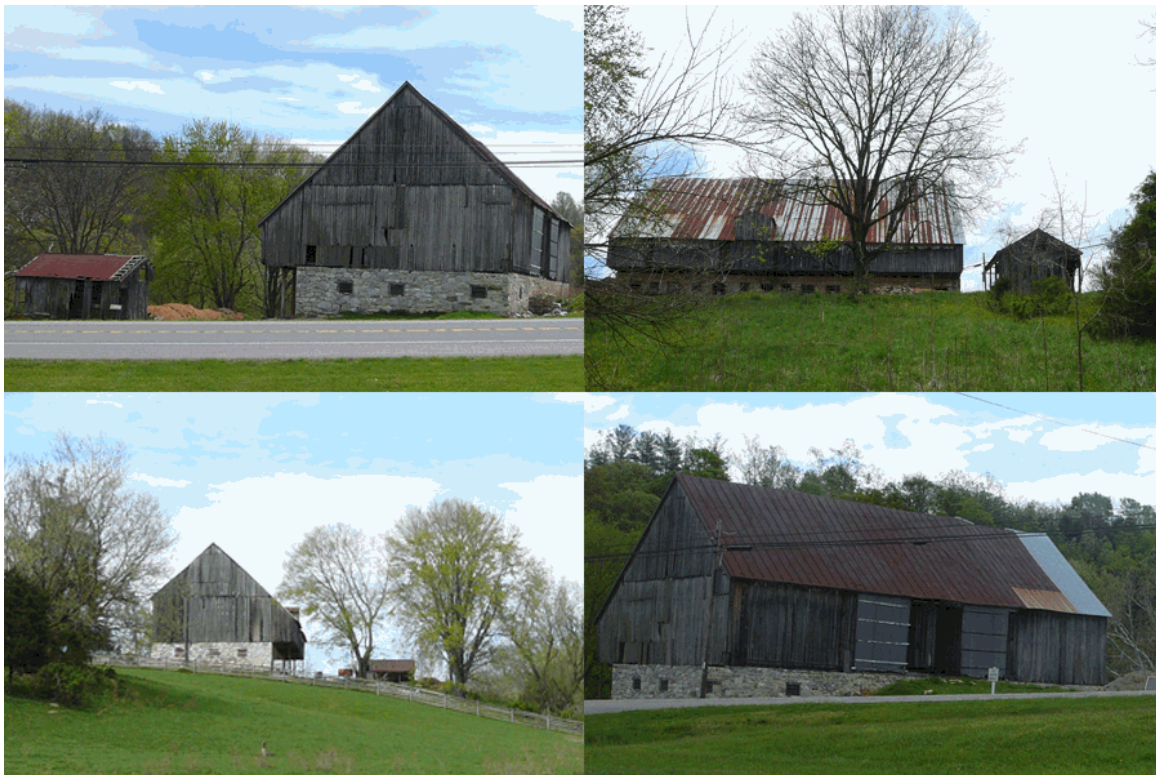
*Historic bank barn and modern hog barn.  
2012 (NCR/CLP)*

Rusty standing seam metal covers the west slope of the roof while, more recent channel drain sheet metal covers the east slope. The standing seam sheet metal roof appears to date from the early 20th century. Such roofs were not used in the local area before the 19th century. Civil War era photographs of the barn show a wood shingle roof on the building. Flooring nails observed in the barn are machine-made. The architectural evidence, specifically the style of stone masonry practiced in the foundation wall, the use of cut nails, and the large size of the barn all indicate early 19th century (pre-1840) construction.

Most of the west elevation and the northwest corner area of the foundation were removed during emergency stabilization efforts in 2003. Prior to this stabilization work the rear foundation had partially collapsed. The NPS reconstructed the collapsed wall and have been repointing the foundation since 2009. The metal roof received emergency stabilization after it was damaged by a wind storm in 2006.

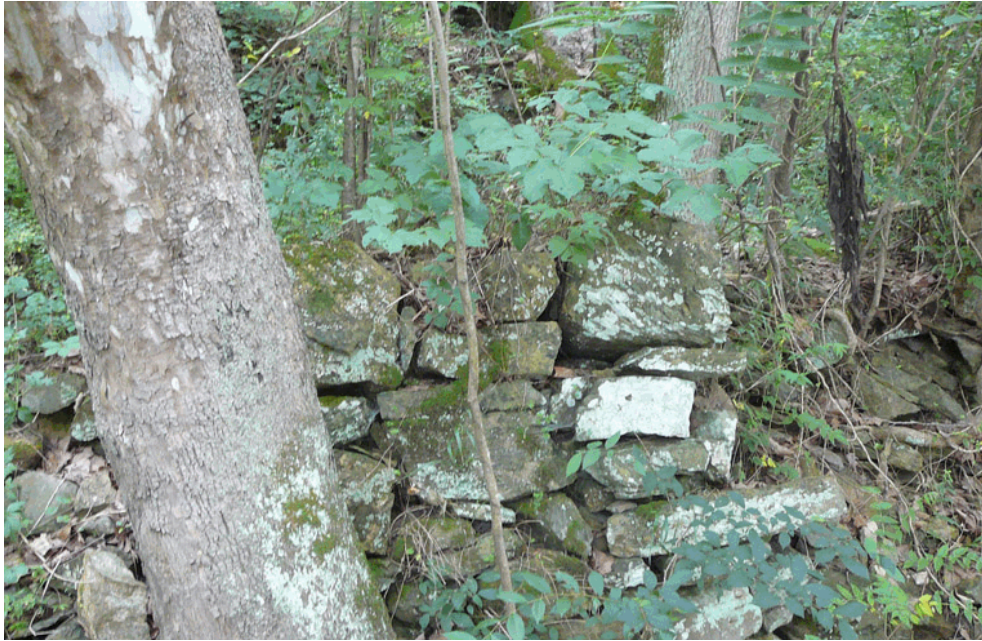
*Ruins of an unknown structure on the east side of Antietam Creek.  
2012 (NCR/CLP)*

On the east side of Antietam Creek, near the water are stone ruins that may be related to the miller's house, or an early bridge abutment. They appear to be dry-laid field stone and at least 5 courses can be seen (CLP Existing Condition photos 2012). Further research is needed to determine a more exact definition of these ruins, but the workmanship and placement suggest that they date to the period of significance.

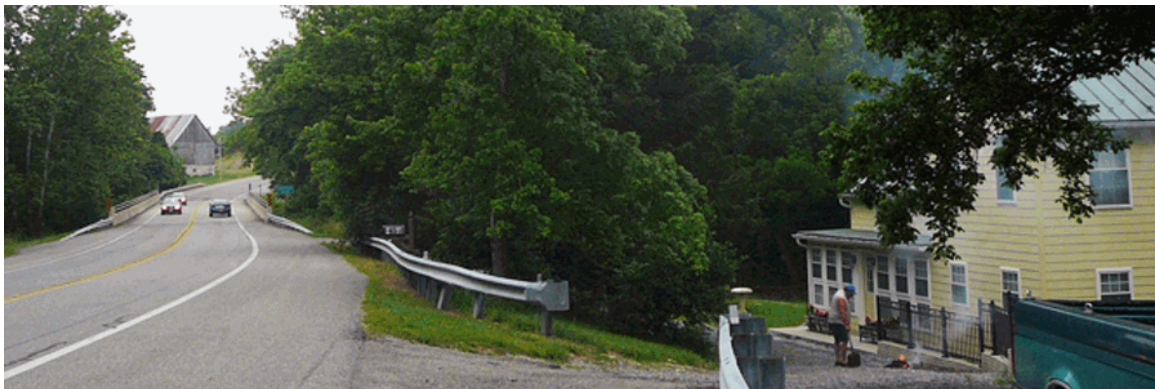
*Looking west along MD Route 34. The barn is on the left, the bridge can be seen just  
where the cars are located and the toll house is the yellow building on the right.  
2012 (NCR/CLP)*

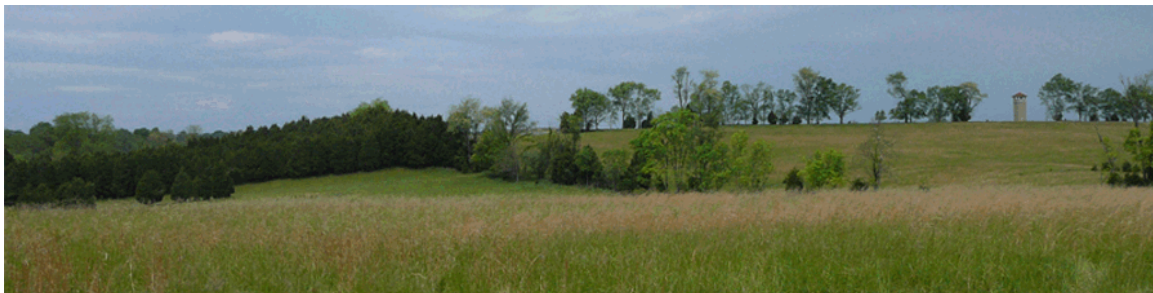
View looking west and slightly north from the location of the Tidball's battery. Note the War Dept era tower at the left. This marks the corner of the Sunken Road (Bloody Lane). 2012 (NCR/CLP)

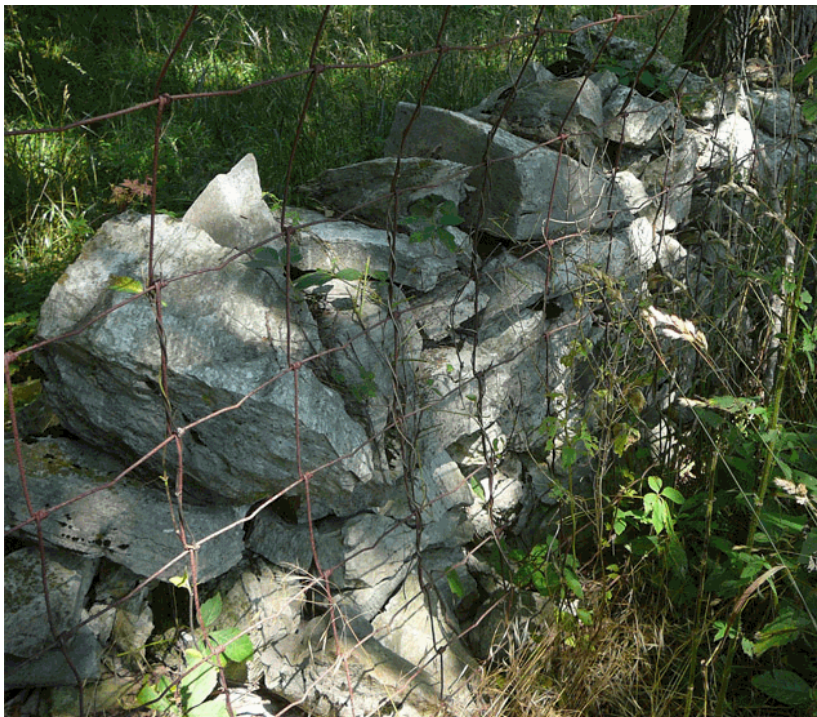
*Bottom: Stone wall remnant on the field boundary between the Newcomer and Sherrick Farmsteads  
2012 (NCR/CLP)*

With the exception of one small section of stone fencing, there is not extant historic fencing found on the Newcomer Farmstead. It can be found along the boundary between the Newcomer and Sherrick Farmsteads. While this second remnant is not depicted on the 1904 Carmen-Cope map, it is the opinion of the author that given its construction method and materials, it dates to the period of significance. The stone fencing along the turnpike depicted on the 1904 map appear to have been removed when the road was changed in 1956.

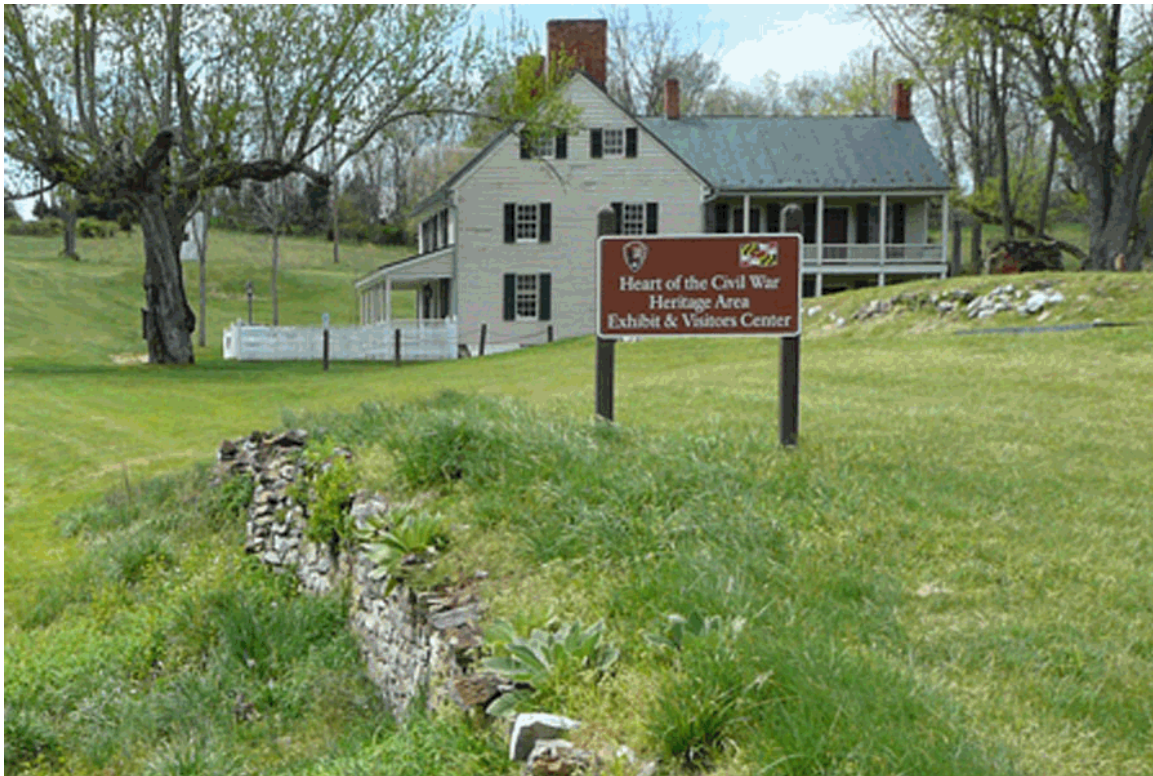
*The stone retaining wall remnant can be seen in the foreground. The Orendorff House foundation ruins are seen just to the right of the sign.*  
2012 (NCR/CLP)

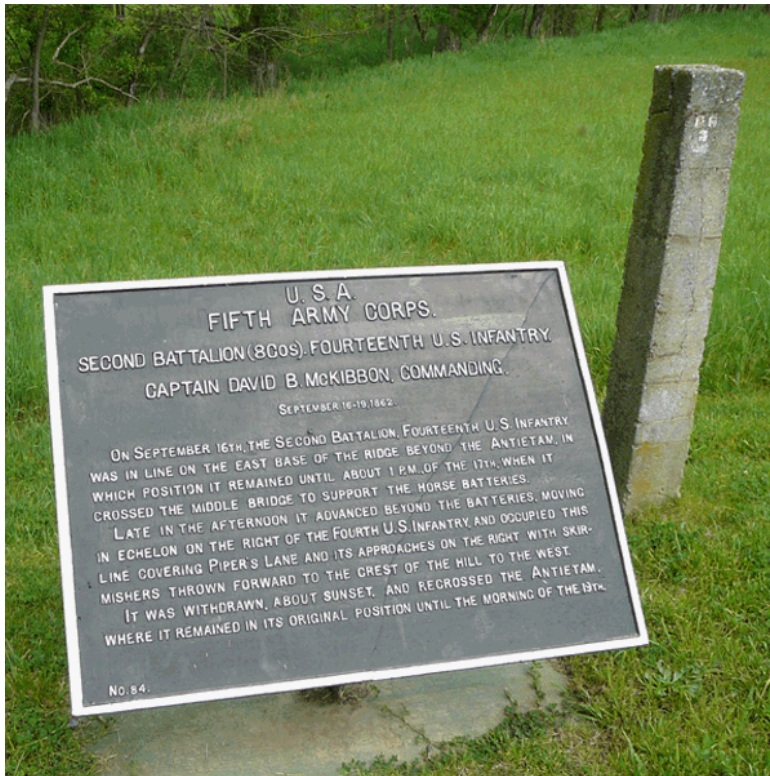
*Union Tablet No. 84. Note the War Dept era concrete fence post.  
2012 (NCR/CLP)*

There are 17 Union Tablets located on the Newcomer Farmstead, most along MD Route 34. These painted cast-iron tablets are generally 35 inches by inches and ½ inch thick with a one inch raised border. They are set on a metal a 3-1/2 foot diameter post historical description of the troop's movement is cast into the tablet. Detailed descriptions the placement of each tablet can be found in the NPS List of Classified structures database.
