**2015 ANNUAL MONITORING REPORT – YEAR 1**

**STRAWBERRY CREEK RESTORATION PROJECT – NPS REACH  
HUMBOLDT COUNTY, CALIFORNIA**

**CORPS FILE NO. 2009-00041N**

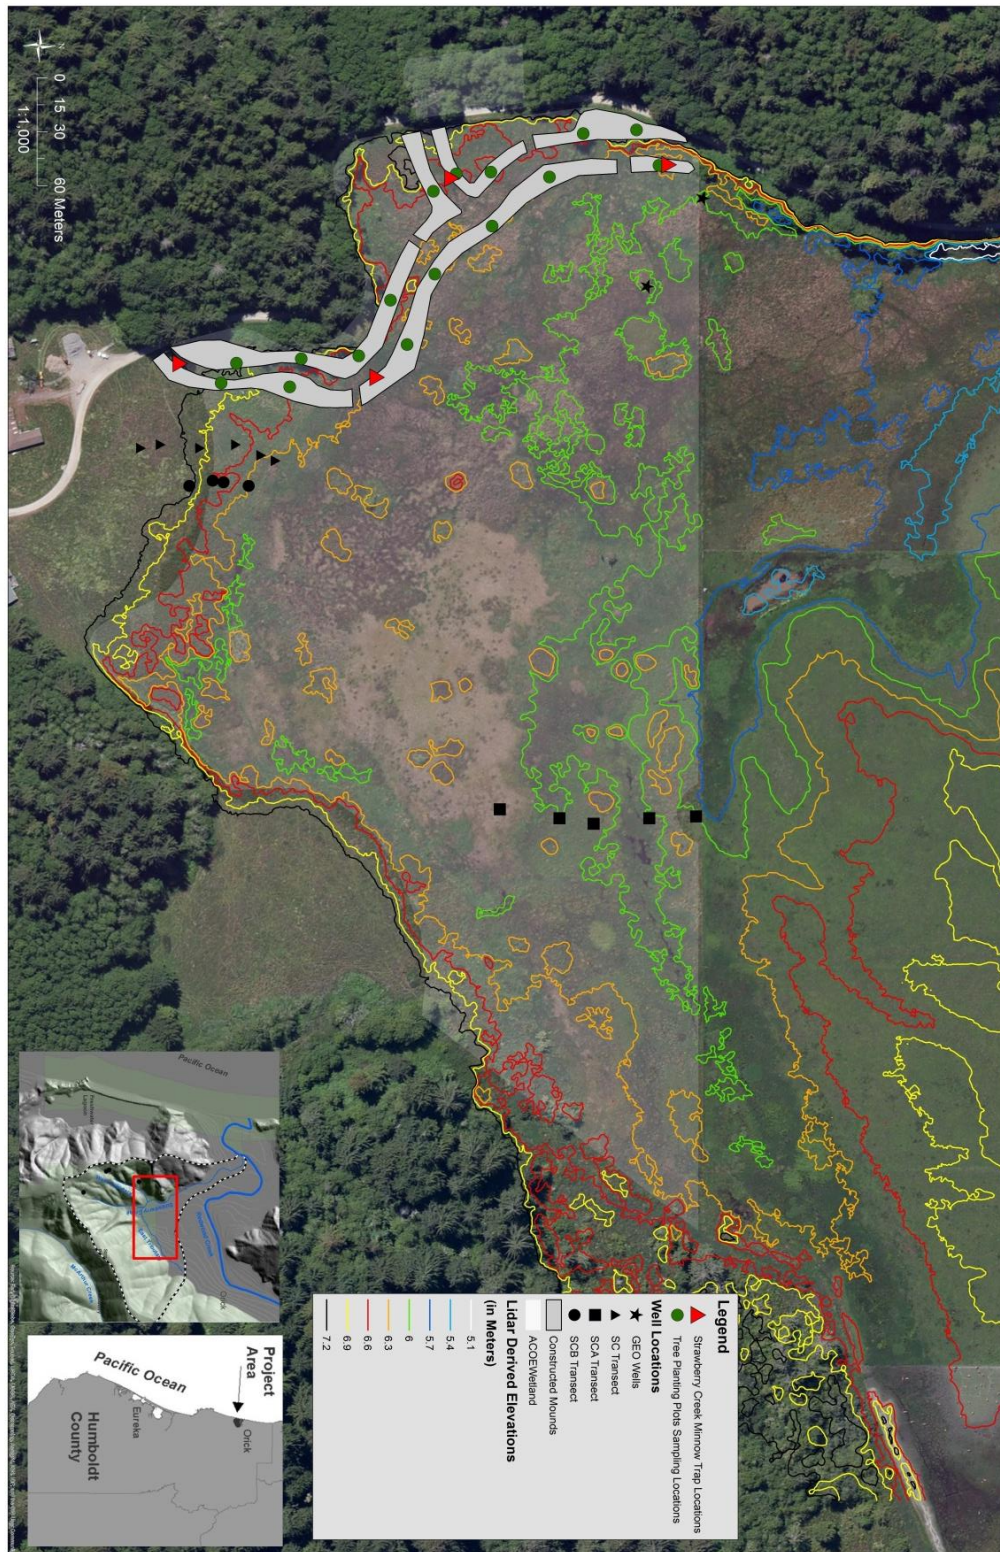
Figure 1. Location of project area near Orick, CA. Map also shows locations of wetland monitoring wells, minnow trap monitoring sites, tree planting monitoring sites and LiDAR derived elevations in meters.

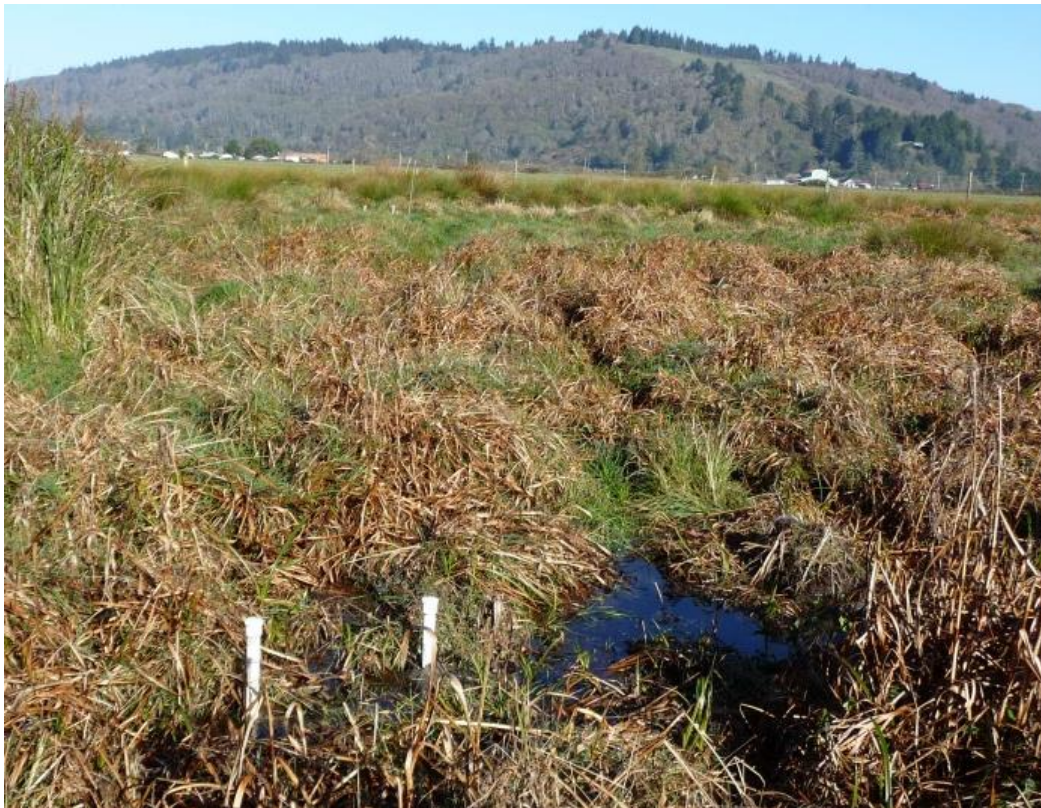
Figure 2. Photo of typical pair of two monitoring wells at Transect SCA plot 3. Note ponded wetland water surrounding wells at time of photo.

To assess the effects of the project on water levels and plant communities in the wetland surrounding the project, three monitoring transects were established in and adjacent to the wetland roughly perpendicular to the wetland edge so as to cross the present wetland margin edge (Figure 1). Each transect contains either five or six sites where a pair of wells (one to a depth of 12 inches and the other to a depth of 30 – 60 inches) were installed to measure water elevation (Figure 2). Transect SC and Transect SCB are both on the southern side of the wetland which is immediately adjacent to the project. Transect SCA is on the northern side of the wetland. A “T” fence post marks the location of each pair of well/piezometer along all three transects. Two gauge plates are used for measuring surface water below the dense floating mat that surrounds the gauge sites. One gauge plate is on Transect SC plot 6, the other is on Transect SCA plot 5. A Solinst Mini Water Level Meter is used to measure depth to groundwater to the nearest 0.01 feet. Surface and groundwater data are collected approximately once per week throughout the year (Table 1). Data have been collected weekly (with a few exceptions) since October 2013.

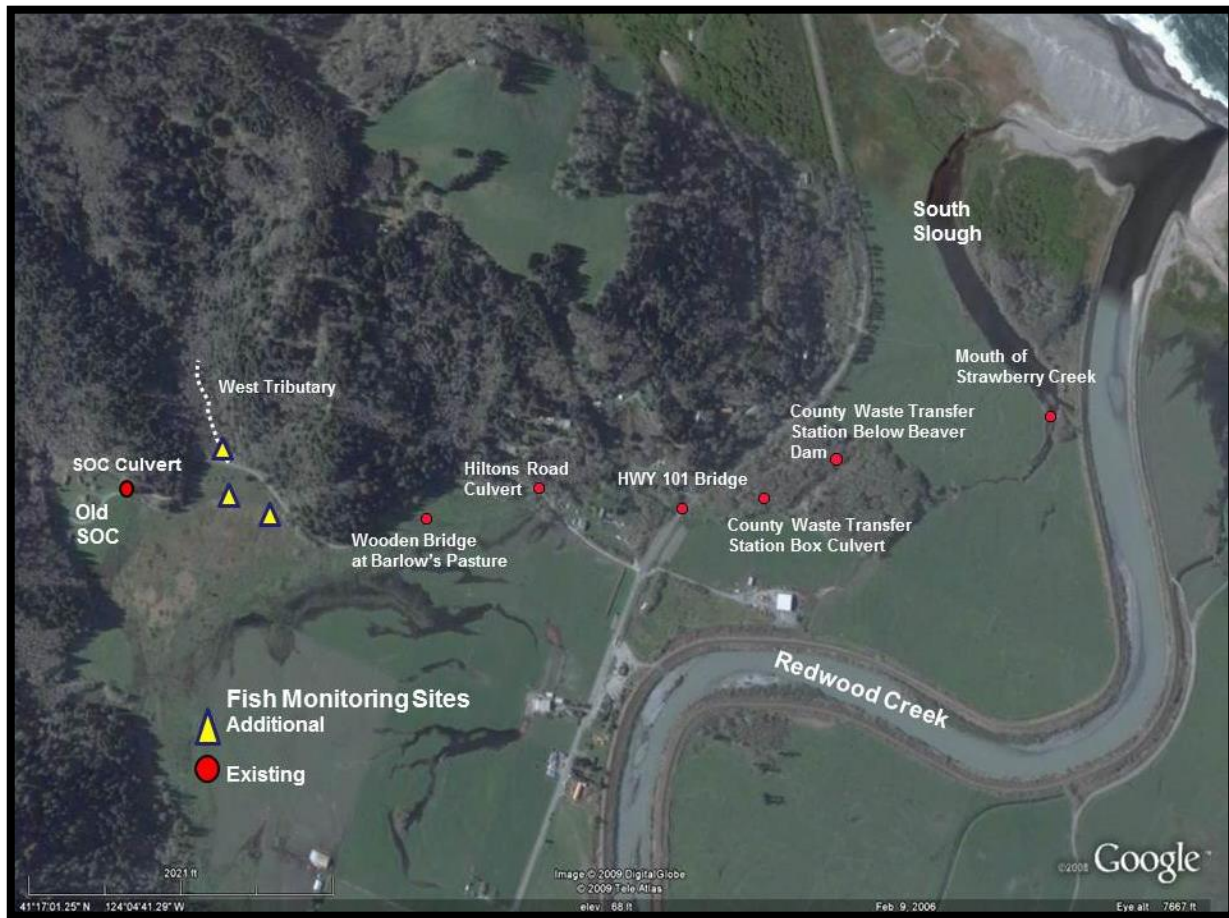
Figure 1. Existing and proposed additional fish monitoring sites on Strawberry Creek.

Coho salmon, cutthroat trout and steelhead have been trapped at the Hilton Road culvert. Steelhead trout have been trapped upstream at the wooden bridge at the Barlow pasture. As salmonids are present as far upstream as Hiltons Road culvert, when project construction is complete, trapping will be concentrated upstream of Hiltons Road culvert and additional sites will be established within the project area (Figure 1). The number of sites will be determined later, but will include the channel at the downstream end of the project, the confluence of the mainstem channel and West Tributary, and upstream of the West Tributary culvert. Presently (2013), there are no fish, salmonid or otherwise, upstream of the West Tributary culvert and no open water/channel where the mainstem channel is proposed to be excavated.

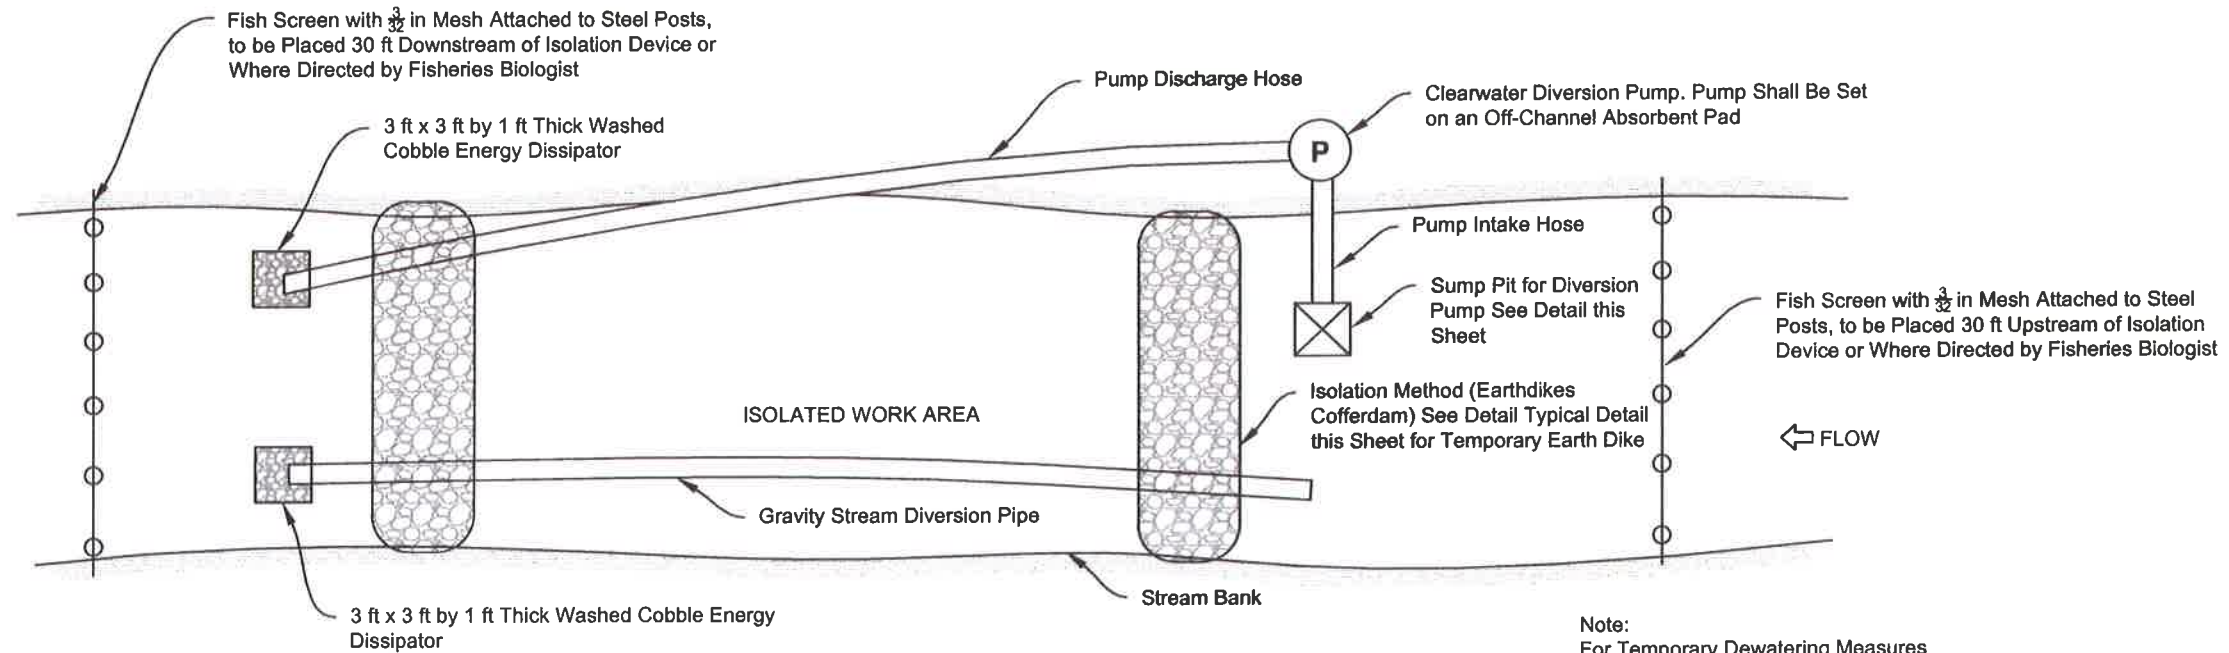
**TEMPORARY CLEAR WATER DIVERSION**  
Plan (NTS)

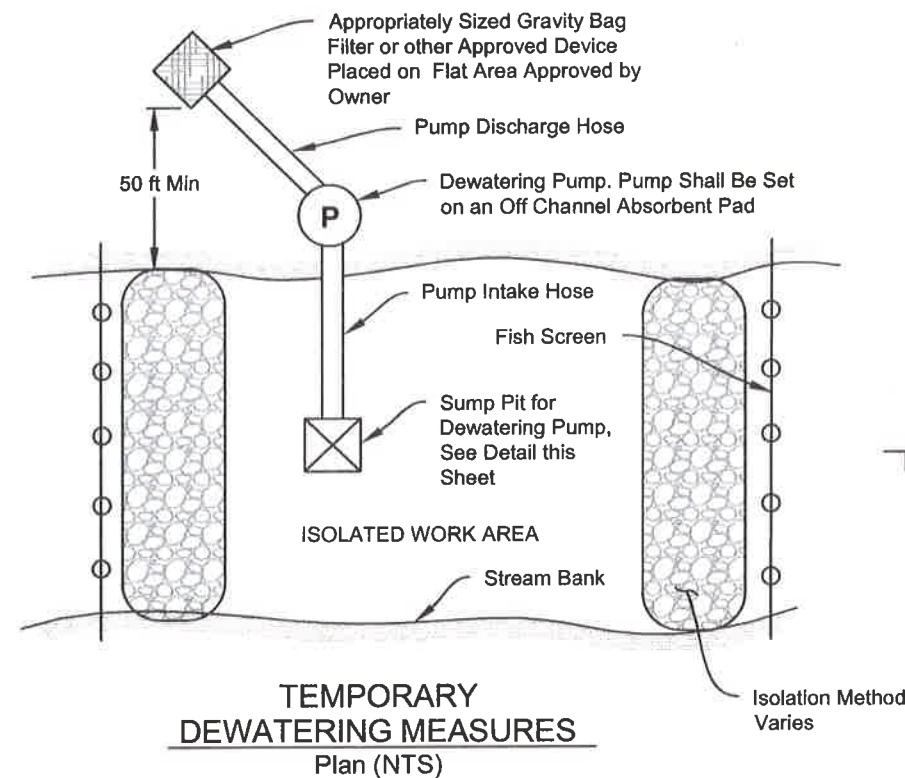
**TEMPORARY DEWATERING MEASURES**  
Plan (NTS)

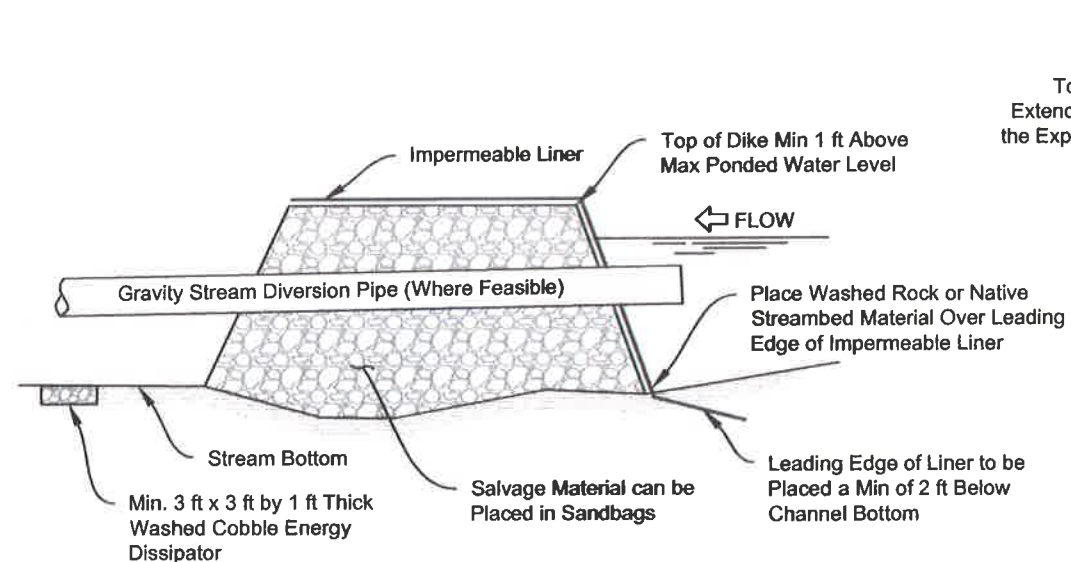
**TEMPORARY EARTH DIKE**  
Profile (NTS)

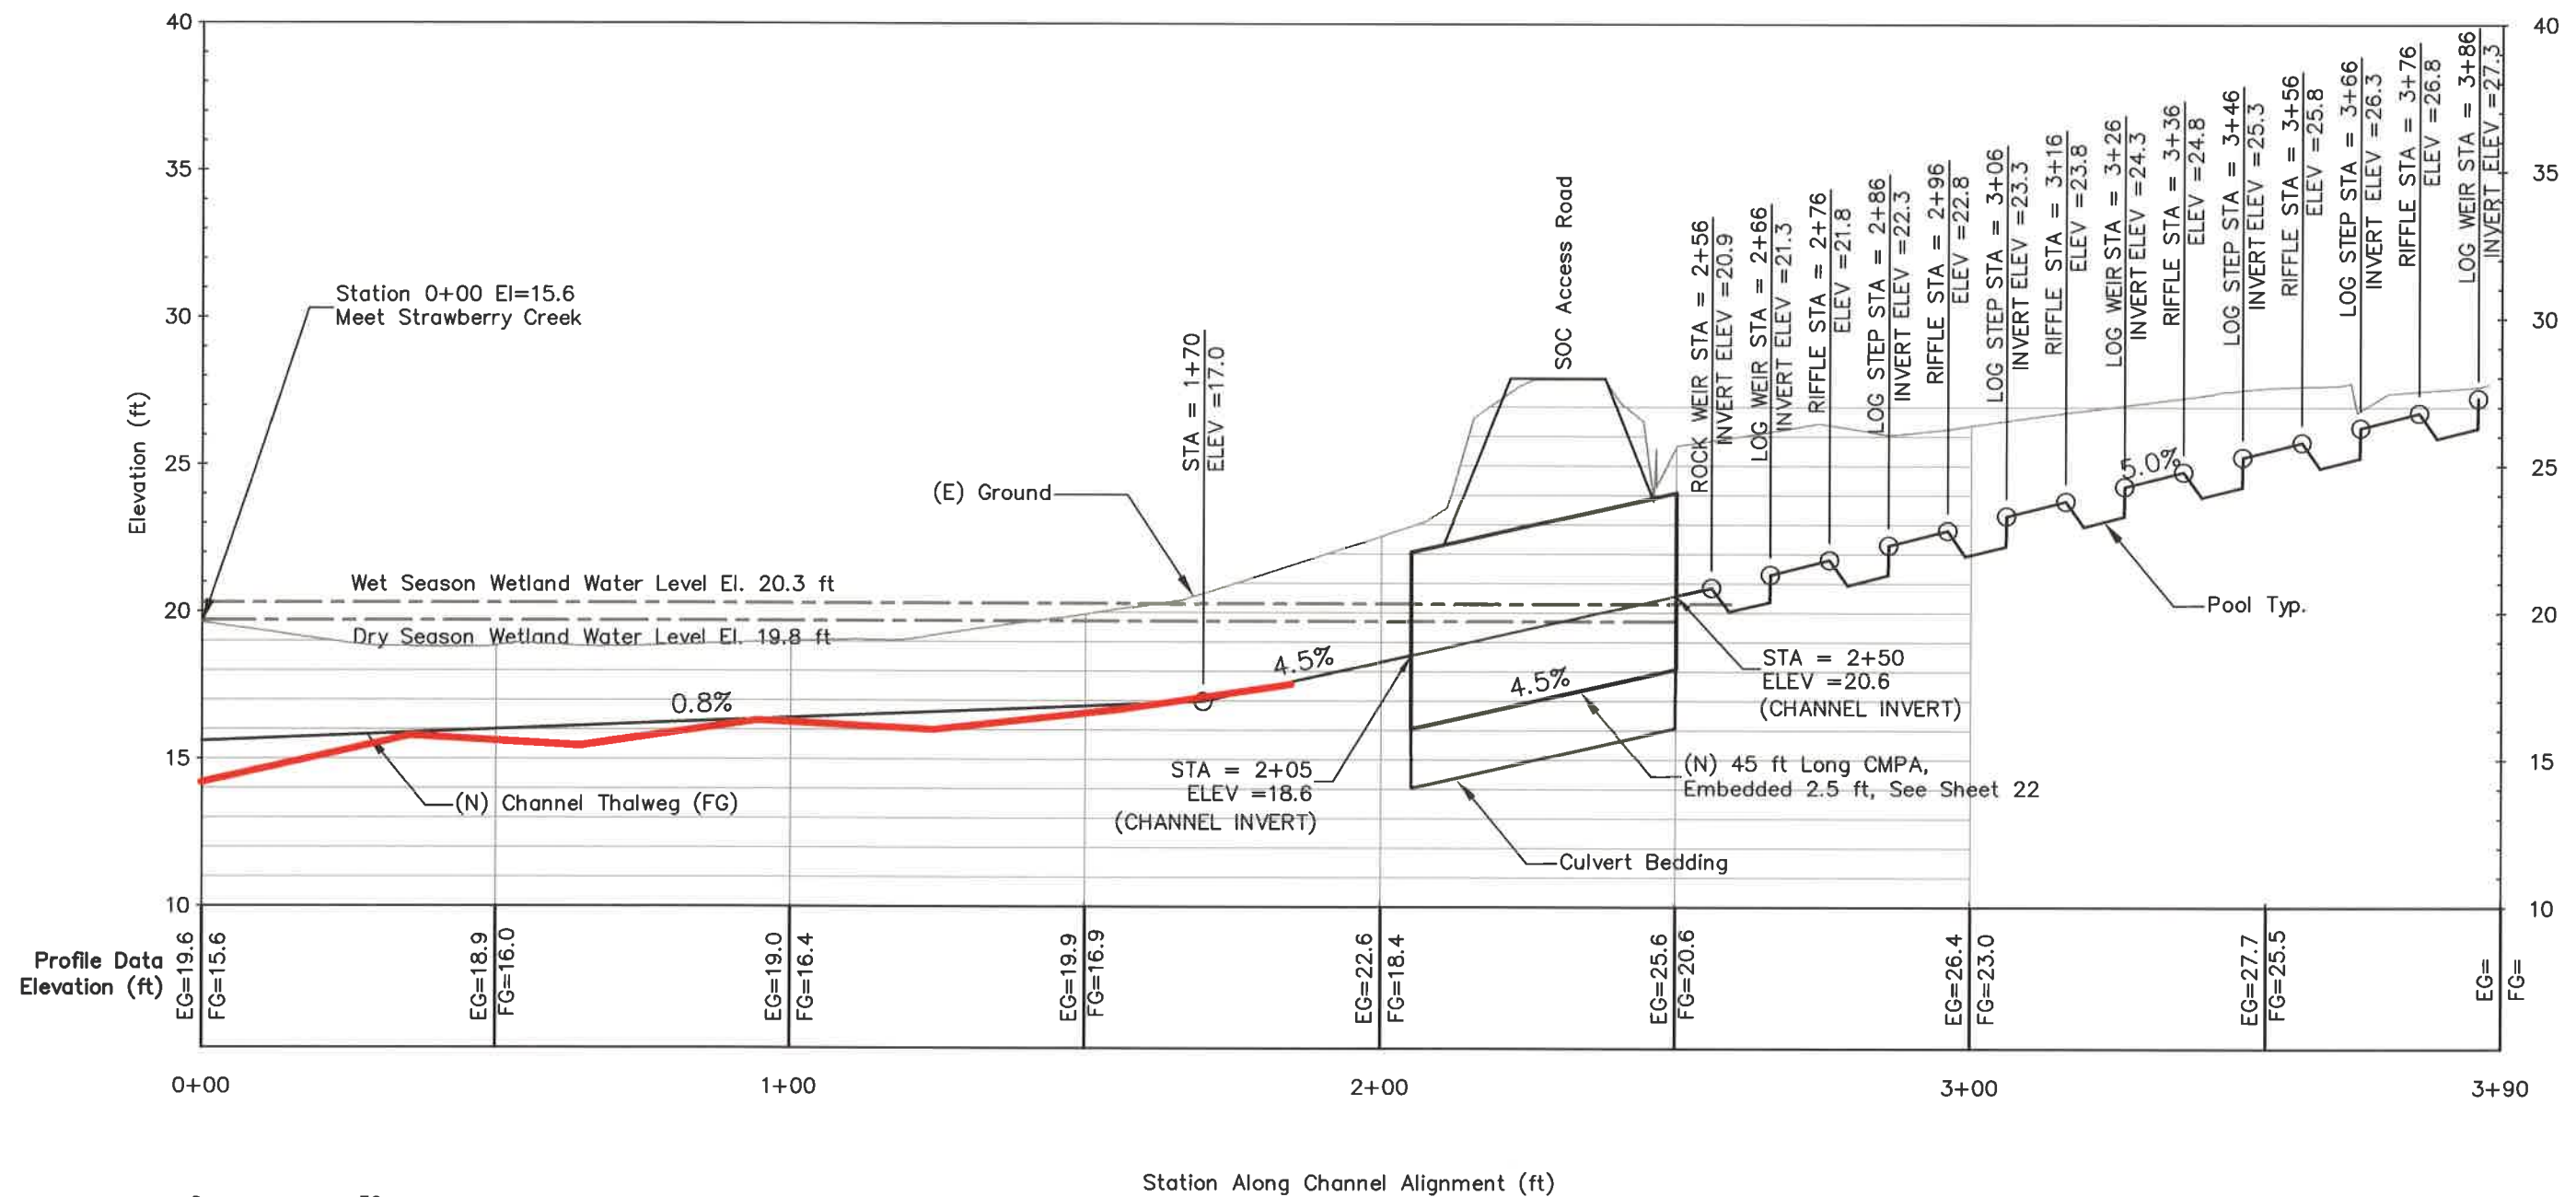
P4  
7,9,26,27  
**WEST FORK TRIBUTARY CULVERT**  
Profile1

**AS-BUILT**  
Date: NOV 7, 2014  
UPSTREAM 1+85  
NOT CONSTRUCTED

The West Fork Tributary culvert replacement and channel construction upstream (Sheet 9 of 33) was not constructed due to budget overruns on other design elements. This part of the project was seen as a logical element to postpone on the project without impacting function of the rest of the project elements. Funding is being sought to complete this component of the project.

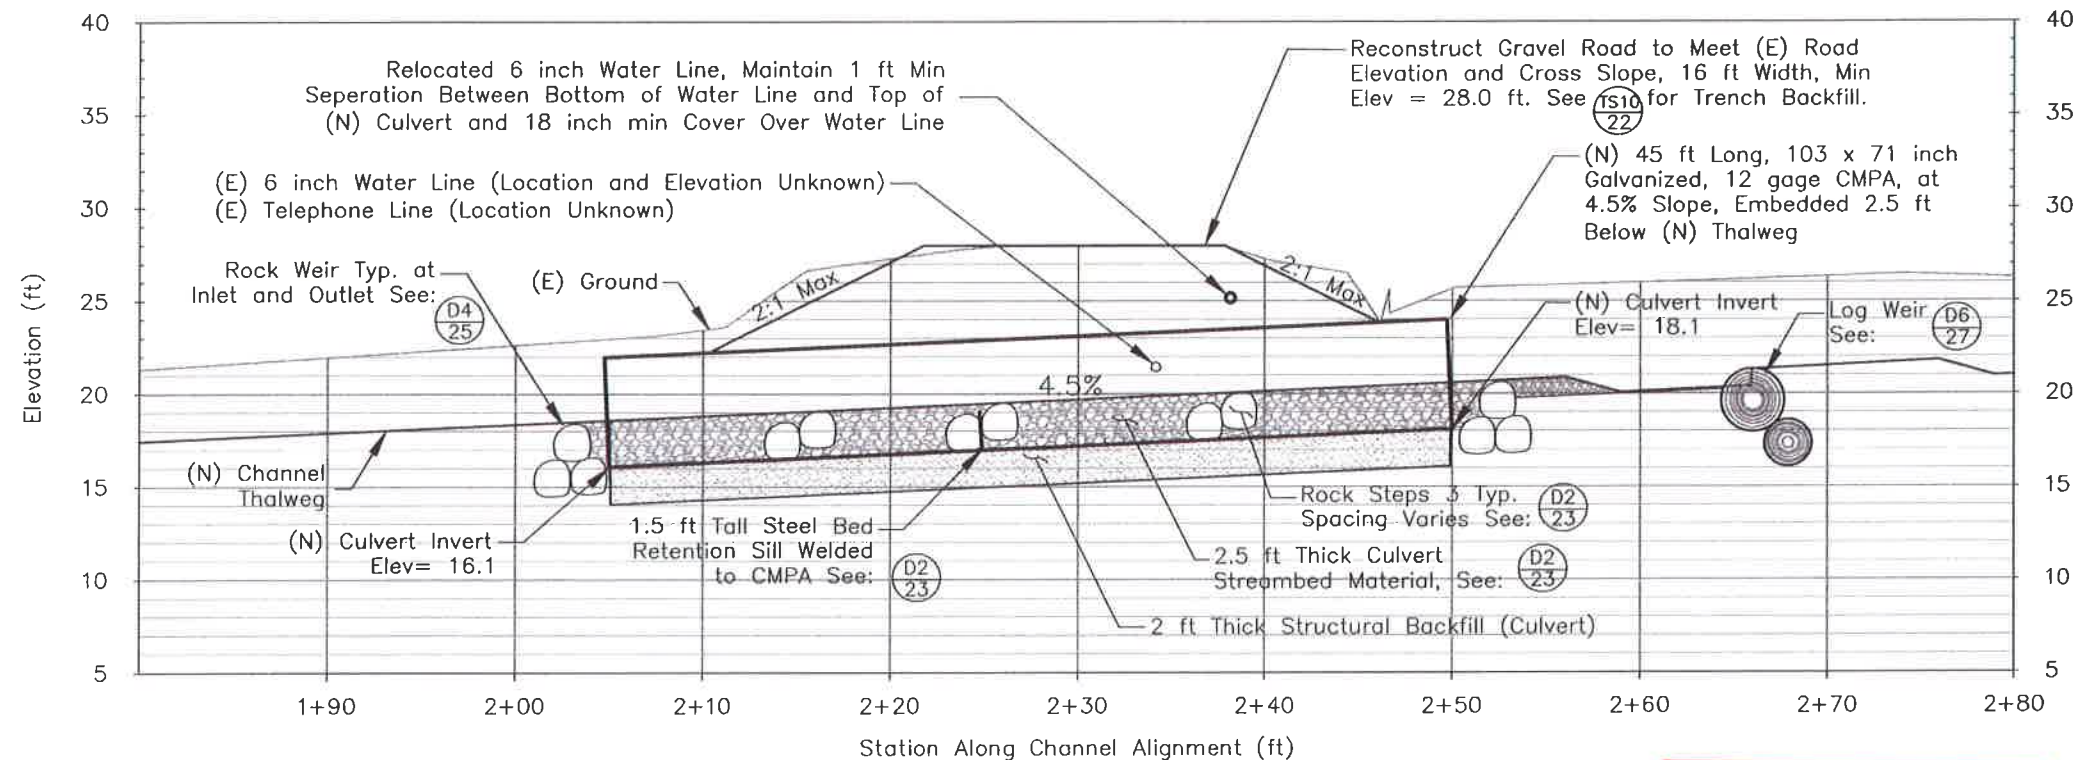
**WEST FORK TRIBUTARY CULVERT**  
Detail Profile

**NOT CONSTRUCTED**  
**NOV 7, 2014**

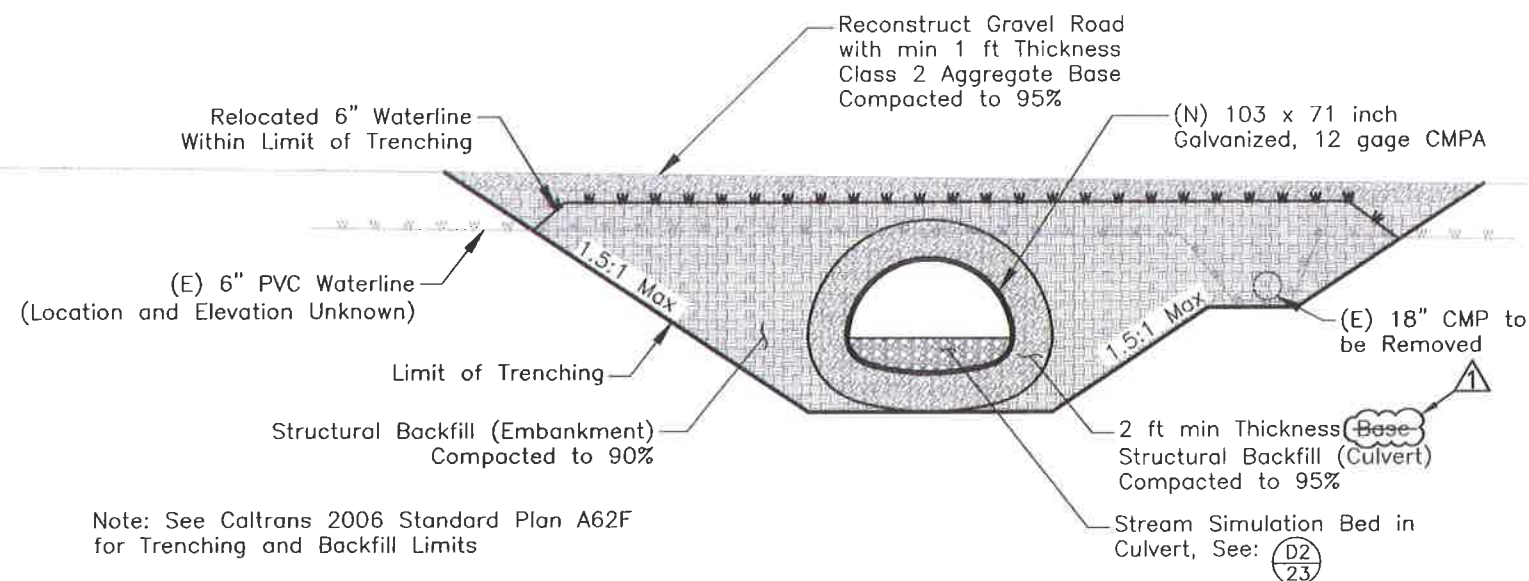
Note: See Caltrans 2006 Standard Plan A62F for Trenching and Backfill Limits

**WEST FORK TRIBUTARY CULVERT**  
Typical Section (NTS)

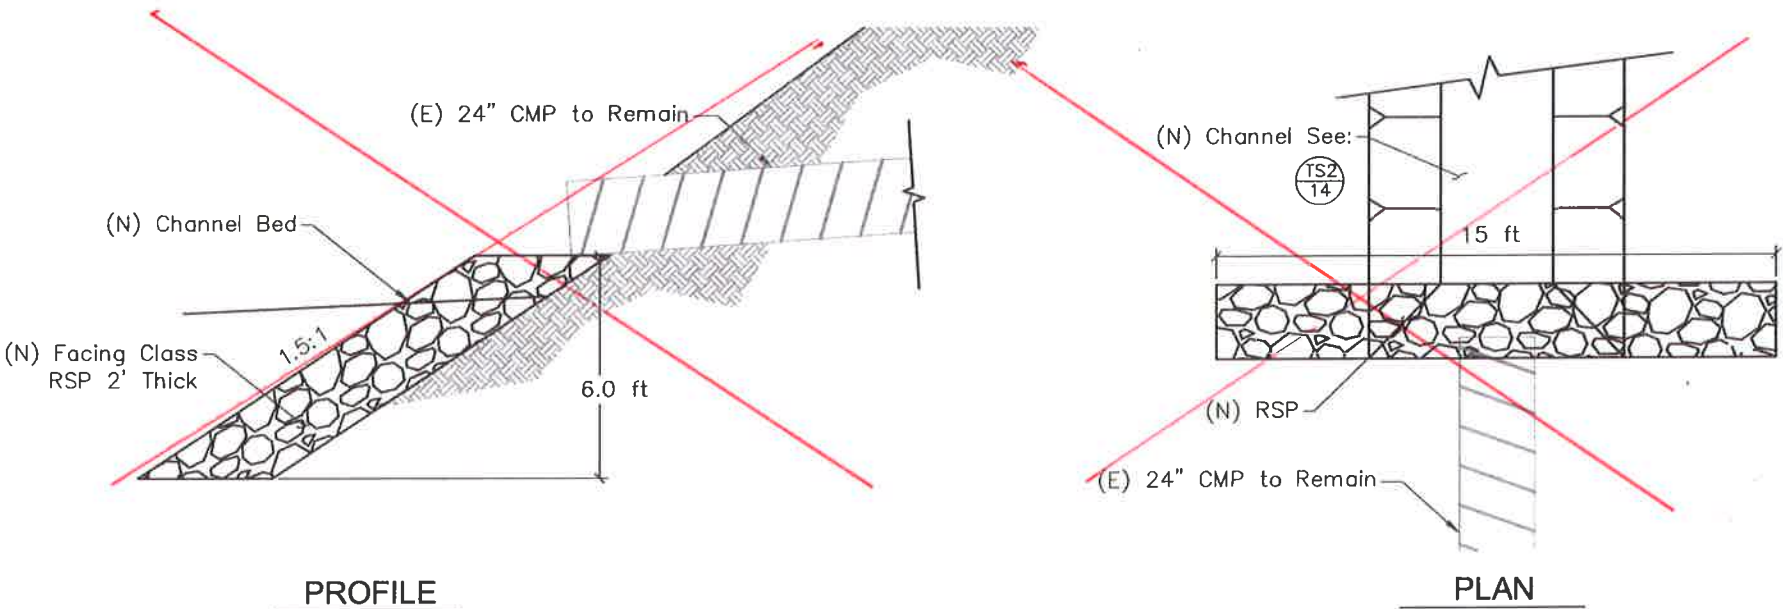
D10 8 RSP CULVERT OUTLET DETAIL (NTS)

REPLACED WITH ROCK WEIR  
AND 2 LOG V-WEIRS

The rock slope protection designed for the culvert outlet at sta 12+00 was replaced with a rock weir and two log “V” weirs after excavation in the area revealed the culvert to be a 48 inch diameter culvert rather than the pre-project estimated 24 inch culvert. Project engineers designed the new outfall structures upon discovering the change and provided installation oversight.

- 5) Log Habitat Structures were installed in locations directed by MLA.
- 6) Upon excavation, it was determined that the buried CMP near station 12+00 of Strawberry Creek was found to be 48" in diameter, and the outlet invert was found to be approximately 1.5 feet lower than shown on the design plans. Therefore, the 1.5-foot drop at the culvert outfall shown on the design plans did not exist. To facilitate fish passage to the culvert, the Facing Class RSP was eliminated and one Rock Weir and two log Vee Weirs were constructed to create 6-inch drops in the water surface profile from the culvert outfall to the new channel thalweg. The rock weir was installed 0.6 feet above the culvert invert to retain natural streambed material within the culvert.

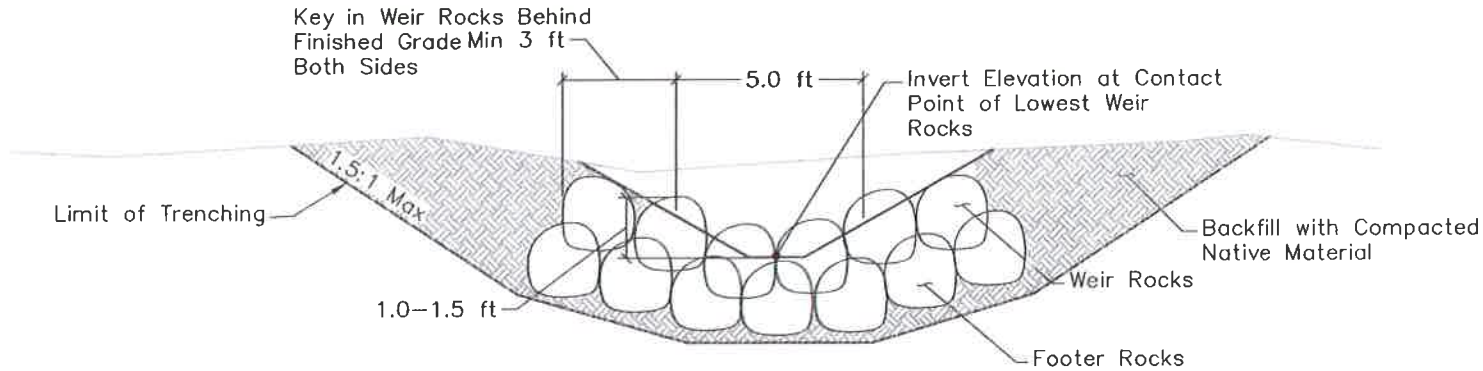
D4 9,22 ROCK WEIR Typical Cross Section (NTS)

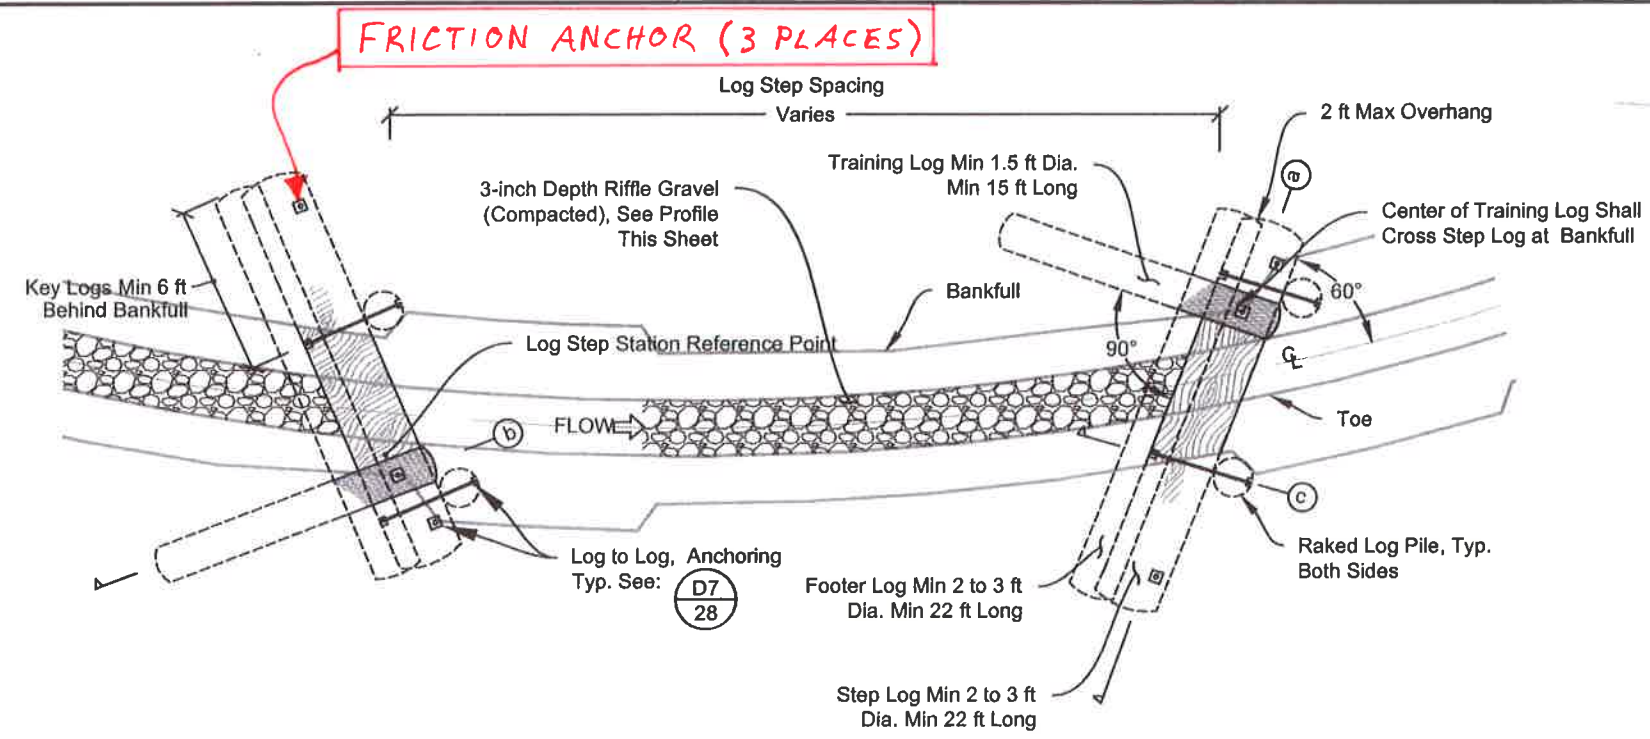
LOG STEP POOL  
Plan (NTS)

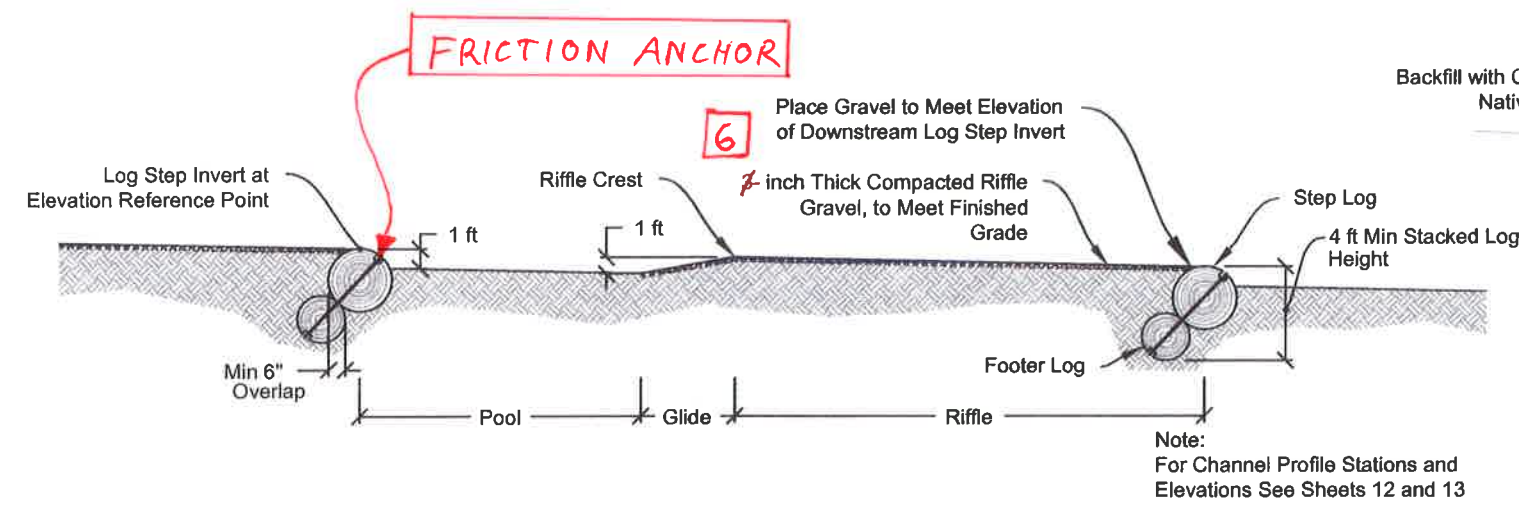
LOG STEP POOL  
Profile Through Log Step Invert (NTS)

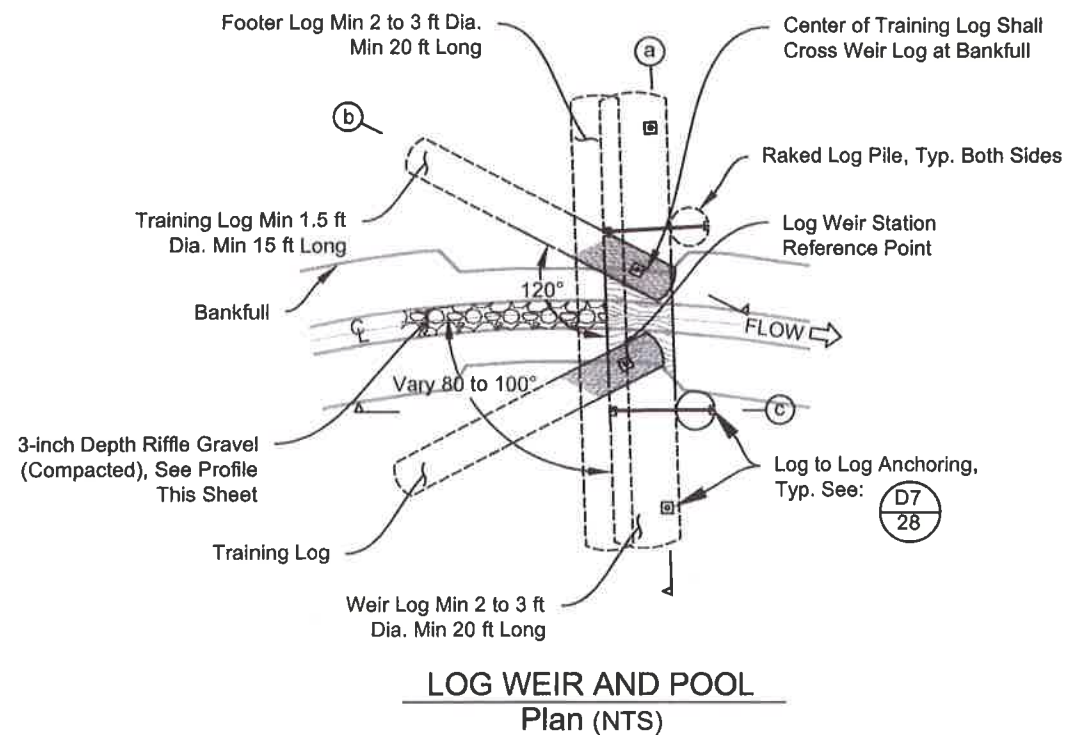
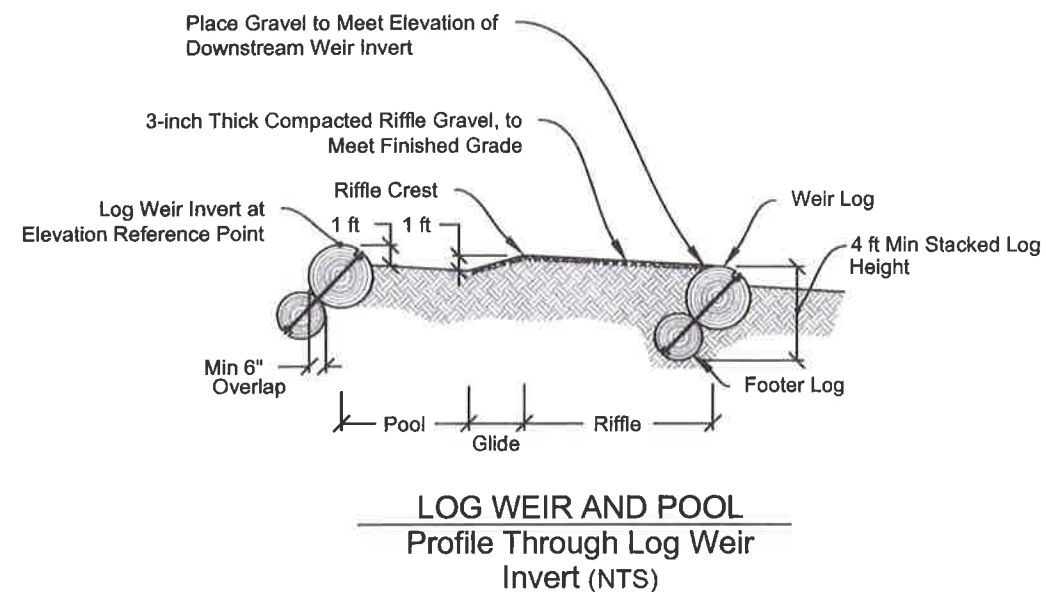
D6  
 9,13,19,22

Note:  
 For Channel Profile Stations and Elevations See Sheet 13

**LOG WEIR AND POOL**  
 Details

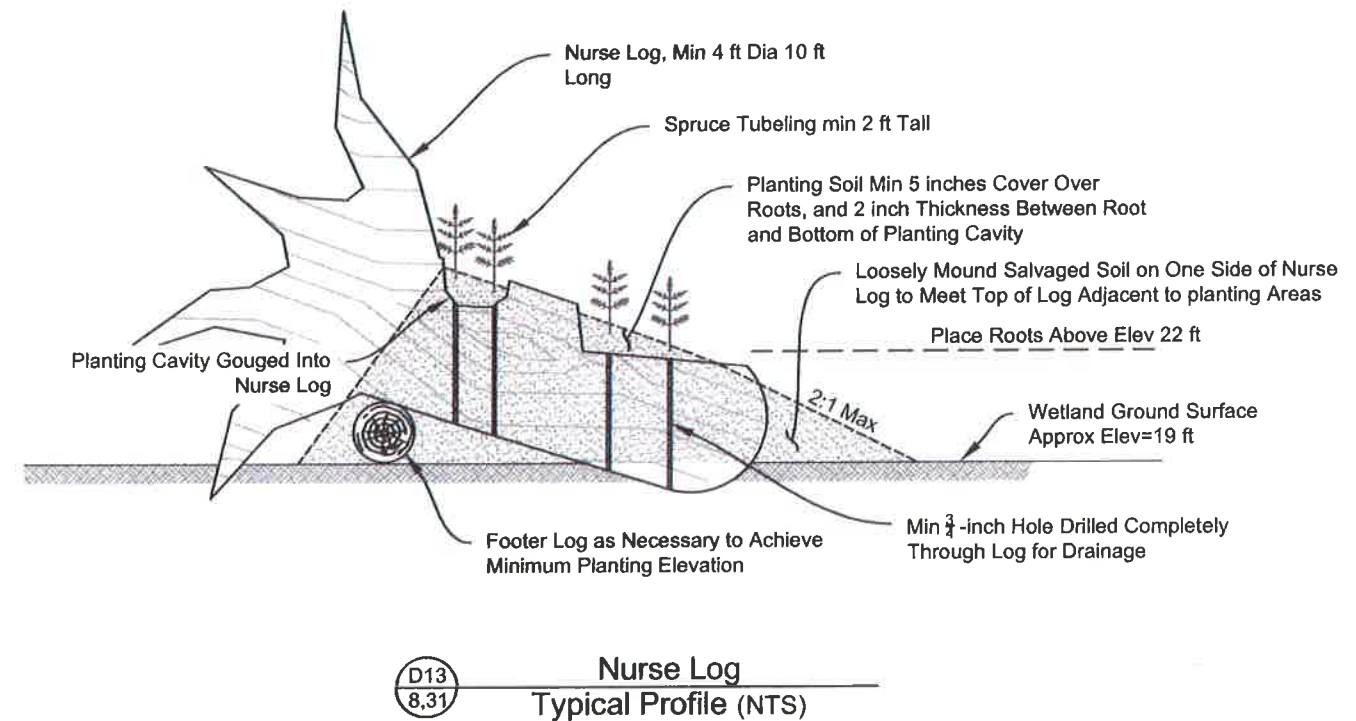
NURSE LOGS PLACED AS SHOWN, NOT PLANTED  
AS OF NOV 7, 2014

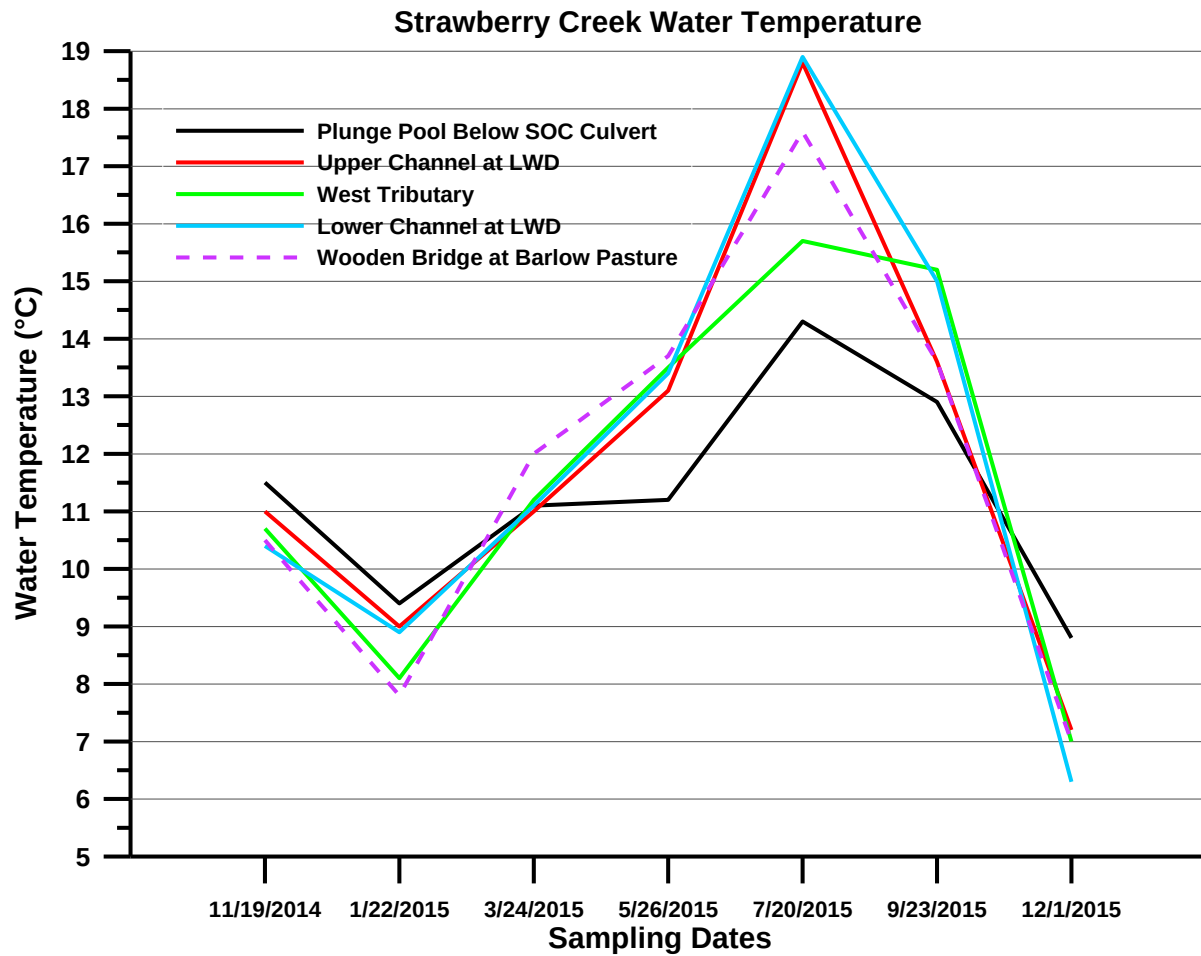
Figure C-1. Bi-monthly water temperatures (°C) at Strawberry Creek monitoring sites within and downstream of the park restoration project, November 2014 through December 2015. Wooden Bridge at Barlow Pasture is the first downstream monitoring site below the restored park reach.

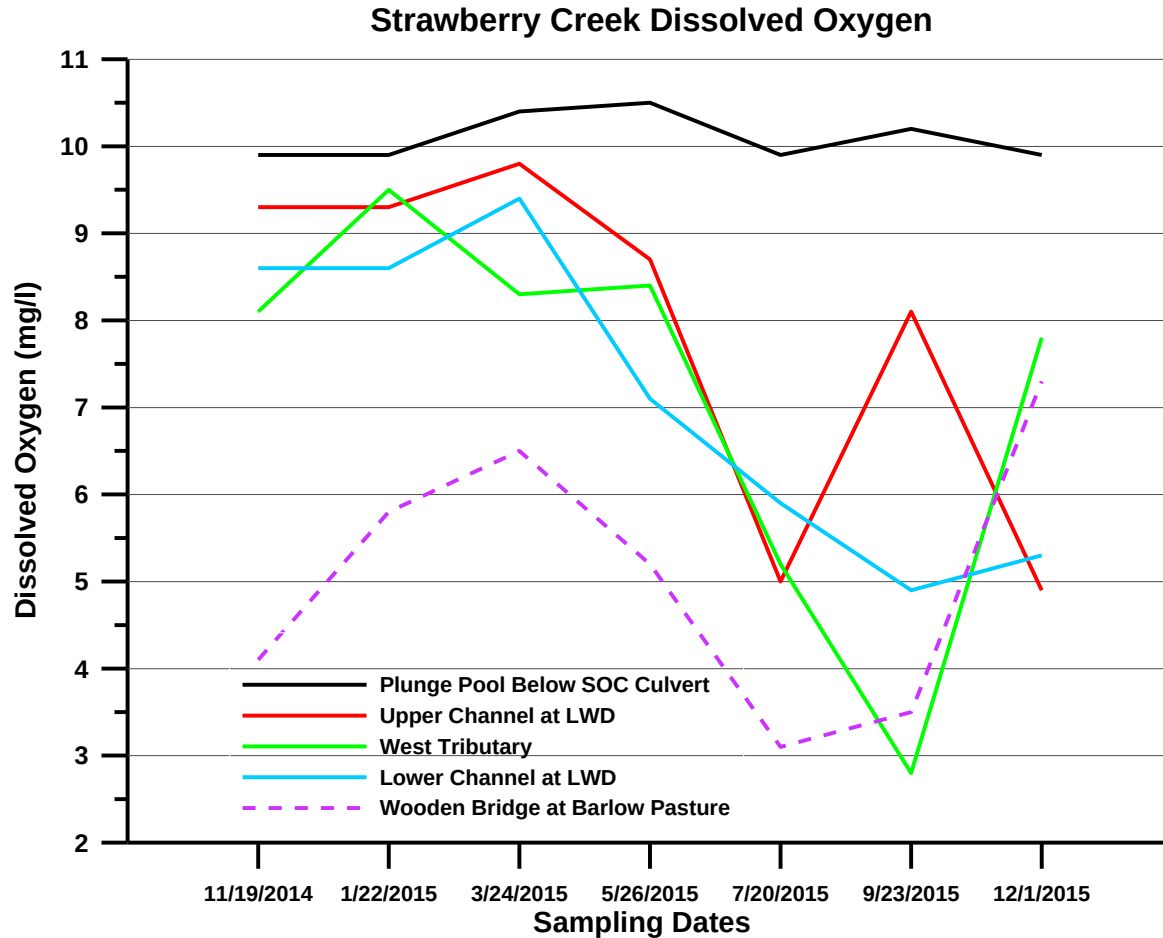
Figure C-2. Bi-monthly dissolved oxygen (mg/l) values ( $^{\circ}\text{C}$ ) at Strawberry Creek monitoring sites within and downstream of the park restoration project, November 2014 through December 2015. Wooden Bridge at Barlow Pasture is the first downstream monitoring site below the restored park reach.

**Figure C-2.** Bi-monthly dissolved oxygen (mg/l) values (°C) at Strawberry Creek monitoring sites within and downstream of the park restoration project, November 2014 through December 2015. Wooden Bridge at Barlow Pasture is the first downstream monitoring site below the restored park reach.

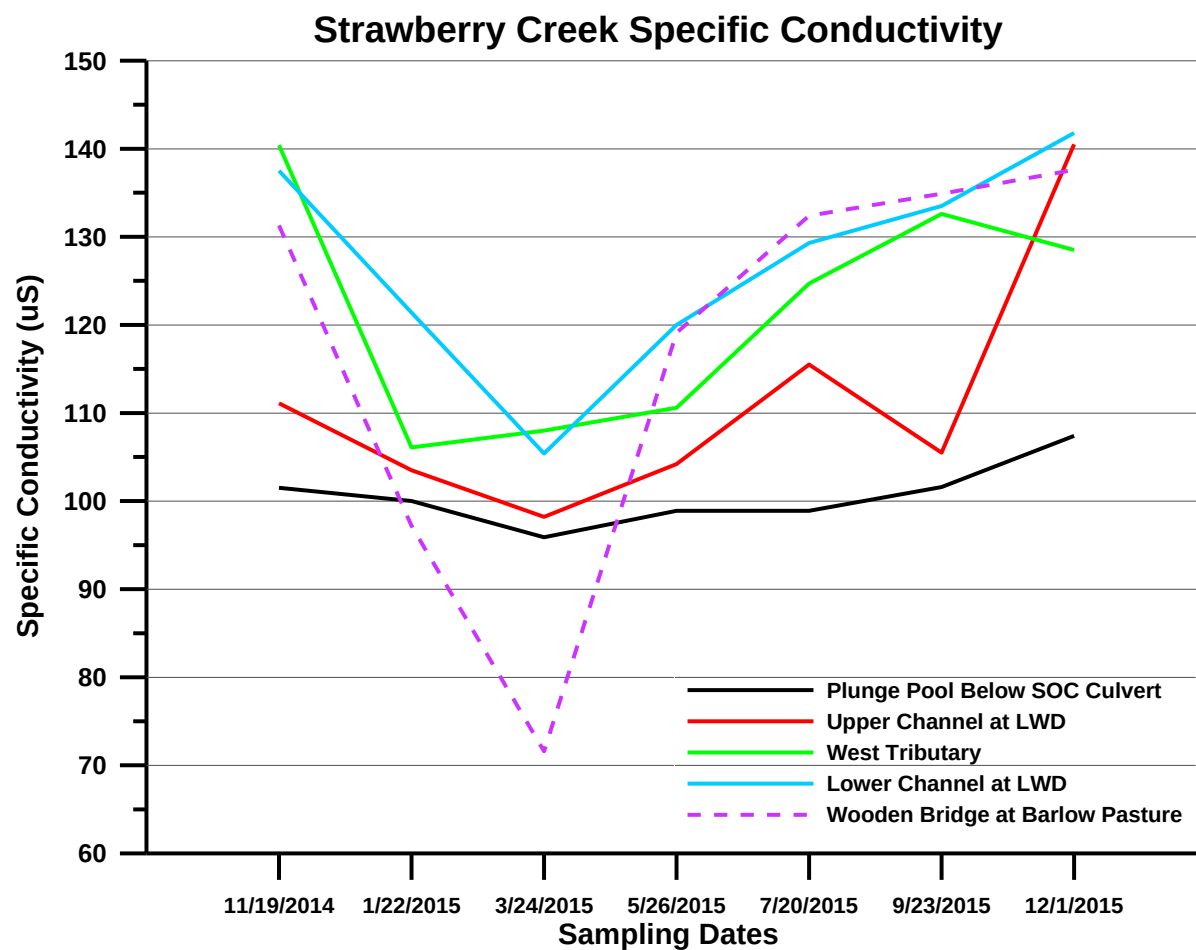
Figure C-3. Bi-monthly specific conductivity ( $\mu\text{S}$ ) values at Strawberry Creek monitoring sites within and downstream of the park restoration project, November 2014 through December 2015. Wooden Bridge at Barlow Pasture is the first downstream monitoring site below the restored park reach.

**Figure C-3.** Bi-monthly specific conductivity (µS) values at Strawberry Creek monitoring sites within and downstream of the park restoration project, November 2014 through December 2015. Wooden Bridge at Barlow Pasture is the first downstream monitoring site below the restored park reach.
