**2015 ANNUAL MONITORING REPORT – YEAR 1**

**STRAWBERRY CREEK RESTORATION PROJECT – NPS REACH  
HUMBOLDT COUNTY, CALIFORNIA**

**CORPS FILE NO. 2009-00041N**

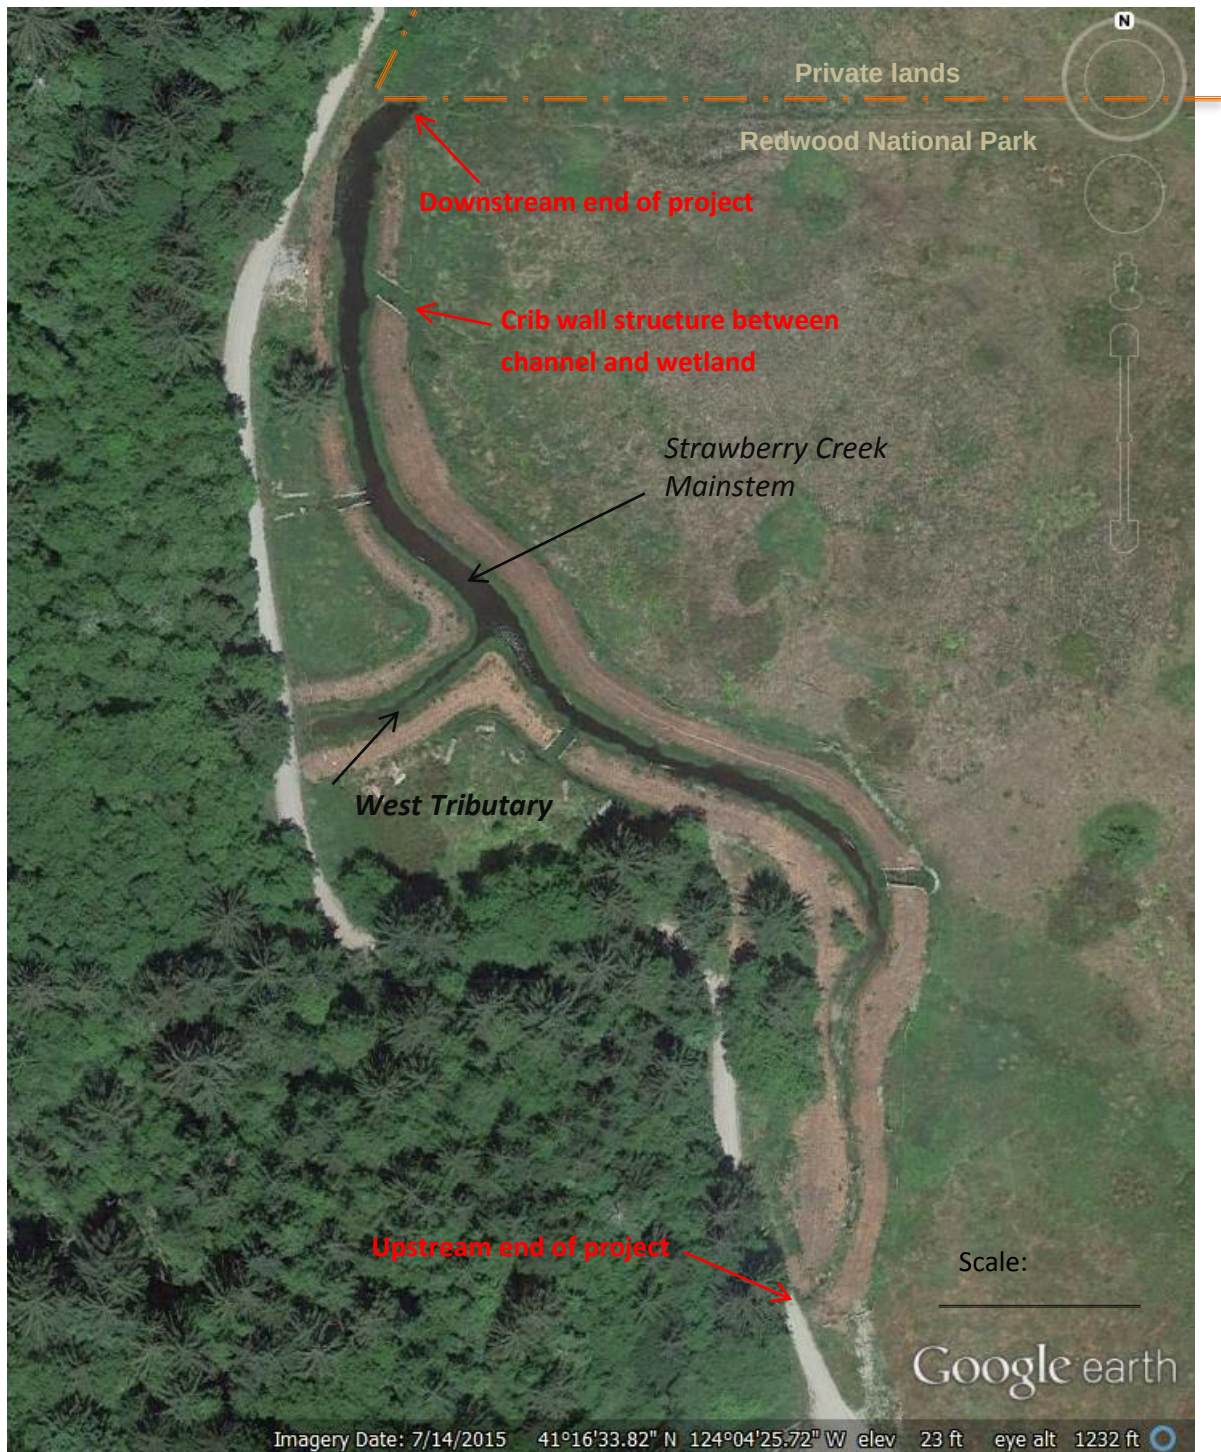
Figure D-1. Google earth image dated 7/14/2015 showing the project reach approximately nine months post-construction of Strawberry Creek mainstem and portion of West Tributary reaches. Visible in photo are the crib wall structures providing conveyance of flows between wetland and constructed channel, planting mounds covered with redwood bark mulch, open water channel of mainstem and West Tributary and invasive grasses lining the bank at the water's edge. The portion of the project not yet constructed is the culvert replacement on West Tributary and log structures upstream of the culvert.

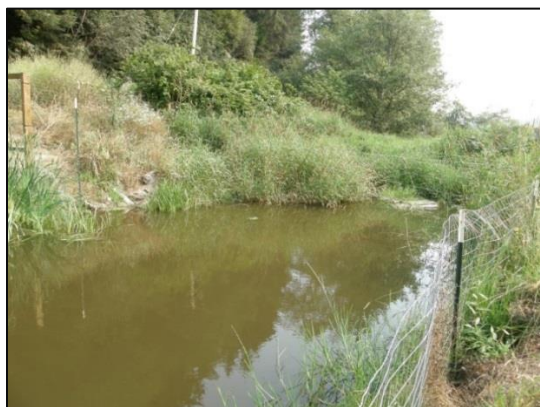
PP 50 (STA 0+50). From mainstem right bank. View of downstream end of project, looking downstream.
