## Strawberry Creek Fish and Water Quality Sampling Humboldt County, California August 2006 to February 2009

*D.G. Anderson. 2009. Strawberry Creek Fish and Water Quality Sampling, Humboldt County, California: August 2006 to February 2009. Redwood National and State Parks, Orick, California. 14pp.*

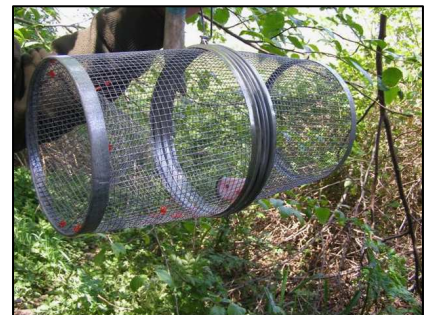
Figure 2. Minnow Trap

Minnow traps (16.5 inches long, 7.4 inches in diameter at the end, with a 1 to 1.5 inch opening in the cone) (Figure 2), one at each location, were baited with cured hot-pink salmonid roe, and placed in the water. The traps rested on the bottom substrate. Traps fished between three to four hours. The traps were retrieved with a fishing line attached to the trap and their contents emptied into a bucket. Fish were identified, counted, and salmonid fork length measured to the nearest millimeter.

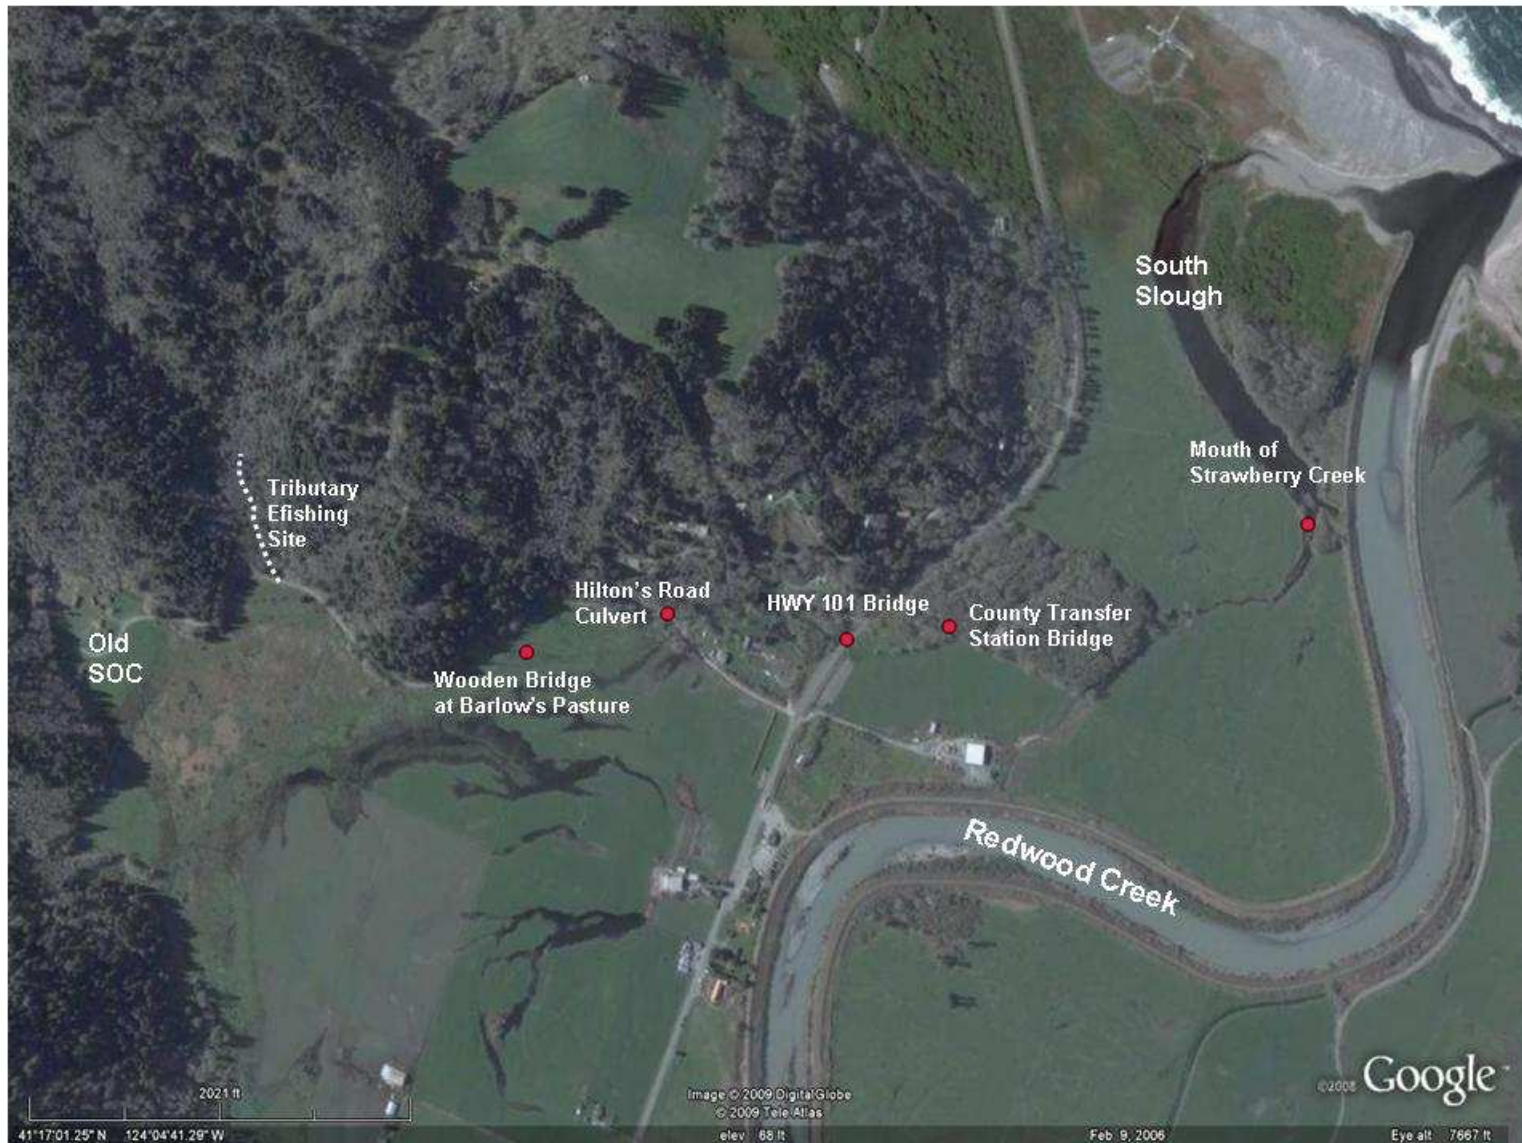
Figure 1. Strawberry Creek (south of Orick, Humboldt County, California) fish sampling locations (red dots).

Strawberry Creek, tributary to Redwood Creek, enters the South Slough of the Redwood Creek estuary, just south of Orick (Figure 1). The trapping sites are low gradient, slow moving water. The water is tannic in color, and except for the waster transfer station lack an over hanging riparian canopy. The exotic reed canary grass (*Phalaris arundinacea*) is the prevalent streamside vegetation at the other sites. Site pictures are presented in Appendix 1.

1. Mouth of Strawberry Creek with its confluence with the South Slough
2. Humboldt County Waste Transfer Station (upstream side of box culvert/bridge)
3. Highway 101 Bridge (~30 ft upstream of bridge)
4. Hiltons Road culvert (downstream end of culvert)
5. Wooden bridge at the Barlow pasture

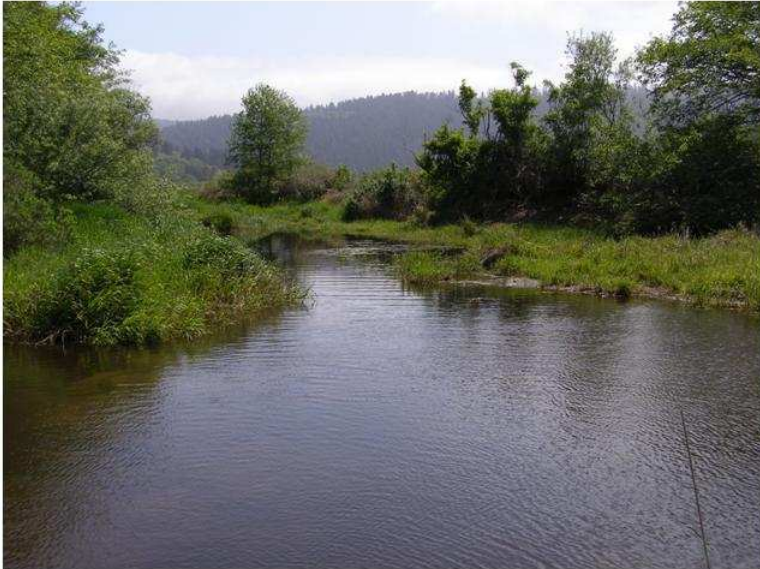
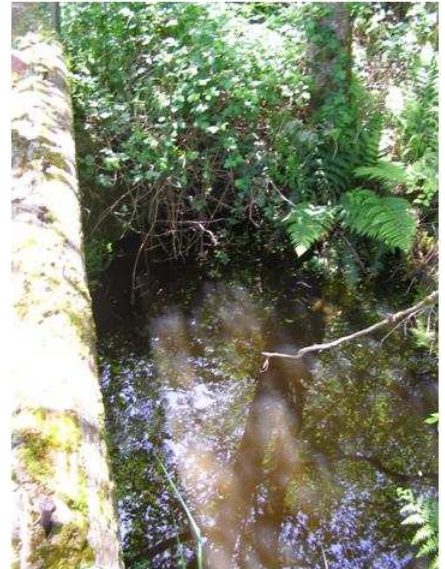
Mouth and lower channel of Strawberry Creek at South Slough (L) and downstream side of bridge/box culvert at Humboldt County Waste Transfer Station (R) on May 7, 2008 (RNSP).

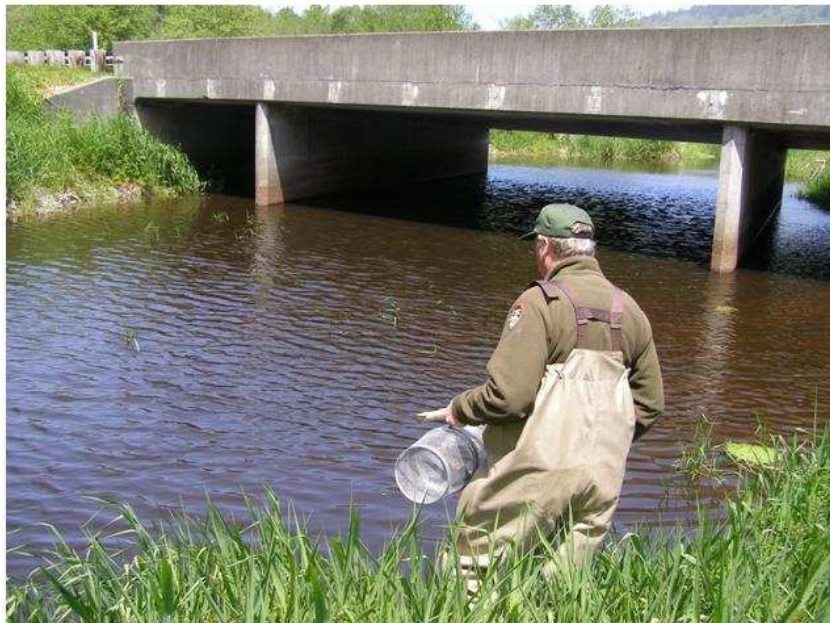
Upstream of Highway 101 Bridge on May 7, 2008 (RNSP).

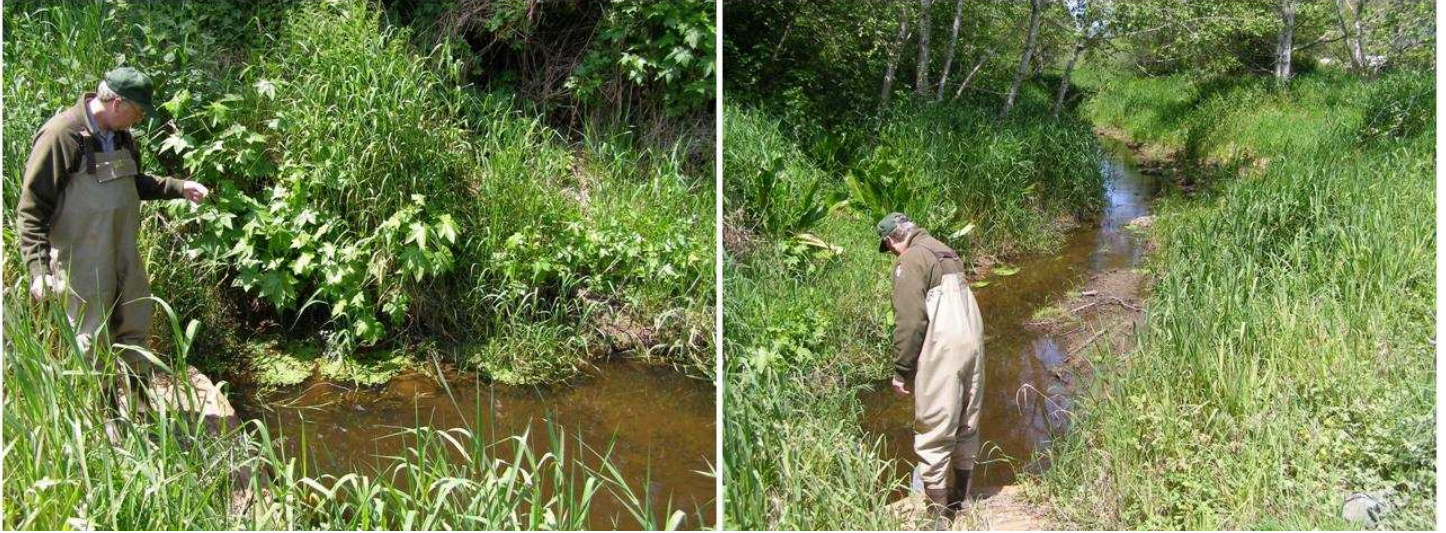
Downstream end of Hiltons Road culvert (L) and downstream channel (R) on May 7, 2008 (RNSP).

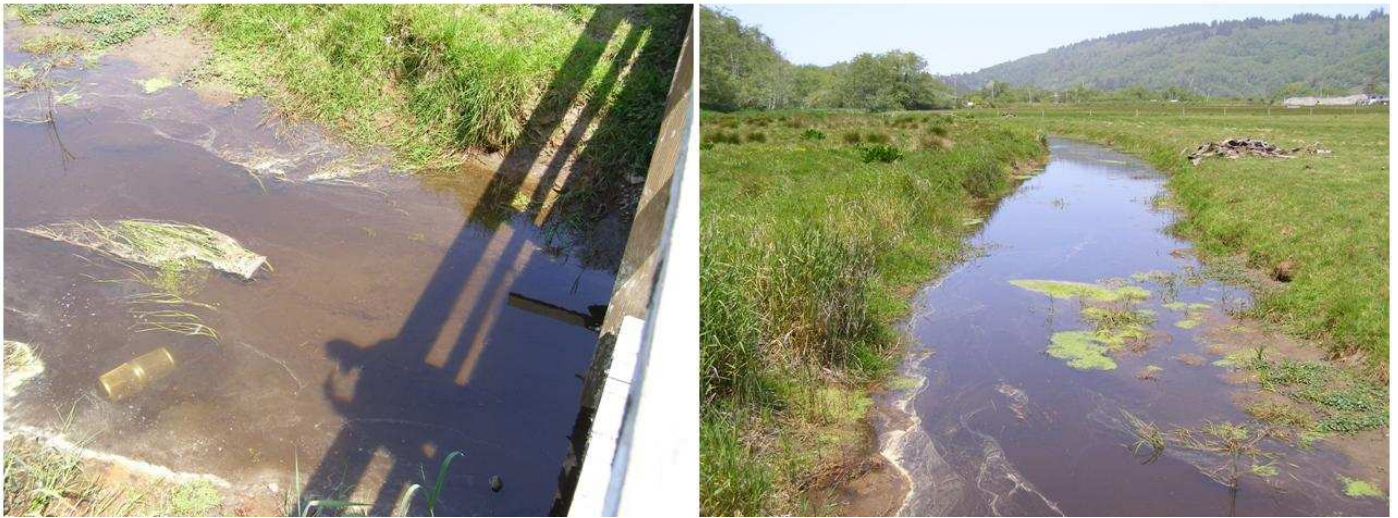
Wooden bridge sampling site at Barlow pasture (L) and Strawberry Creek channel downstream of wooden bridge through pasture (R) on May 7, 2008 (RNSP).

The water at the Barlow pasture bridge was daylighted (open with not a lot of vegetation in the channel.) We could see the muddy substrate. Upstream and downstream of the Hilton Road culvert were covered with the reed canary grass but at the upstream side of the culvert there were small open sites where you could see water flowing. At the downstream 101 bridge site, the water was covered with canary grass.
