# Characterization of North Coast and Cascade Network Water Quality Study Sites

Natural Resource Data Series NPS/NCCN/NRDS—2017/1097

Carmen A. Welch and Ashley K. Rawhouser

April 2017

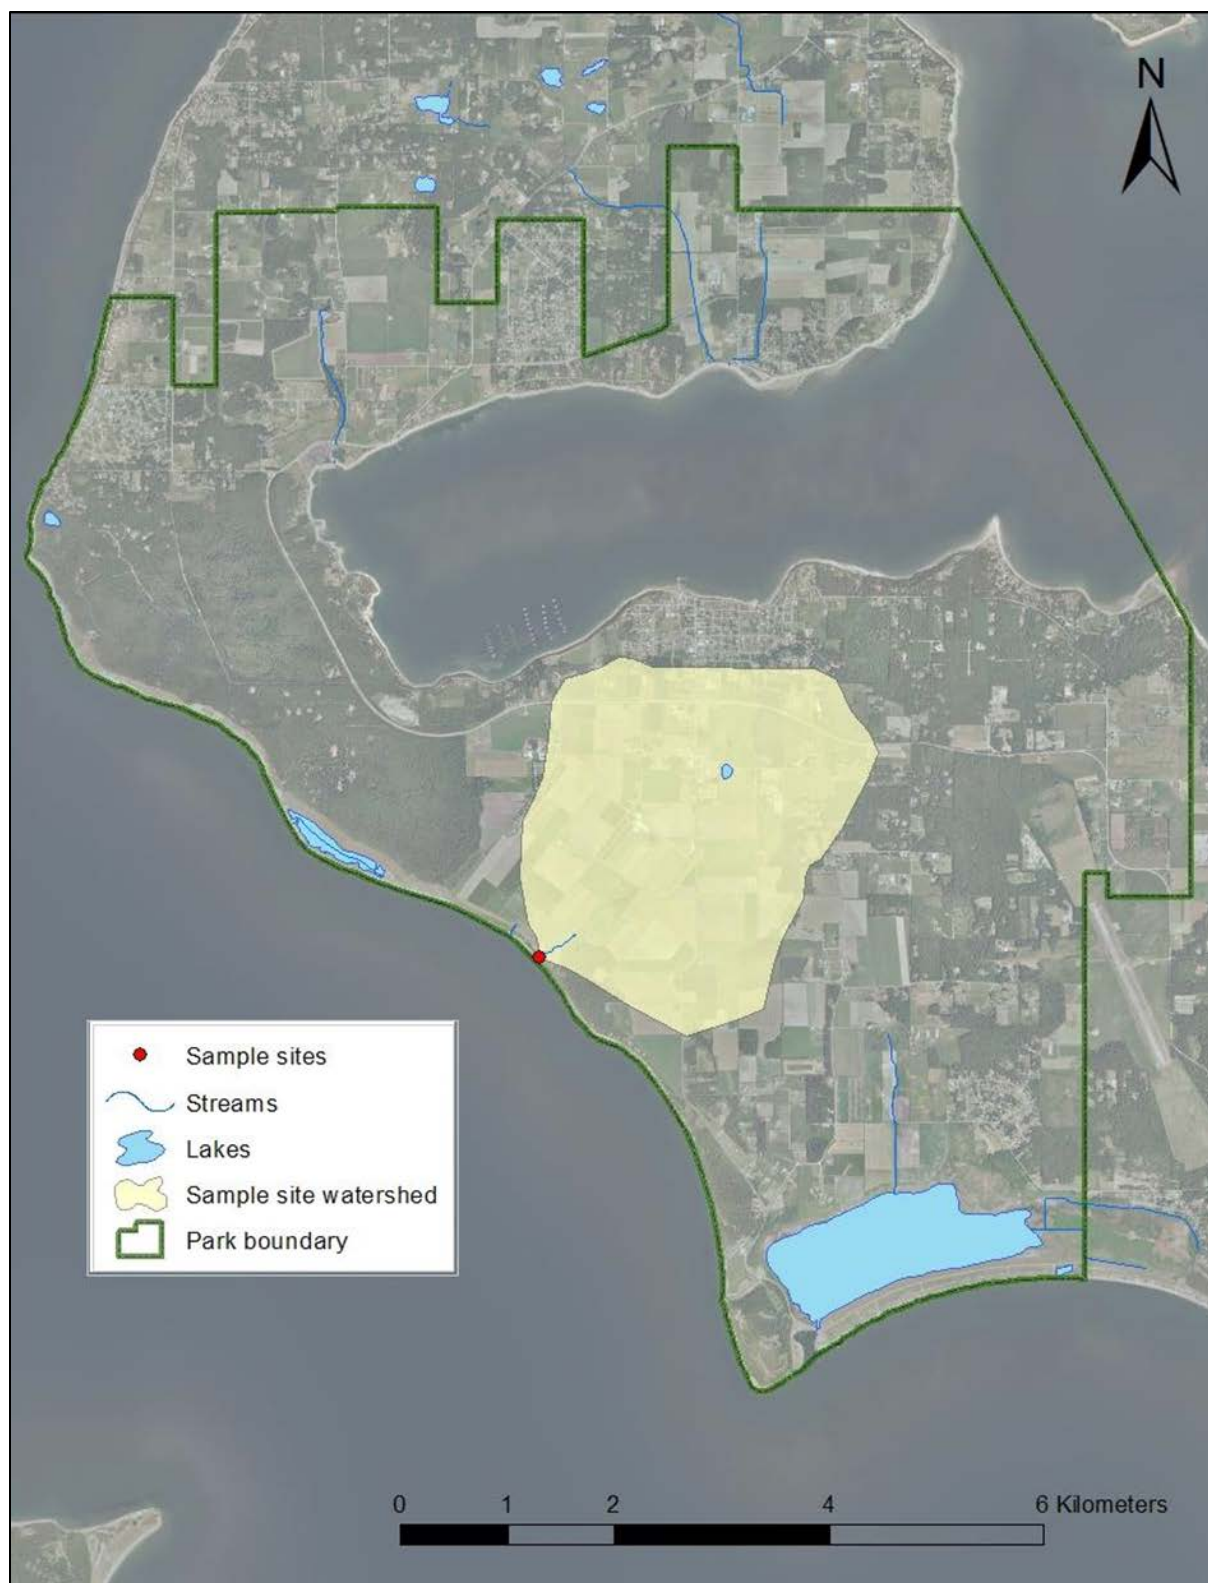
**Figure 2.** Map of the Ebey's Watercourse stream location and watershed in Ebey's Landing National Historical Reserve.

One stream, Ebey's Watercourse, is sampled in Ebey's Landing National Historical Reserve as part of the NCCN Water Quality monitoring protocol (Figure 2). The Ebey's Watercourse watershed encompasses 8.5 km<sup>2</sup>, ranges in elevation from 13 to 67 m above sea level, and receives an average precipitation of 54 cm/year. The stream is seasonally intermittent and is fed primarily by surface runoff of rain and groundwater inflow. Small wetlands found in the watershed (Larrabee 2011) likely help to recharge groundwater inflow. Contained within the Olympic Rainshadow Level IV Ecoregion; the watershed is composed of mixed forest, coastal coniferous forest, restored natural grassland, as well as agricultural lands used for crop production and pasture (Omernick 2010). The stream drains directly into Admiralty Inlet on the west side of Whidbey Island.

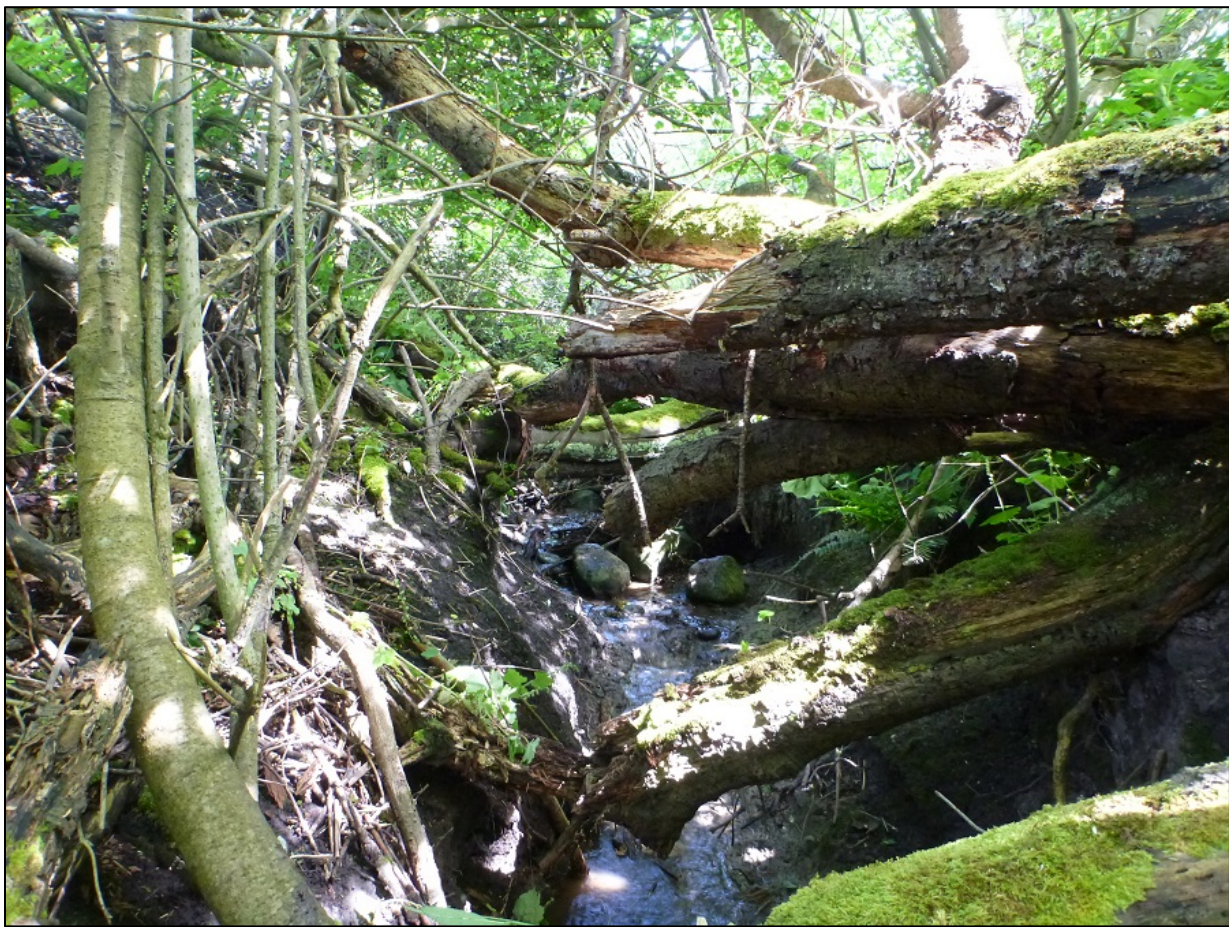
**Figure 4.** Looking upstream into the sample reach in Ebey's Watercourse.

The sample reach in Ebey's Watercourse is 150 m long, starts at an elevation of 13 m above sea level, and begins approximately 200 m upstream from the confluence with Admiralty Inlet. The sample reach is a 1<sup>st</sup> order intermittent stream (Strahler 1952) occupying a single channel that is constrained by incision into the surrounding terrace (Figure 4 and Table 2). This incision is considered to be severe and has greatly reduced habitat complexity and degraded habitat quality (Tables 2 and 3).

The channel was dry in August of 2012 during the first annual site visit therefore the stream was revisited in the spring when water was expected. The visit in Figure 4 occurred in May of 2013, and since the sample reach was watered at this time, future sample events will occur in May.

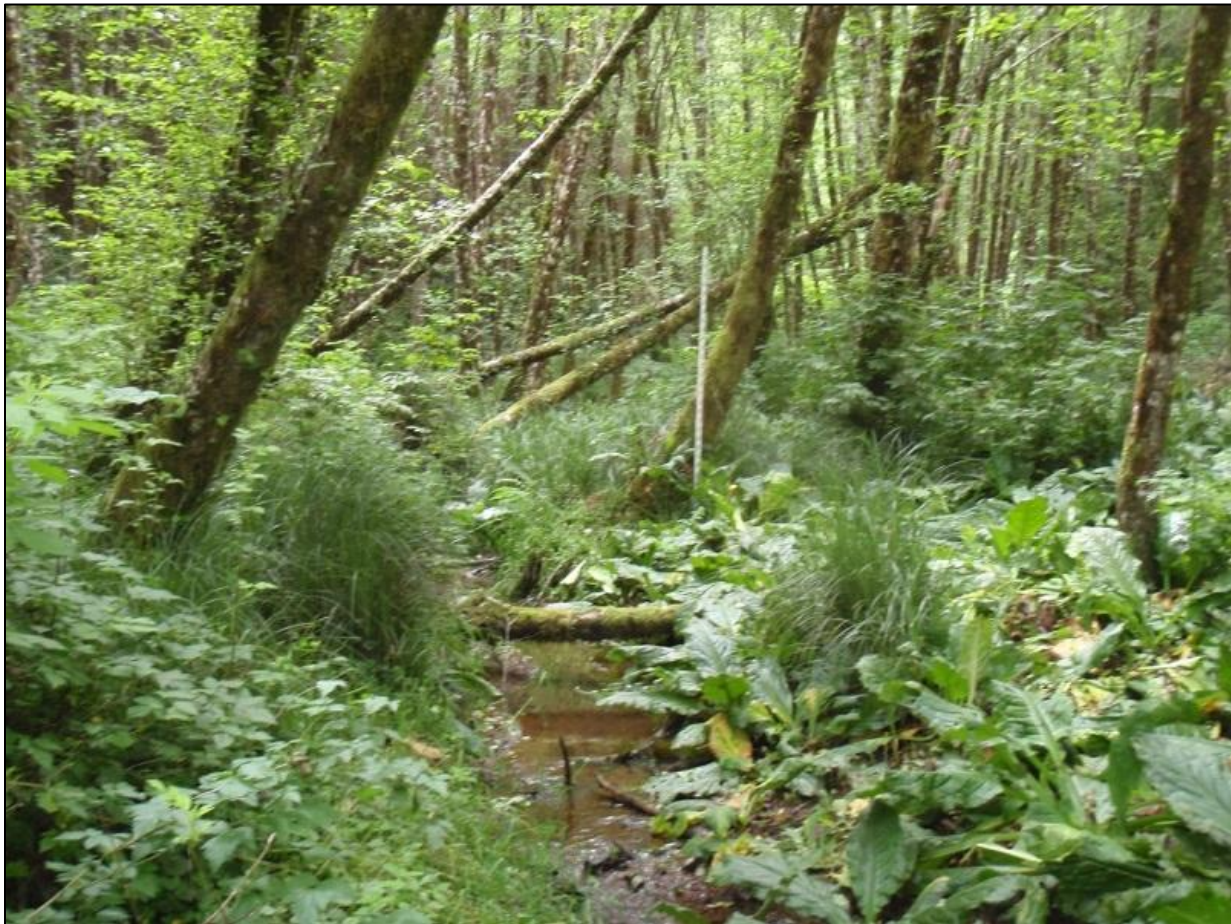
**Figure 7.** Looking upstream into the sample reach in Colewort Creek. Note: Two-meter stadia rod for scale.

Rapid Habitat Assessment scores for Colewort Creek indicated poor to moderate habitat quality (Table 7 and Figure 7). Though minimal channel alteration was present, channel sinuosity and pool variability were low, failing to provide diverse and stable habitat. Poor habitat quality was also indicated by the large amounts of sediment deposition present in the sample reach.

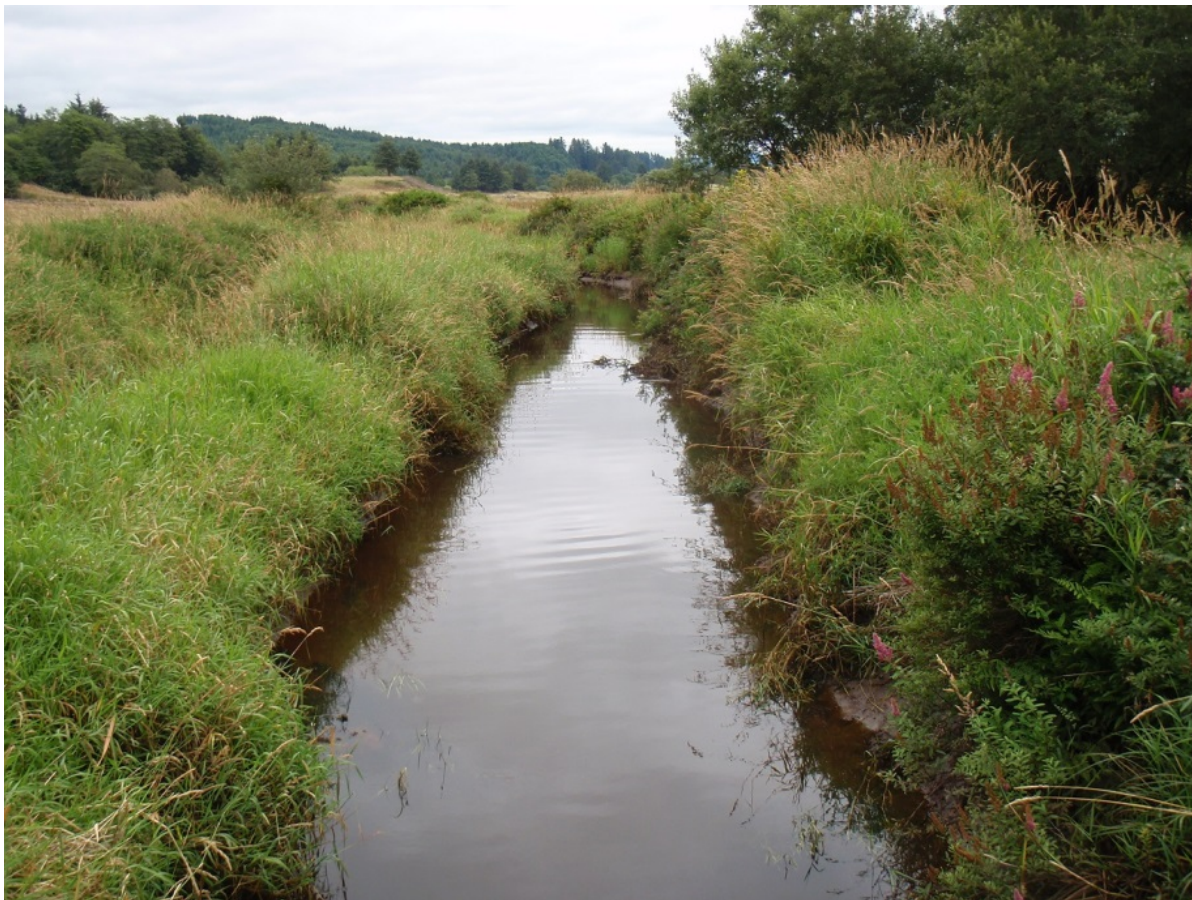
**Figure 8.** Skipanon River, upstream from the stream location (which is also the foot bridge across the river).

The Skipanon River at the sample reach is a 2<sup>nd</sup> order river (Strahler 1952) (Table 10). The sample reach is 103 m in length and occupies a single channel that is highly constrained by incision within the coastal plain (Figure 8). The length of the sample reach was restricted to less than the recommended 150 m minimum because of limited access (Rawhouser et al. 2012). The stream location is approximately 8.5 km from Youngs Bay, and it is unclear if there is any saltwater intrusion to the sample reach, but water level rises and falls dramatically in response to tidal fluctuations.

The Rapid Habitat Assessment conducted for the Skipanon River in 2012 indicated that the sample reach was in marginal condition, chiefly due to channelization (Table 11). The banks were stable, but the dominance of non-native and invasive reed canary grass (*Phalaris arundinacea*) and Himalayan blackberry (*Rubus armeniacus*) provided for poor riparian zone cover and minimized the potential for large woody debris recruitment (Figure 8).

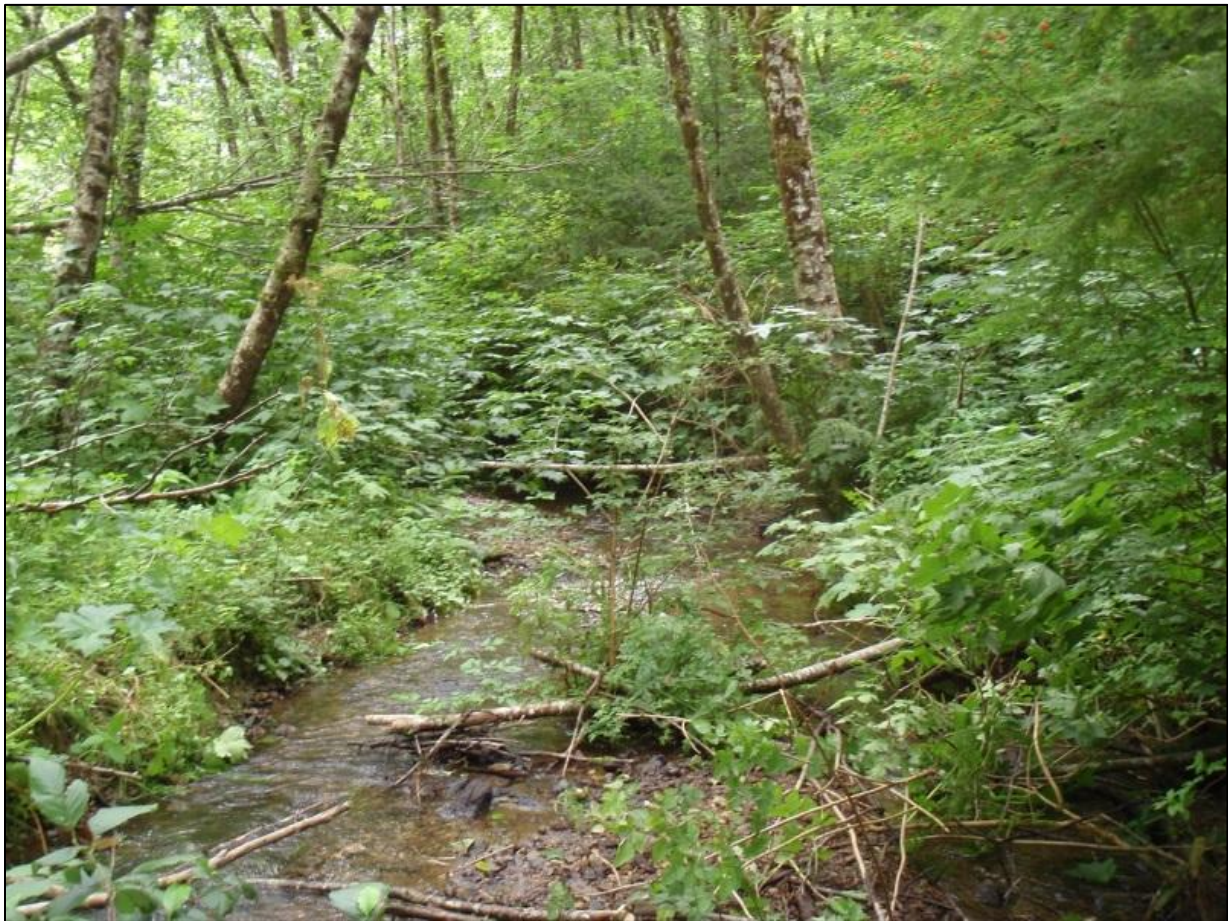
**Figure 10.** Megler Creek, looking downstream from the reference point.

The Rapid Habitat Assessment conducted for Megler Creek in 2012 indicated that the sample reach was in sub-optimal condition due to the lack of in-stream cover and a low diversity of velocity and depth regimes (Table 15).

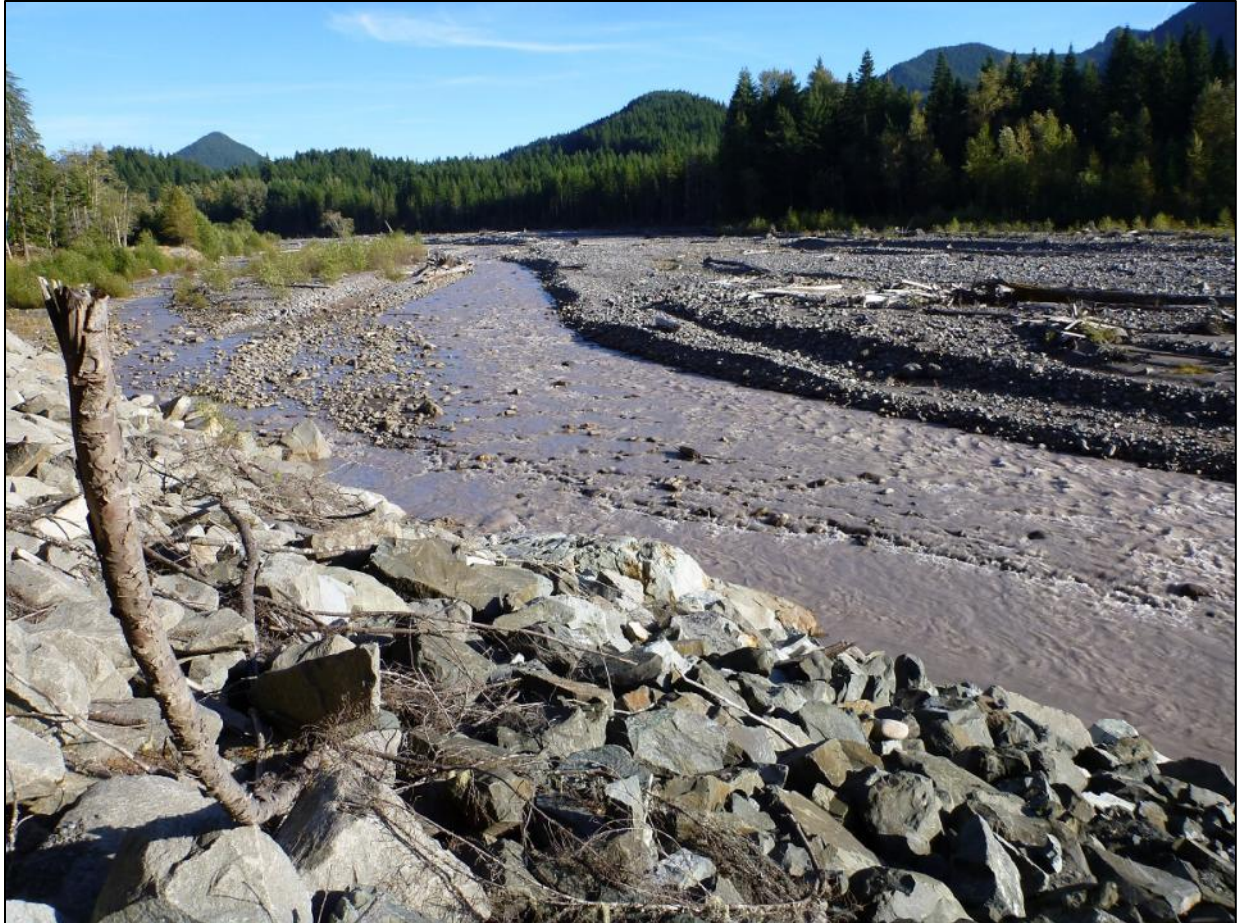
**Figure 13.** Photograph of the Nisqually River at Park boundary sample reach illustrating the broad floodplain and braided channel characteristics. Note: Bank armoring/rip-rap in the foreground.

The NIBO sample reach is 500 m long and is a 4<sup>th</sup> order river (Strahler 1952) that occupies a braided channel in an unconstrained broad floodplain (Figure 13). Torrent evidence strongly suggests that both scouring and deposition occur in this reach (Table 18). Beason et al. (2014) determined average aggradation for the NIBO sample reach to range from -0.17 m/year in 2005 to 0.36 m/year in 2012. The high amounts of silt deposition, channel alteration, and low variety of velocity and depth regimes contributed to the sub-optimal habitat rating in the Rapid Habitat Assessment conducted for the NIBO sample reach in 2012 (Table 19).

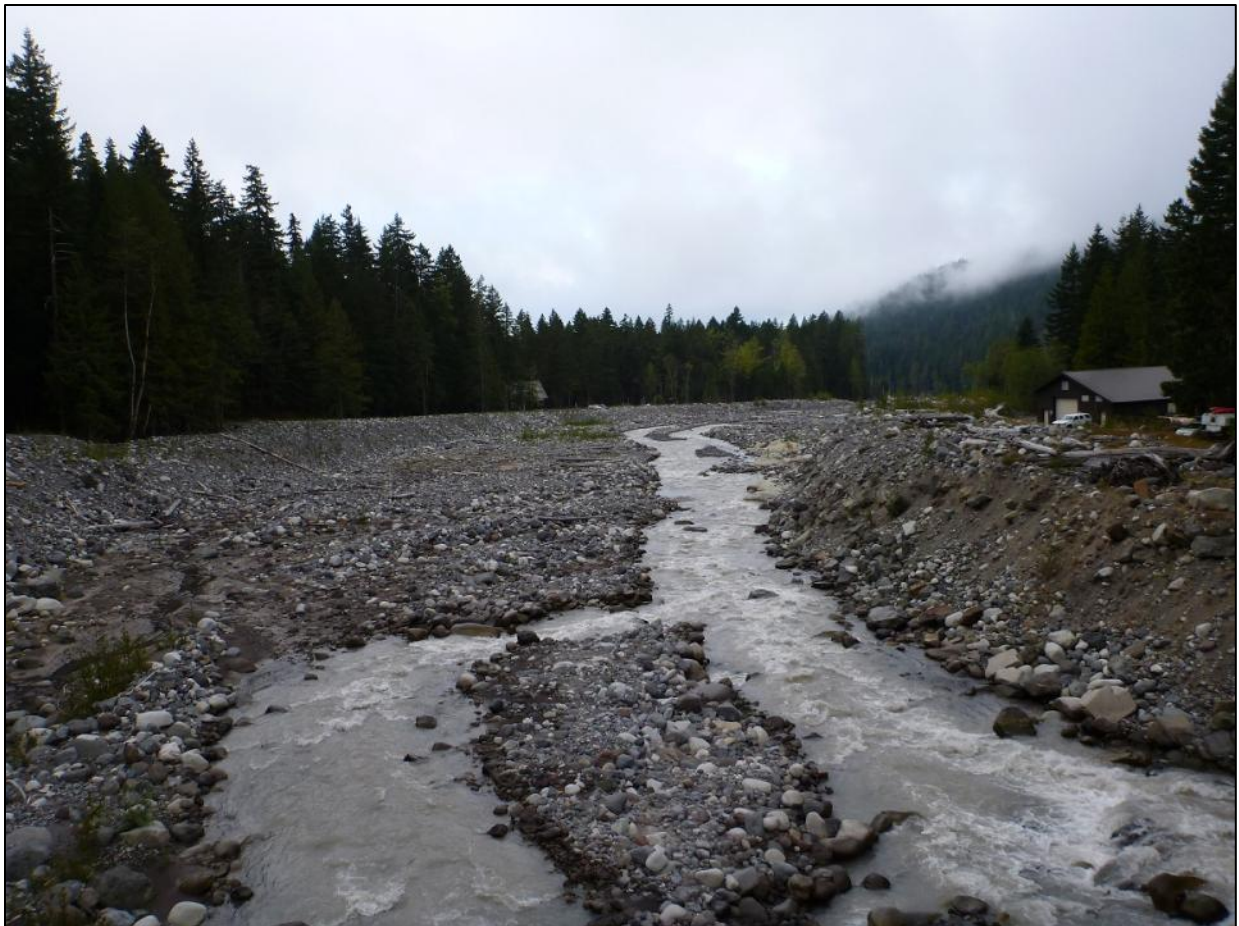
**Figure 14.** Looking downstream into the sample reach in the Nisqually River at Longmire. The MORA service compound can be seen to the right in the photograph.

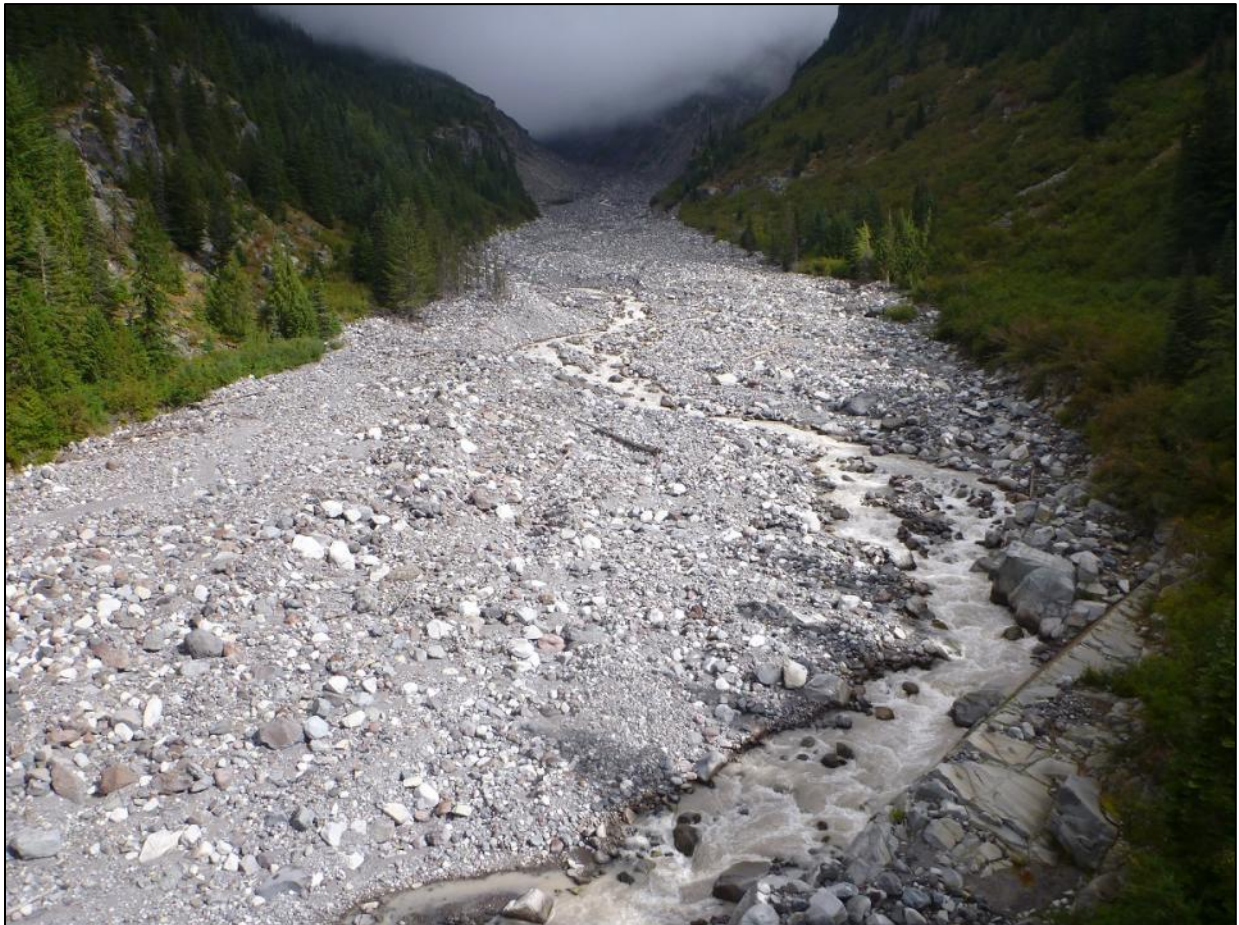
**Figure 15.** The Nisqually River at Glacier Bridge sample reach braided within its floodplain and constrained by steep valley walls.

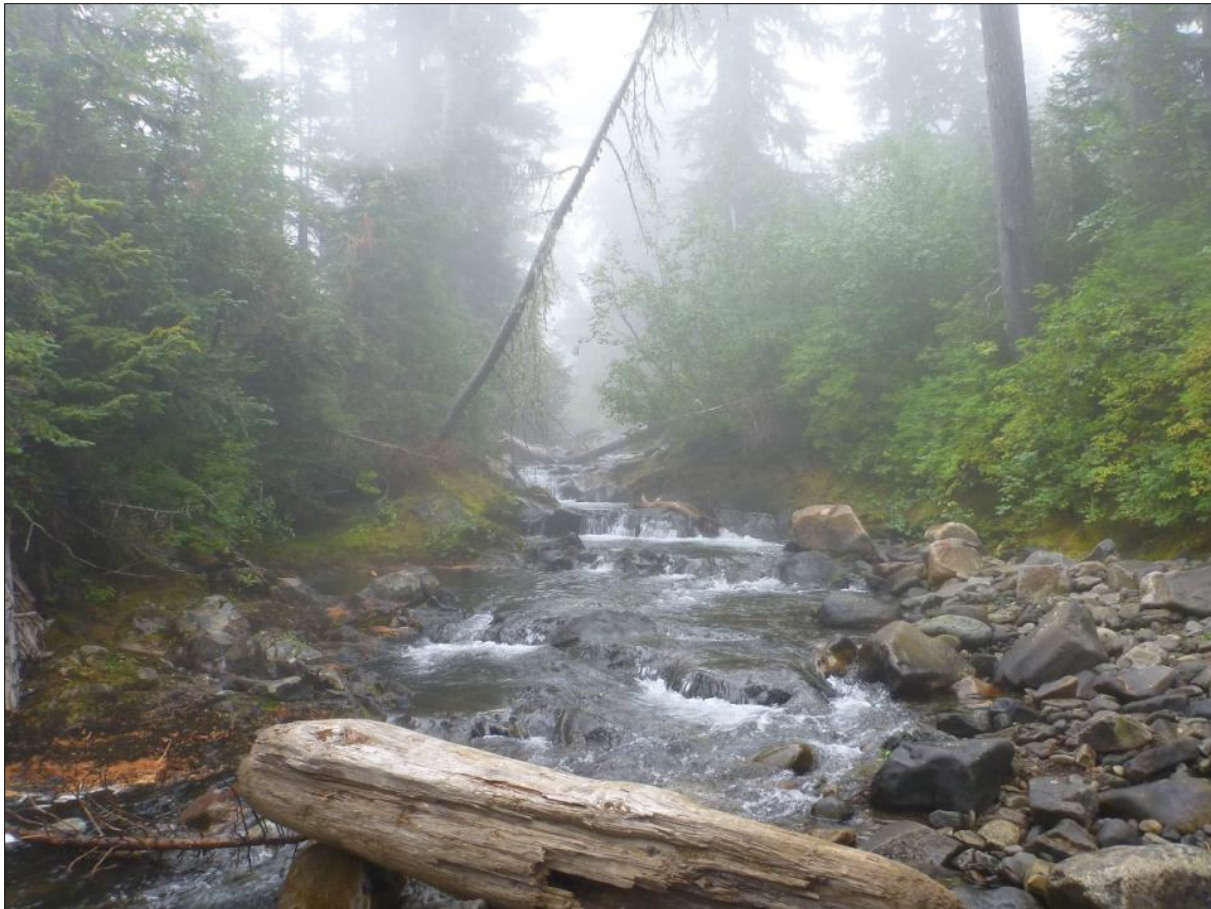
**Figure 16.** Looking upstream into the Paradise River sample reach.

The Paradise River sample reach is 150 m long and starts at 1,354 m above sea level, extending up to 2,241 m in elevation. The sample reach is a single channel 2<sup>nd</sup> order stream (Strahler 1952), located in the bottom of a narrow valley, and constrained by bedrock and boulder walls and debris aprons (Table 30, Figure 16). The Rapid Habitat Assessment conducted for the Paradise River in 2012 indicated that the sample reach was in optimal condition (Table 31).

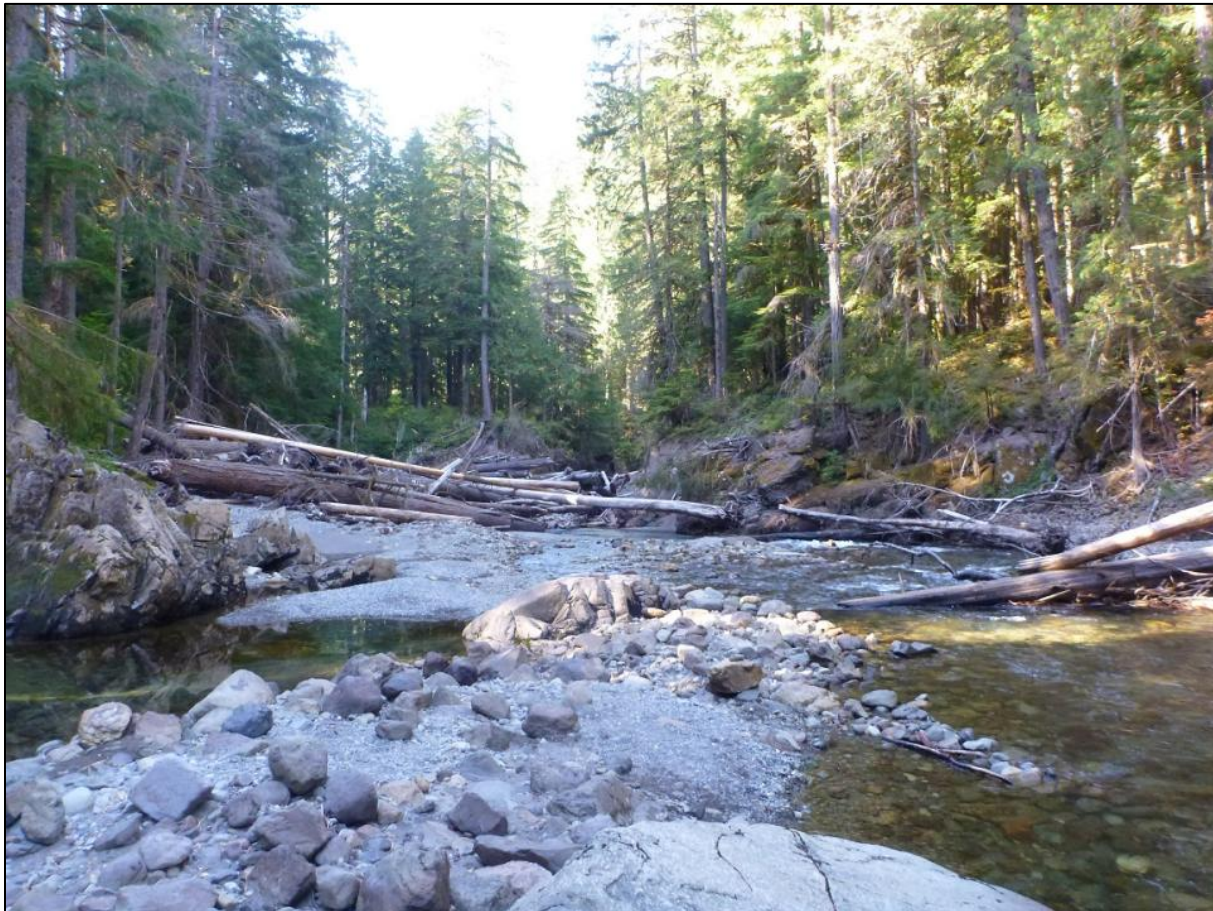
**Figure 18.** Bedrock and boulder constraints are evident, looking downstream to the start of the Ohanapecosh sample reach.

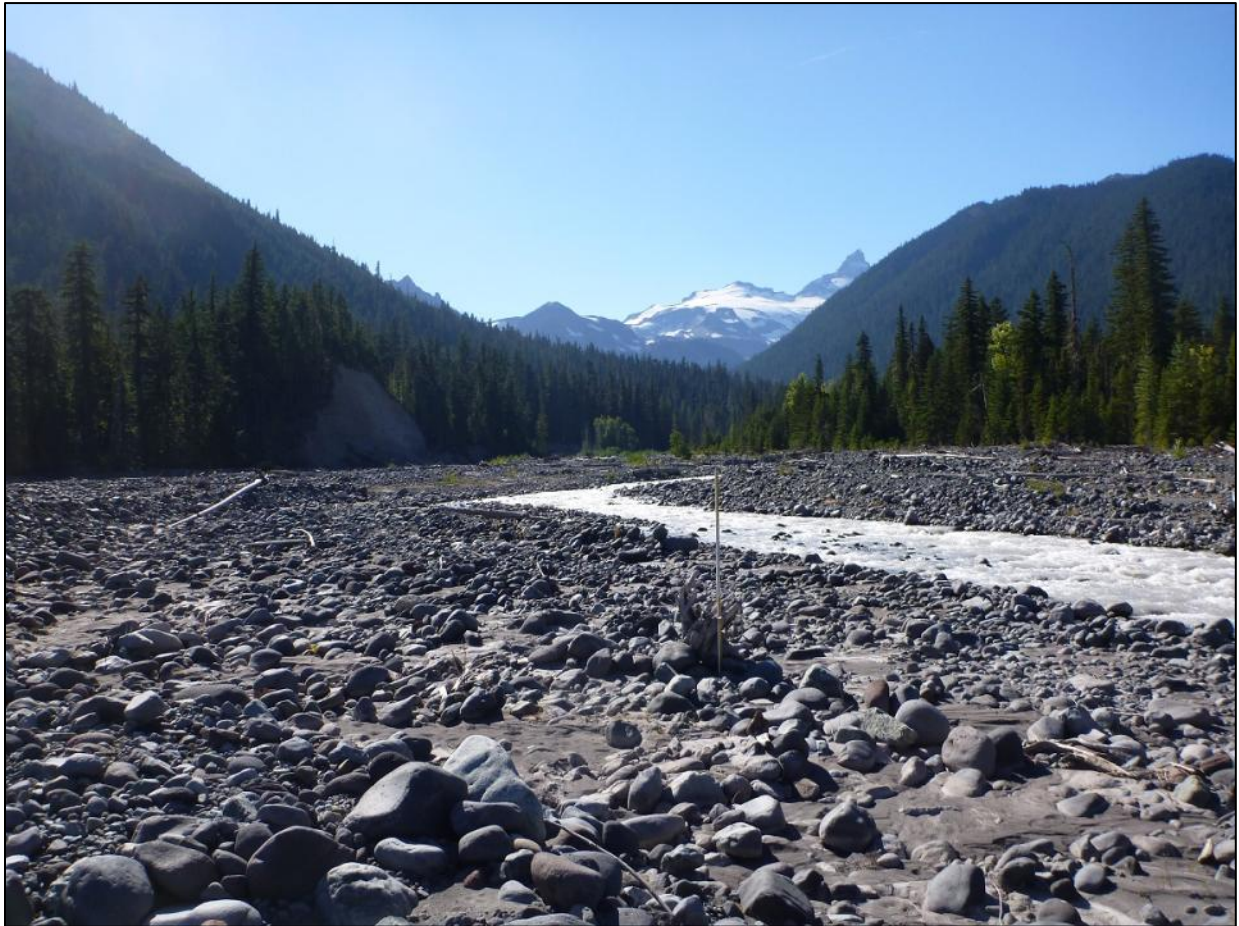
**Figure 21.** The White River at littorals sample reach, showing braided channel within its broad valley.

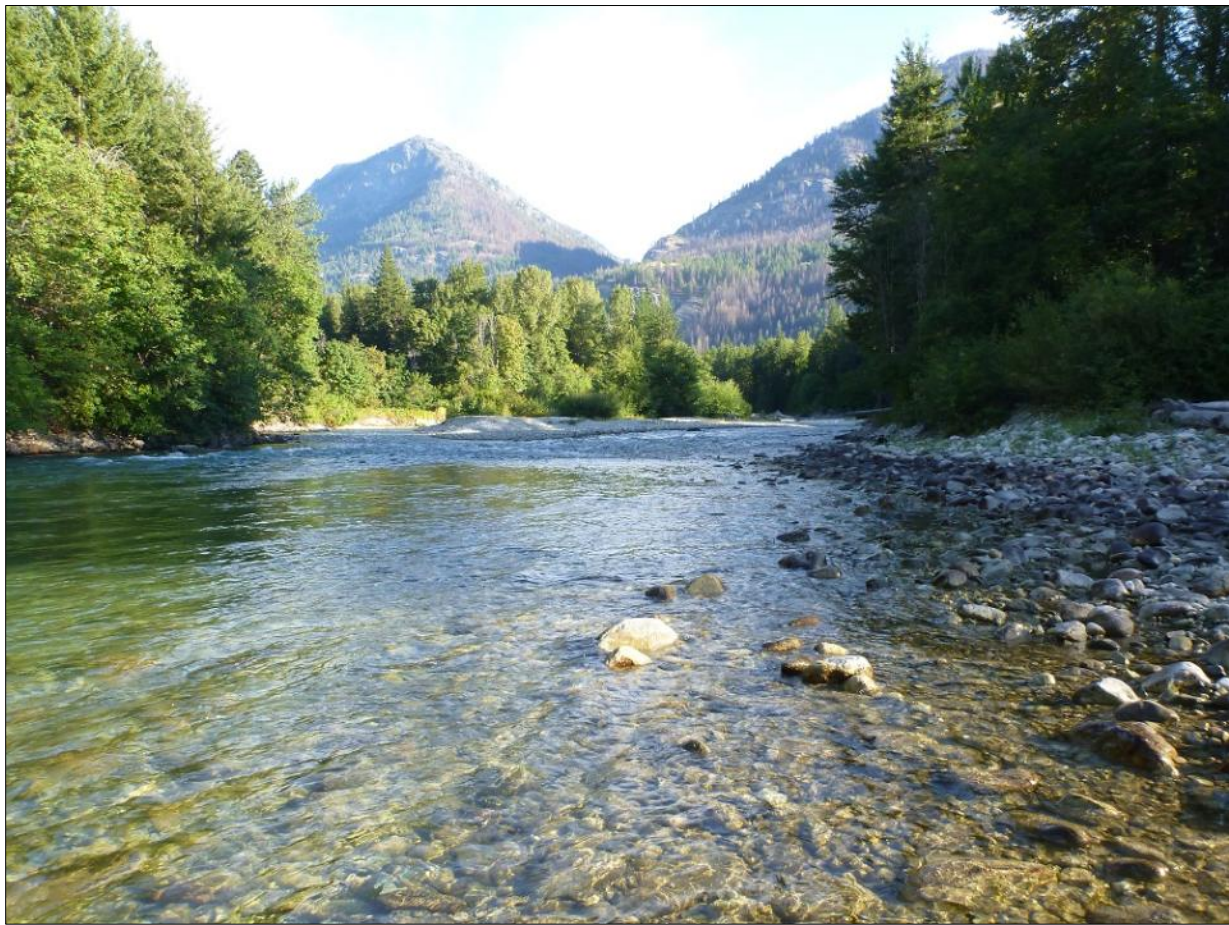
**Figure 24.** Looking upstream into the Stehekin River sample reach.

optimal condition chiefly due to recent flooding events that have deposited large amounts of sediment in the reach and increased bank erosion (Table 47, Figure 24).

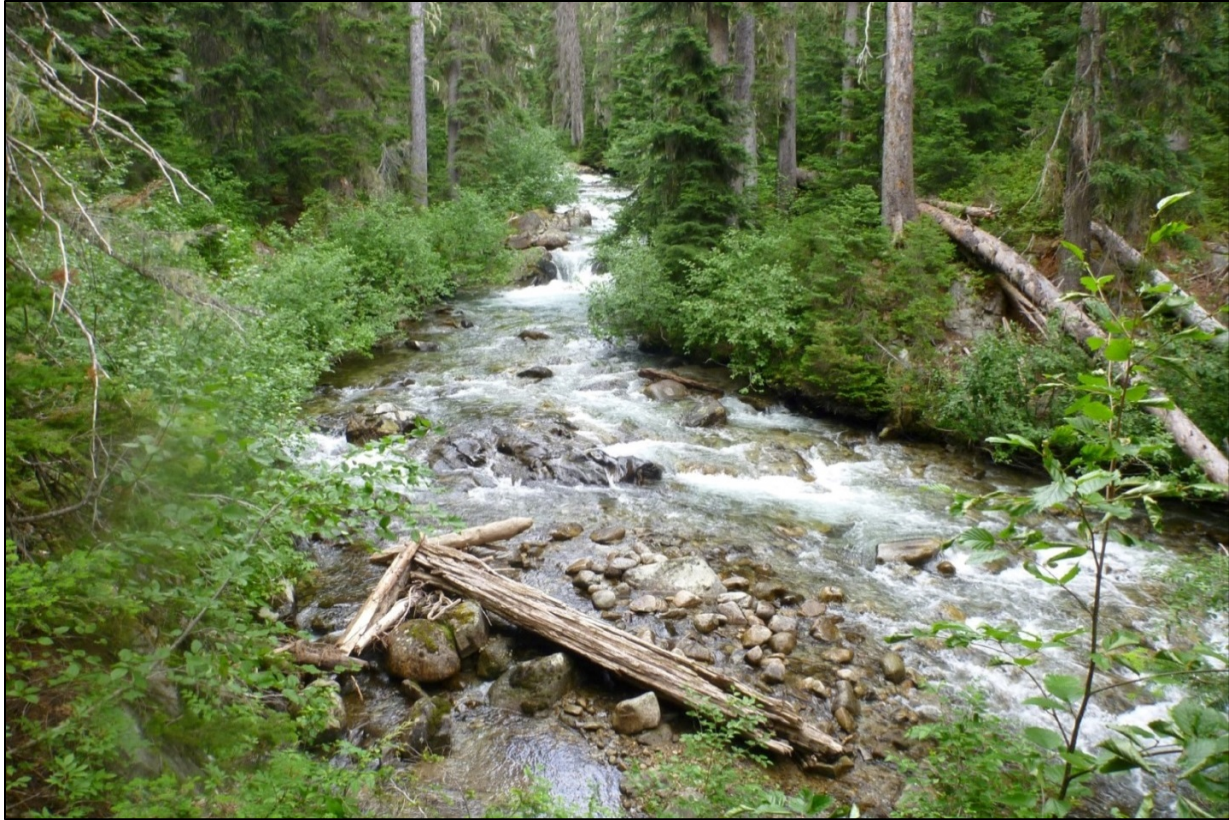
**Figure 25.** Representative habitat in the Bridge Creek sample reach.

The sample reach in Bridge Creek is 400 m long and starts an elevation of 1,216 m above sea level. This sample reach occupies a single V-shaped channel, which is constrained by bedrock and large boulders. The sample reach is a 3<sup>rd</sup> order stream (Strahler 1952), typical of mountain streams in the North Cascades (Table 50, Figure 25). The Rapid Habitat Assessment conducted for the Bridge Creek sample reach indicated optimal habitat conditions (Table 51).

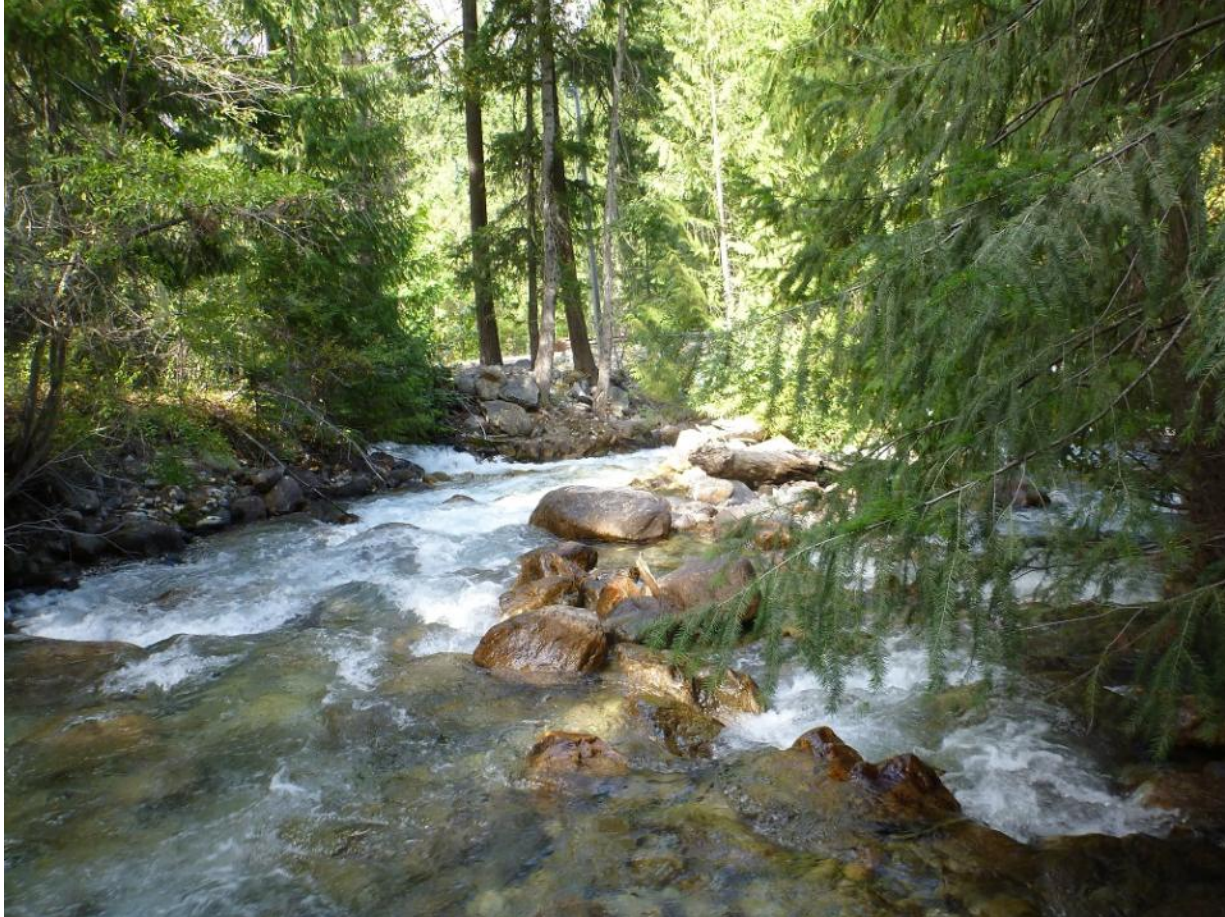
**Figure 26.** Looking down stream in the Company Creek sample reach. The outfall of the hydroelectric project can be seen on the left side of this photograph.

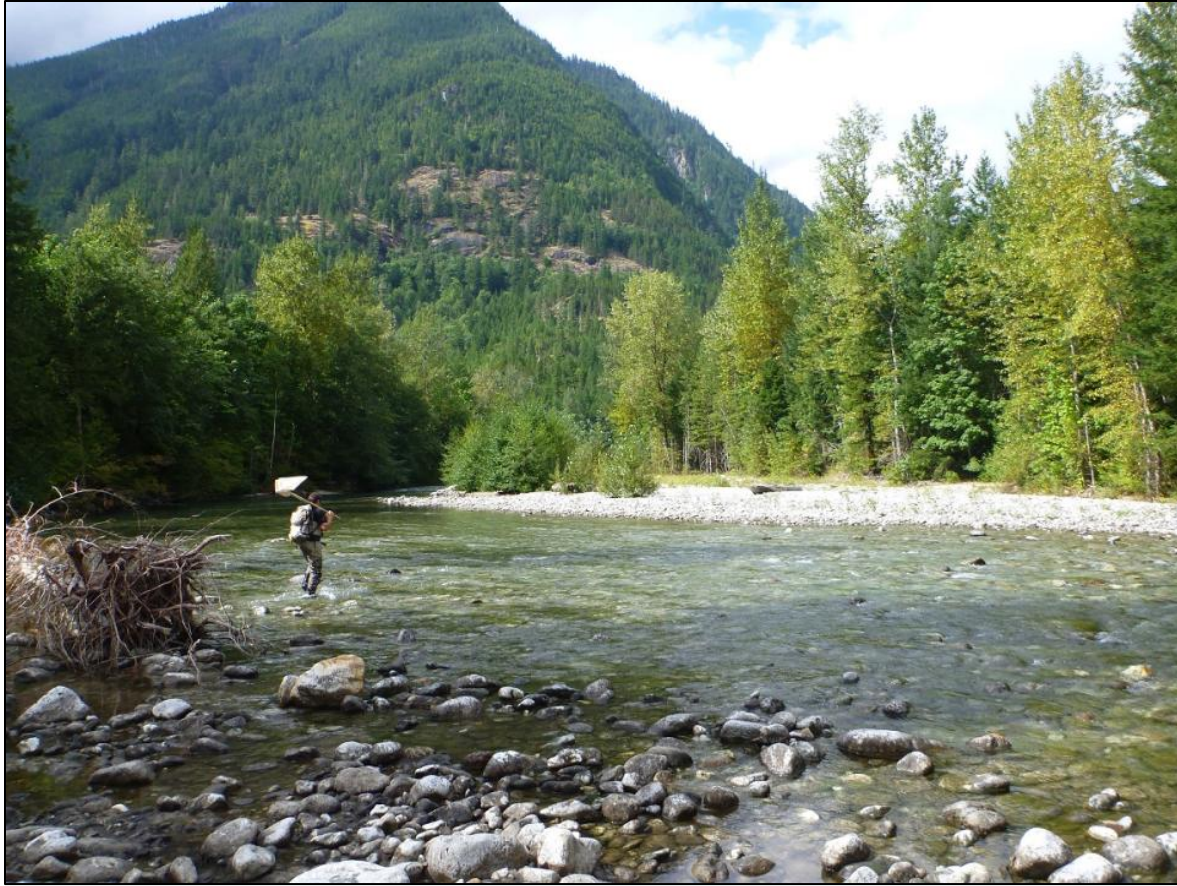
**Figure 28.** Braided habitat and exposed gravel bars in the Goodell Creek sample reach.

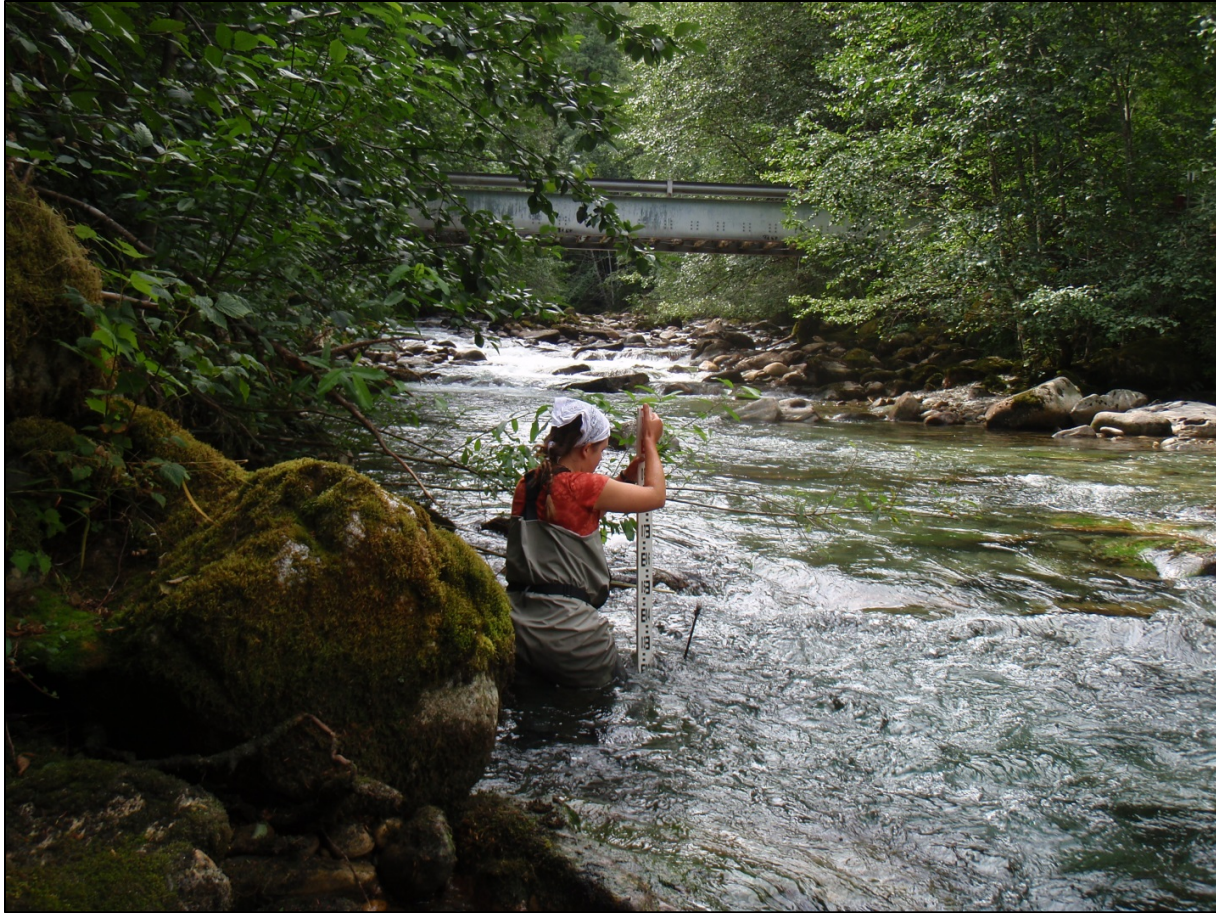
**Figure 30.** Technician measuring water depth at the water temperature monitoring station in Newhalem Creek. Bridge used for vehicle access is seen in background of photograph.

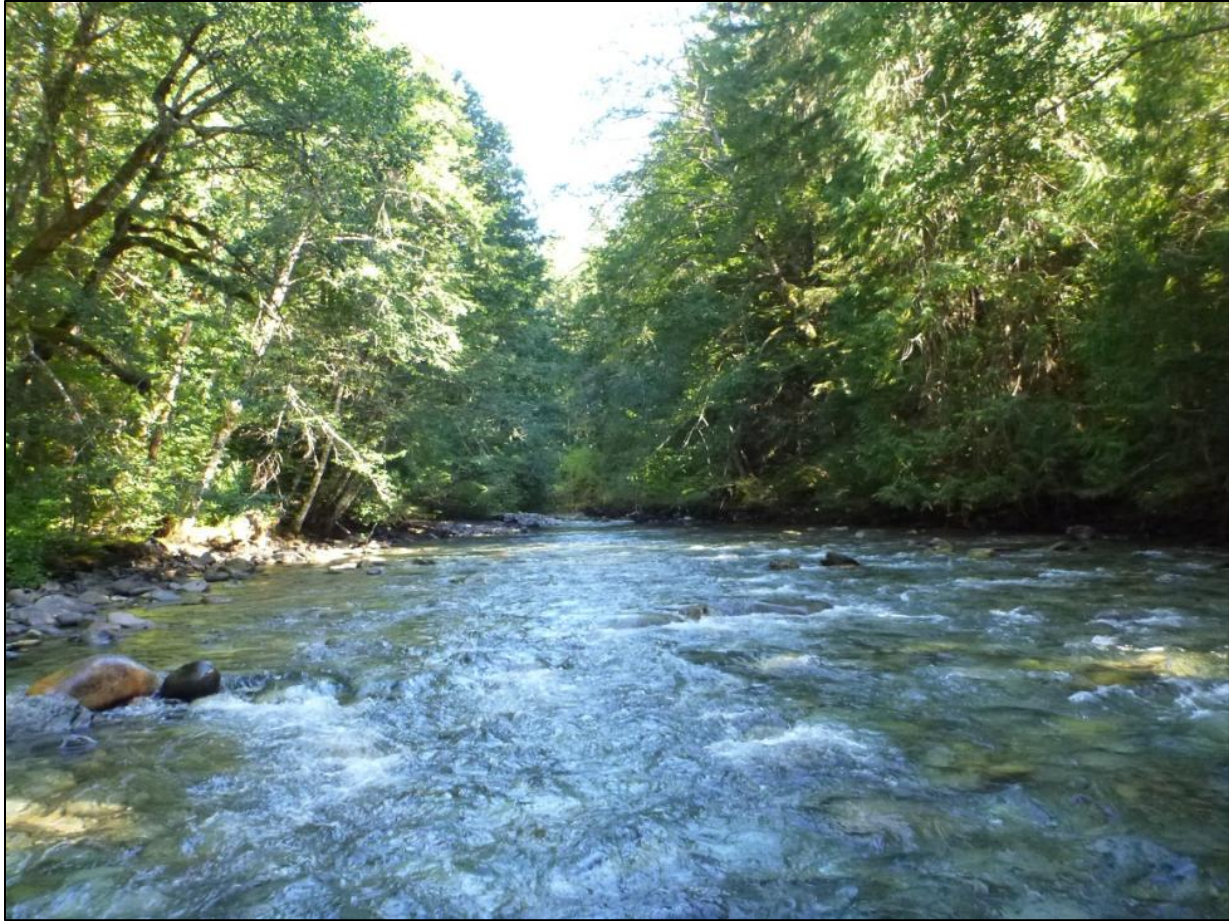
**Figure 34.** Looking upstream into the Ruby Creek sample reach.

The Ruby Creek sample reach starts at 512 m above sea level and is 500 m long. Located at the bottom of a V-shaped valley in a river canyon, the Ruby Creek sample reach is a 4<sup>th</sup> order stream (Strahler 1952) that occupies one channel and is highly constrained by boulder, bedrock, and steep valley walls (Table 70). The Rapid Habitat Assessment conducted in 2012 on the Ruby Creek sample reach indicated optimal habitat quality (Table 71, Figure 34).

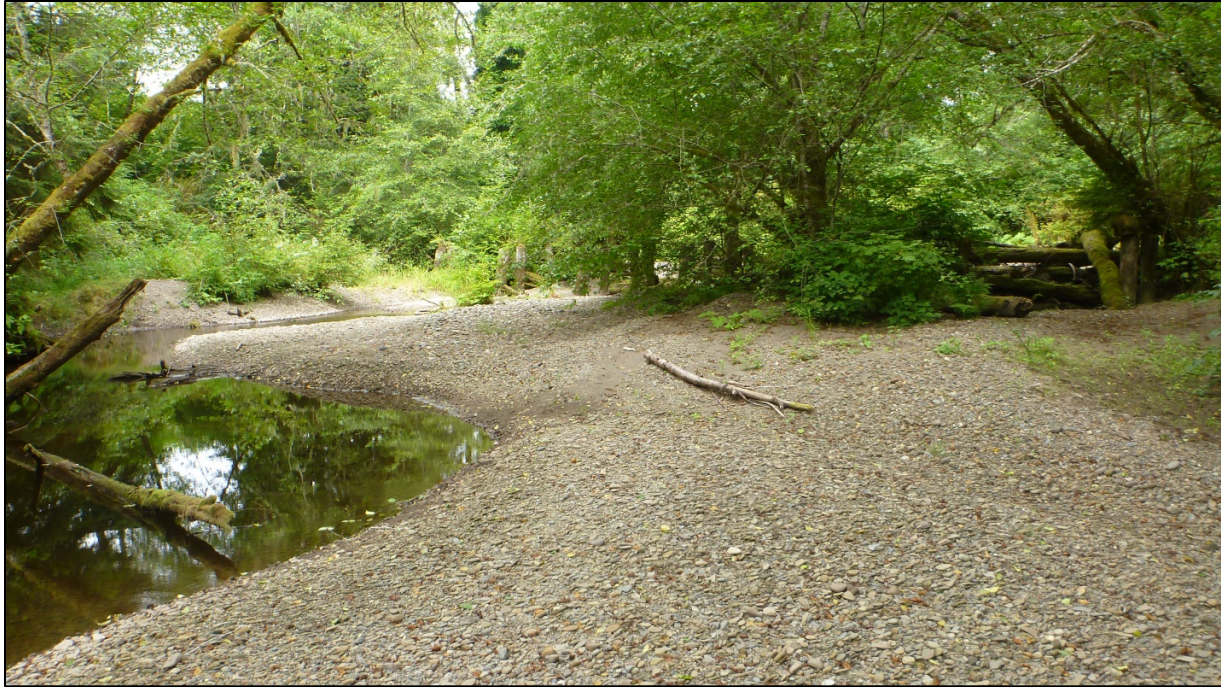
**Figure 39.** Photograph showing typical habitat and gravel deposition within the Umbrella Creek sample reach.
