# Characterization of North Coast and Cascade Network Water Quality Study Sites

Natural Resource Data Series NPS/NCCN/NRDS—2017/1097

Carmen A. Welch and Ashley K. Rawhouser

April 2017

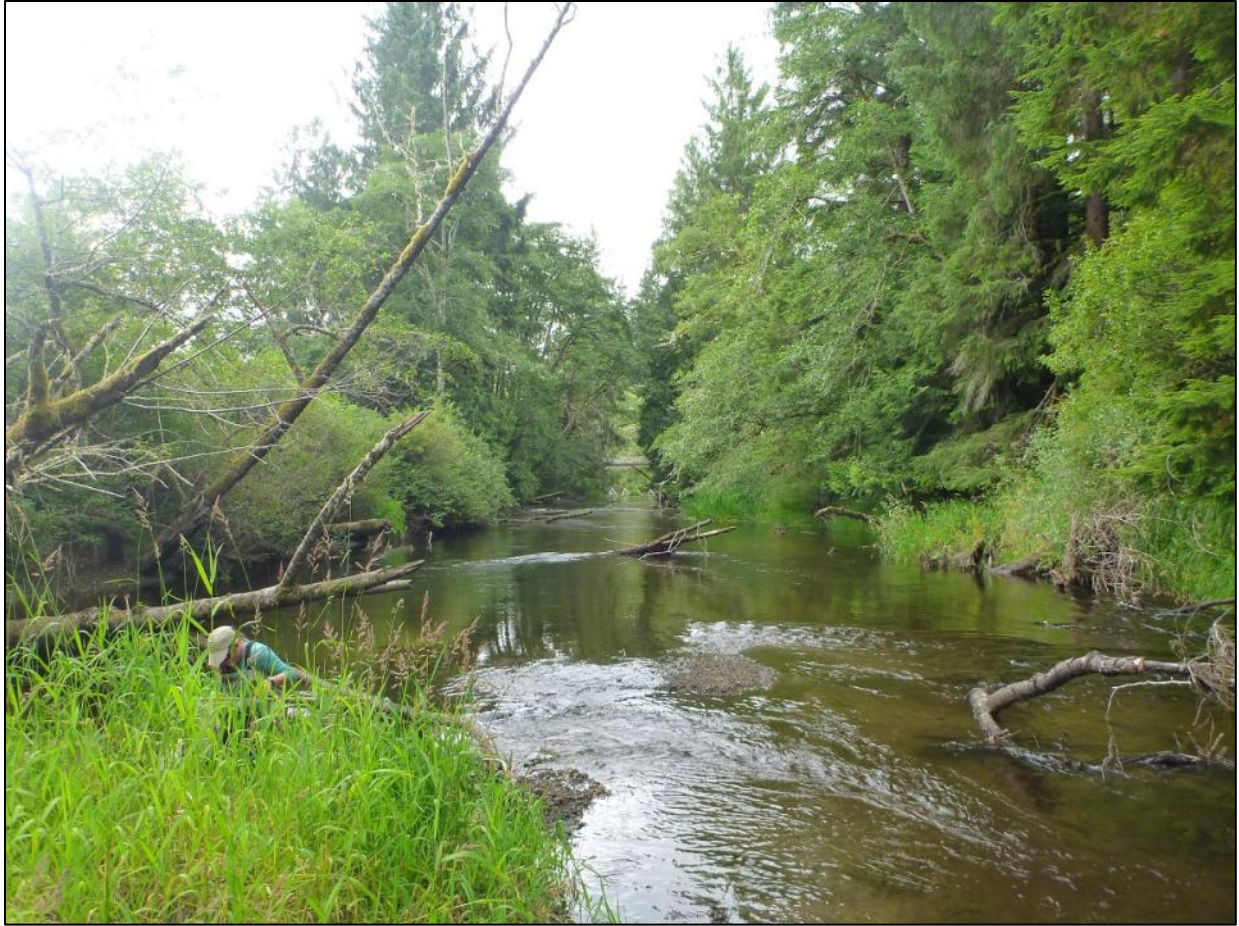
**Figure 40.** Uniform habitat conditions in the Ozette River sample reach. Example of reed canary grass island can be seen in the lower left corner of the image.

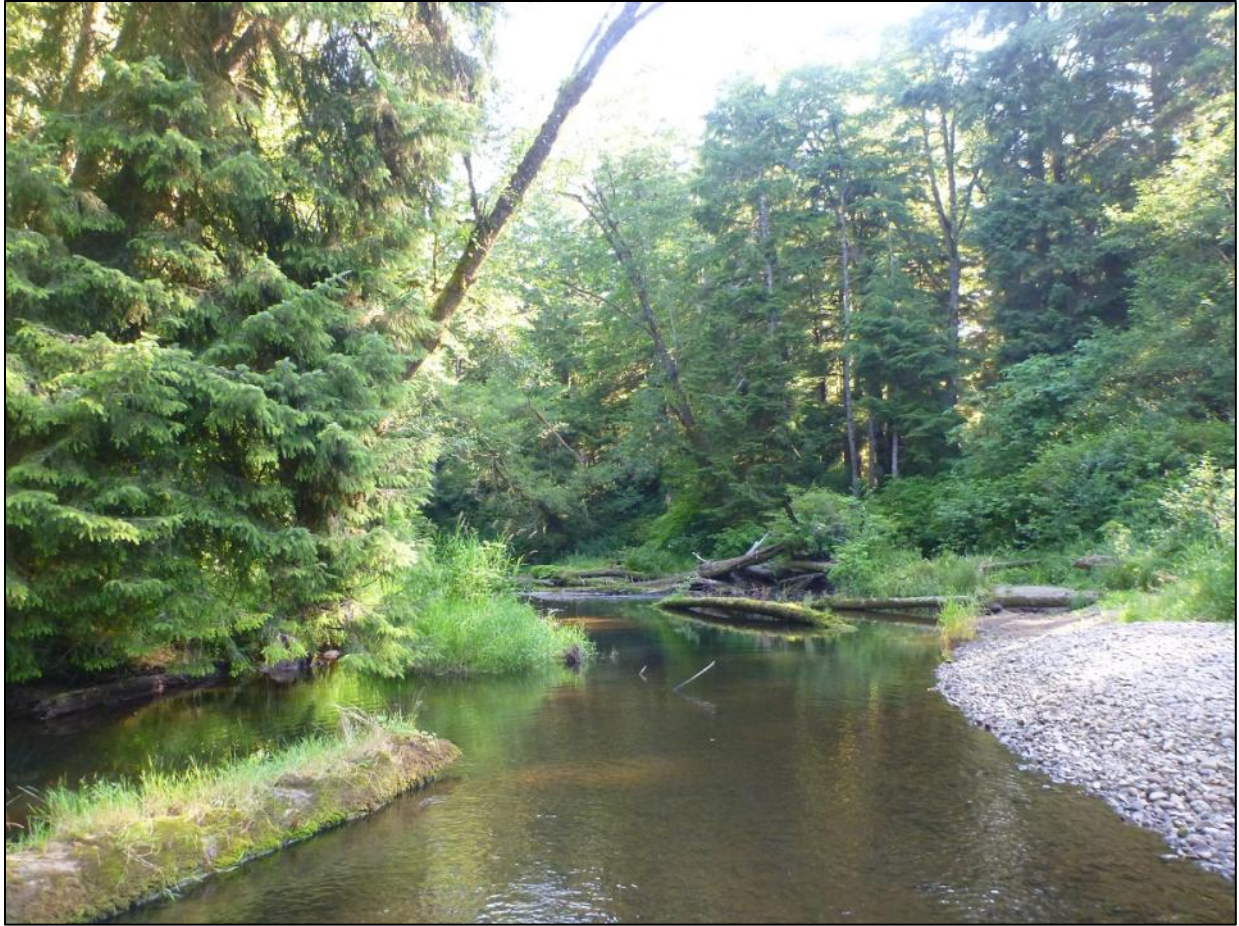
**Figure 42.** Kalaloch Creek, looking downstream into the sample reach.

The sample reach in Kalaloch Creek starts approximately 1 km upstream from the creek mouth at the Pacific Ocean and is at 6 m above sea level, which is beyond the influence of saltwater. The sample reach is 400 m long and is a 3<sup>rd</sup> order stream (Strahler 1952) occupying a single channel, which is incised into a broad terrace (Table 86, Figure 41). The Rapid Habitat Assessment conducted for Kalaloch Creek in 2012 indicated optimal to sub-optimal conditions within the sample reach (Table 87, Figure 42).

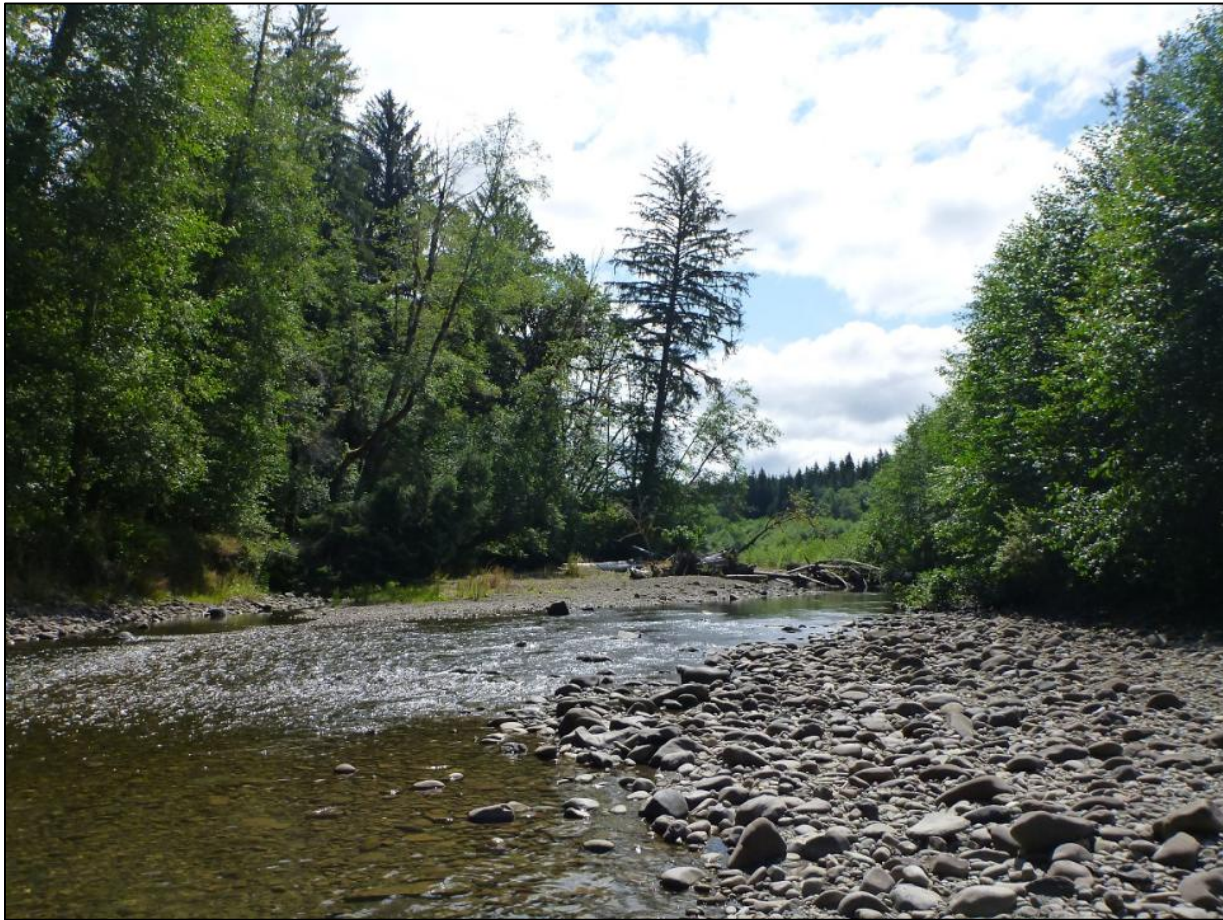
**Figure 44.** Habitat representative of the sample reach within Matheny Creek.

The Rapid Habitat Assessment conducted for Matheny Creek in 2012 indicated optimal to sub-optimal habitat conditions within the sample reach (Table 91). Stable and diverse habitat was created by a high diversity of velocity and depth regimes as well as a high frequency of riffle habitat. However, bank stability was compromised by lack of vegetative protection, and channel flow status was low, resulting in expansive areas of exposed gravel bars (Figure 44).

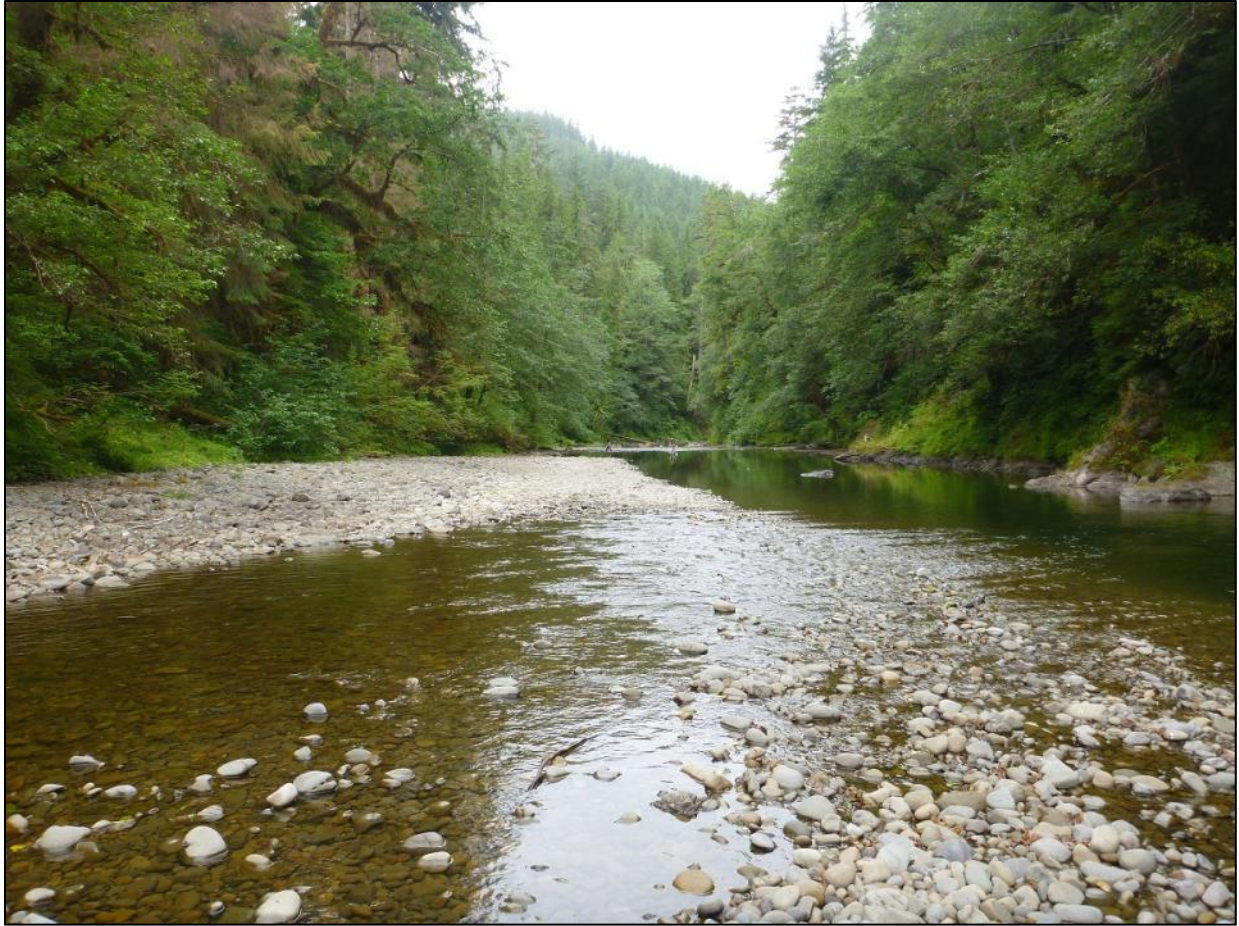
**Figure 46.** South Fork Calawah River habitat, showing bedrock constraints on right side of photograph.
