# WINDOW ASSESSMENT NOBLE BUILDING

324 PUJO STREET  
LAKE CHARLES, LOUISIANA 70601  
APRIL 2014

WRITTEN AND PREPARED BY  
LAUREN HARRELL, PRESERVATION ARCHITECT  
RANDALL D. BROUSSARD – ARCHITECT, L.L.C.

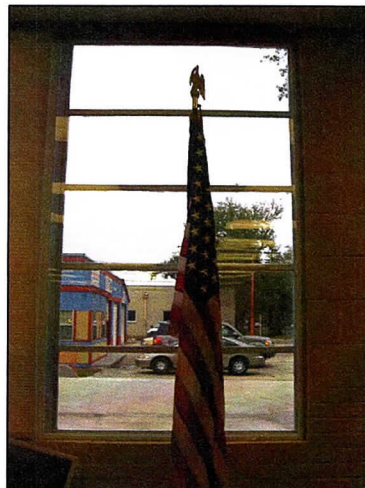
Pictures taken at Ed Smith's Stencil Works in New Orleans show the combination of interior Magnetite panels and historic metal windows. The first image demonstrates the attachment method while the second picture was taken from the interior of the building. The final picture illustrates the view from the exterior of the building.

Based on visual observation and the technical data provided, the addition of Magnetite panels to the interior of the windows of the Noble Building is a viable and recommended solution to the thermal and sound concerns present in the building. In combination with the historic single-glazed window, Magnetite windows seem to outperform conventional replacement windows and films while maintaining the original windows.
