# NATIONAL HISTORIC LANDMARK EVALUATION: FORT SISSETON

*PREPARED FOR SOUTH DAKOTA HISTORIC PRESERVATION OFFICE*

*May 2015*

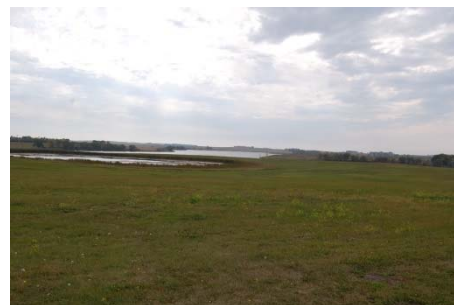
Figure 1. Setting, Facing South

Fort Sisseton is set within the Coteau des Prairies area near the Kettle Swamp in Fort Township, Marshall County, South Dakota. The location, on a 600-foot rise above the plains and nearly surrounded by lakes, was strategically chosen for its commanding view of the region and for its controlled access (Figure 1). The original military reservation encompassed some 82,000 acres measuring 9 by 15 miles. The historic site is limited to the fort itself, which is now designated as Fort Sisseton State Park (Figure 2).

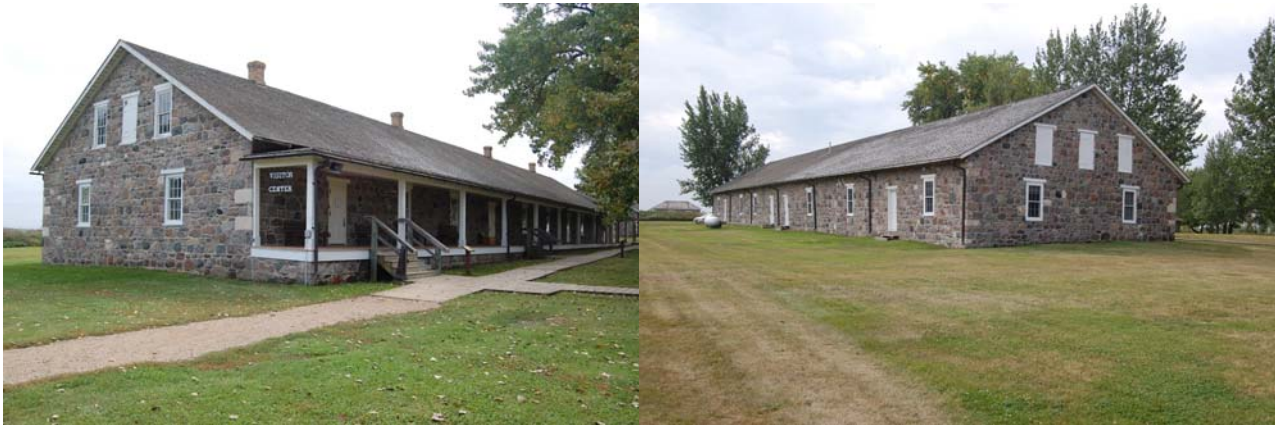
**Figure 4. North Barracks and South Barracks**

*North Barracks:* Contributing. One-and-a-half story with gabled roof building with measuring 45' by 182' was constructed in 1866 of split granite field stones. An open porch with wood posts is found along the west side. It was significantly reconstructed in 1934 when only the walls remained standing. Today it serves as the main visitor center, and includes gift shop, restrooms, offices, exhibits, and restored interpretive areas (Figure 4).

*South Barracks.* Contributing. Also constructed in 1866, it is similar to the North Barracks but does not have a porch. Portions of the wall and roof were reconstructed by the WPA in the 1930s. Its interior is used as an event center (Figure 4).

| <b>Table 1. Status of Structures Extant in 1889</b> | | |
|---|---|---|
| North Barracks | Extant | WPA reconstruction of roof and portions of walls; remodeled in 1960s, and further renovations in 1980s and 1990s for office, gift shop, visitor's center and replica barracks; porch and roof restored; windows and doors replaced; geothermal heating and cooling 1992; storm windows 1997 |
| South Barracks | Extant | WPA reconstruction of roof and portions of walls; cut wide wagon door in south wall mid-20 <sup>th</sup> century; windows and doors replaced; kitchen and restrooms added; radiant heating system; window screens added |

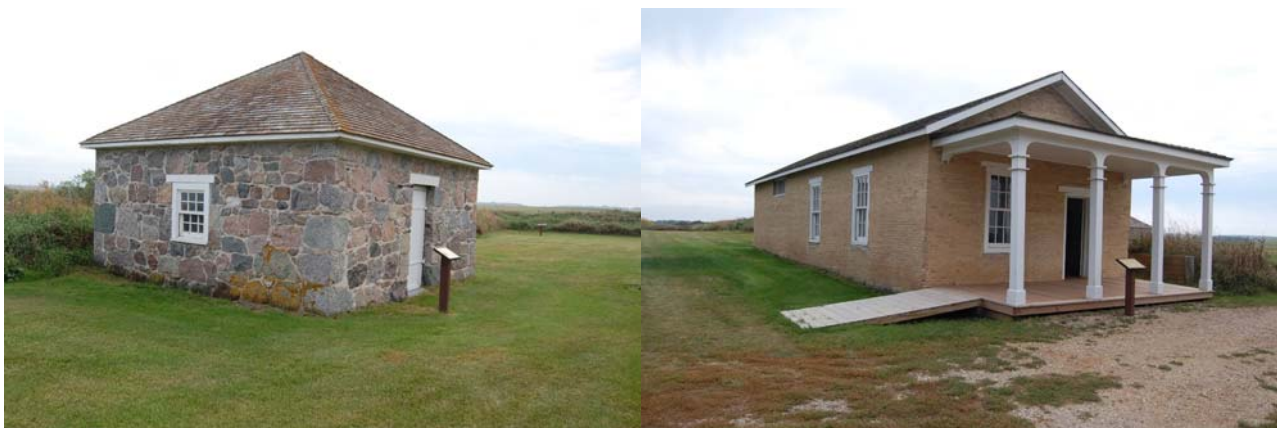
**Figure 5. Oil House and Guard House**

*Oil House.* Contributing. Square granite stone structure used to store oils for lamps, machinery and other needs at the fort. Constructed in 1888 (Figure 5).

*Guard House.* Contributing. Constructed in 1865, the brick rectangular guard house has a gabled roof and front porch (Figure 5).

| <b>Table 1. Status of Structures Extant in 1889</b> | | |
|---|---|---|
| Guardhouse | Extant | WPA restoration of walls and reroof; windows and doors replaced |

| <b>Table 1. Status of Structures Extant in 1889</b> | | |
|---|---|---|
| Oil House | Extant | Relatively unaltered; windows and doors replaced |

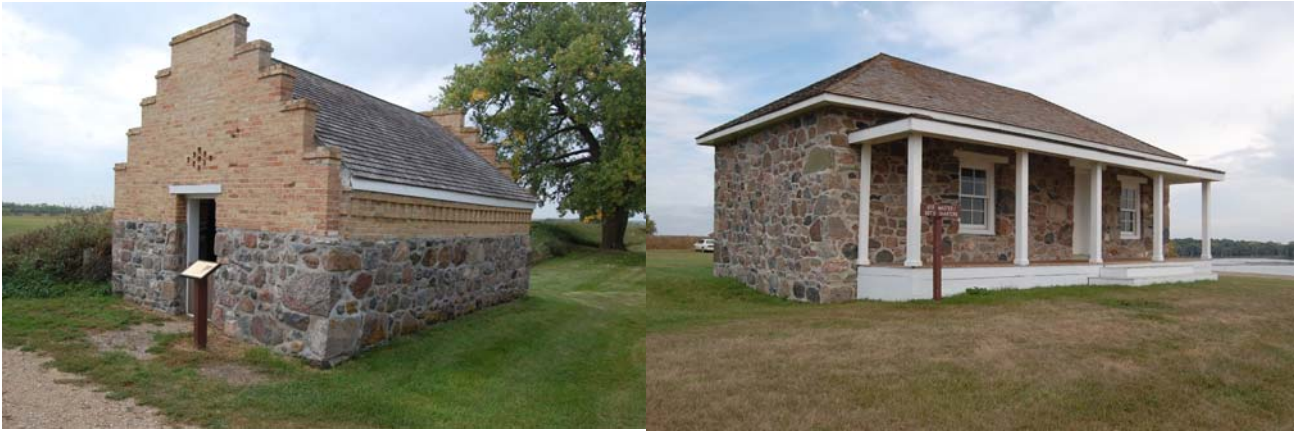
**Figure 6. Magazine and Commissary Sergeant's Quarters**

*Magazine.* Contributing. Located opposite the Guard House is the Magazine, constructed in 1866 to store munitions. It is constructed of a granite fieldstone base with brick upper walls. The gable ends have stepped walls (Figure 6).

*Commissary Sergeant's Quarters.* Contributing. This one-story, c. 1880, rectangular plan dwelling has granite split fieldstone walls and a hipped roof. It stands outside of the breastworks, just south of the south gate. It was rehabilitated in the 1930s after it was allowed to deteriorate (Figure 6).

| <b>Table 1. Status of Structures Extant in 1889</b> | | |
|---|---|---|
| Magazine | Extant | WPA roof reconstruction; door replaced |

| <b>Table 1. Status of Structures Extant in 1889</b> | | |
|---|---|---|
| Sergeant's Quarters | Extant | WPA restoration and new cellar dug beneath. New porch constructed 2004. Windows and doors replaced. |

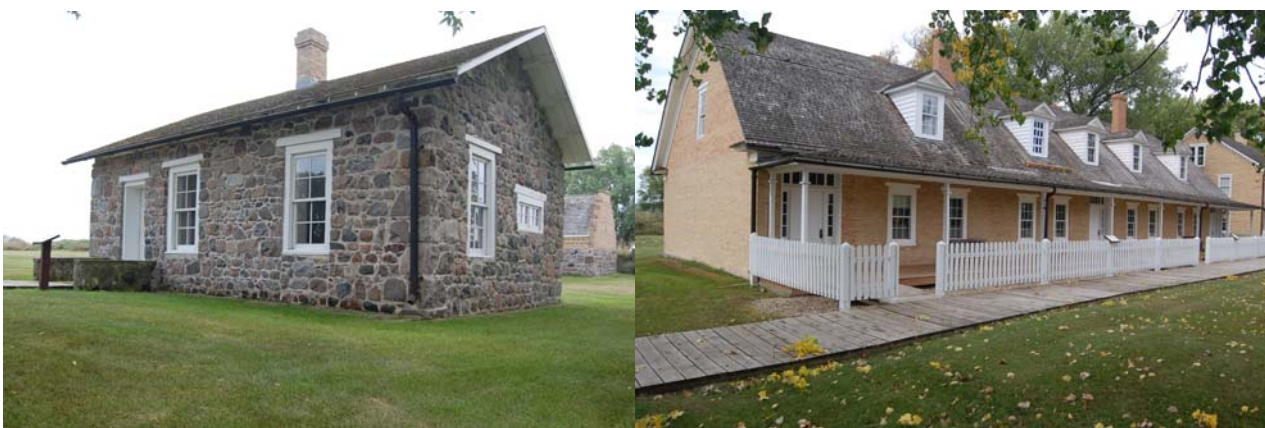
**Figure 7. Adjutant's Office and Officers' Quarters**

*Adjutant's Office.* Contributing. Constructed in 1869, the one-story, gabled building is constructed of split granite fieldstone. It was converted into a dwelling in the 1930s, entailing the construction of a basement, addition of a fireplace and application of plaster walls (Figure 7).

*Officers' Quarters.* Contributing. The long, one-and-a-half story brick building has a gambrel roof with dormers and housed the fort's officers. Three doors under the east porch offered access to the dwelling units. It was significantly rebuilt by the WPA in the 1930s (Figure 7).

| <b>Table 1. Status of Structures Extant in 1889</b> | | |
|---|---|---|
| Officers' Quarters | Extant | Major WPA restoration including re-plastered interior walls, beadboard ceilings, new woodwork, reconstructed roof with new dormers. Windows and doors replaced, porch reconstructed, picket fence installed, perimeter foundation drainage installed in 1990s to 2012. |
| Adjutant's Office | Extant | In 1930s converted to dwelling; basement dug beneath it, window replaced with casement window, new gable roof, and retrofitted interior with new plastering, woodwork and fireplace. Window and doors replaced in 1990s. |

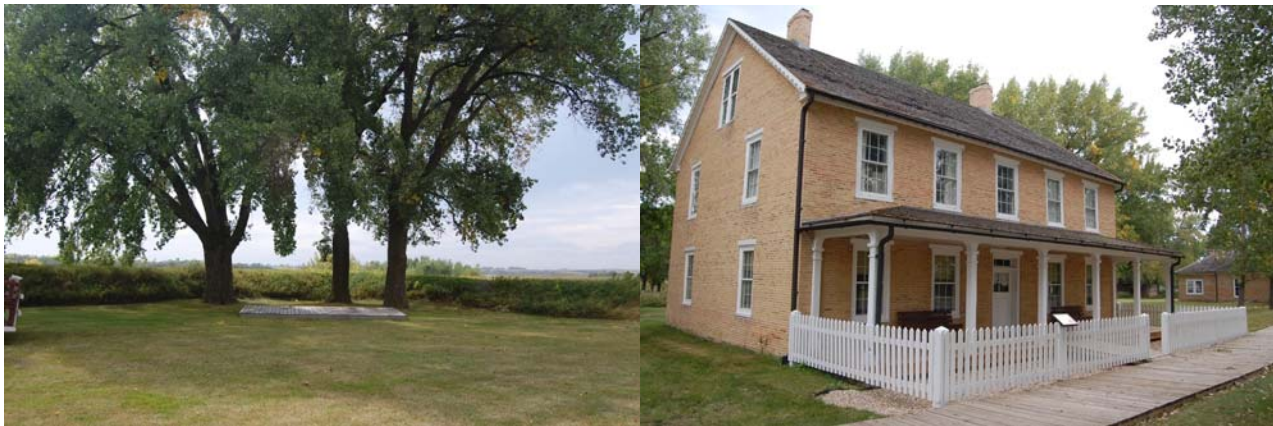
**Figure 8. Original Magazine Site and Commanding Officer's Residence**

*Original Magazine Site.* Not specified in NR nomination. The original log magazine was located within the southwest corner of the fort's breastworks, and was replaced by the brick and stone structure. It is marked by a shallow depression and protected by wood decking. This site was mentioned, but not enumerated among the properties in the National Register nomination (Figure 8).

*Commanding Officer's Residence.* Contributing. The 1866, two-story brick house with gabled roof and porch was used by the commanding officer. Following the decommissioning of the fort in 1889, it became the headquarters of the cattle and hunting lodge operation (Figure 8).

| <b>Table 1. Status of Structures Extant in 1889</b> | | |
|---|---|---|
| Commanding Officers' Residence | Extant | Interior renovations during 1920 for use for cattle operation and hunting lodge; front port replaced; exterior stabilization; work on roof; window and door replacement; addition of picket fence. Repairs to foundation and geothermal heating and cooling installed 1996. Storm windows installed 1997. |

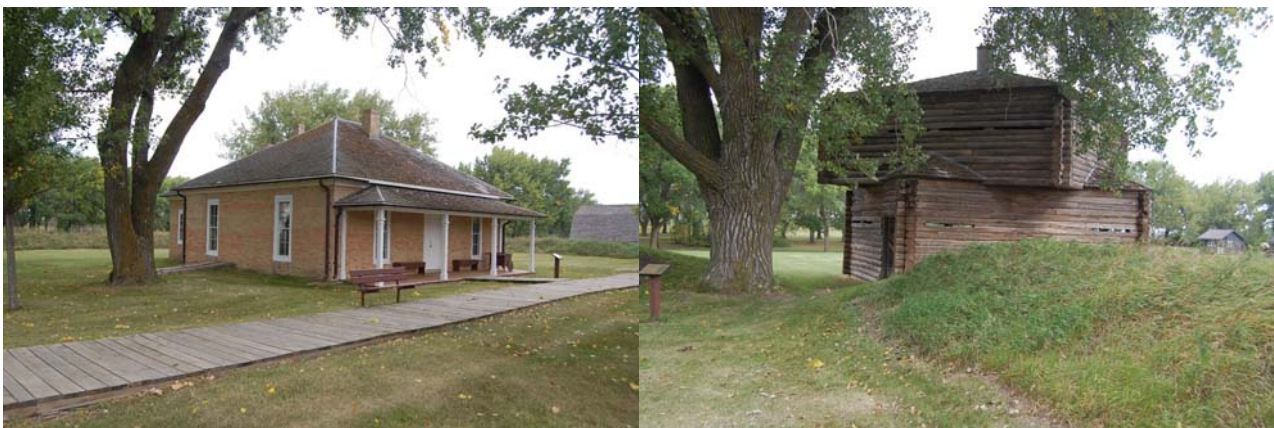
**Figure 9. Doctor's Quarters and Reconstructed Blockhouse**

*Doctor's Quarters.* Contributing. Constructed in 1881, the one-story brick dwelling has a hipped roof and was occupied by the fort's doctor. It was extensively restored in the 1930s (Figure 9).

*Blockhouses.* Non-contributing. Log blockhouses were constructed at the southeast and northwest corners of the breastworks for defensive purposes. As the threat of conflict faded, the blockhouses were used for storage. The wood structures did not survive. The northwest blockhouse was reconstructed in 1980 based on early images (Figure 9).

| <b>Table 1. Status of Structures Extant in 1889</b> | | |
|---|---|---|
| Surgeon's Quarters | Extant | WPA restoration including roof reconstruction and re-plastering; possible addition of cellar. Windows and doors replaced. |

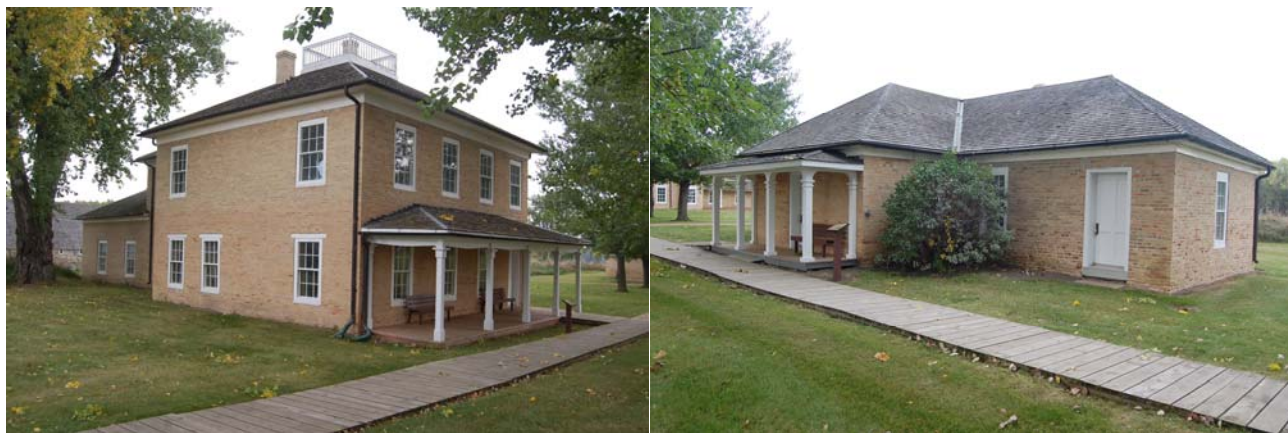
**Figure 10. Hospital and Library/Schoolhouse**

*Hospital.* Contributing. The two-story brick hospital was constructed in stages and currently reflects the period of the fort's decommissioning in 1889. During the 1920s, it was used as a hunting lodge. Evidence of a later addition, since removed, is visible by the footings on the building's east side (Figure 10).

*Library/Schoolhouse.* Contributing. The one-story brick building has a cross plan with a hipped roof and was constructed in 1881 (Figure 10).

| <b>Table 1. Status of Structures Extant in 1889</b> | | |
|---|---|---|
| Hospital | Extant | Extensive renovations in the 1920s for its use as a hunting lodge; roof reconstructed; interior re-plastered; windows and doors replaced; restroom and mechanical upgrades |

| <b>Table 1. Status of Structures Extant in 1889</b> | | |
|---|---|---|
| School-Library | Extant | WPA restoration including roof reconstruction and re-plastering. Likely that the west addition removed at that time. Windows and doors replaced. Additional renovation in 2006. |

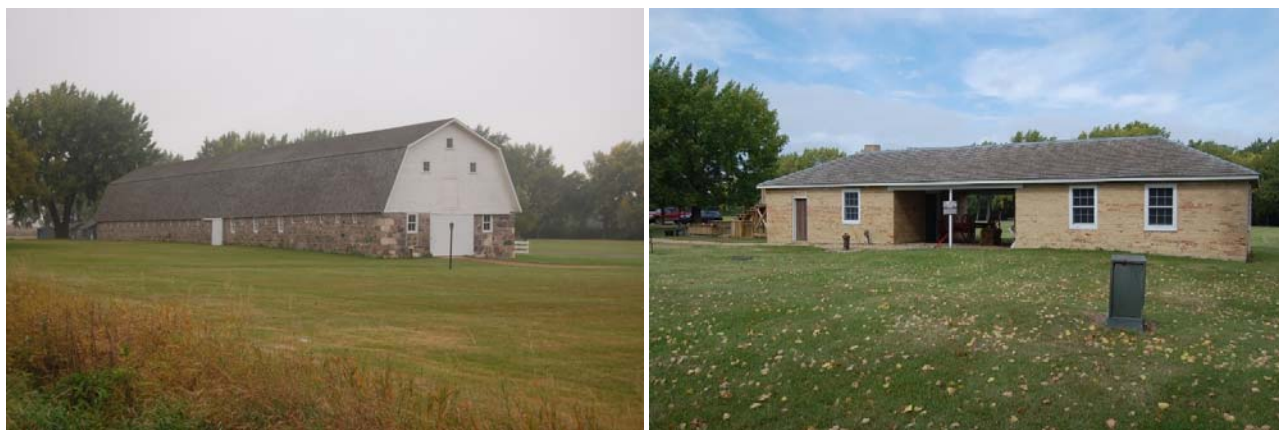
**Figure 11. Stable and Carpenter's/Blacksmith's Shop**

*Stable.* Contributing. A large stable or barn measuring 35' by 219' stands to the north of the breastworks. Originally constructed by 1873, its base is made of split granite stones. The roof was reconstructed in the 1930s in a gambrel style, replacing the deteriorated gable roof. It was intended to be used as a dairy barn, but never was. Most of the main floor contains horse stalls, and modern restroom facilities are placed at the west end (Figure 11).

*Carpenter's and Blacksmith's Shops.* Contributing. These one-story, brick shops are joined under one hipped roof and separated by a breezeway. They were constructed by 1889 (Figure 11).

| <b>Table 1. Status of Structures Extant in 1889</b> | | |
|---|---|---|
| Blacksmith Shop (with Carpenter's Shop) | Extant | Restoration in 1930s after period of decay; replacement of doors and windows |
| Wheelwright/Carpenter's Shop (with Blacksmith's Shop) | Extant | Restoration in 1930s after period of decay; replacement of doors and windows |

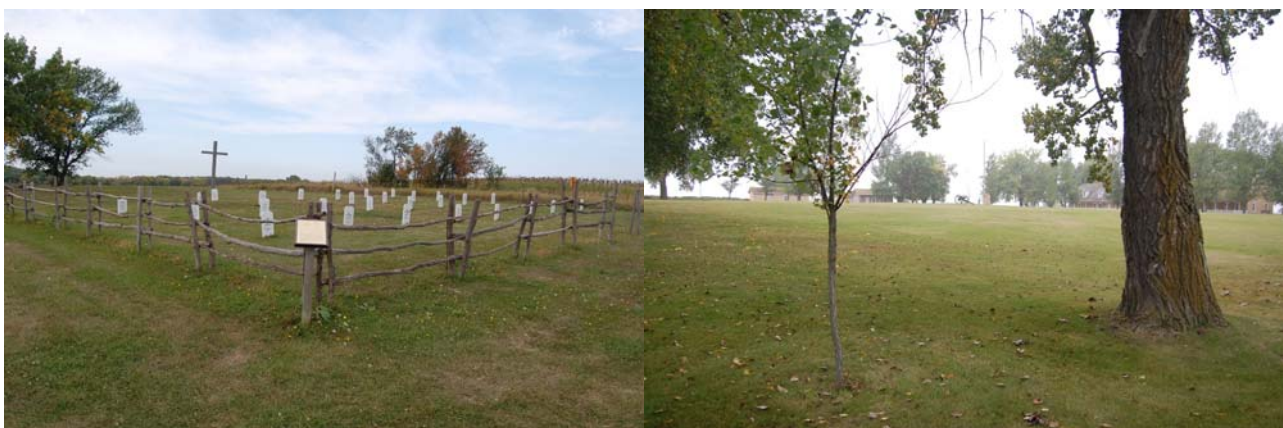
**Figure 12. Cemetery Site and Parade Grounds**

*Cemetery Site.* Not specified in NR nomination. The fort's cemetery was located about one-quarter mile west-northwest of the fort's enclosure. The remains were disinterred and removed to another military cemetery upon the fort's decommission. The site is marked by a split rail fence, and temporary grave markers are placed for interpretive purposes (Figure 12).

*Parade Grounds.* Not specified in NR nomination. The breastworks and perimeter buildings form the setting for the center Parade Grounds, an open turf area. Several objects are grouped at the center of the Parade Ground, including a reconstructed wooden flag pole, 120-pounder Napoleon Model 1857 cannon (placed in 1990), a time capsule placed within a concrete block in 1964 and marked by a metal marker, and a bronze plaque within a brick pedestal marking the work of the WPA. The plaque reads "Fort Sisseton Rebuilt by State of South Dakota and Works Progress Administration, WPA Project Number 3384, nineteen thirty-nine" (Figure 12).

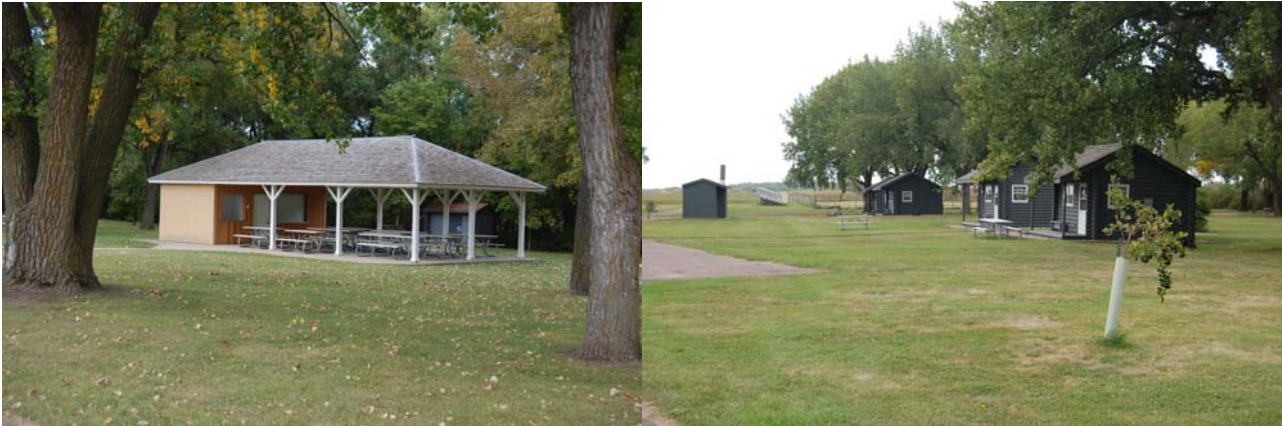
**Figure 13. Picnic Shelter and Camping Cabins**

*Picnic Shelter.* Non-contributing. A picnic shelter, with a yellow brick enclosure and hipped roof, is a modern construction designed to blend with the look of the fort's historic buildings. It is located, along with a privy, to the north of the park's main entrance, outside of the historic fort area (Figure 13).

*Camping Cabins and Sites.* Modern log camping cabins are placed northwest of the historic fort, outside of the historic fort area. Camping sites are located to the north and west (Figure 13).

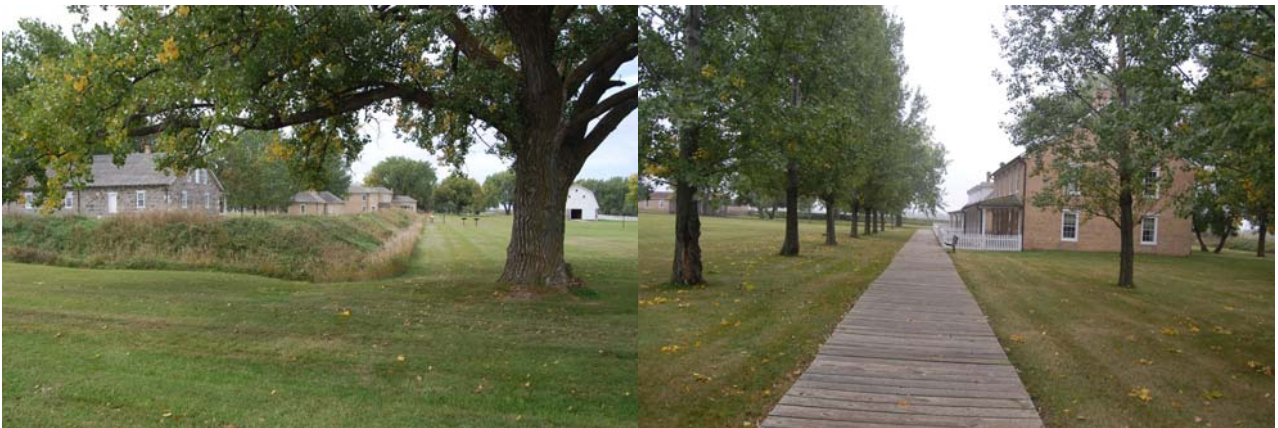
**Figure 14. Breastworks and Reconstructed Boardwalk**

*Circulation and Landscape.* Within the breastworks enclosure, pedestrian circulation is provided by wood plank sidewalks placed to the front (inner) side of the perimeter buildings and is based on 1885 topographic maps showing the locations of boardwalks (Figure 14). Gravel drives provide access for service vehicles. A row of trees generally line the inner perimeter, and in some locations trees are planted between the buildings and the breastworks (Figure 14). At the north of the fort enclosure is the park's primary entrance and a small parking area. Camping and picnic facilities are provided in these areas. The two-lane County Road 5 is just east of the fort, beyond which is Kettle Lake. Modern intrusions within the historic area are minimal, but include some lighting, gravel trails, boardwalks, a propane tank, benches and interpretive signage.
