# **NATIONAL HISTORIC LANDMARK EVALUATION: EDGAR AND ALICE BROWN HOMESTEAD (PRAIRIE HOMESTEAD)**

*PREPARED FOR SOUTH DAKOTA HISTORIC PRESERVATION OFFICE*

May 2015

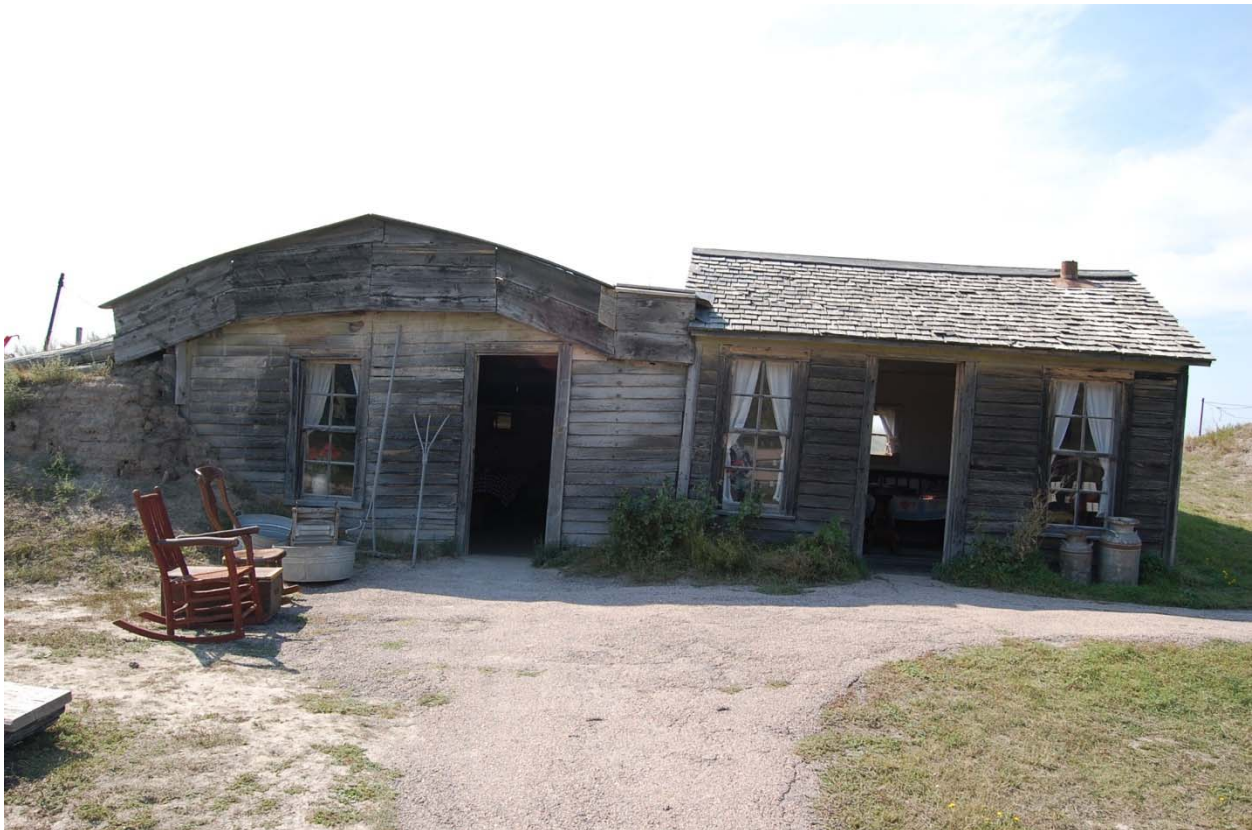
**Figure 3. Façade of Dugout (left) and Claim Shack (right), Facing West**

The dwelling is the focal point of the farmstead's historical significance. The first portion was constructed in 1909 by carving out a portion of the east-facing slope to form a dugout. The dugout's interior walls are faced with sod blocks. The east wall is constructed of wood logs laid horizontally and clad on the exterior with weatherboard siding. A single door and a single four-over-four double-hung sash window are inserted within this wall. A broad, segmental arch cornice made of wide unpainted boards covers the upper portion of the wall. The roof is made of earth planted with native vegetation and pierced by a metal stovepipe. The roof is supported by wood planks resting on three unhewn cottonwood purlins. Cross beams support the purlins, which in turn stand on wood posts imbedded within the earthen walls; another post in the center supports a center beam. The interior of the space has a dirt floor, and the wood plank and beam ceiling is exposed. The lower half of the wall is covered with wood planks, while the sod is exposed on the upper portion. Small top-hinged windows are placed within the earthen wall on the south and north sides. A brown paper screen serves as a room-divider between the bedroom (rear) and the kitchen (front) of this space (Figures 3 through 6).

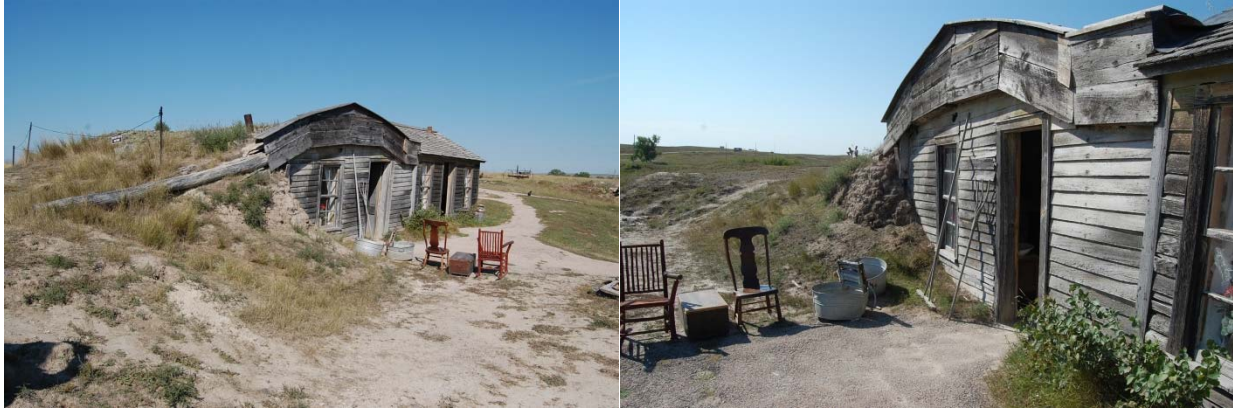
**Figure 4. Dugout, Facing Northwest (left) and Southwest (right)**

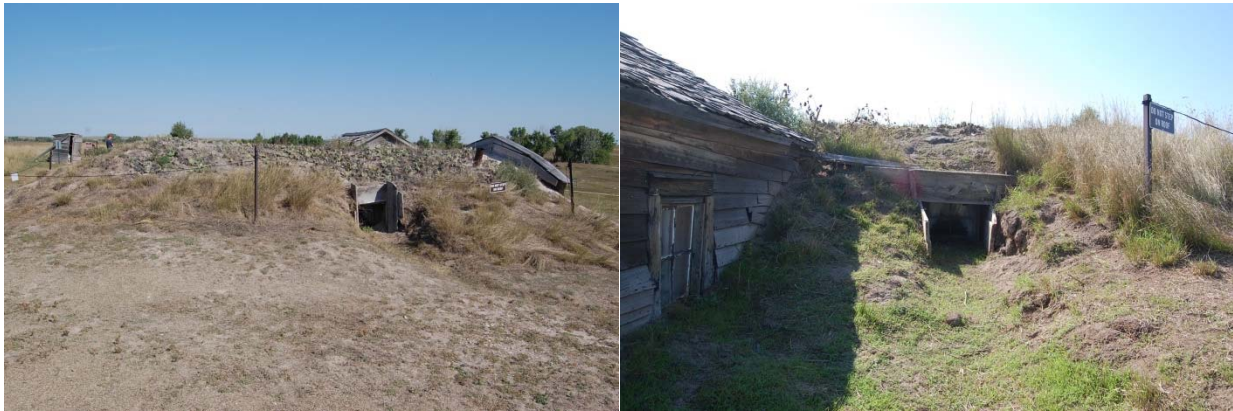
**Figure 5. Dugout, Facing Northeast (left) and Southeast (right)**

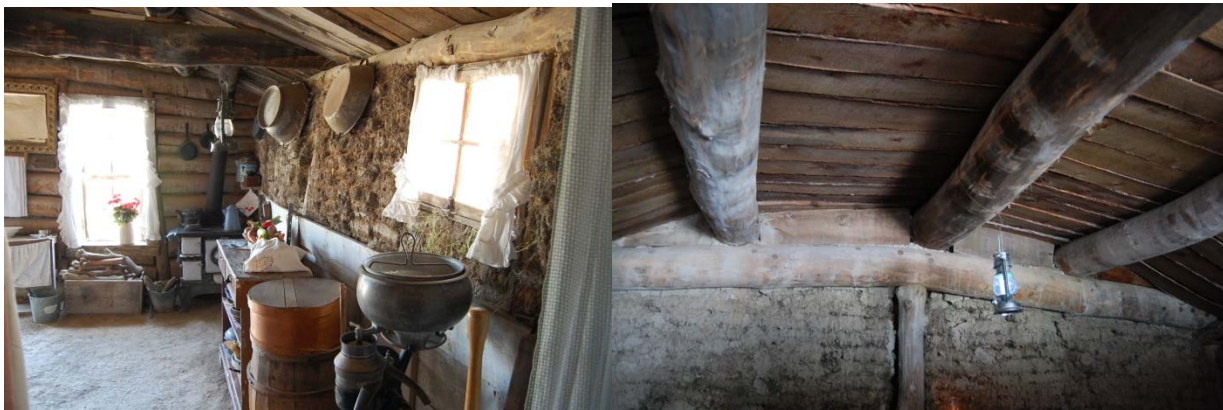
**Figure 6. Dugout Interior, Southeast Corner of Front Room (left) and Rear (west) Wall of Back Room (right)**

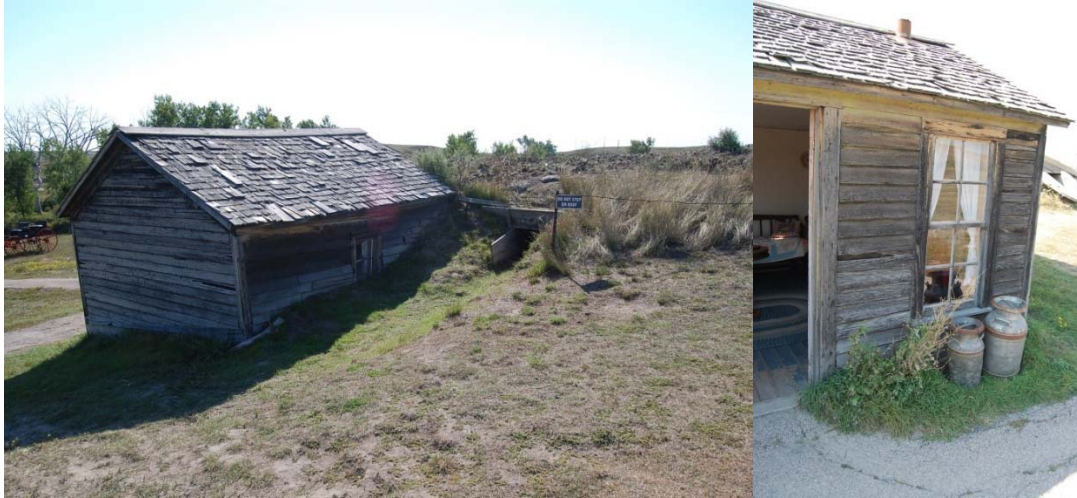
**Figure 7. Claim Shack, Facing Southeast (left) and Northwest (right)**

In 1913 the dugout was expanded by the addition of a frame structure to the north, an abandoned claim shack. This one-room structure is accessed by a door opening on the north wall of the dugout's kitchen area. The frame structure is partially cut into the slope and has a side-gabled roof covered with wood shingles. A center door in the east wall is flanked by single four-over-four double-hung sash wooden windows. A four-light window is placed on the west wall. The walls are clad with wood weatherboard. The interior, comprising one room, has walls covered with wallpaper and a wood floor (Figure 7).

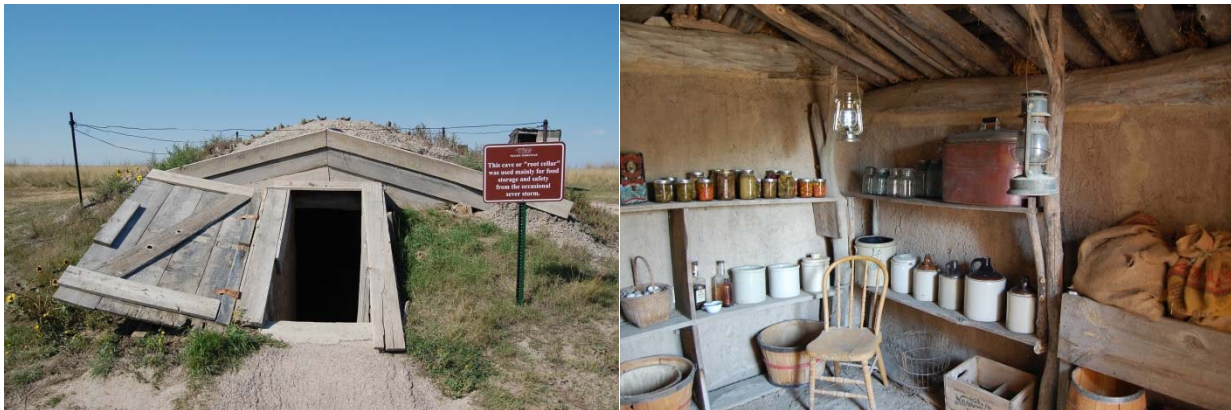
**Figure 8. Restored Root Cellar, Exterior, Facing West (left) and Interior (right)**

The root cellar north of the dwelling was restored in the 1960s following the collapse of the original structure. It is accessed by a wood bulkhead door and three steps leading onto the dirt floor. Its walls are covered with stucco and the reconstructed earthen roof is supported by unhewn log rafters resting on log top plates (Figure 8). North of the root cellar is a wood plank privy, reconstructed on the location of the original privy (Figure 9).

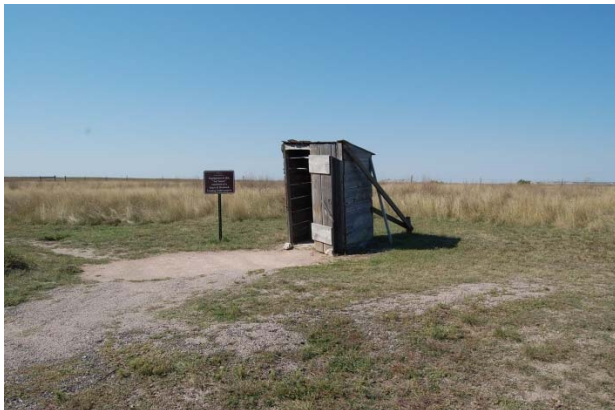
**Figure 9. Reconstructed Privy, Facing Southwest**

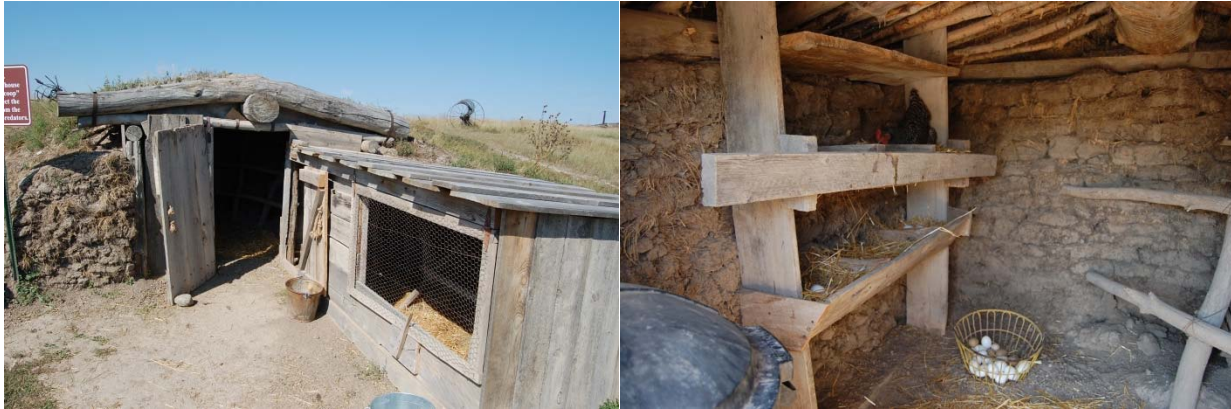
**Figure 10. Reconstructed Chicken Coop, Facing Northwest (left) and Interior (right)**

The chicken coop, mostly reconstructed in its original location, is also built into the hill using sod blocks. A heavy log ridge beam is supported by the earthen wall and a cross beam over the wood door on the east end. The roof is earthen (Figure 10).

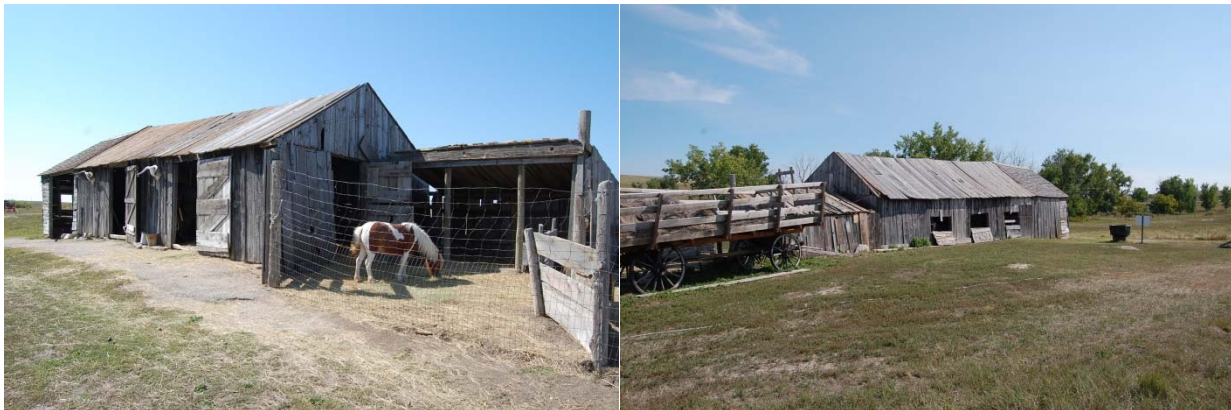
**Figure 11. Barn, Facing Southwest (left) and Southeast (right)**

Northeast of the other buildings is the barn, a one-story side-gabled structure with vertical plank siding and plank roofing. The northern two bays provided stalls for livestock. A shed-roof shelter extends from the northern end, adjacent to a corral enclosure. A third bay, clad with drop siding and a wood shingle roof, was added c. 1920 to the south end for an automobile garage (Figure 11).

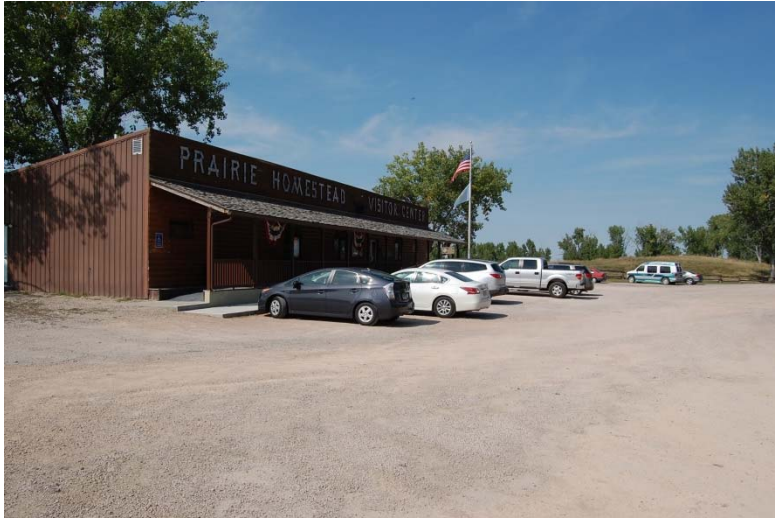
The visitor center, constructed in 1992, serves as the gateway access point to the farmstead. It has a rectangular plan with a shed roof and wood siding (Figure 12).

**Figure 12. Visitor's Center and Parking Area, Facing Northwest**

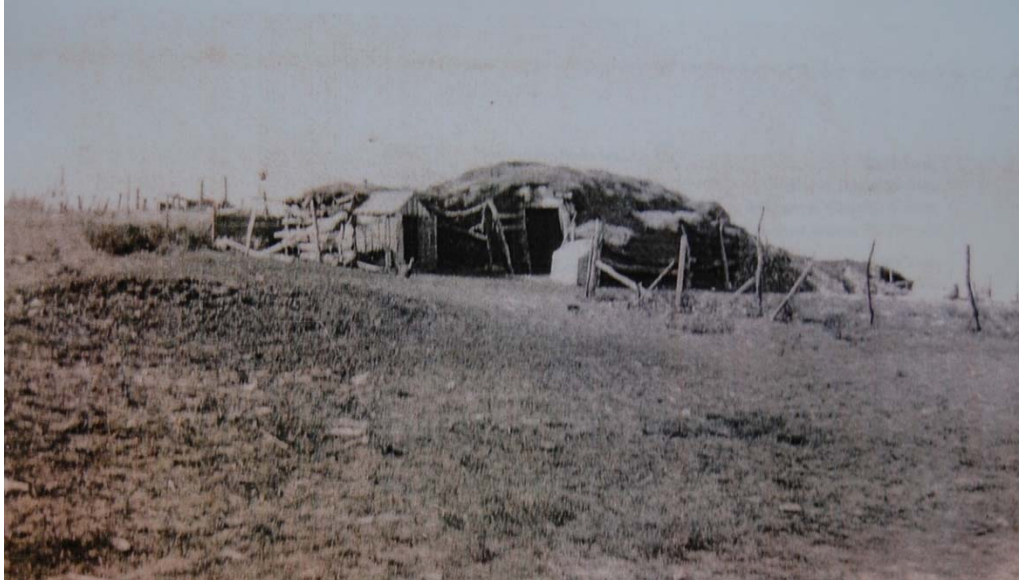
**Figure 14.** The 1913 photograph is believed to show the “straw barn,” west of the existing barn, no longer extant

Brown mortgaged the property for \$500 in 1911, due in five years' time. This substantial mortgage suggests an expansion of his farming operation, perhaps an investment in cattle or other livestock. Investments in other structures on the farmstead would have been relatively inexpensive. By 1913, the family had four outbuildings to support their modest lifestyle and farming operation. An "outhouse" or privy was placed north of the house, and would likely have been an early necessity. A root cellar, sometime referred to as the "cave," was dug into the ground and constructed in a similar fashion as the house. Its purpose was to store food in the temperate earthen shelter. A chicken coop was also built into the hillside. The fourth structure, a barn made with poles, straw and wire, was placed farther north, and is no longer extant<sup>3</sup> (Figure 14).

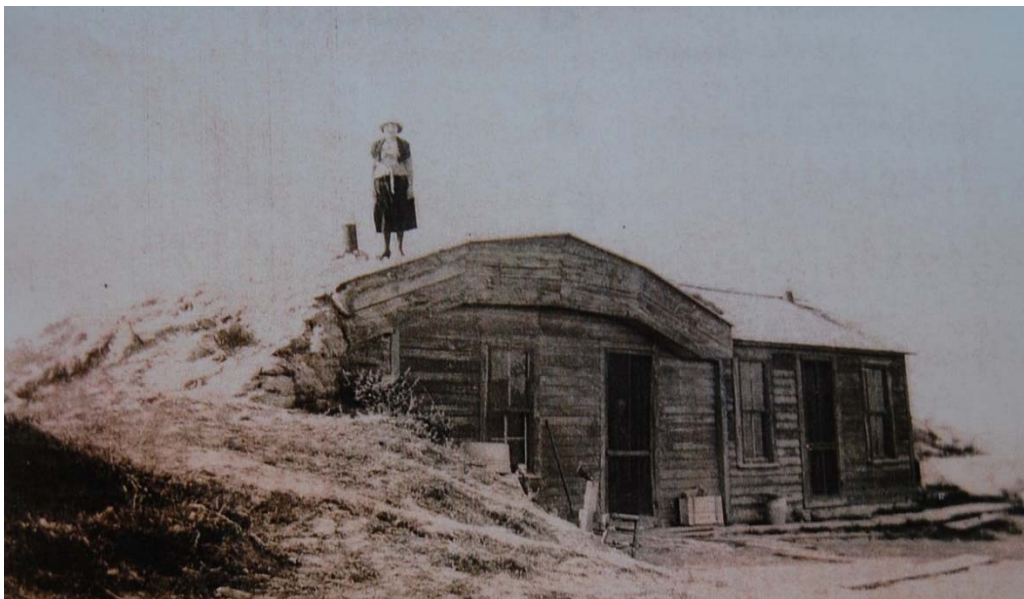
**Figure 15.** Dugout and Claim Shack, c. 1913

By 1913, the Browns acquired an abandoned frame homestead shack, which was moved on skids onto the property and attached to the dugout. The additional structure offered the expanded conveniences of a parlor (Figures 15 through 18). Two years later, a new wood barn was erected, and in 1920 it was amended with another section to house Charles Brown’s Model T Ford. Ed Brown died in the dugout house in 1920, leaving his wife and son to tend the homestead. Alice continued to live there until 1934, when she moved to Long Beach, California to live with her daughter and son-in-law, Candace and Grundy McDonald. Charles remained on the homestead only two more years, selling the household and farm equipment in the summer of 1936, and moving to California to be with his mother and sister.<sup>4</sup>

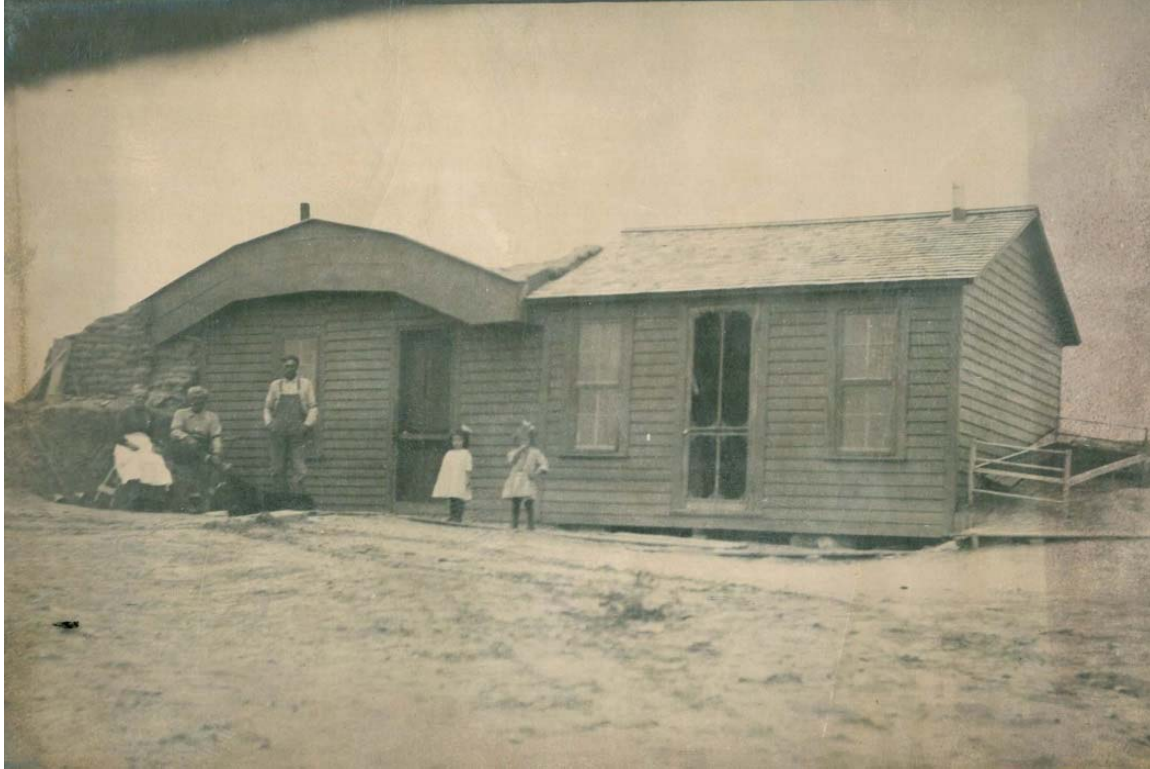
**Figure 16. Dugout and Claim Shack, c. 1913**

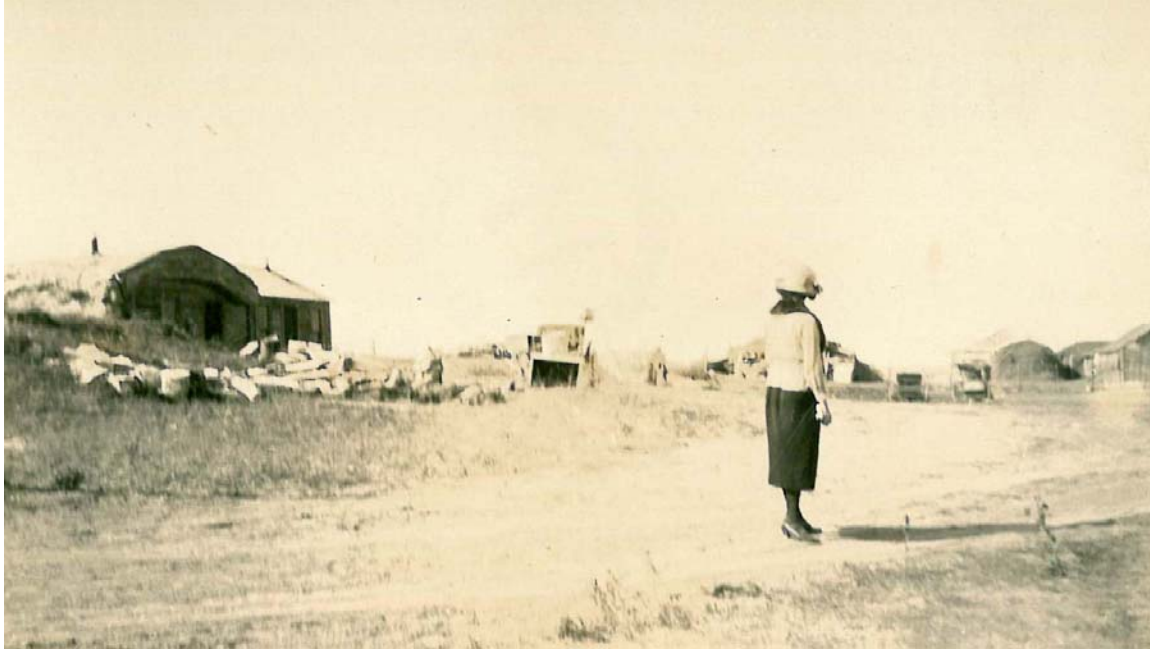
**Figure 18. Brown Homestead, c. 1913**

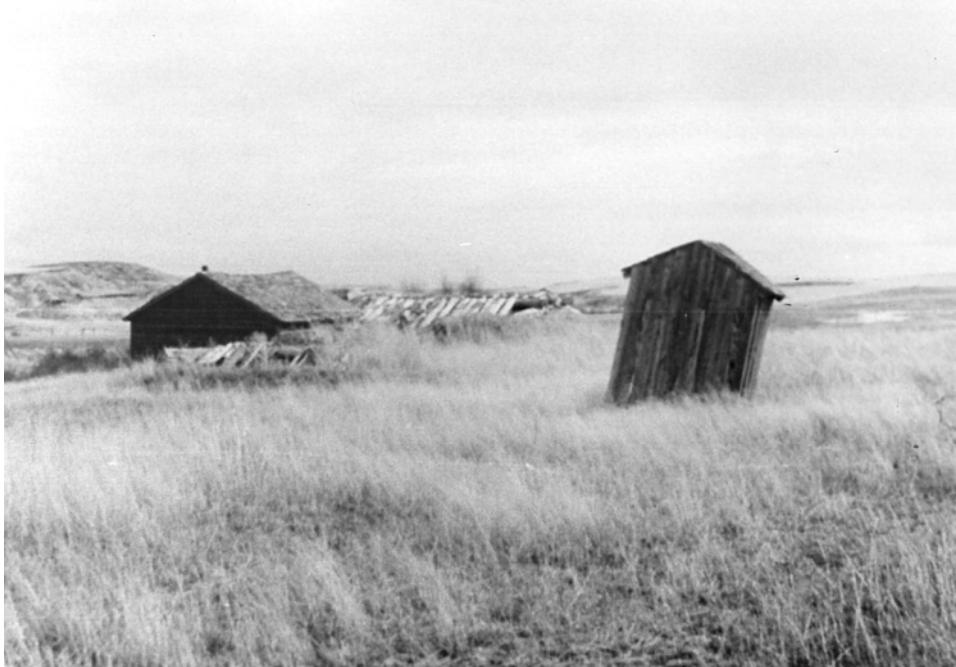
**Figure 22. Dugout/Claim Shack, Root Cellar and Privy, c. 1962**

Unoccupied, the homestead fell into disrepair and became dilapidated (Figures 22 through 26). The north room of the house – the old claim shack – had been used to store oats, and most of the distinctive arched façade of the dugout shelter had fallen down. Eventually, the property came under the ownership of Keith and Dorothy Crew, the son and daughter-in-law of Leslie and Jessie Crew. In 1962, the Crews undertook a restoration effort to open the property as a tourist attraction (Figure 27). Several of the sod blocks that had eroded were re-created and replaced, “just enough to make them look presentable,” wrote Keith Crew.<sup>7</sup> The Browns’ original stove, dining table and washstand remained intact, and were supplemented with other period furnishings. The root cellar had collapsed, and so its roof was reconstructed to its original appearance. In time, the privy was replaced with a replica. The chicken coop was also in disrepair and later reconstructed on its site. A new approach from the highway was constructed and an 8’ x 10’ entrance booth was erected. Success of the operation warranted the expansion of the entrance booth in 1966. In 1974, Prairie Homestead, as it was called, was listed in the National Register of Historic Places. In 1992, the visitor center was replaced with the current facility.

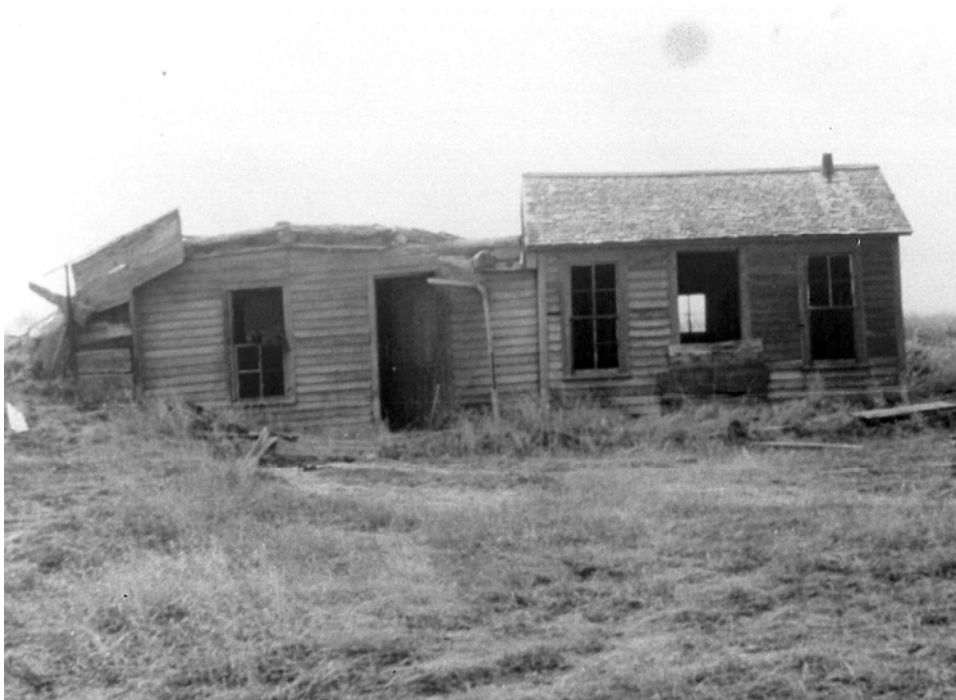
**Figure 23. Dwelling, c. 1962**

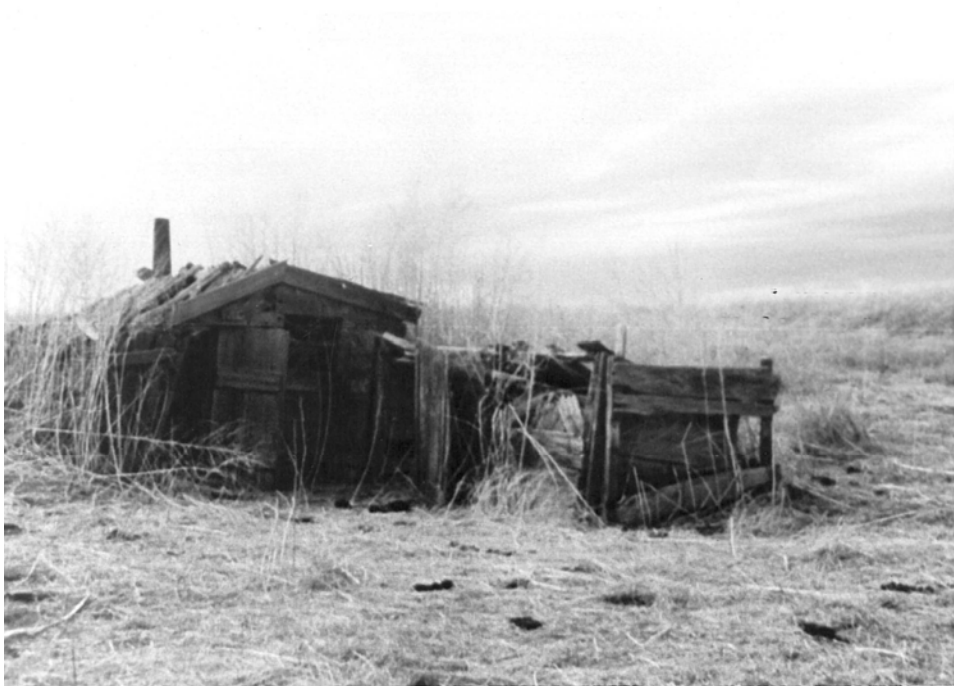
**Figure 24. Chicken Coop, c. 1962**

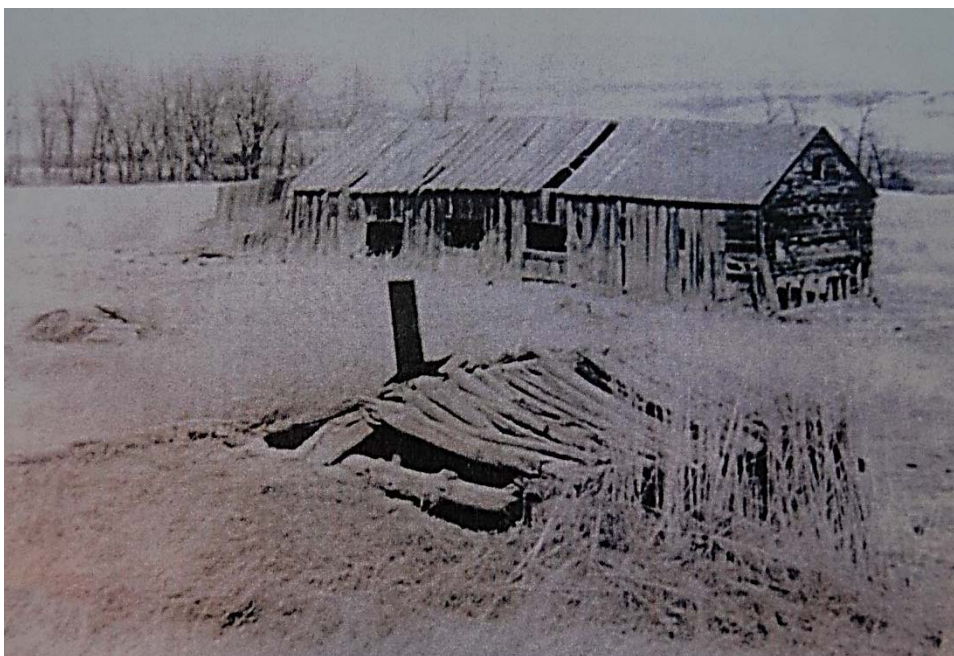
**Figure 25. Chicken Coop (foreground) and Barn (background), c. 1962**

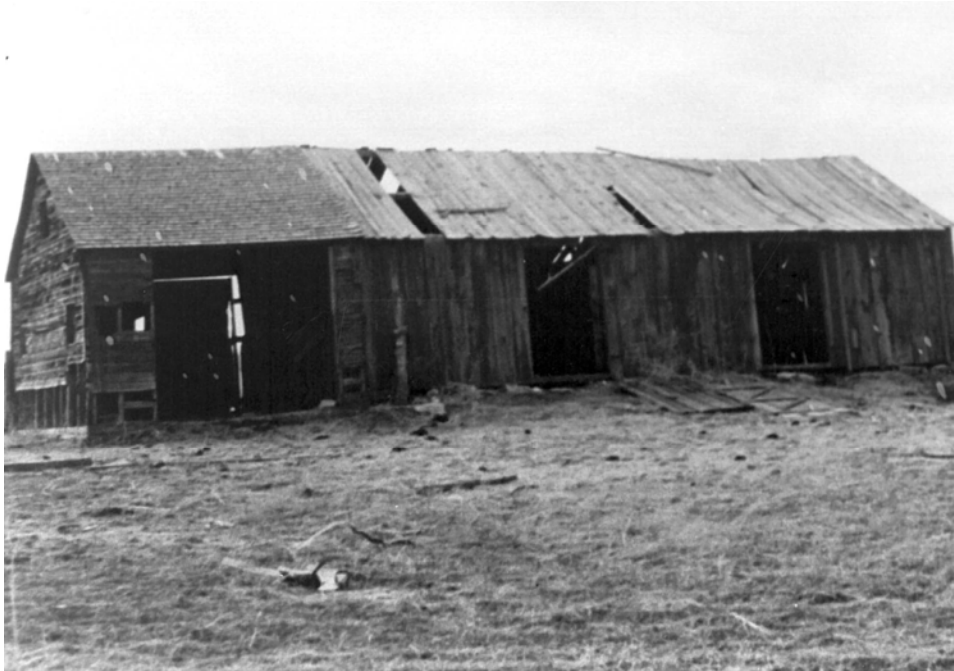
**Figure 26. Barn, c. 1962**

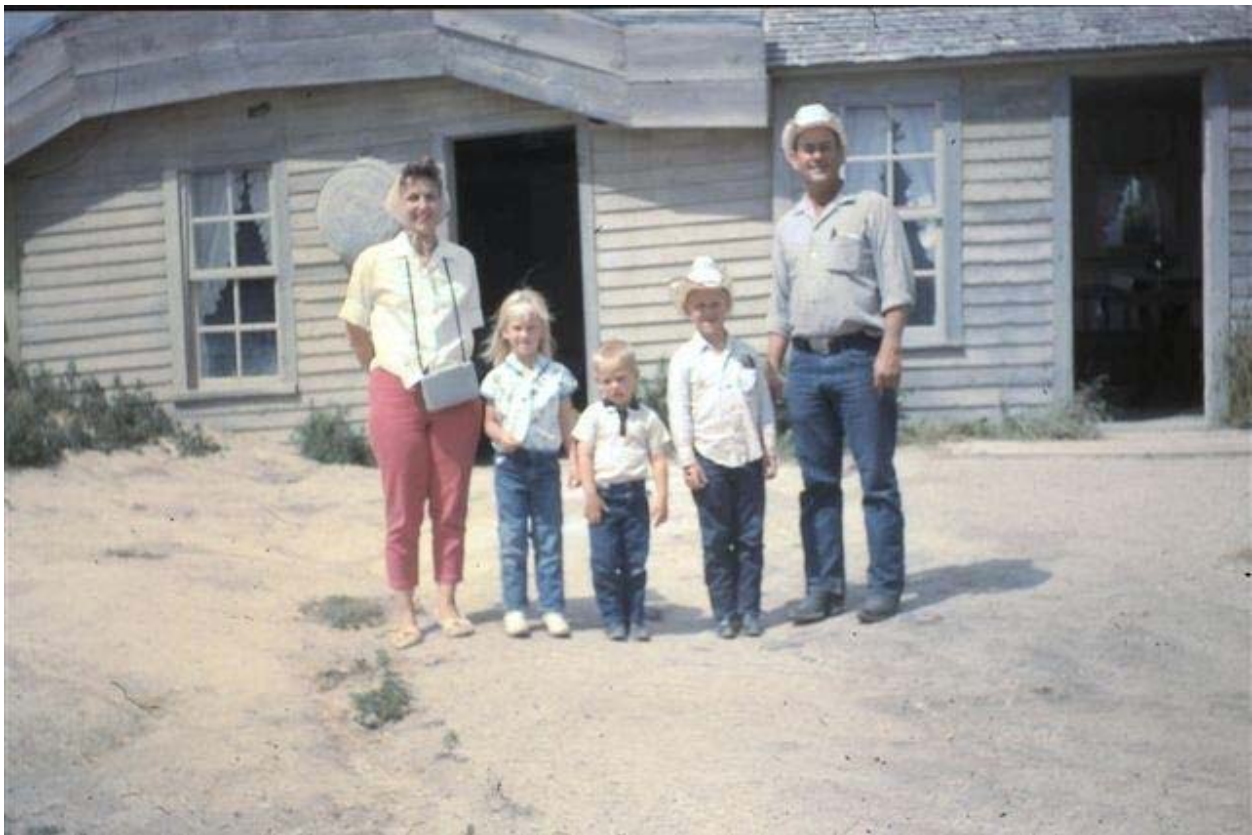
**Figure 27. The Crew Family and the Newly Restored Dwelling, c. 1966**

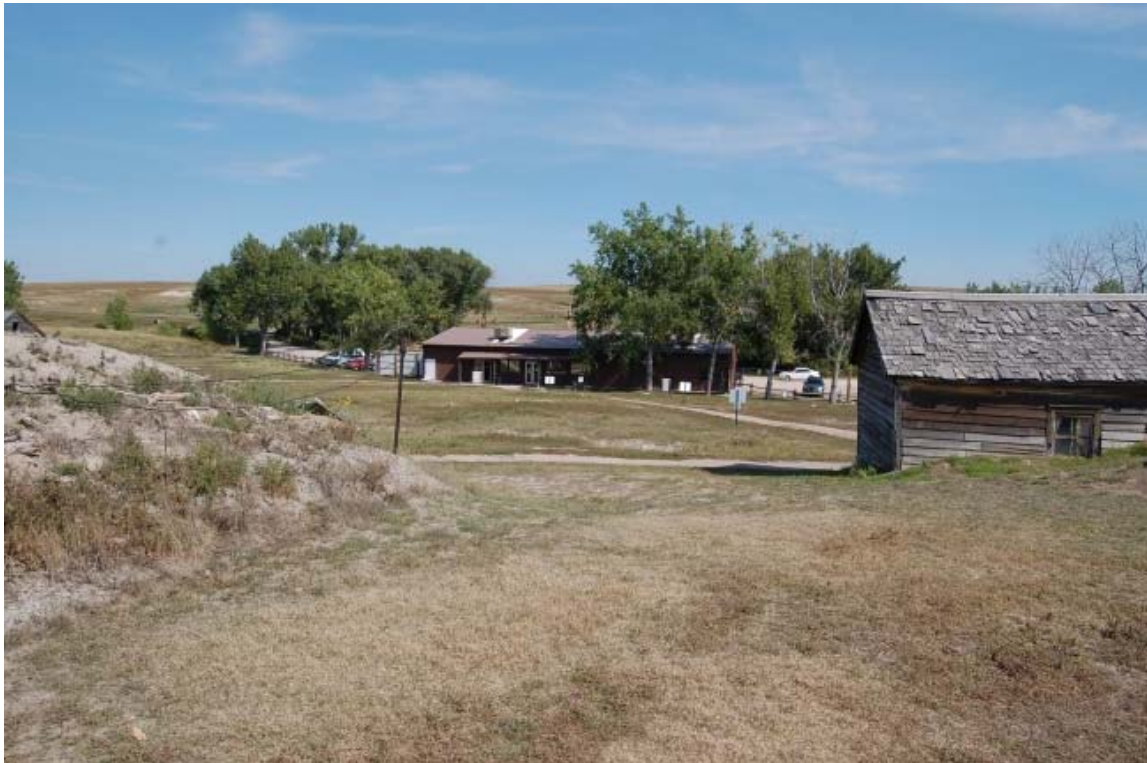
**Figure 28. View to visitor center from west side of dwelling seen on right and root cellar seen on left**

*Setting.* The setting for the Brown Homestead remains very rural and rugged. Stands of cottonwood trees in the nearby slough contrast with the surrounding terrain of rolling, treeless plains and vividly evoke the reasons why and how the original dwelling was built the way it was. The aforementioned highway and visitor center are among the few modern encroachments into the setting that would significantly alter the perspectives once held by the original residents (Figure 29). Although now separated by the highway, the eastern portion of the 160-acre land parcel remains used as ranch land. At a narrower scale, the setting surrounding the dugout dwelling is enhanced by the thoughtful reconstruction of secondary outbuildings restored or rebuilt on their original locations, and designed based on early photographic documentation.

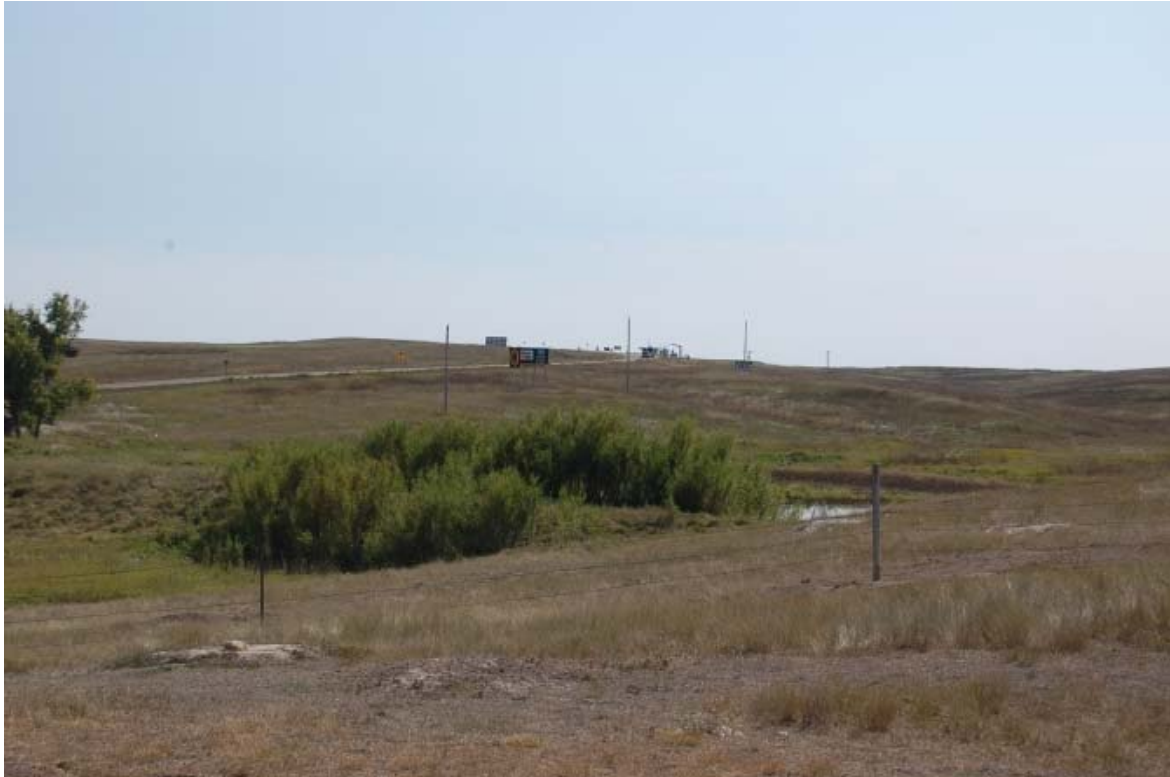
**Figure 29. View to the southeast of Highway 240 from south side of farmstead**
