**A REPORT ON AN INTENSIVE LEVEL  
ARCHITECTURAL & HISTORICAL  
SURVEY & EVALUATION  
OF THE  
CENTRAL BUSINESS DISTRICT IN  
OTTUMWA, IOWA**

**Prepared for the  
Ottumwa Historic Preservation Commission**

**Prepared by  
Molly Myers Naumann  
Consultant  
June 2013**

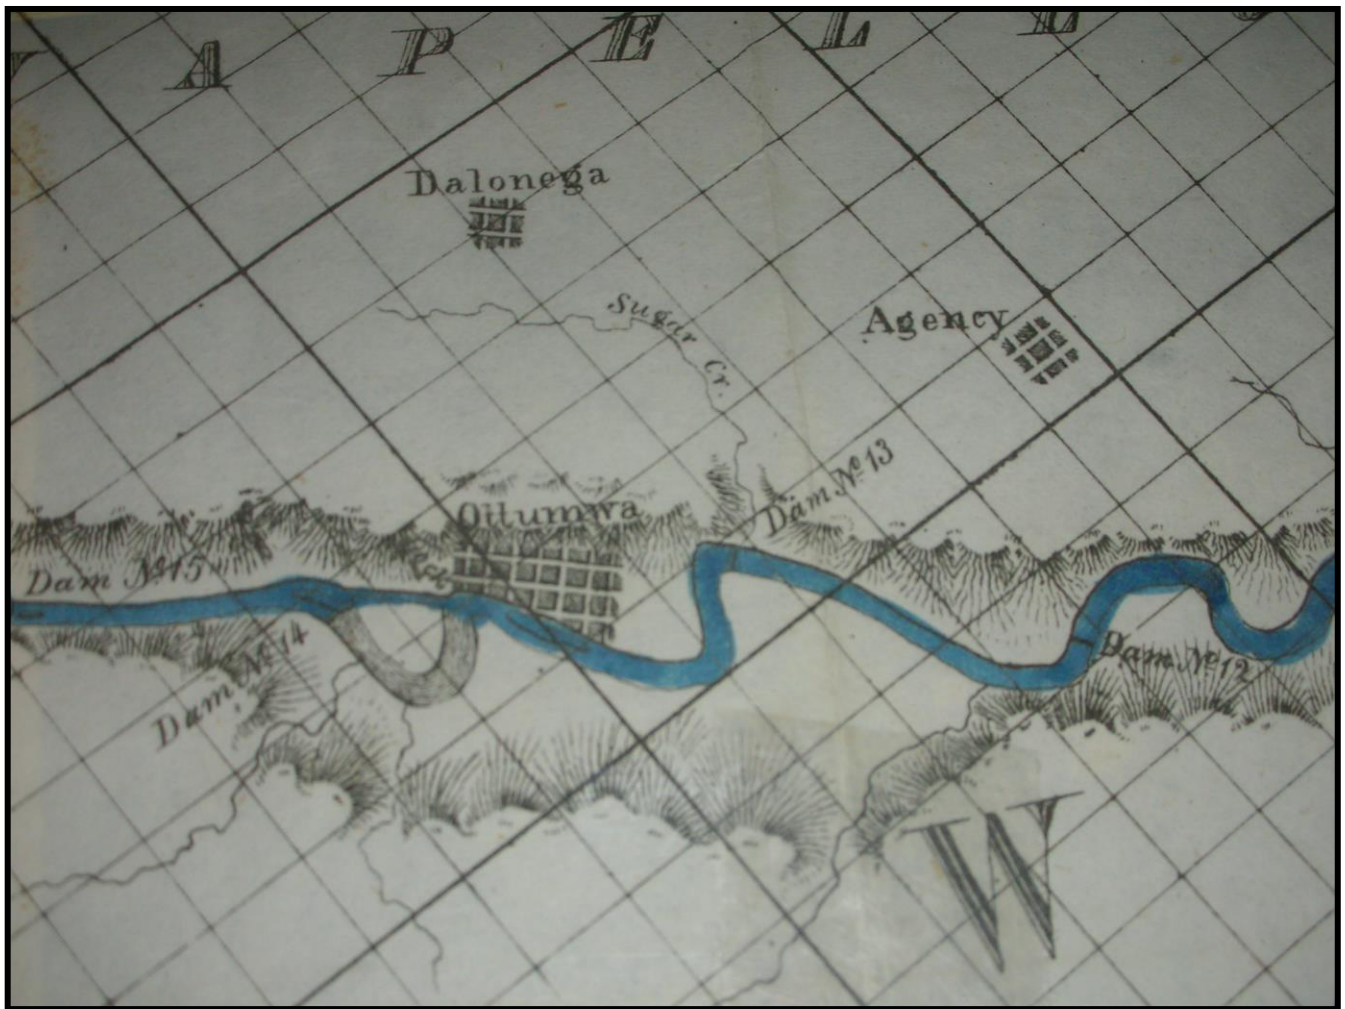
Figure 5  
 1849 survey map of the Des Moines River showing the location of  
 proposed locks and dams in the Ottumwa area.  
 Note that a canal was proposed to avoid the ox bow on the south side of the river  
 (State Historical Society of Iowa)

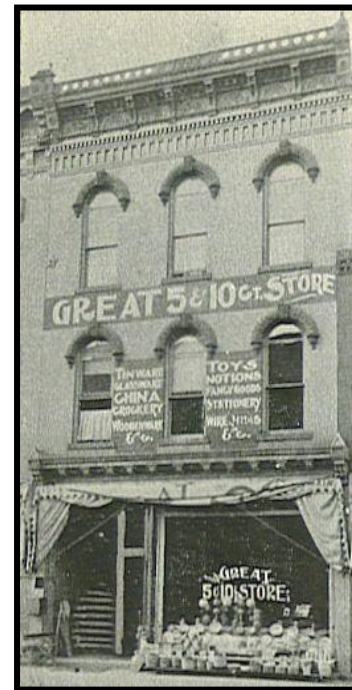
Figure 8  
107 E Main, c.1870-75  
Photograph c. 1890

These facades are currently (2013) slip covered so it is impossible to determine integrity.

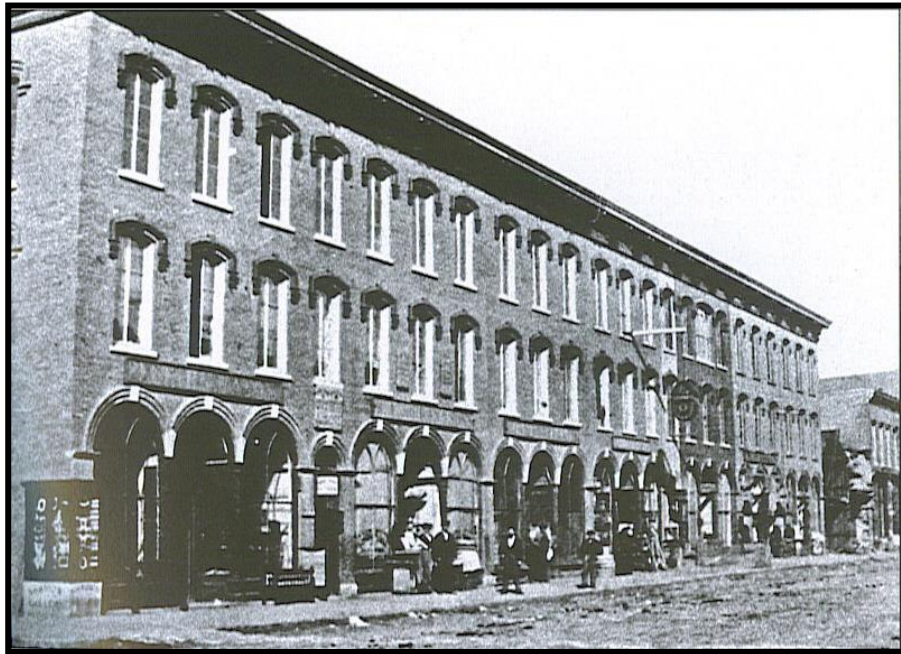
Figure 9  
 Union Block, east end of 200 Block E Main, looking SW  
 Note arcaded storefronts.  
 Destroyed by fire 1872

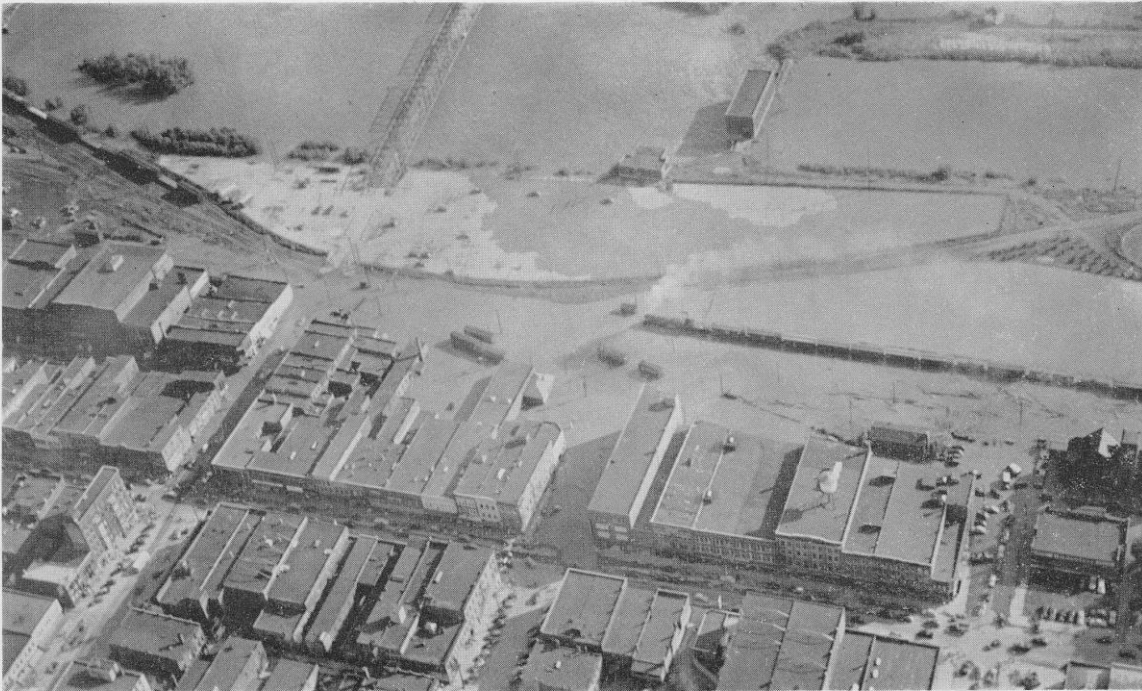
PARKING LOT—BEGINNING OF OVERFLOW, JUNE 6

Figure 54  
The Floods of 1947 climbing out of the banks at Market Street

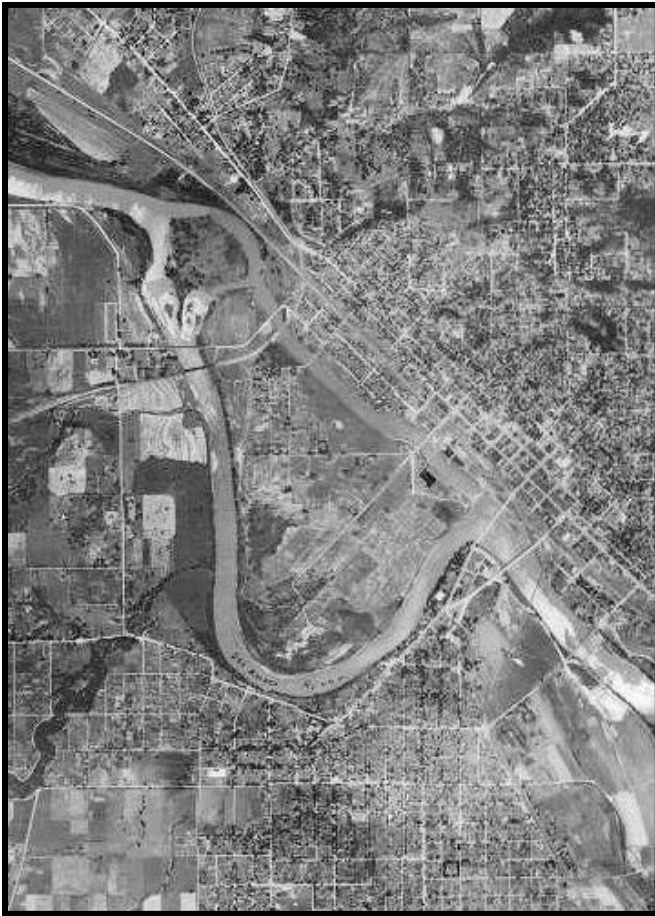
Figure 69  
1950s Aerial of Ottumwa showing  
Central Addition, the area inside the river  
ox bow  
(Iowa Geographic Map Server)

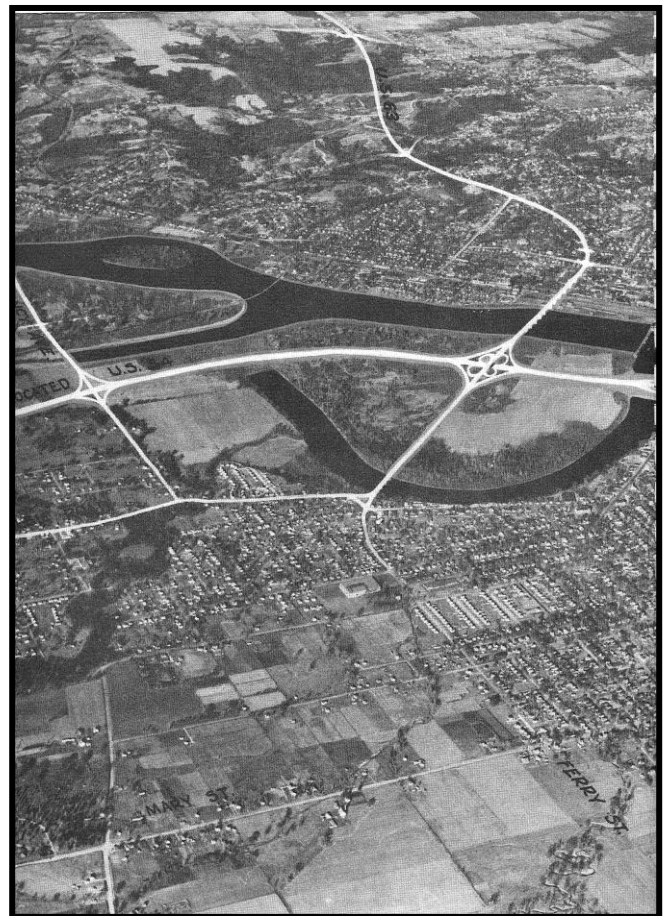
Figure70  
Aerial photo with overlay of proposed relocation  
of highways 34 (right to left) and 63 (top to center)  
The cloverleaf intersection in Central Addition, now  
Ottumwa Park, was never built  
(The Plan for Ottumwa, Iowa: Looking Ahead 50  
Years)

On June 1, 1955 the City Planning Commission issued a report, “The Plan for Ottumwa, Iowa, Looking Ahead 50 Years.” This report included plans for the relocated highways, showing that US 34 and 63 would intersect in the middle of Central Addition, the area which had become an island when the race was cut through in the 1870s. (Figures 69 & 70, page 67) Central Addition had been covered with water during every flood since the city was established. The race running parallel to the railroad tracks was to be widened and straightened, while the old river channel (the ox-bow) was to become a controlled level lagoon. The first contract for the river widening was let in August 1956. (*Ottumwa Courier*, September 1, 1956, p 9) With the new levees along the widened channel, Central Addition would no longer be in danger of flooding. Plans released that September showed proposed recreation areas to be created in Central Addition, an area to be renamed Greater Ottumwa Park. In the decades that followed the 340 acre park became the center of recreational activities for the community with ball parks, tennis courts, walking and biking trails, a camp ground, and an open area used for hot air ballooning.

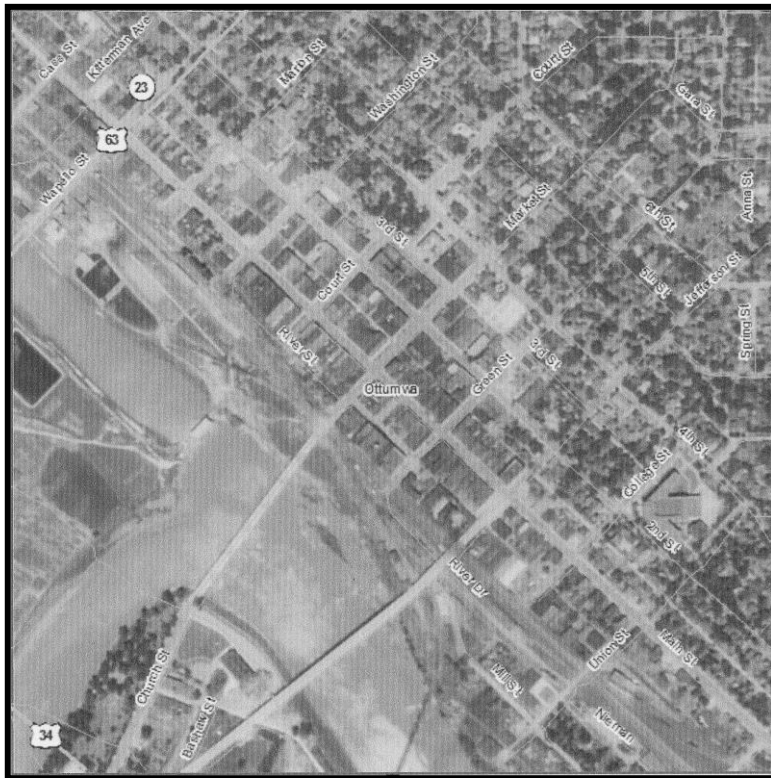
Figure 73  
1950s aerial map of Ottumwa central business district  
Note densely built-up blocks along Main and Second Streets

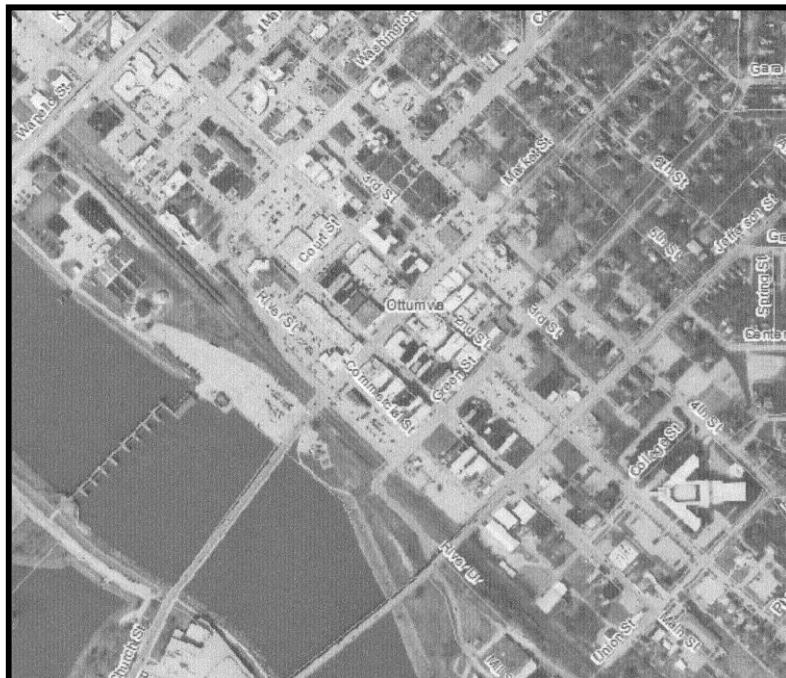
Figure 74  
2010 aerial photo of Ottumwa central business district  
Note large demolished areas now used for parking lots

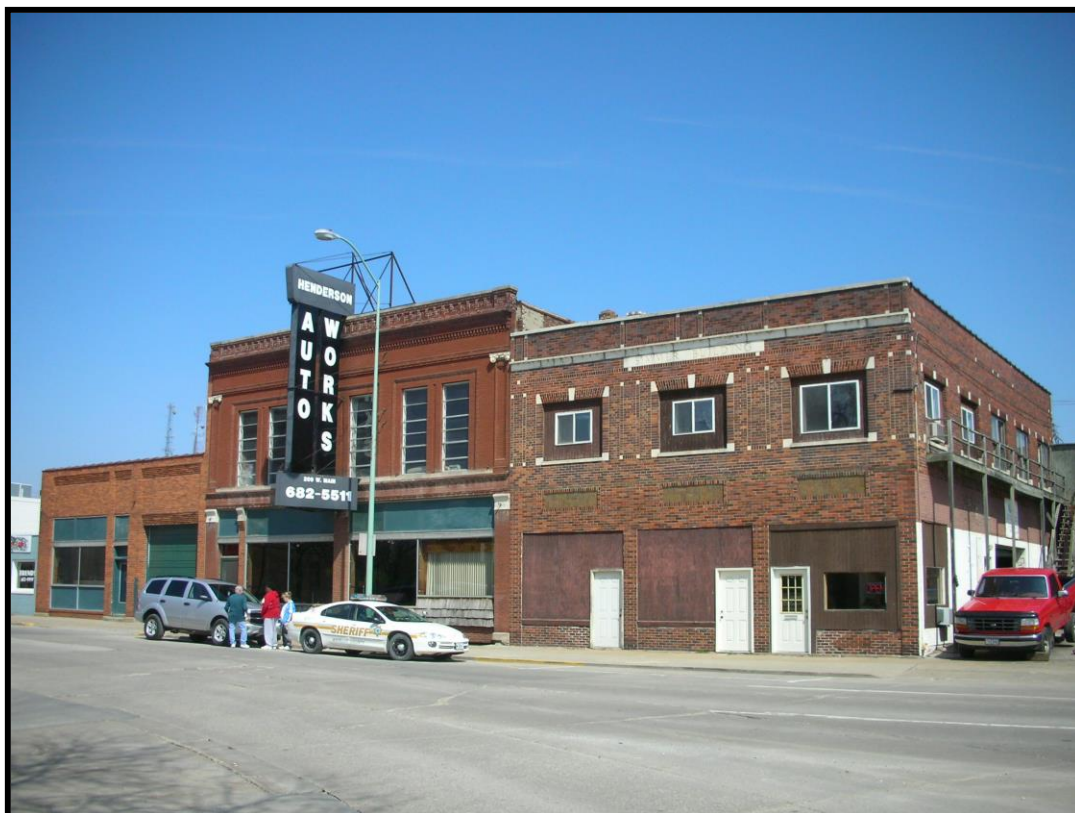
Figure 76  
200 block W Main, north side looking north

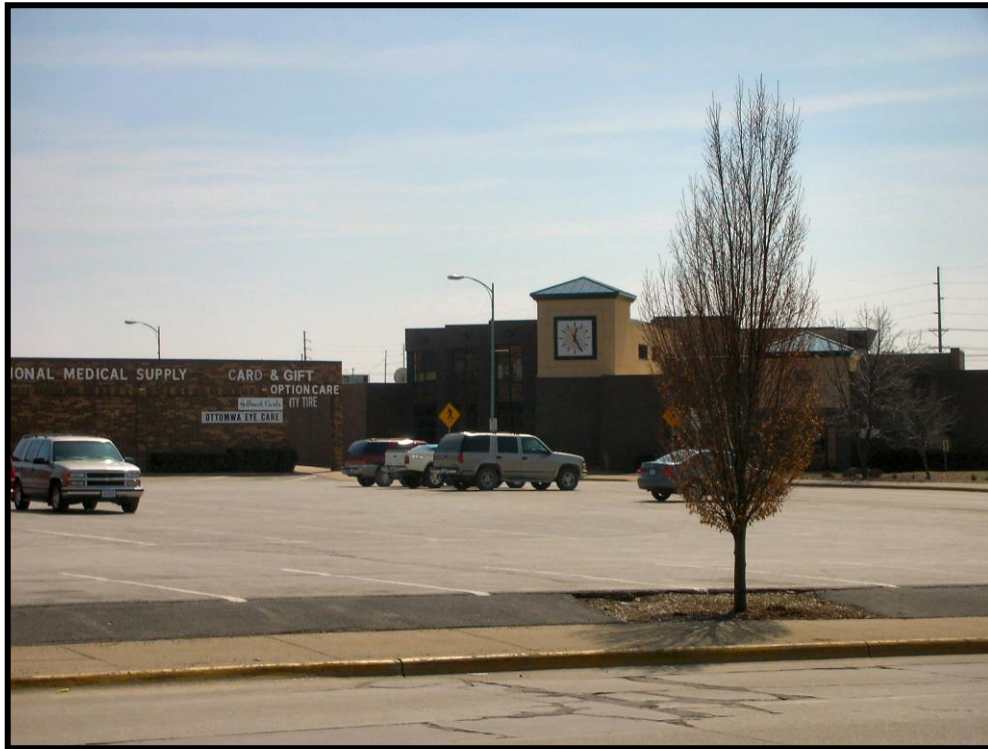
Figure 77  
100 block W Main looking SE from Washington

Completely new construction following total demolition of both square  
Blocks during urban renewal in the late 1970s

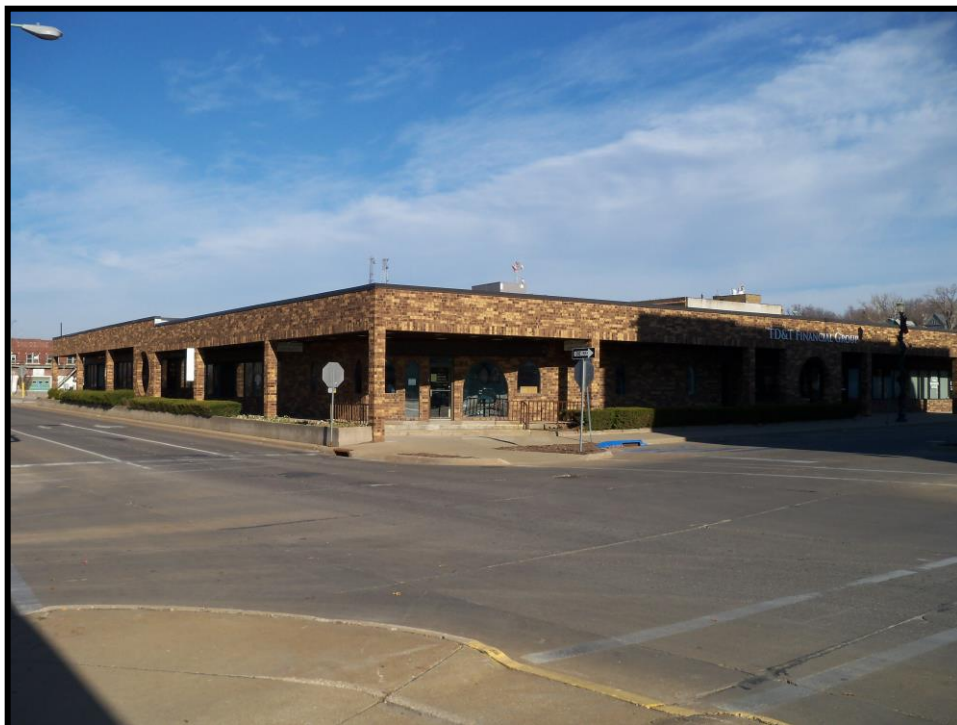
Figure 78  
100 block W Main looking NW from Court

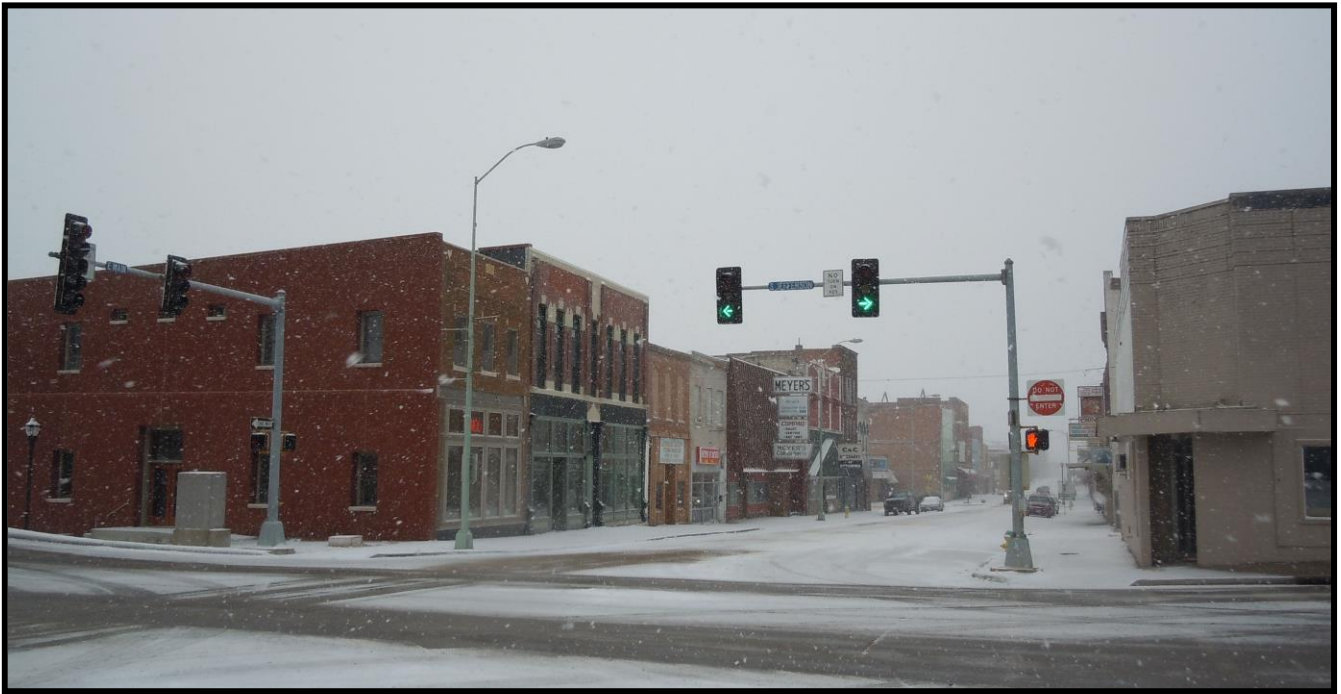
Figure 91  
300 block of E Main looking west from Jefferson

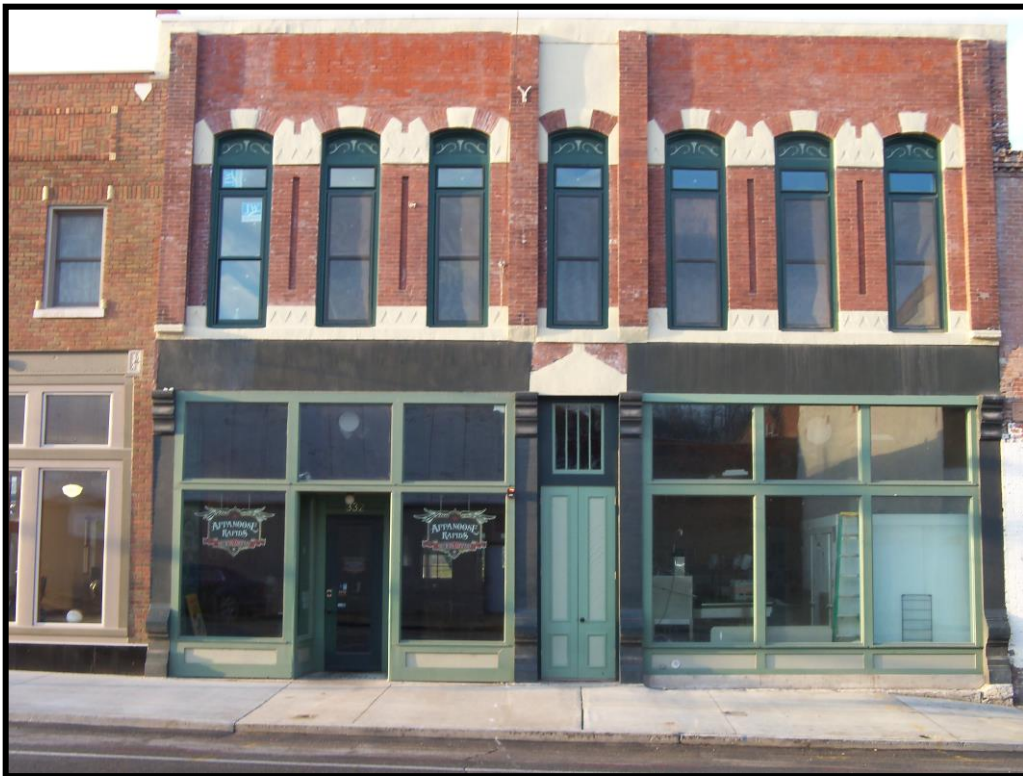
Figure 92  
Recent rehabilitation of 330-332 E Main
