HISTORIC LANDSCAPE ASSESSMENT  
FOR  
EASTERN MILL YARD,  
BOOTT COTTON MILL No. 6

LOWELL NATIONAL HISTORICAL PARK  
LOWELL, MASSACHUSETTS

Prepared by the  
Olmsted Center for  
Landscape  
Preservation

March, 1995

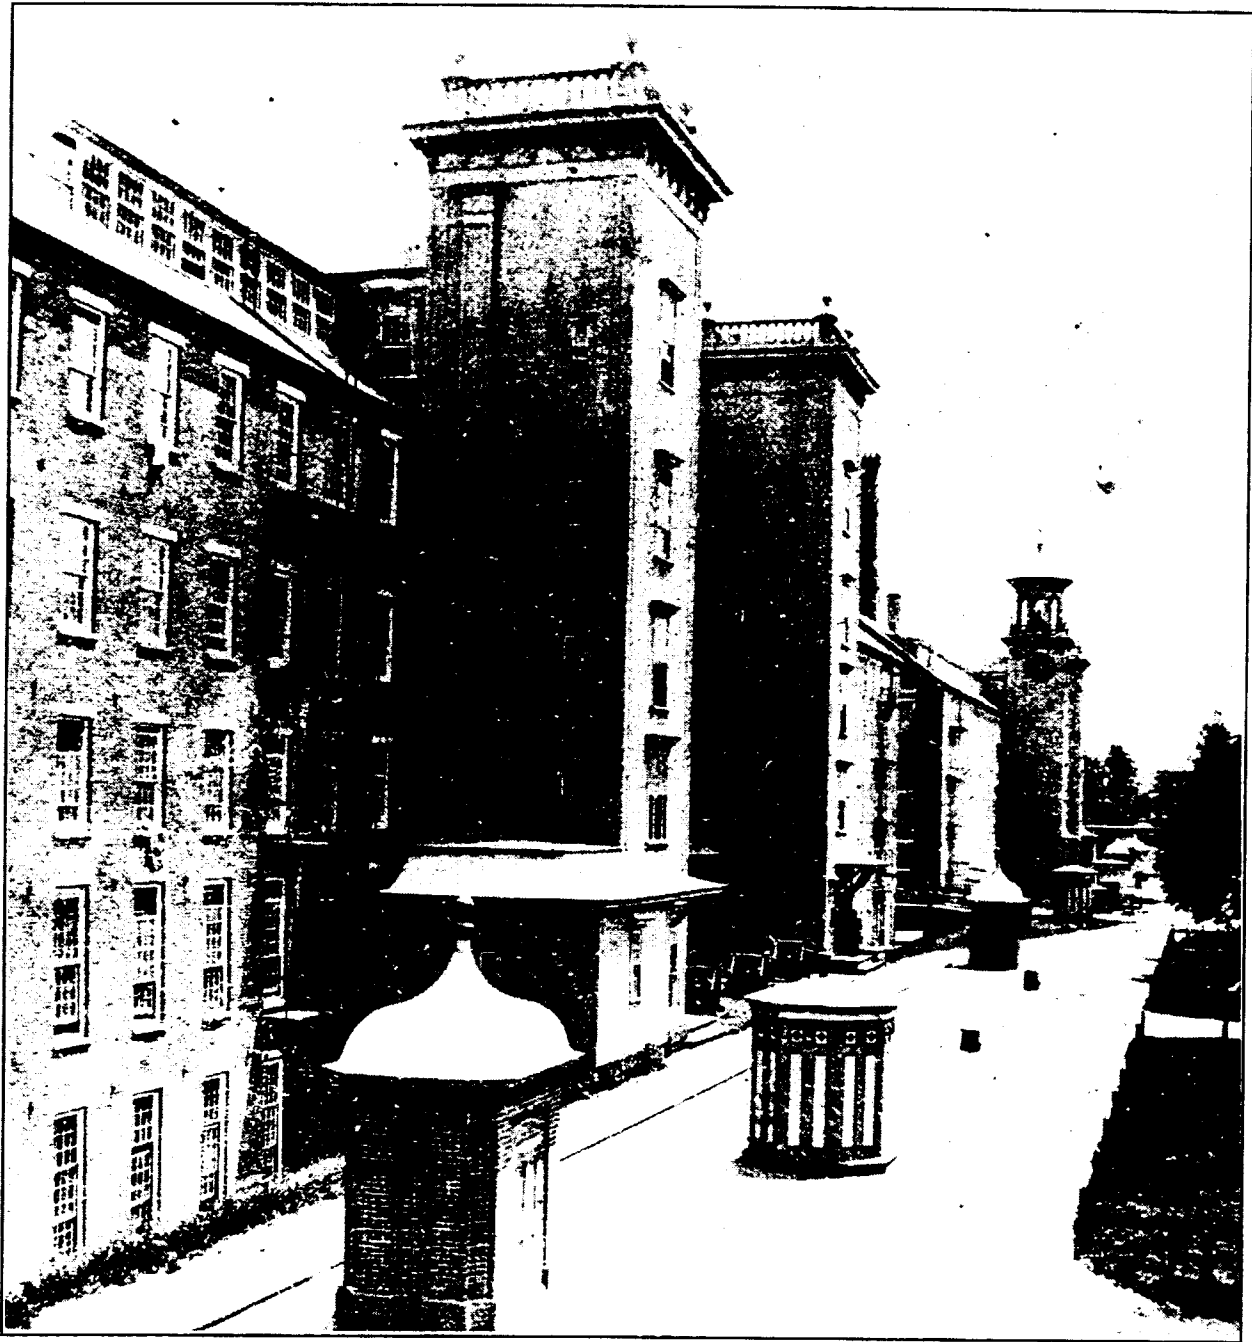
**Figure 7.** Stereoptic view of the Boott Cotton Mills, looking east. By John S. Moulton, circa 1865-1870. Source: Lowell Museum. This view shows the light trenches with unmowed grass in front of the mills, seven hose houses in two distinct styles, the grass panels with trees and rounded corners, the raised walk, and the ramps leading around the inside edges of Mills No. 2 and 3.

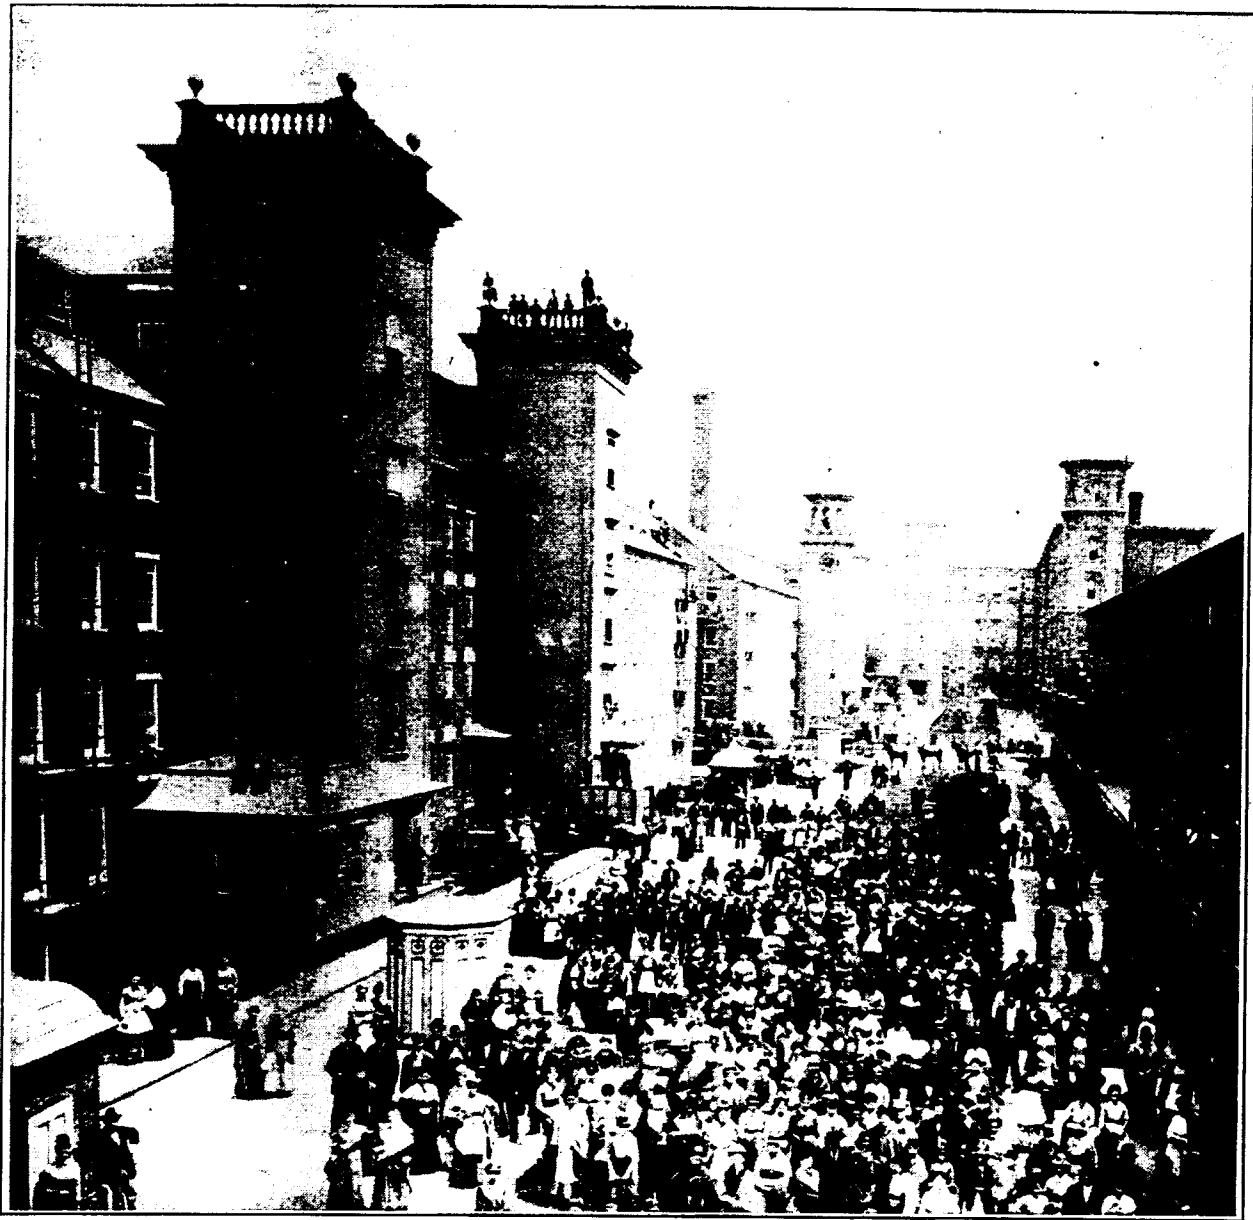
**Figure 9.** View of Boott Cotton Mill Yard with workers, 1878. Source: Lowell Museum. Nine of the ten hose houses located in the upper Mill Yard (see Figure 8) are evident in this photograph. In addition, note the trolleys on both the elevated track on the right and on the track in front of Mill No. 3, horses pulling a wagon in the main entrance. Although the plant urns remain on the lawn, the trees have either died or been removed by this time.

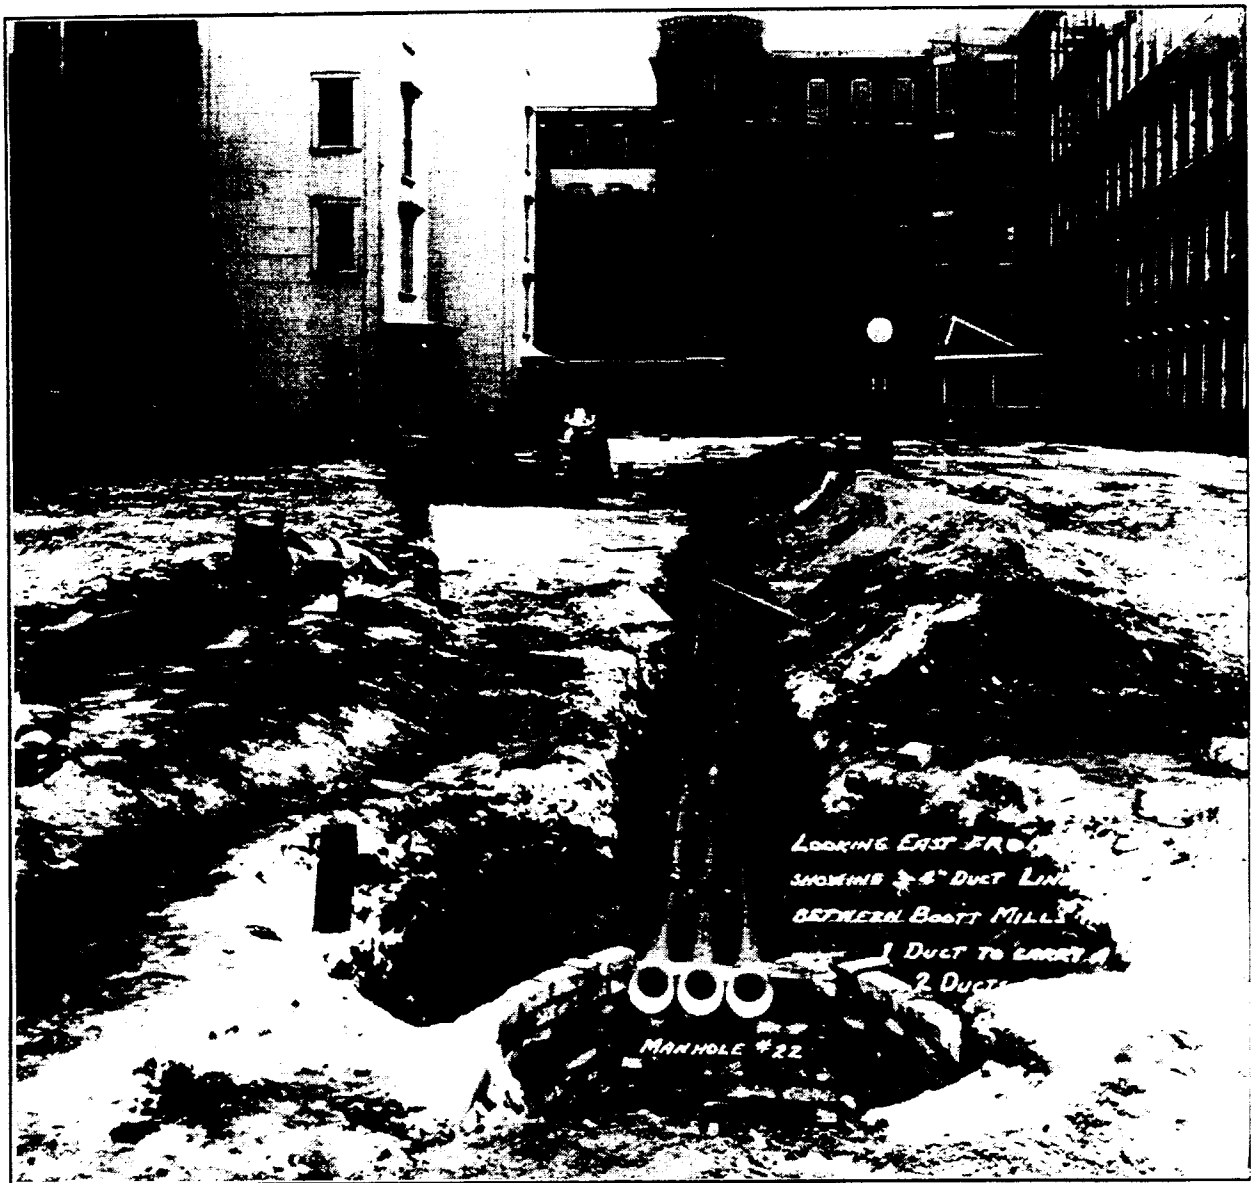
**Figure 18.** "Looking east from hole #22, Boott Mills, Dec. 5, 1933. Locks and Canals Photograph. Source: Center for Lowell History. The bicycle rack evident in the 1927 photograph is gone, as are the doors on the north facade of Mill No. 6. The trolley tracks appear buried in this image, and it is difficult to discern surfacing materials, including the grass plots and the raised walk.

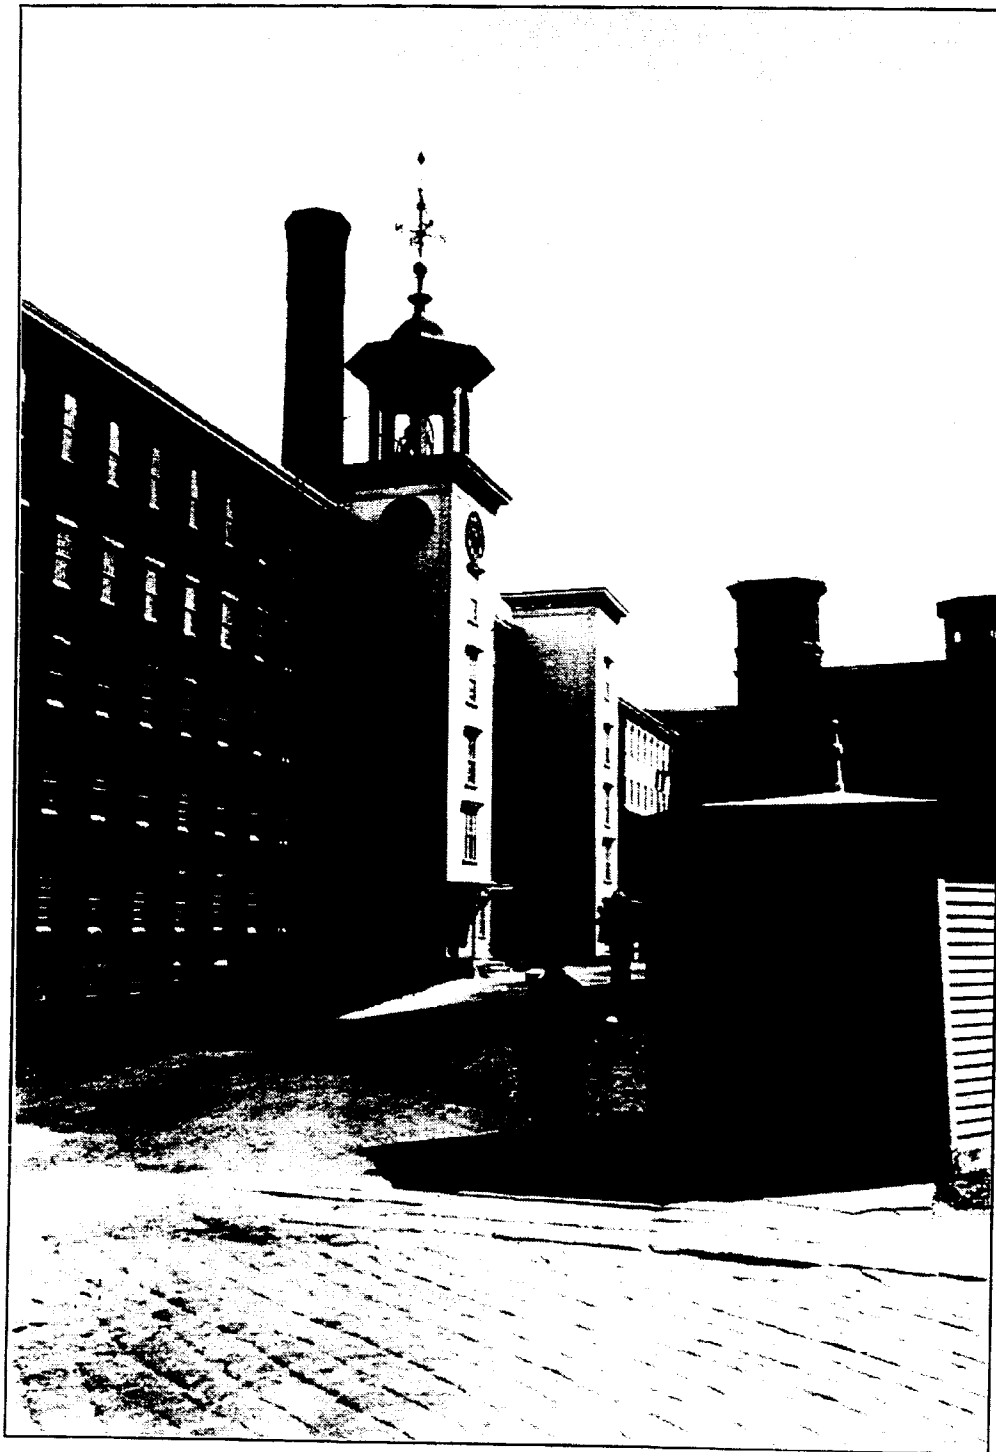
**Figure 19.** View of clock tower, Boott Cotton Mills by John Coolidge. Circa 1930s. Source: Museum of American Textile History. Note the two types of granite pavers in front of the hose house, and that the grass plot around the hose house is much less distinct. Also vines are still evident on the buildings (see Figure 14) and the vehicular surface appears to be packed dirt.

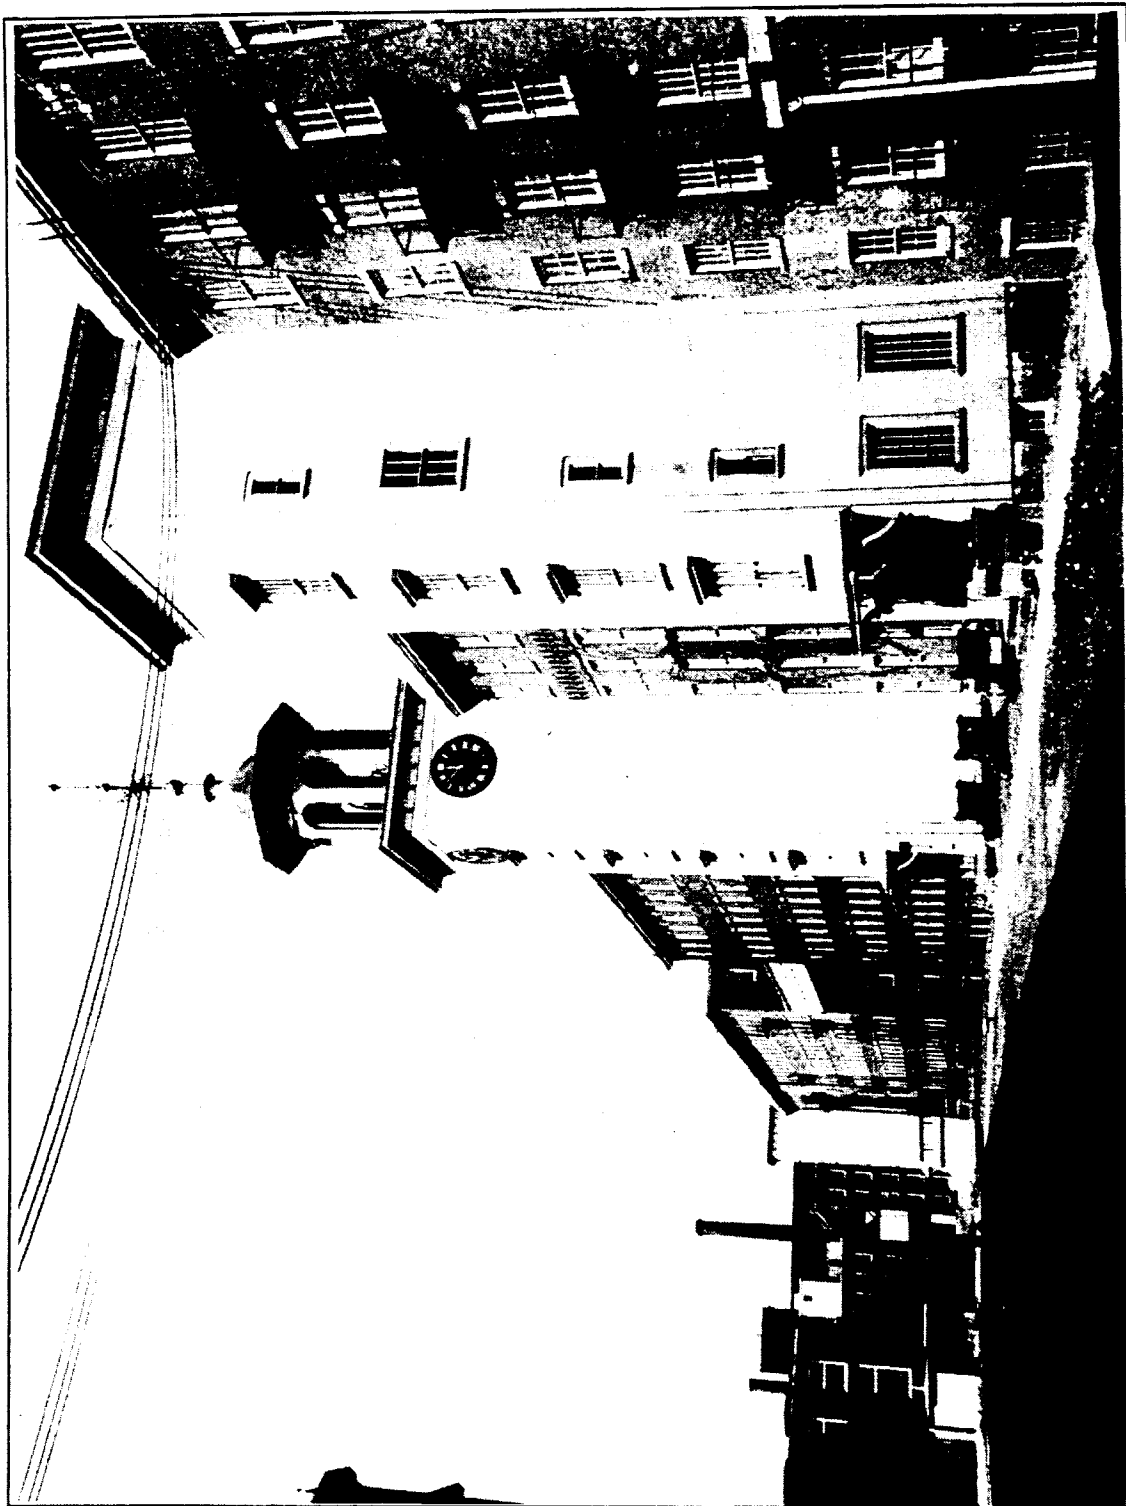
**Figure 21.** View of Boott Cotton Mills looking west, by John Coolidge. Circa 1930s. Source: Museum of American Textile History. Note the sidewalk along Mills No. 1 and 2 and traces of the paths across the Mill Yard.

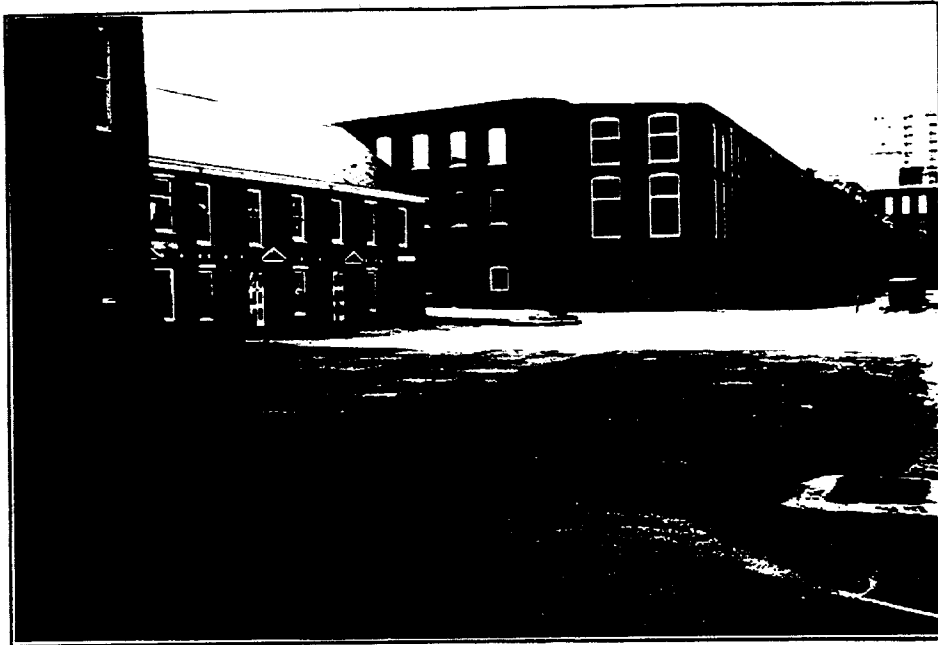
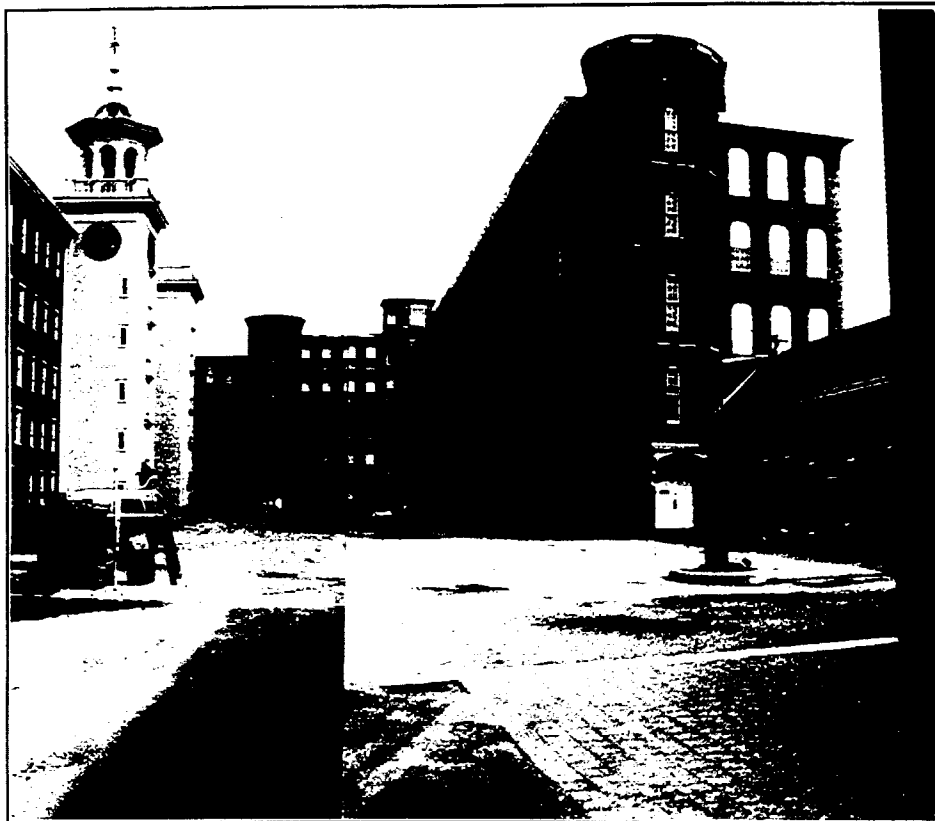
**Figures 26, above and 27, below.** The Mill Yard looking southwest above, and looking east at Mill No. 6 below. Note the vehicles parked flush to the buildings, the dumpster and the lack of traffic delineation.

Rehabilitation of the Mill Yard will also allow the park to remedy safety and maintenance problems such as the lack of delineation between vehicular and pedestrian traffic, the need for a defined outdoor orientation area for group tours, deteriorated paving and associated problems of puddling and safety. The immediate priority in this area for Lowell NHP is to provide safe, clearly delineated visitor access to the Museum, the Museum Store, and the business entrance at the southeast corner of Mill No. 6. The first phase of each of the three alternatives described in the following section respond to this by focusing on the restoration or rehabilitation of the historic sidewalks that ran along both the Counting House and Mill No. 6. In addition, the alternatives recommend limiting vehicular traffic to light deliveries and emergency vehicles. Large trailer trucks will be prohibited from entering the Mill Yard. Park staff vehicles will be restricted when absolute necessary.

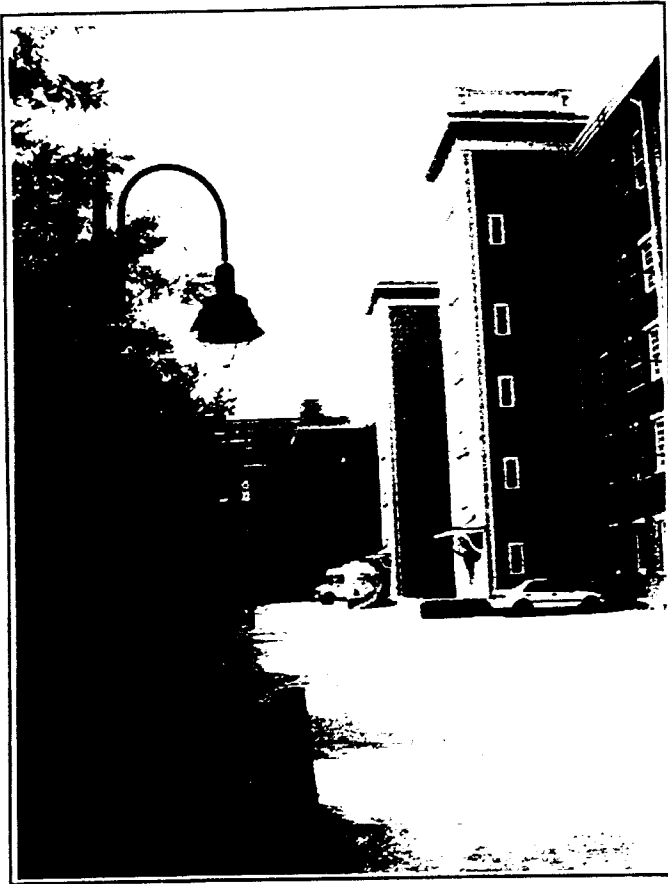
Figures 28, left and 29, below show the relandscaped western portion of the Mill Yard. The surface is packed crushed stone. Oak trees, lamp fixtures, and bollards screen Mill No. 8. The shrub planting, around the sluice gate hoist includes burning bush and helps screen the view of the eastern portion of the Mill Yard. The lower photo shows the Counting House on the right with Mill No. 6 behind it. Except for the NPS orientation sign in front of the Counting House, there is little definition to the eastern portion of the Mill Yard.

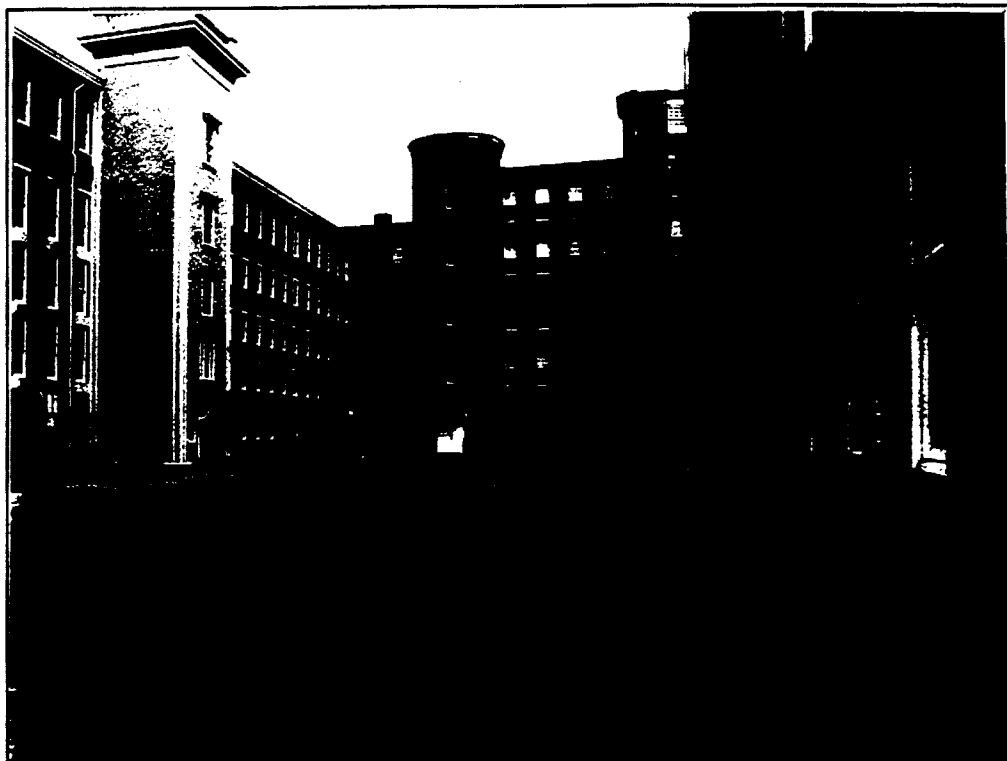
**Figure 31**, below, shows the eastern end of the Mill Yard. Note the visitors circumventing the cars parked flush with the building, and the trailer parked in front of Mill No. 1.

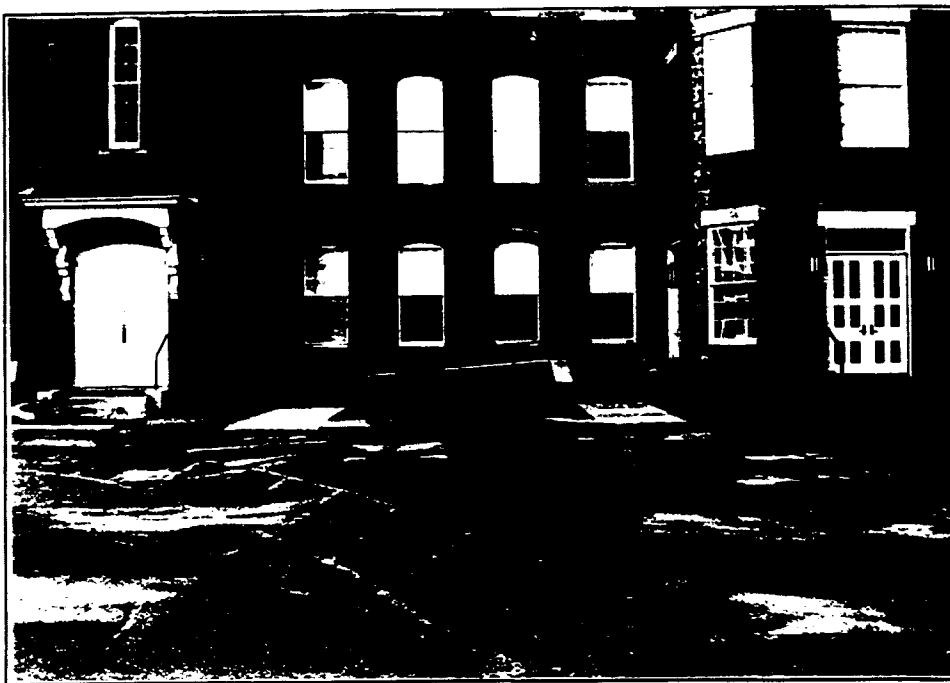
Figures 32 and 33 show details of the eastern end of the Mill Yard. Figure 32, above shows the new business entrance and ramp to Mill No. 6. The historic entrance to the stair tower on the left is used for group tours. Note the striped path painted on the surface; this path, which is yellow, was added to help guide pedestrians around the more deteriorated and uneven portions of the Mill Yard to the stair tower.

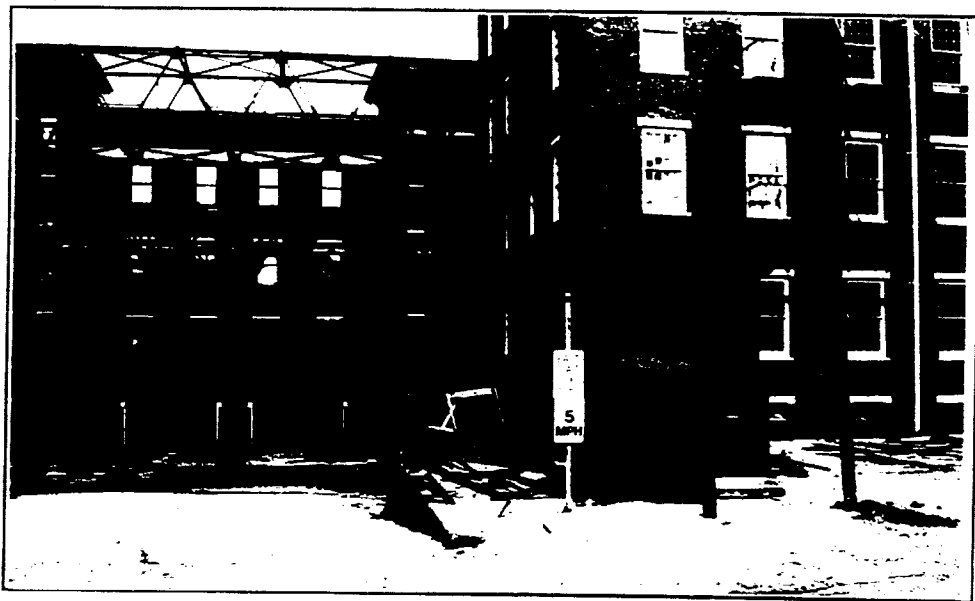
**Figure 34**, above, looking toward Mill No. 5, shows the hose house in its nonhistoric location at right. Bollards protect both the hose house and the sluice gate (which is functional) from vehicular traffic. Also note the collapsed railing on the retaining wall to the left of the hose house.

- Install 4 panels of grass in modified historic configuration with Ryerson steel edging and bollards.
- Add granite block pavers in front of Counting House to create a gathering area.
- Repair and move hose house to historic location.
- Install new orientation signage.
- Resurface Mill Yard (all or partial) to match the surface of western end of Mill Yard.
- Expose granite blocks and slabs at entrance to Mill Yard.
- Reset valve boxes and granite around historic catch basins.
- Install new benches in front of Counting House.
- Install fence between Mills 1 & 6 to screen dumpster (see Alternative A).

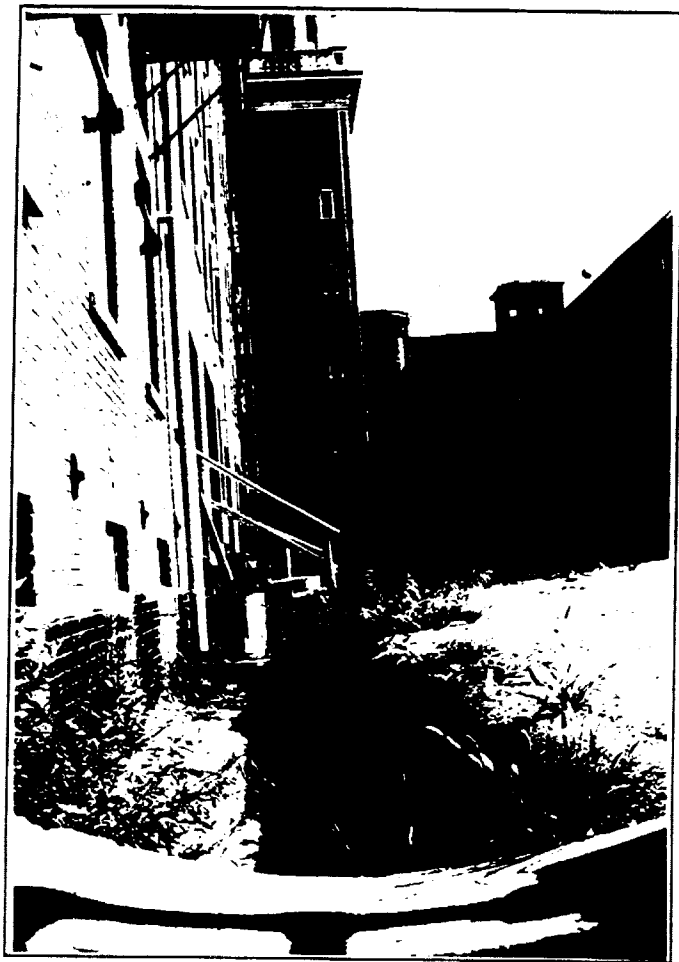
**Figure 35**, left, shows the remnant of the light trench in front of Mill No. 2, which is now used for drainage. The wooden steps and railing lead to a loading dock added in the 1950s. The single pane windows on the left are the remnants of the full length ground floor windows which were sealed when the light trenches were filled in the 1950s.
