Gills Creek

## An Introduction to the Water Resources of Booker T. Washington National Monument

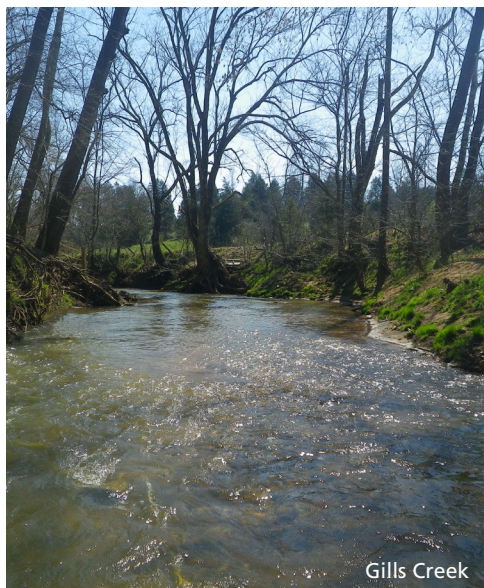
## Booker T. Washington National Monument - Land Use

Land use map and table. Note that BOWA land use is similar to the surrounding watershed.

Within BOWA boundaries, vegetation maintained or altered by human activity covers a large part of the park (35%; see map and table, page 2). These areas include turf, pastureland, hayfields, and other maintained lands. Early successional or transitional vegetation covers 31% of the park. Weedy tree species with large areas of underlying nonnative invasive plants dominate these areas. Undisturbed later successional forests cover the remaining 34% of BOWA. There are no documented wetlands in BOWA.

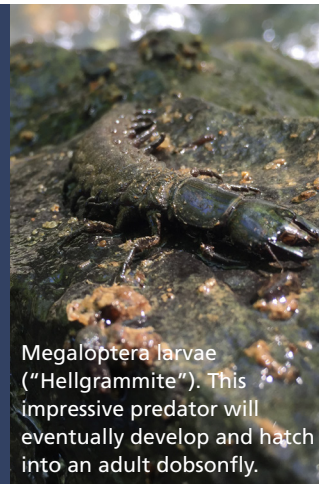
Megaloptera larvae (“Hellgrammite”). This impressive predator will eventually develop and hatch into an adult dobsonfly.

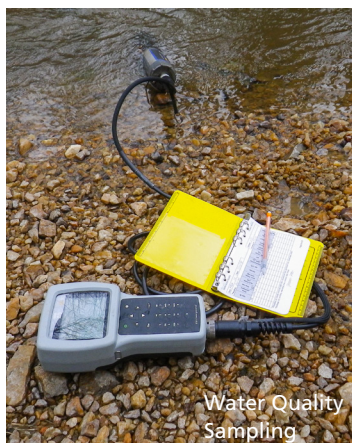
Water Quality Sampling

In order to better monitor the status and trends of wadeable streams at BOWA, the Mid-Atlantic Inventory and Monitoring Program (MIDN) has established several long-term monitoring sites. Sites were placed in streams of significant value as determined by BOWA and MIDN staff. Five sites are currently monitored by MIDN in BOWA: upper, middle, and lower Jack-O-Lantern Branch, Gills Creek, and an unnamed tributary to Gills Creek. At each of these sites, MIDN staff measure water temperature, specific conductance, pH, and dissolved oxygen concentrations. Some sites contain automated equipment that records this information many times a day. MIDN staff also record observations about the weather and discharge stage. In some sites, data on benthic macroinvertebrates is also collected.
