## Preservation Plan **Beaver Meadows Visitor Center** January 2008

The purpose of the Beaver Meadows Visitor Center Preservation Plan is to provide a comprehensive “road map” for the long-term stewardship of Rocky Mountain National Park’s only designated National Historic Landmark. The plan includes recommendations for the future maintenance, use, and interpretation of this historic building. It is intended to serve as a reference and guide for park management, maintenance staff, interpretive staff, and all tenants and users of the building.

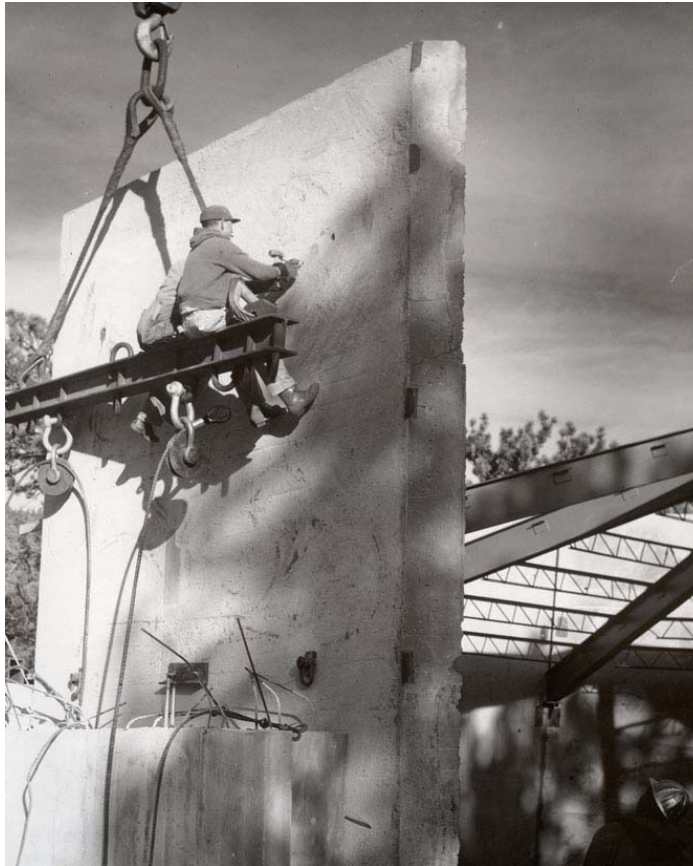
A worker taps on the masonry panel around the auditorium. (NPS-RMNP photo)

*When we did our condition assessment, we looked at all the steel and all the masonry. It's as sound as the day it went in there. And it's going to be that sound a century after. And those are the two major structural elements of the building. This is the way architecture ought to be: what you see is what you get.*

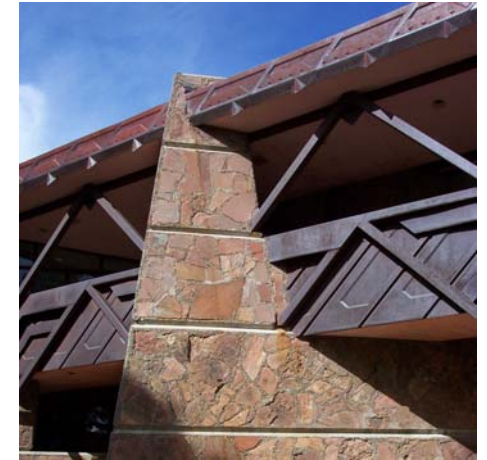
Masonry and Steel

The use of Cor-Ten weathering steel for the external frame is one of the building's most notable features. As Tom Casey described it, this is an example of Wright's principle of organic design. Weathering steel creates a layer of rust over time that gives the building a patina of age and a "naturalness" that helps blend the structure with its surroundings, particularly the rust-colored ponderosa pines on the site. The foundation of the visitor center is another key structural element. The foundation consists of concrete panels filled with lichen-covered red sandstone that is marked by strong horizontal joints. The stones are laid in a natural, uncoursed manner and the mortar is mixed with coarse aggregate to give a very natural overall appearance. Casey explained that this construction technique was directly inspired by Wright's use of a similar method for the walls of Taliesin West in Scottsdale, Arizona.

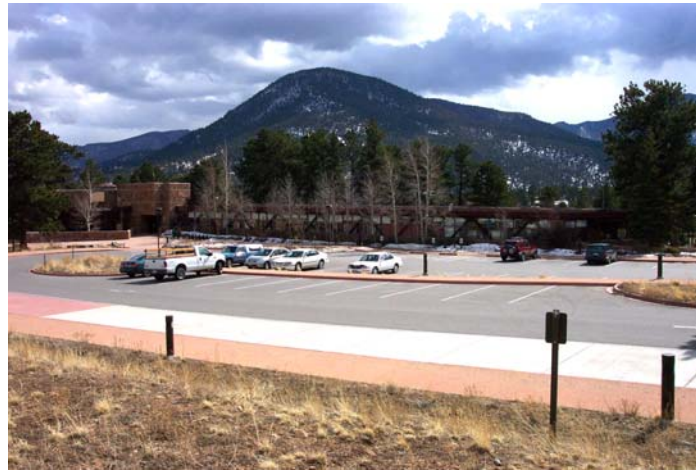
above: The 2002 parking lot expansion allows large RVs and tour buses to stop at the visitor center.

Because most visitors arrive at the building by car, the layout of the parking lot is critical to a proper entry sequence. There is an upper and lower parking lot because separate entrances for visitors and employees was important to Tom Casey. The upper (north) visitor lot serves 88 cars (plus space for buses and RVs) and the lower (south) employee lot serves 48 cars. They are both roughly rectangular and paved in asphalt.

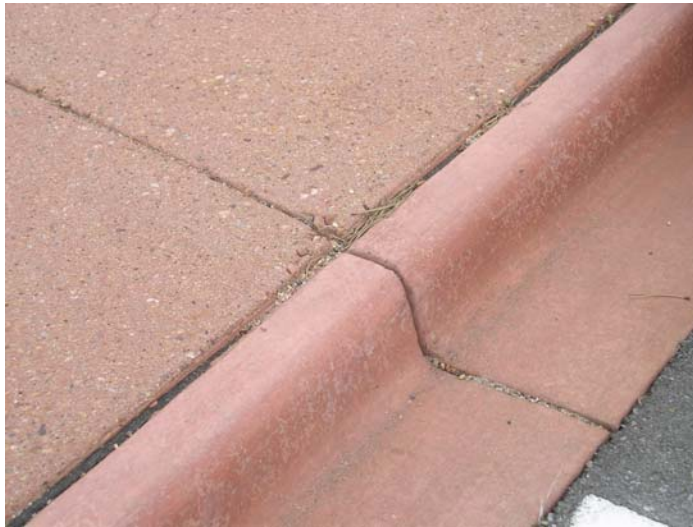
**above:** The new walkways are exposed aggregate; the curbs are smooth finish.

On-going: Patch and repair walks, curbs, and sidewalks to prevent tripping and to facilitate accessibility. Prevent proliferation of signs, trash receptacles, and other objects that will inhibit circulation and detract from clean, modern lines of the building.

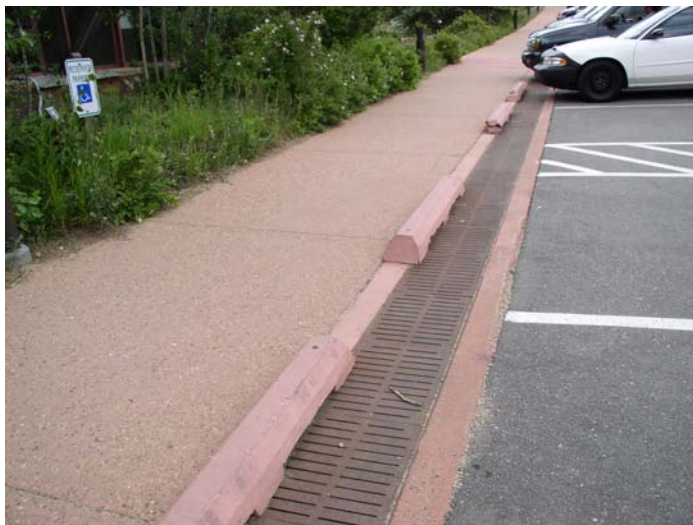
**below:** The at-grade drain and lack of curb make the handicap parking readily accessible. (NPS-ROMO photos)

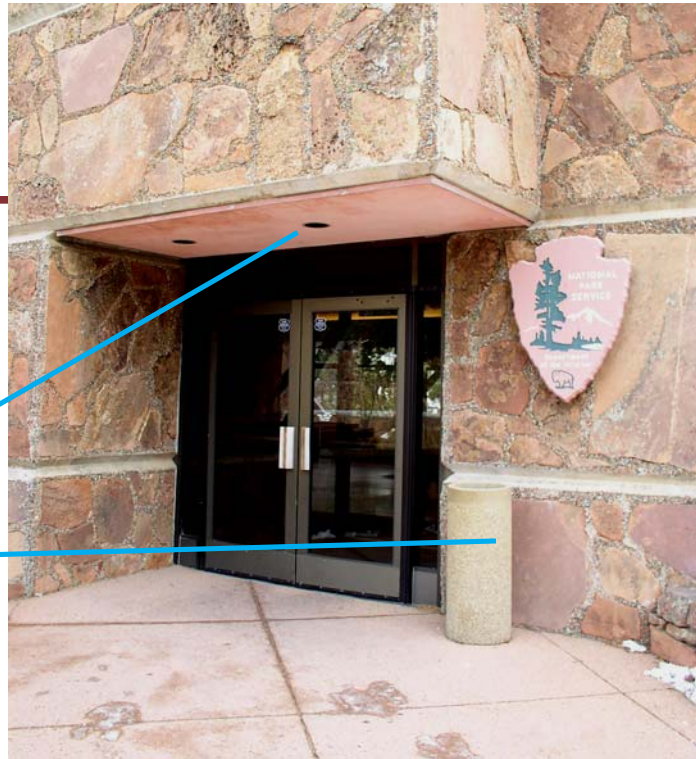
Minimal, recessed lights maintain the "hidden" nature of the front door while providing enough light to allow safe entry

Non-original ash can clutters the entrance

**above:** The front door location and design makes it a subtle entry to the asymmetrical building.

This preservation plan anticipates replacement of both sets of doors to comply with the Americans with Disabilities Act. The new door will be lighter weight, but matching the physical size of the original doors. As well, the new doors will match the original powder-coated rust color of the interior set of doors. Both sets of doors should have transparent sidelights and transom. It is important that the glass is not highly reflective but rather smoky-colored, matching the building's windows and doors.

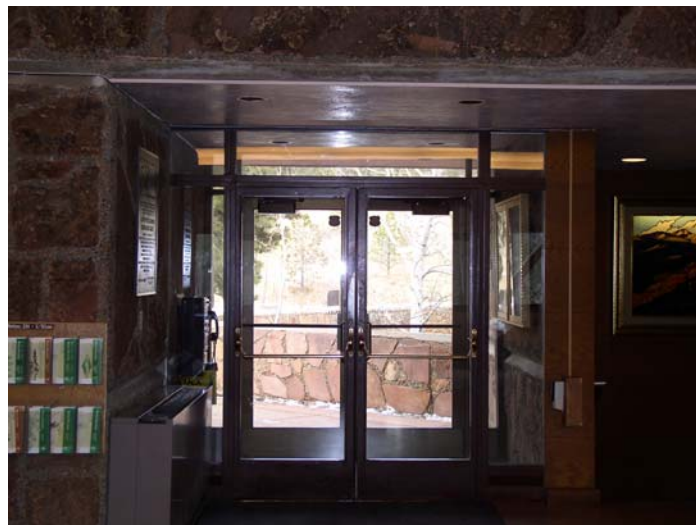
**below:** The front entry is a small, confined space that opens to a high-ceiling room, similar to other Taliesin-designed buildings. (NPS-ROMO photos)

A key feature of the Taliesin entry sequence is the front door. Many Taliesin-designed buildings have low-ceiling, dark entrances that open up into larger and lighter spaces.

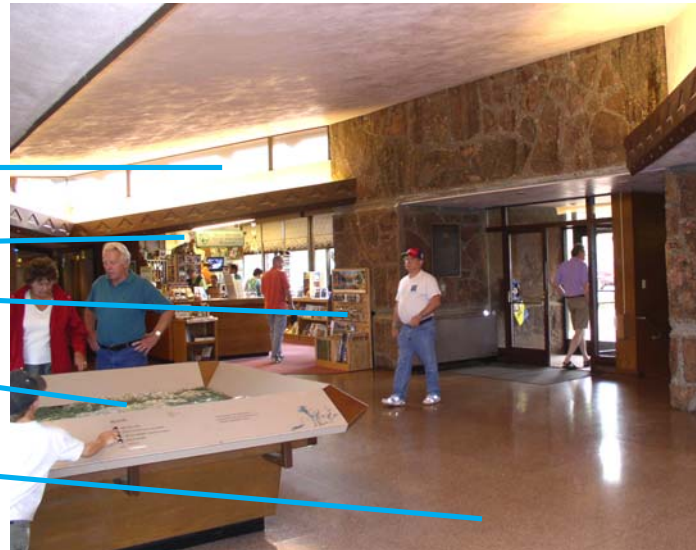
Original topographic model of park

Natural materials such as terrazzo and stone connect visitors to the outside.

above: The lobby as it appeared in 2005. (NPS-ROMO photo)

Tom Casey intended the upper lobby to feel like a hotel lobby, with ample seating in front of a wide fireplace. The hearth is central to many Taliesin buildings. The upper lobby has red oak paneled walls with strong horizontal lines. Clearstory windows illuminate the space to the north, while a wall of glass looks over the Rocky Mountains to the south. Terrazzo floor is made of native stone. The oak casework and wall finish give a warm feel to the otherwise stark interior. The original relief model of the park remains.

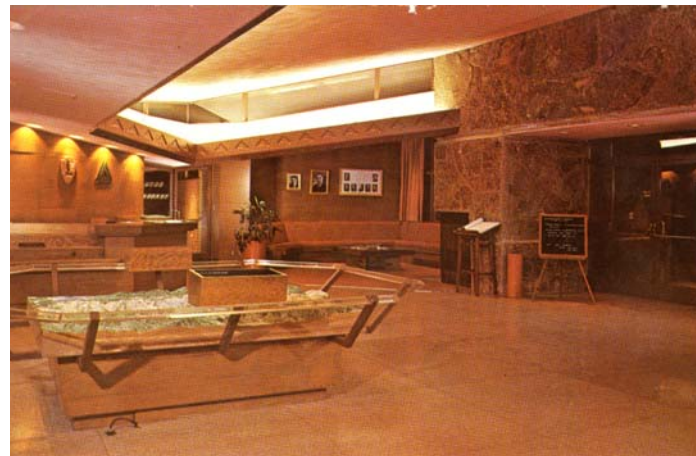
below: This image shows the original configuration of the lobby, including the seating area in front of the fireplace, now occupied by the bookstore. (NPS-RMNP, photo by Lew Dakan, Dexter Press, Inc. postcard)

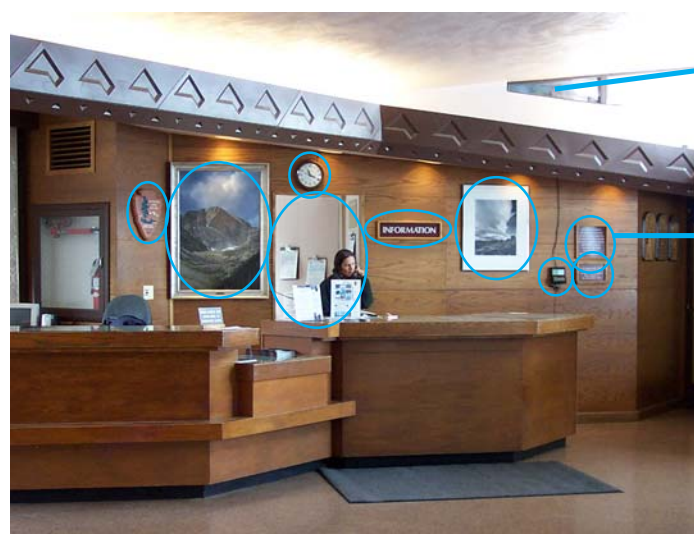
below: Today a frenzy of artwork, signs, and open doors make the area a distraction and minimizes the architectural lines in the ceiling and clearstory windows.

Clearstory windows and recessed fixtures bounce light off the ceiling

Cluttered walls distract from horizontality

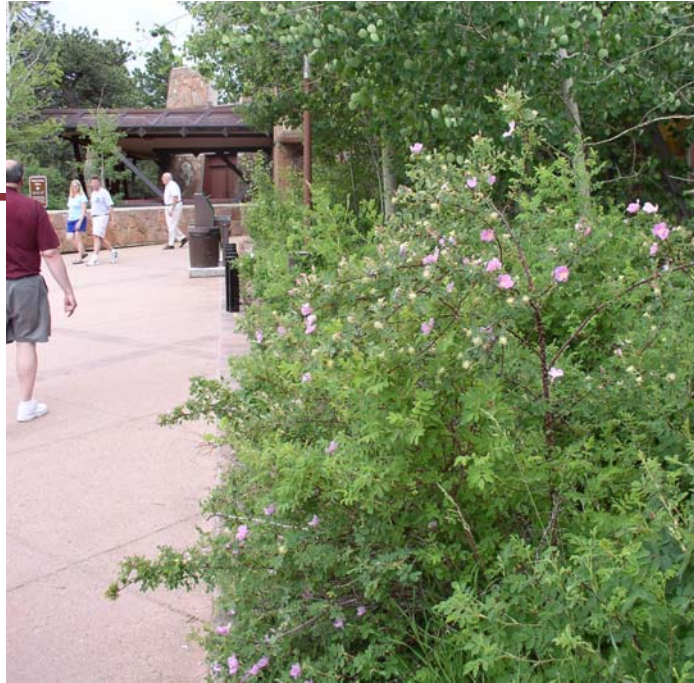
**above:** The planters in front of the visitor center host overgrown shrubs. Refer to planting plan by DHM Design. Maintain plants with annual pruning and replanting as needed.

The naturalistic design of the planters that surrounding the building reinforce the connection to the greater landscape. Though Tom Casey did not choose the landscape plants, he noted, "I would definitely say that it softens it.... And adds another dimension to the perception of it. And it also softens the view from the inside...." Resident landscape architect James O'Shea designed the original planting and lighting plan in 1967. The park twice tried to use an irrigation system in the planters to maintain plants. Landscape plans from the landscape architecture firm DHM (see drawing at right) recommended use of drought-tolerant, native plants.

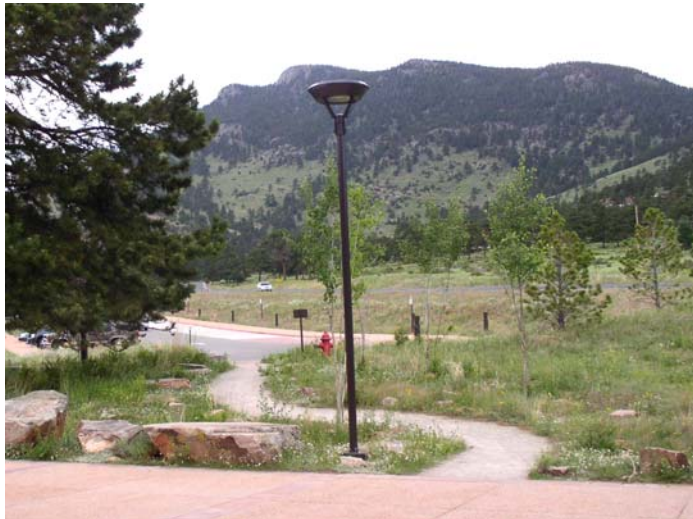
**above:** New lights reflect the color and modern design of the building, while preserving the night sky.

As needed: bulbs may be replaced with newer technologies to improve energy efficiency. However, all bulbs should be replaced at once so that the color temperature and hue is consistent throughout the landscape.

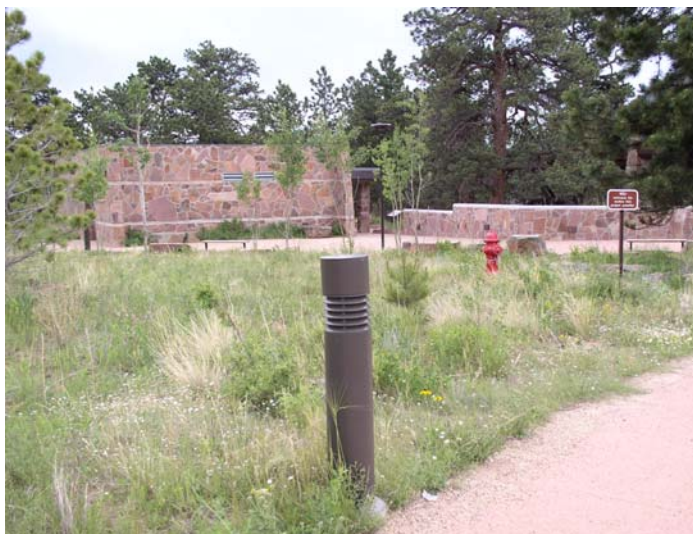
**below:** Other lights are scaled to pedestrians, and provide a soft light along walkways. (NPS-ROMO photos)

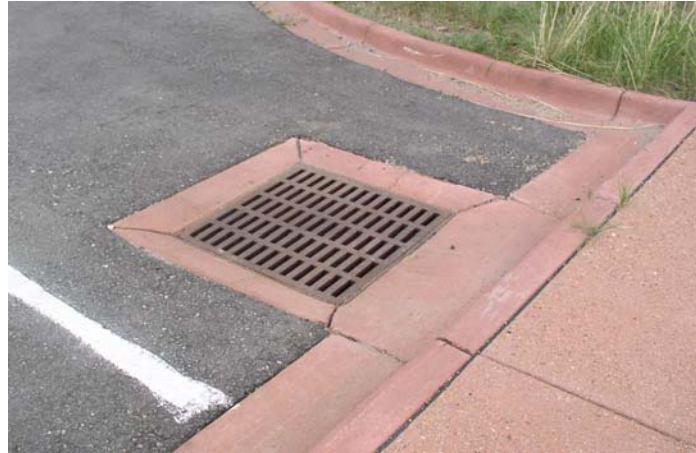
Steel drains match the color of the building's structural steel. (NPS-ROMO photo)

Assure water does not splash against the building and that trees and shrubs do not hold moisture against the Cor-Ten.

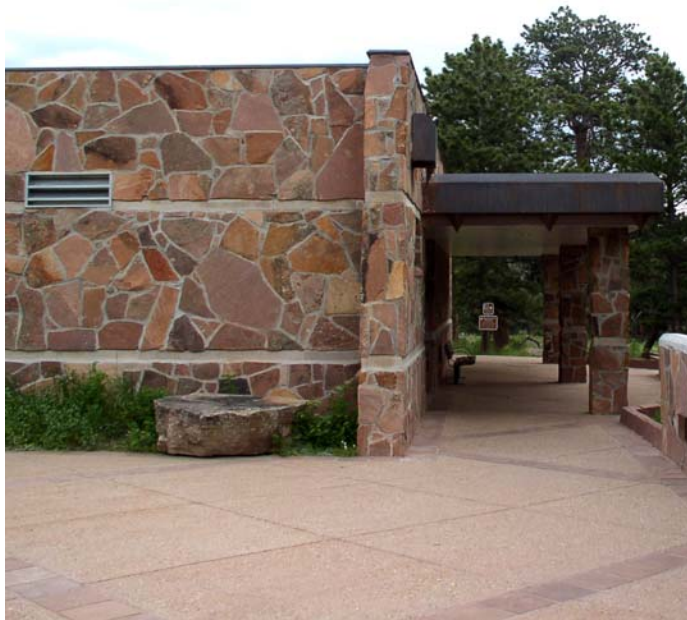
**below:** Like the visitor center, the comfort station uses random-laid native stone, horizontal lines, and decorative accents. (NPS-ROMO photo)

The design was intended to be subordinate and visually unobtrusive. The bunker-like building is concrete block veneered with sand stone. The concrete between the stones has a smooth texture. Decorative accents on the building are copper that weathers to a dark brown patina, since weathering steel was both expensive and difficult to acquire. Furthermore, a craftsman to stamp the steel was not found.

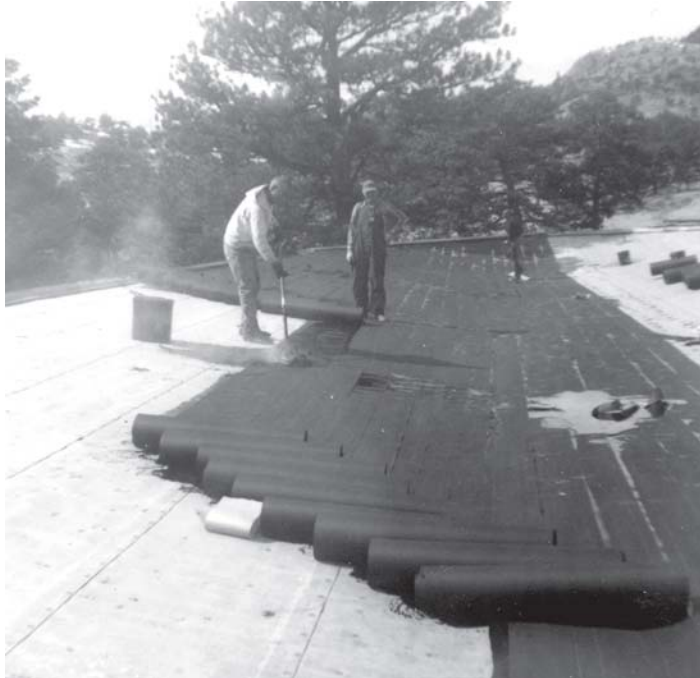
above: Installing the original rolled roof in March 1966. (NPS-ROMO photo)

Flat roofs are a common feature on Taliesin-designed buildings. The butterfly roof on the visitor center gives the building its low, horizontal profile. Although the original roof was rolled roofing with tar seams covered in lava rock, this plan assumes the roof replacement is an ethylene propylene diene monomer (also known as terpolymer) or EPDM roof covered in lava rocks. Cast iron drains are covered with small cages and punctuate through the exterior masonry walls. Steel flashing has been sealed with tar.

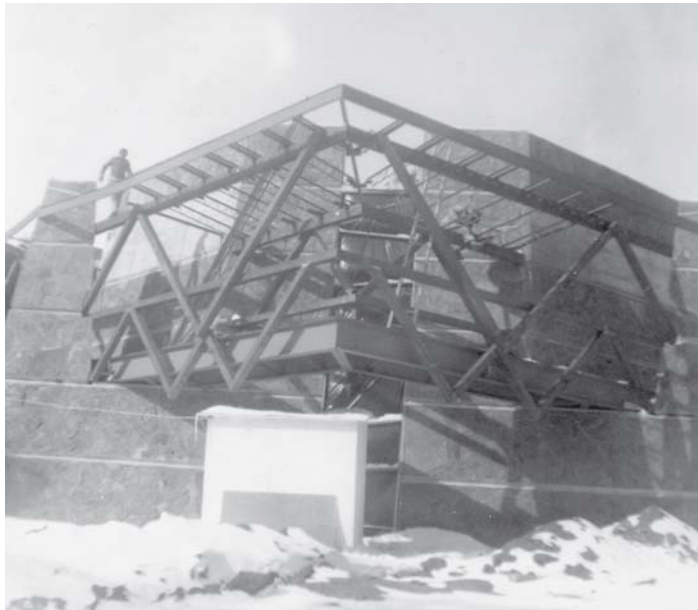
**above:** Steel tubes form the structure of the auditorium and cantilevered balcony, March 1966. (NPS-RMNP photo)

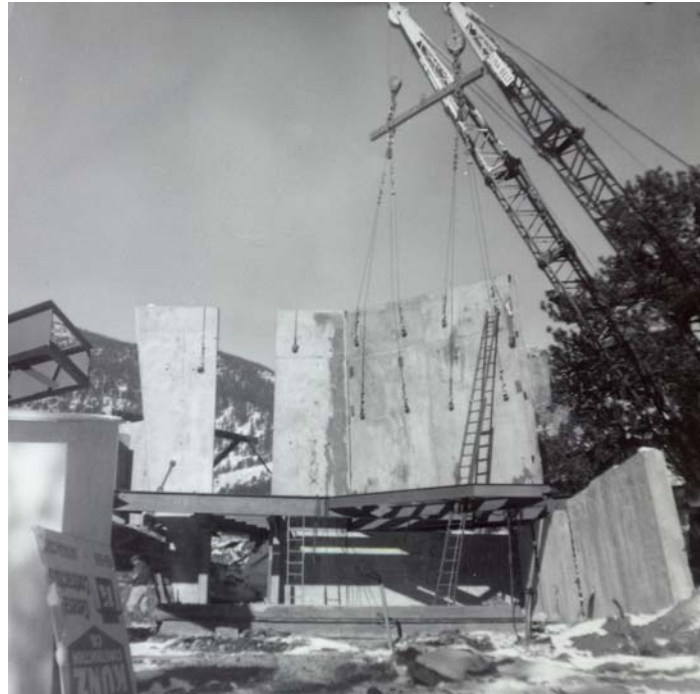
**above:** Cranes set the auditorium panel. The largest masonry panel weighted 65,000 lbs.

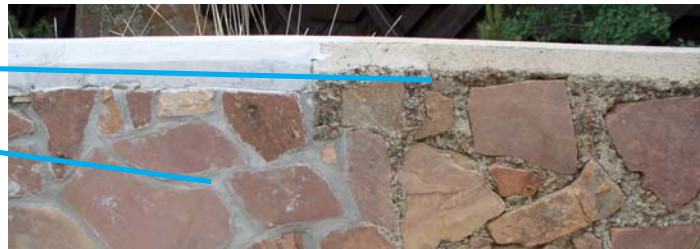
**below:** The original retaining wall at right has crumbled stone set in the mortar. The new retaining wall at left has a lighter colored concrete and lacks the crushed stone. (NPS-ROMO photos)

The original retaining wall has crusted stones between the mortar

The new retaining wall does not

As needed: New wall construction should match the original in color and finish (crushed stone).

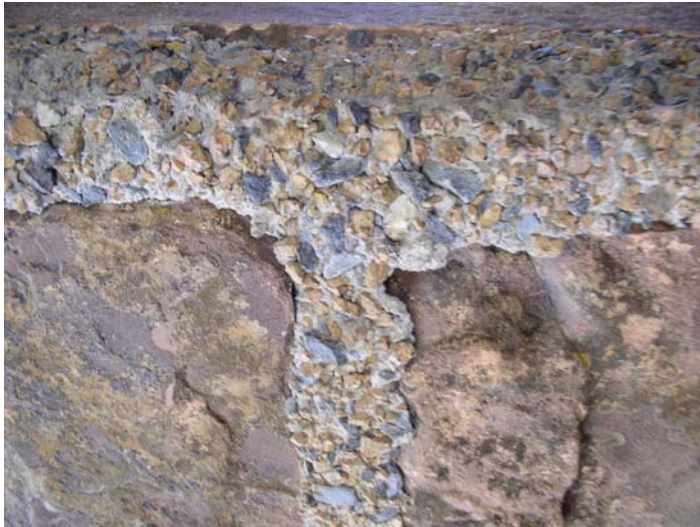
**above:** The crushed stone in the mortar is an important feature of the masonry on the building (NPS-ROMO photo)

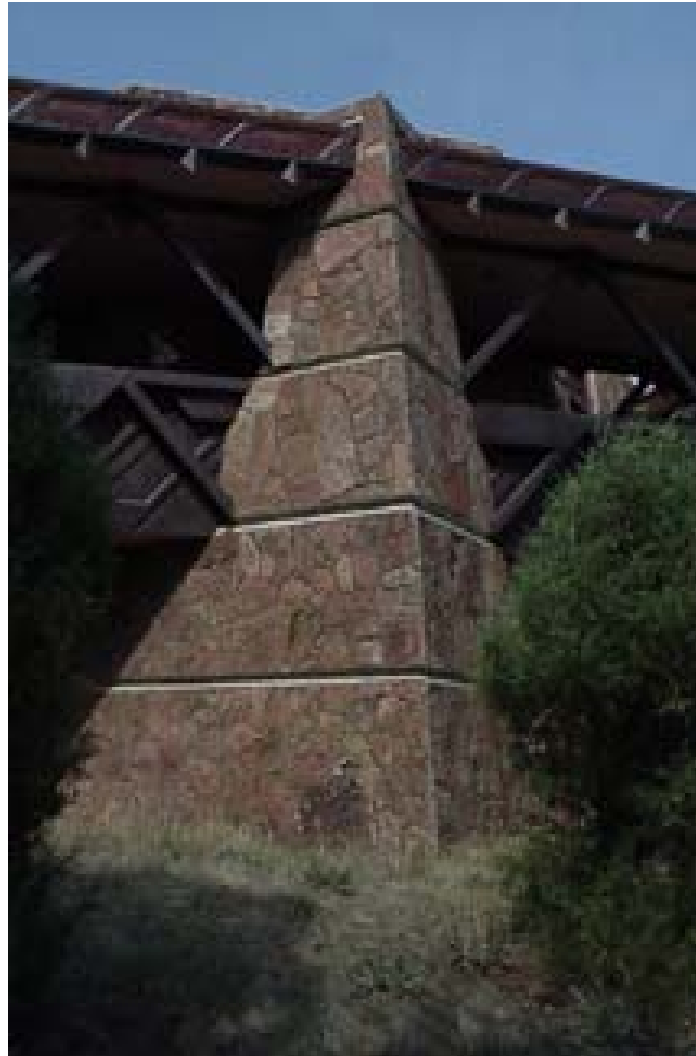
Horizontal bands in the masonry panels reinforce the horizontality of the building; they also serve as joints for where two panels meet. (NPS-ROMO photo)

As needed: Repair mortar and loose stones mixing mortar (including color and setting crushed rock) to match the original.

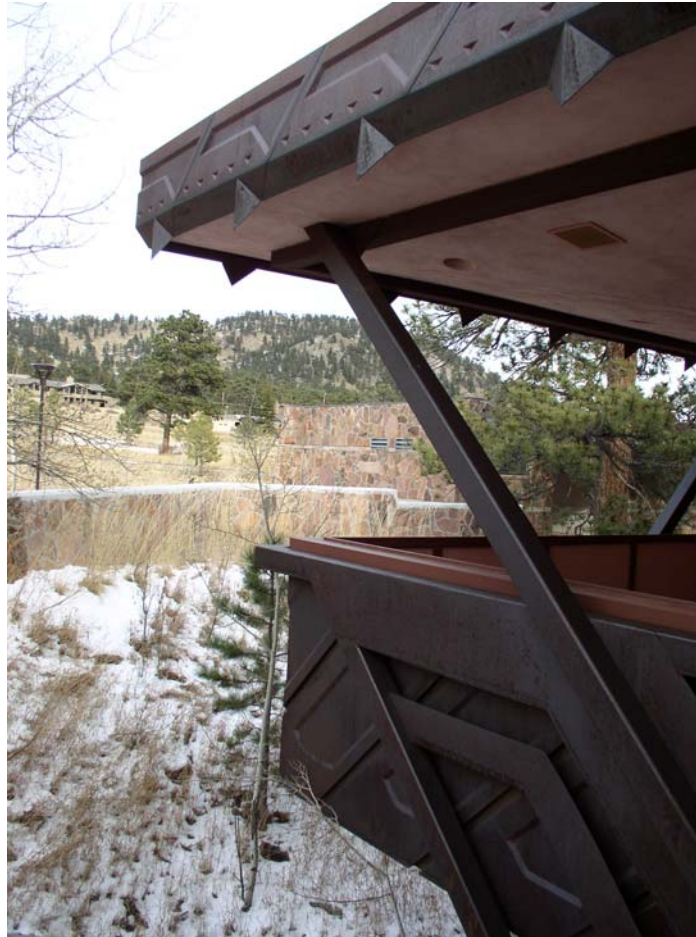
USS Cor-Ten steel's natural weathering helps it blend with its surroundings, a key goal of the design. (NPS-ROMO photo)

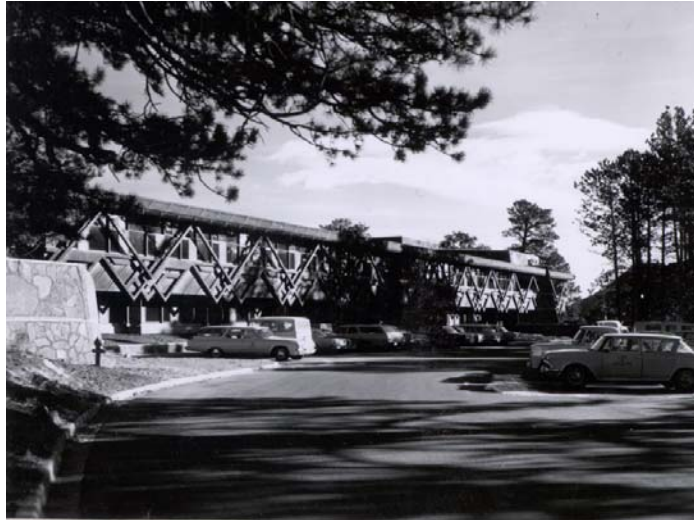
This December 1968 photo shows the rear of the building.

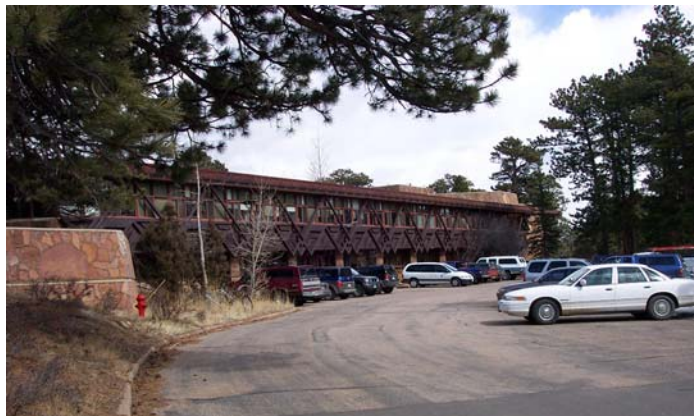
The same view in March 2005. (NPS-RMNP photos)

The band of windows reinforced the horizontality of the building. Use of steel windows emphasizes the Modern design. Sliding, steel sash banded windows envelop the building. The dark, reflective glass unifies the building and minimizes the visibility of interior partitions. Clearstory windows allow natural light to penetrate deep into the building, especially in the lobby. Heavy glass doors sit in steel frames. All the steel surrounding the windows and doors has a factory-baked, rust-colored finish. The powder coat finish provides a uniform layer, with no bubbles or streaks.

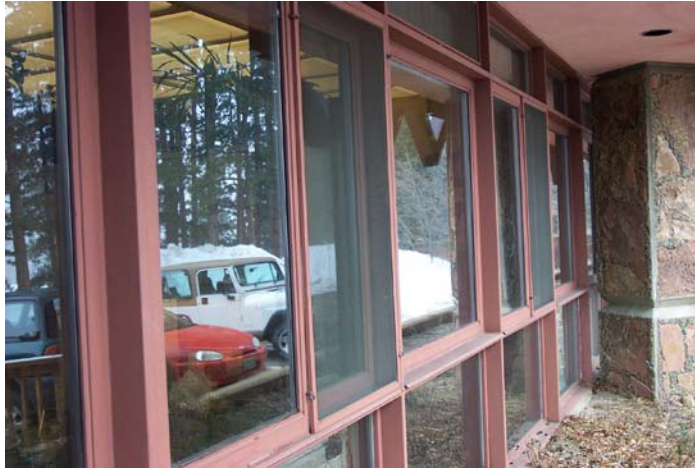
**above:** The window frames may require touch-up painting with a flat, enamel, exterior paint to match color. The screens' mesh size and color is important for creating a uniform look.

**below:** The banded windows reinforce the horizontality of the building. The glass in the building should be dark and reflective but not mirrored.

The windows and doors were all powder-coated at the factory before they were installed and should not need regular painting. However, damaged sections should be touched up with a flat, enamel, exterior paint to match color. Otherwise the window frames should not be painted.

Screens should be repaired using matching mesh size and color. Use exterior screens on half of every other window pair. The use of exterior screens on half of every other window pair should be maintained to preserve the regular pattern of the window banding.

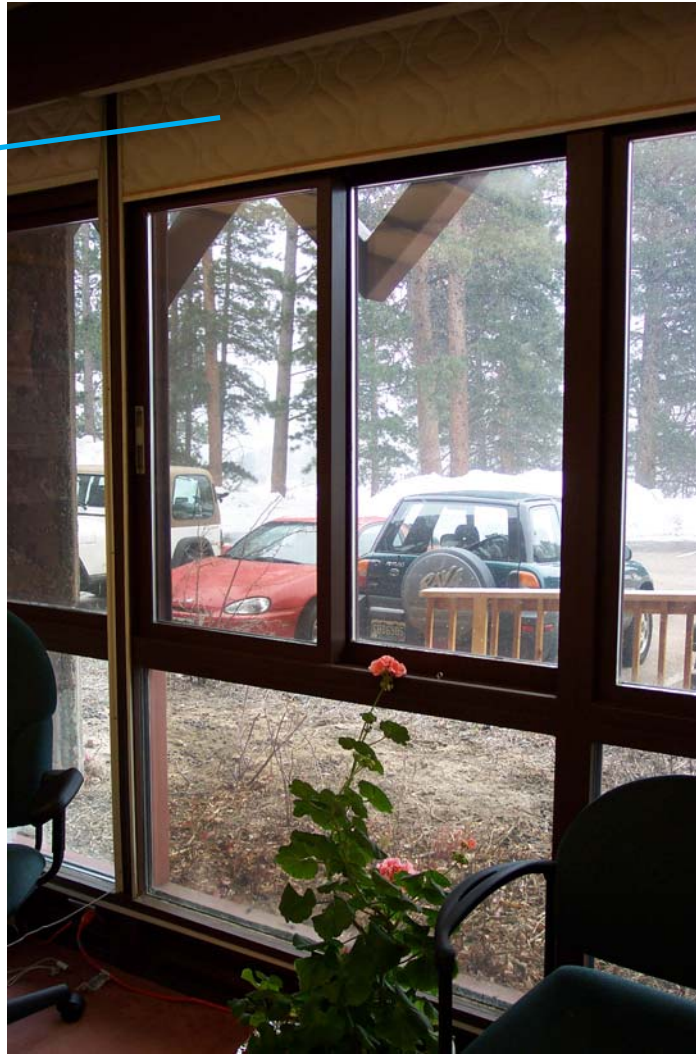
These quilted shades sought to minimize cold air seep. They are not original and should be removed.

above: Before the rehab, quilted shades provided additional insulation through single-paned windows. (NPS-ROMO photo)

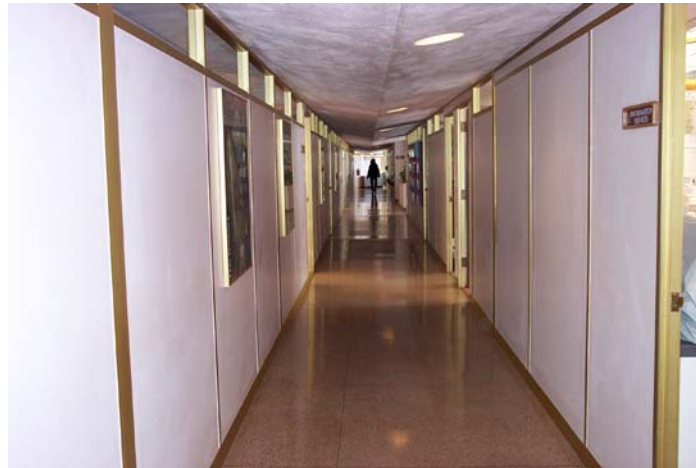
**above:** Because the interior partitions are not load bearing, spaces may be rearranged freely.

As needed: Move flexible partitions, taking care not to damage the terrazzo floor and retaining the gold trim and original doors.

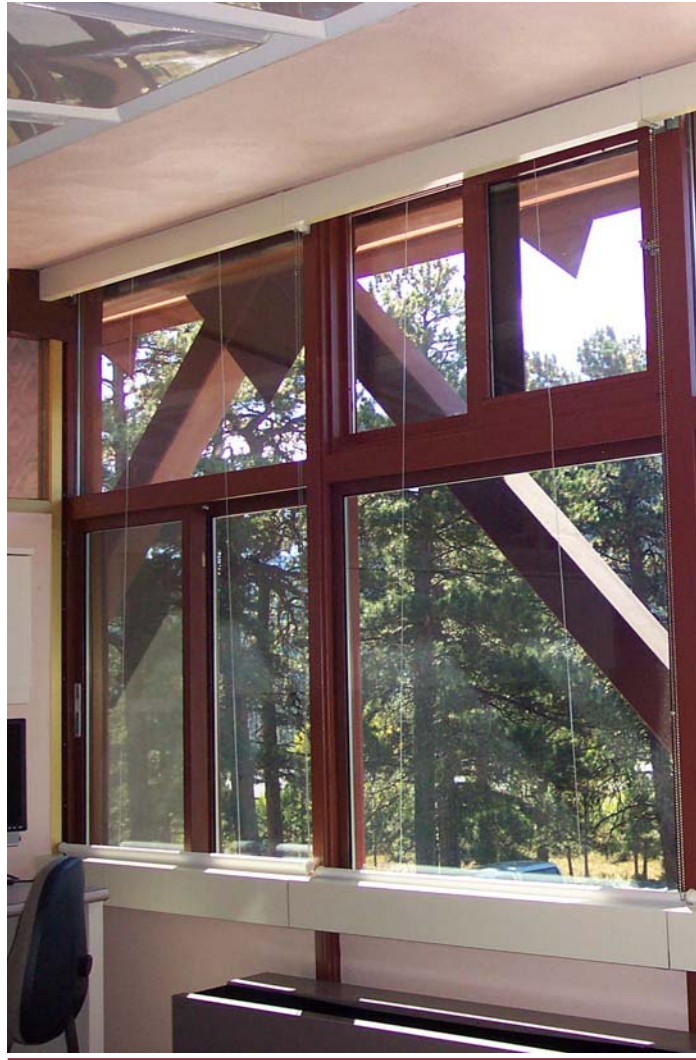
Custom-made light panels create a luminous ceiling through both bulbs and reflectivity from the clearstory windows. New glazing allows for the removal of quilted shades and opens up the view to Longs Peak. (NPS-ROMO photo)

The lights and light panels give a distinctive Modern design to the building's interior space. Lights in the corridors are recessed, incandescent with flush trim and gold anodized accents. They are flush with the plaster ceiling, whether flat or sloped. Fixtures in the bathrooms--though scheduled for replacement--should be simple, with a Modern design.

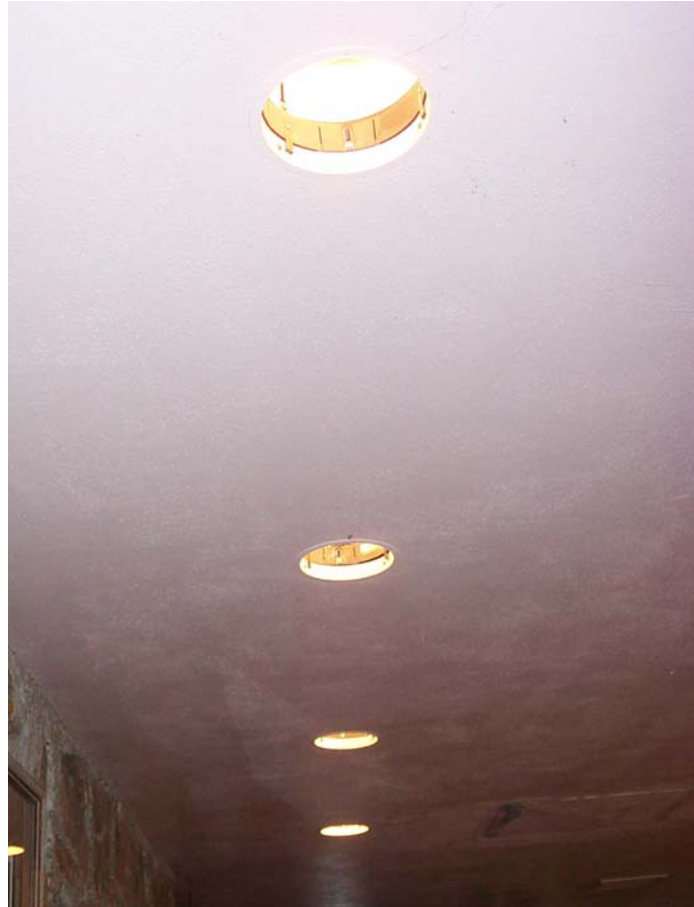
above: Recessed lighting installed in a row is important for creating clean lines.

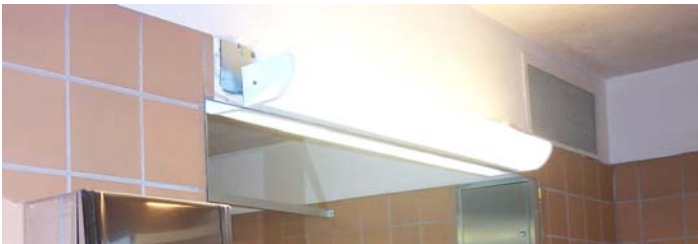
left: Original bathroom fixtures were of a simple, fluorescent design. (NPS-ROMO photos)

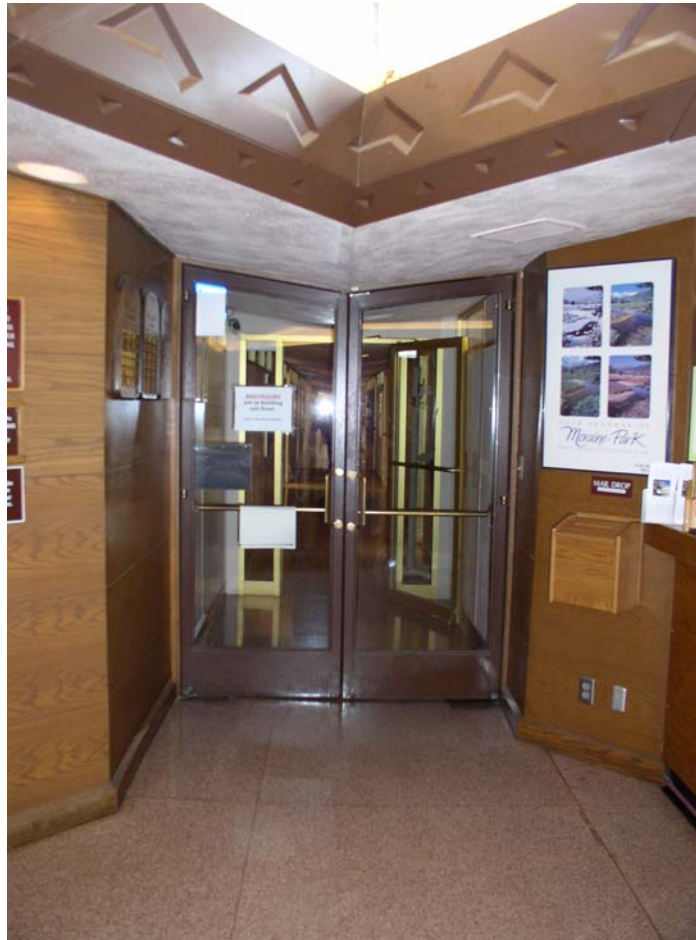
**above:** The doors into the office area from the lobby reflect the butterfly roof shape. (NPS-ROMO photo)

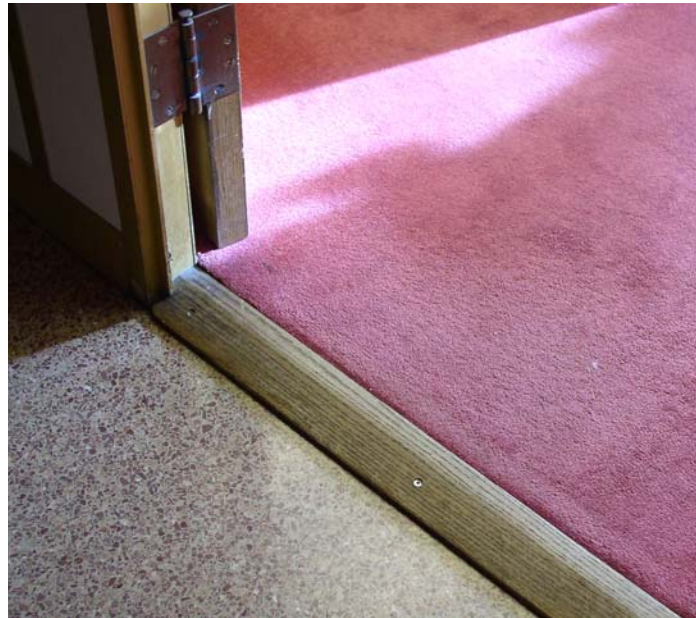
**above:** Carpeted offices meet terrazzo hallways in most of the office space. Carpets may be replaced but should be low pile and harmonious with the terrazzo. (NPS-ROMO photo)

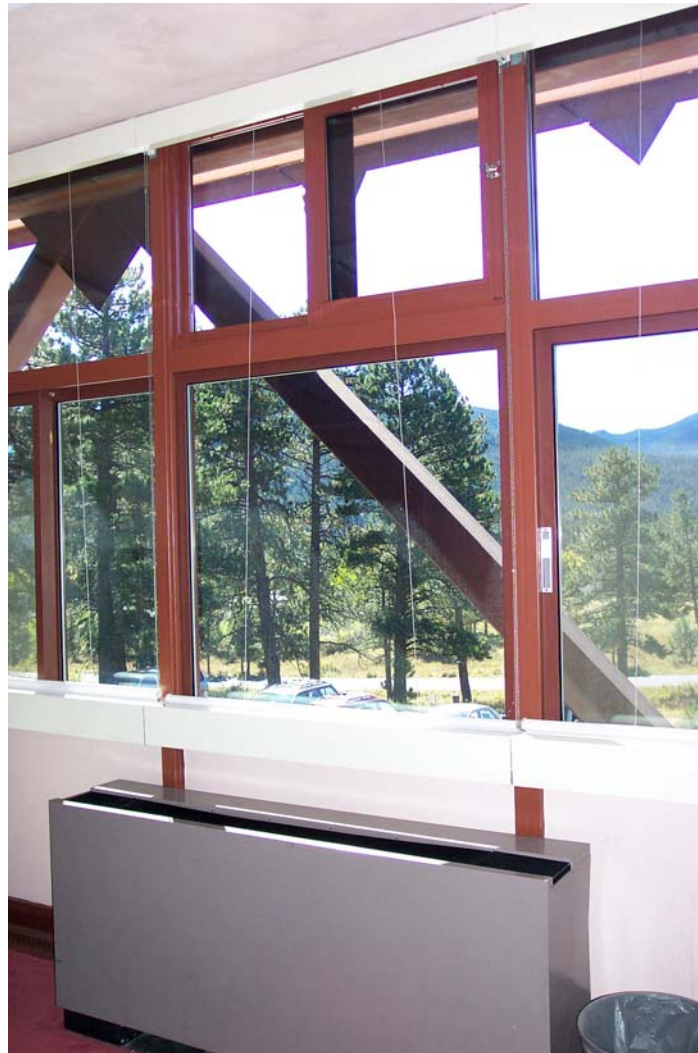
Wall vents have been supplemented by fan coil units that take up additional space. New HVAC throughout will correct this deficiency. (NPS-ROMO photo)

Superintendent Lyles, at the time of construction, did not believe that air conditioning was necessary to the building. Soon after the building opened, the park determined it did need air conditioning and that the heating system was not working properly. Retrofits and fixes to the HVAC system have occurred continuously since the building was constructed. This plan assumes a complete rehabilitation of the HVAC system.

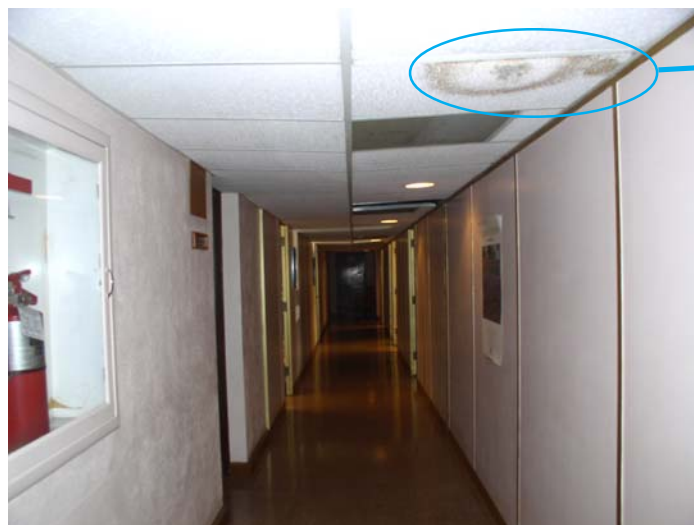
below: the lower corridor. (NPS-RMNP photos)

Water damaged ceiling tiles should be replaced in-kind

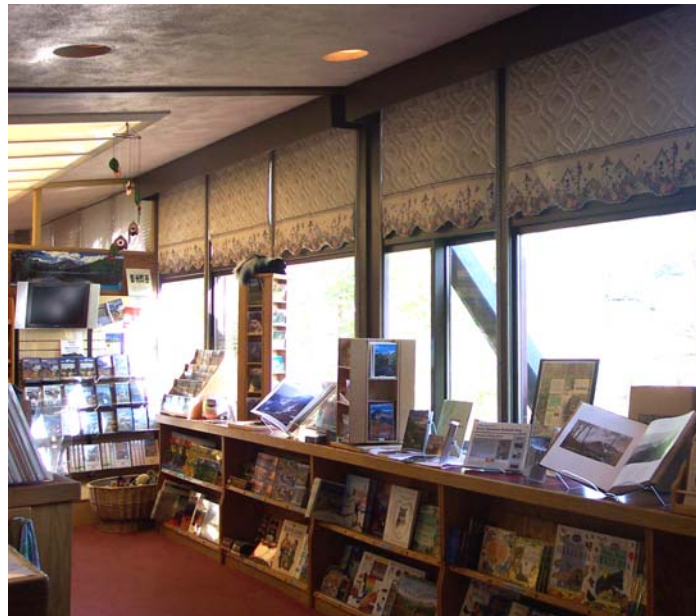
below: The small bookstore uses oak shelving to match the rest of the building. (NPS-ROMO photo)

Build new bookcases in oak veneer finished in a honey stain.

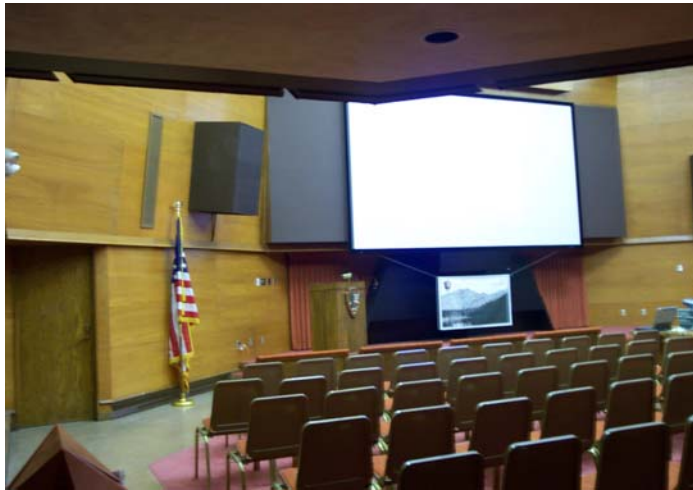
**above:** The furnishings, oak paneling, light ceiling, and terrazzo floor are important features of the auditorium. Original chairs are shown above. (NPS-ROMO photo)

The ceiling should remain white or light colored. Wood surfaces should not be painted. Any repairs or replacement of oak paneling should be in-kind being careful to match the grain and honey color stain.
