# Water Quality Summary, 2016

## Overview

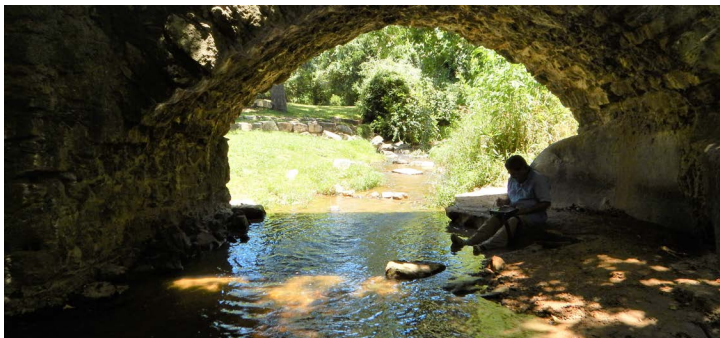
**Figure 1.** A San Antonio River Authority hydrologist records water-quality data at Piedras Creek under the Acequia Espada aqueduct, June 22, 2016. Image by San Antonio River Authority.

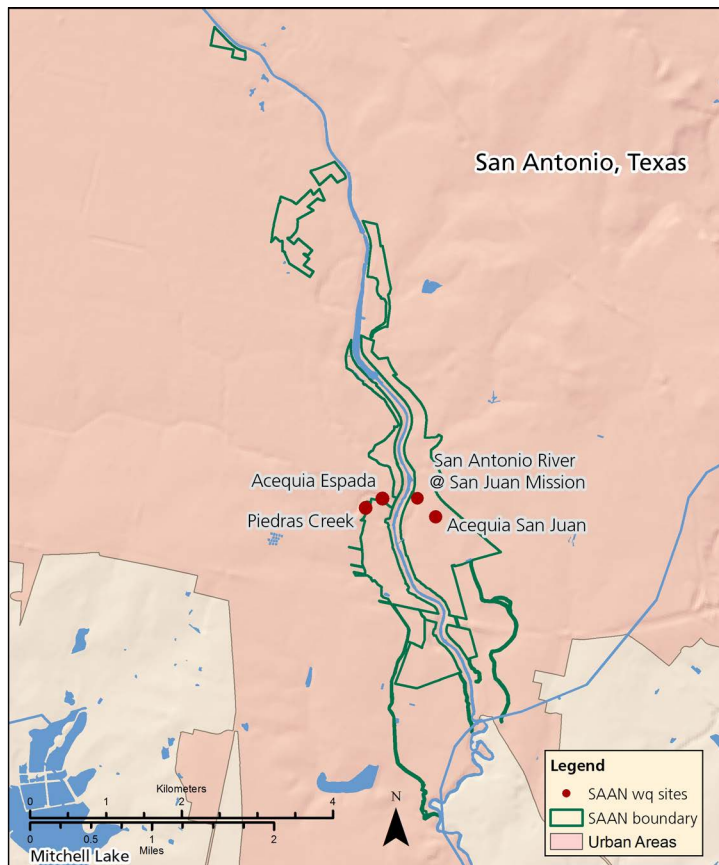
**Figure 3.** Map of San Antonio Missions National Historical Park water-quality monitoring sites.

The network began long-term monitoring of water quality at San Antonio Missions National Historical Park in October 2008. Water quality is measured bi-monthly at four park sites—Acequias Espada, Acequias San Juan, Piedras Creek, and the San Antonio River at San Juan Mission—through a contract with the San Antonio River Authority. Monitoring is conducted concurrently with that of the Upper San Antonio River Texas Clean Rivers Program (CRP). Parameters are the same as the Upper San Antonio River and include standard field measures (water temperature, specific conductance [SpC], dissolved oxygen [DO] and pH) and laboratory analysis for key ions and nutrients.
