National Park Service  
Cultural Landscapes Inventory  
2008

Roosevelt Lodge Historic District  
Yellowstone National Park

## **Inventory Unit Summary & Site Plan**

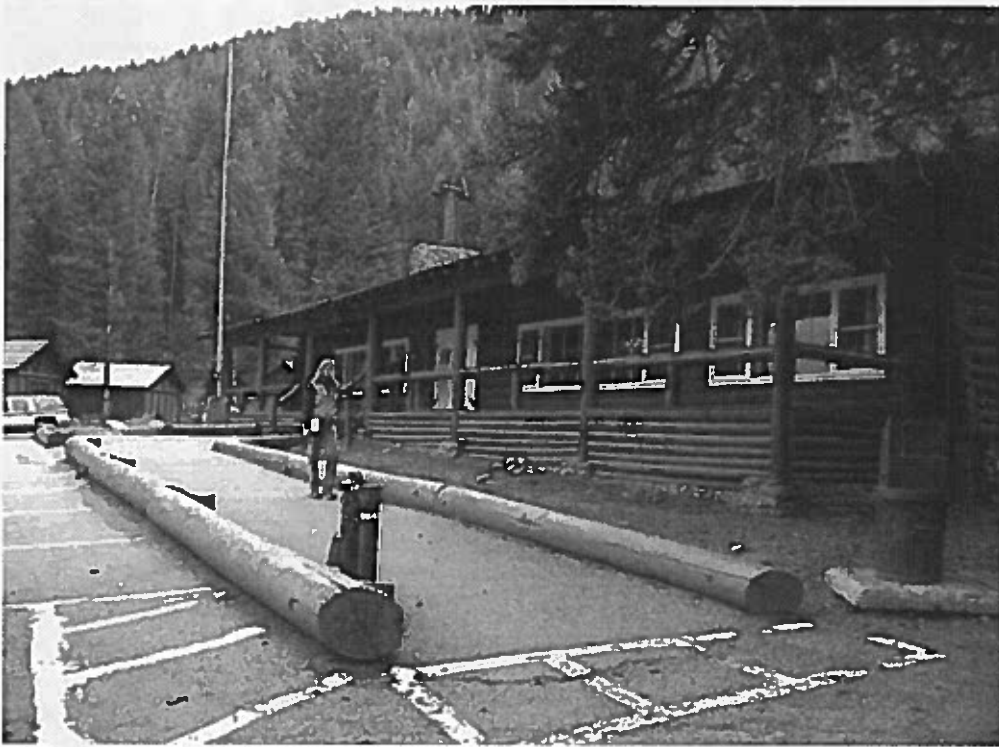
*Built in 1919-1920, the Roosevelt Lodge remains the central building in the district. The walk and log curbing in this view are non-contributing. Source: Shapins Associates, 2004.*

The Yellowstone Park Company built the lodge in 1919-1920. Ultimately, Roosevelt Lodge was the smaller of the lodges built in Yellowstone National Park (Culpin 1982). Executed in the Rustic Style, the lodge is of horizontal log construction, and features large stone chimneys and a deep porch. In October 1919 the Superintendent's Monthly Report proposed to make the area "something of the order of the 'dude ranch' of the West" (Culpin 1982). The lodge was to be the center of this complex, surrounded by Rustic structures for accommodations. Strictly speaking, the buildings and landscape at Roosevelt Lodge constitute a lodge complex rather than a dude ranch. (The lodge is primarily a form of tourist accommodations, while a dude ranch is a ranch that caters to tourists on a reservation basis.) Yet the general arrangement of buildings and their rustic character is evocative of a dude ranch, even to this day.

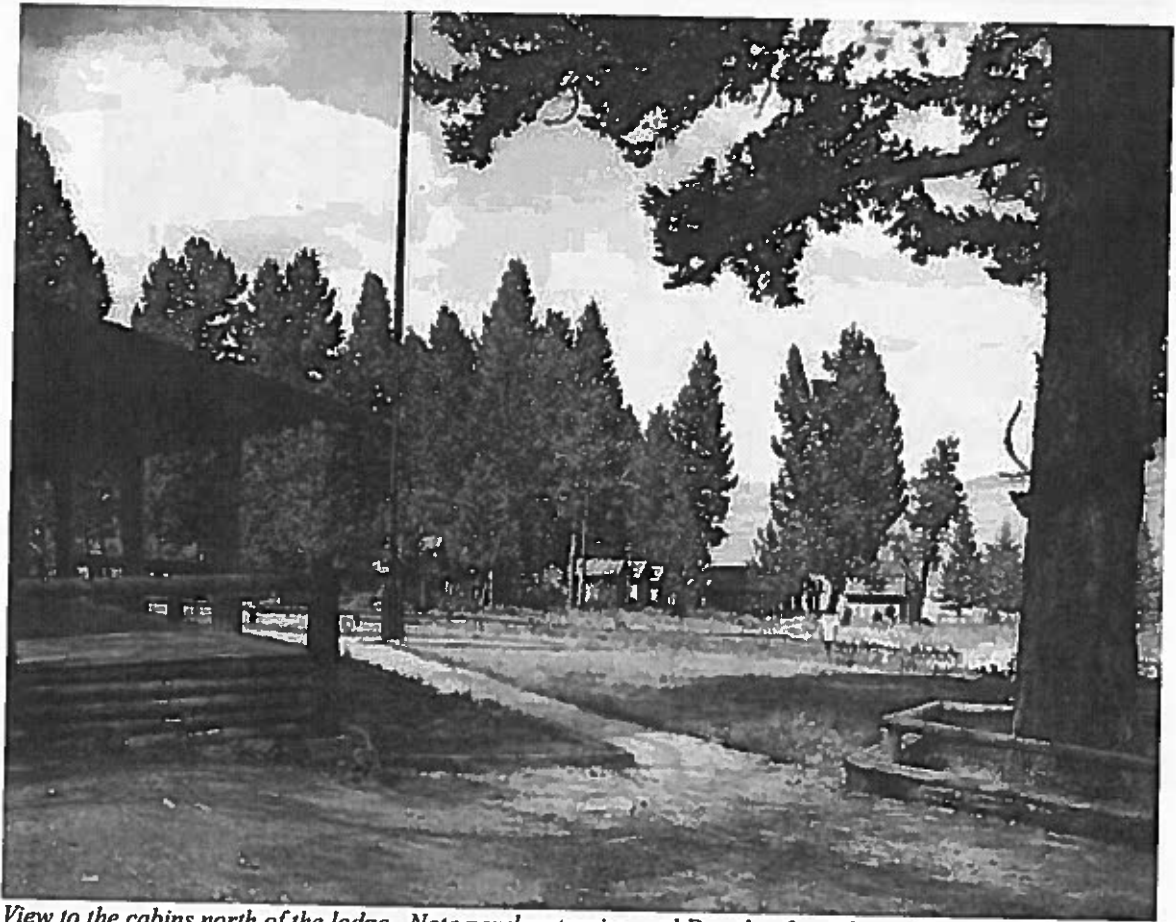
*View to the cabins north of the lodge. Note porch extension and Douglas-fir with seat/fence (not extant today). Source: Montana State University Library, Merrill G. Burlingame Special Collection, circa 1924-1929, photo 220.*

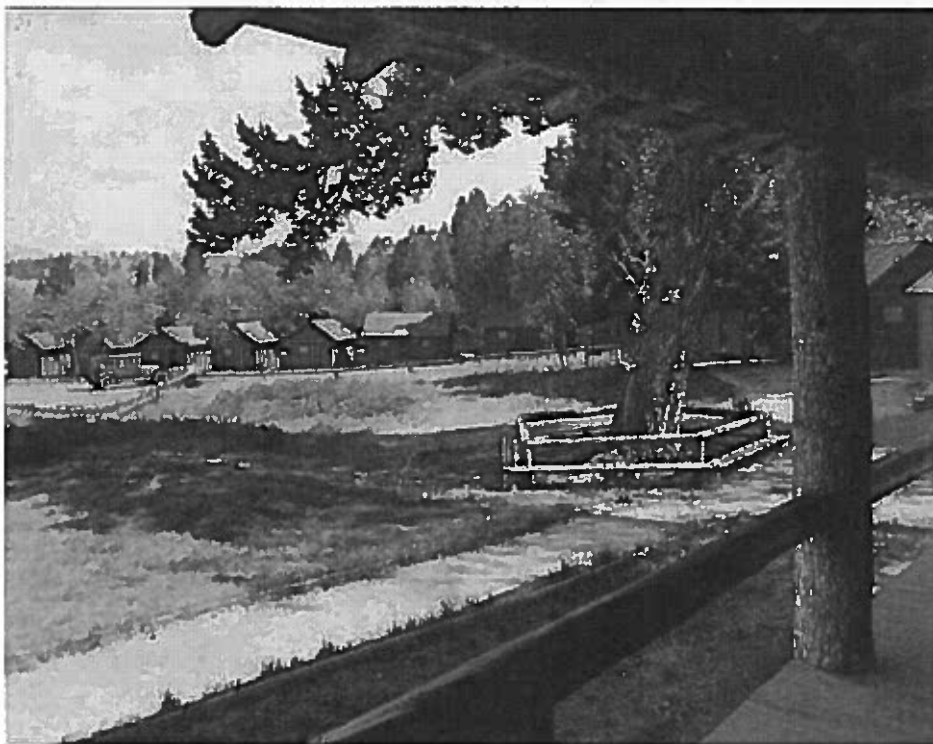
*Historic view of walkways and raised log curbing, which appears to meet the antler fence and defines a parking area. Source: Montana State University Library, Merrill G. Burlingame Special Collection, circa 1924-1929, photo 219.*

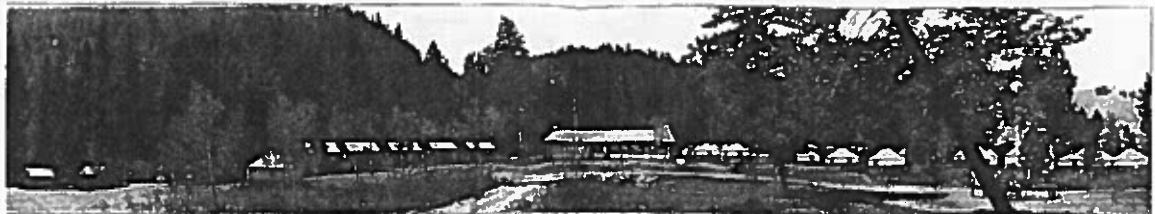
*View of Camp Roosevelt from YPCC promotional pamphlet, 1923 season. Log cabins at base of slope are established, while other cabin areas are occupied by tents and other type cabins. Source: YELL archives.*

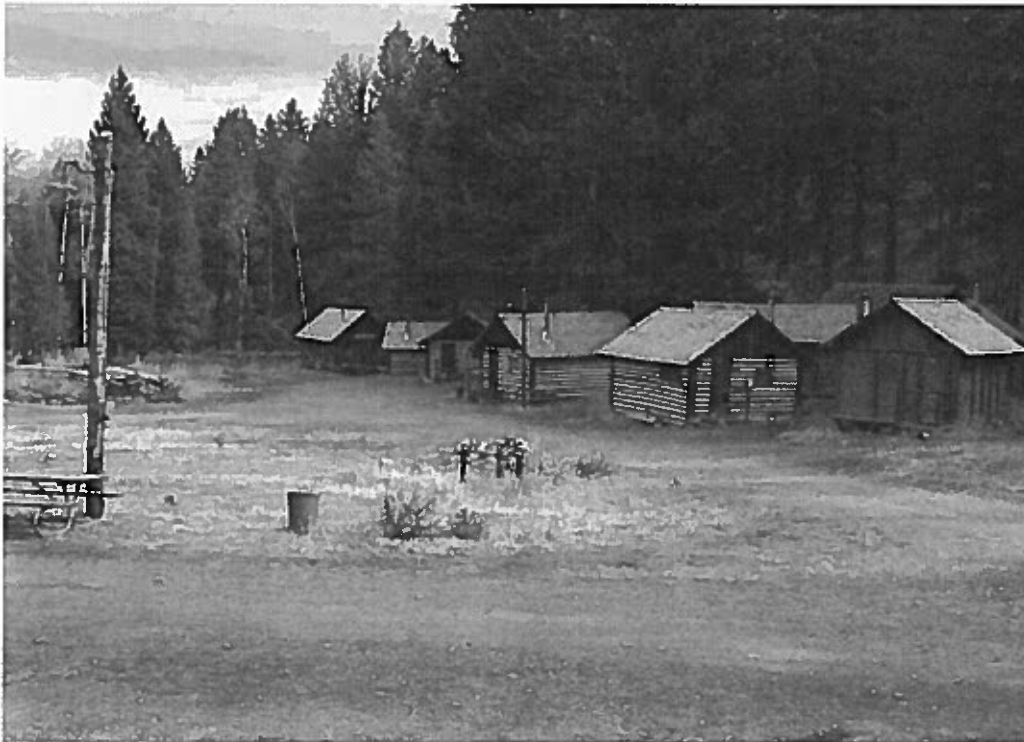
*The cluster of log cabins in Cabin Group A were some of the first buildings erected at Roosevelt Lodge. Over time, many frame cabins were brought to this area from other sections of the park. Source: Shapins Associates, 2004.*

Cabin Group A is composed of a number of Rustic cabins that form a very irregular line at the base of a steep slope. The organization of this cluster is very loose: the size and orientation of the buildings vary. One rustic-frame "logs-out" cabin in this group was constructed as early as 1924. Other such cabins have been added over time (McDonald Architects 1993, 24). The most conspicuous members of the group are six original log cabins, which were built about 1922. Featuring horizontal logs and white chinking, these cabins were the first cabins constructed specifically for the new lodge system at Yellowstone. Within the park, this type of cabin is unique to Camp Roosevelt (McDonald Architects 1993, 23). Cabin group A is now used for employee residential purposes.

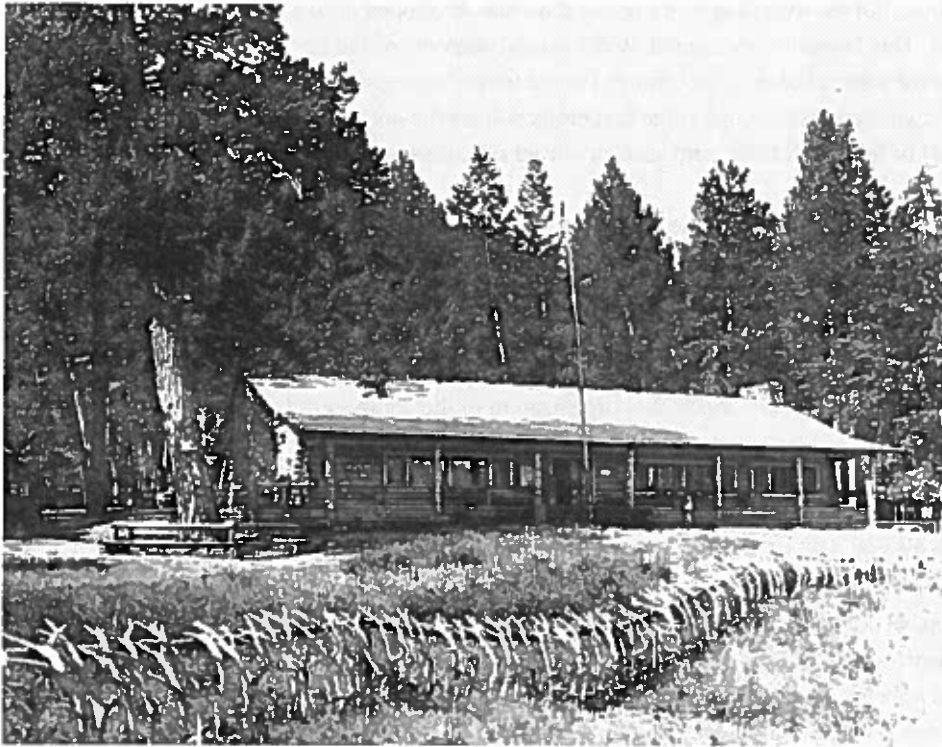
*Small-scale features include an elkhorn fence, peeled-log flagpole, and the large pentagonal seat/fence protecting the landmark Douglas-fir. Source: Montana State University Library, Merrill G. Burlingame Special Collection, circa 1924-29.*

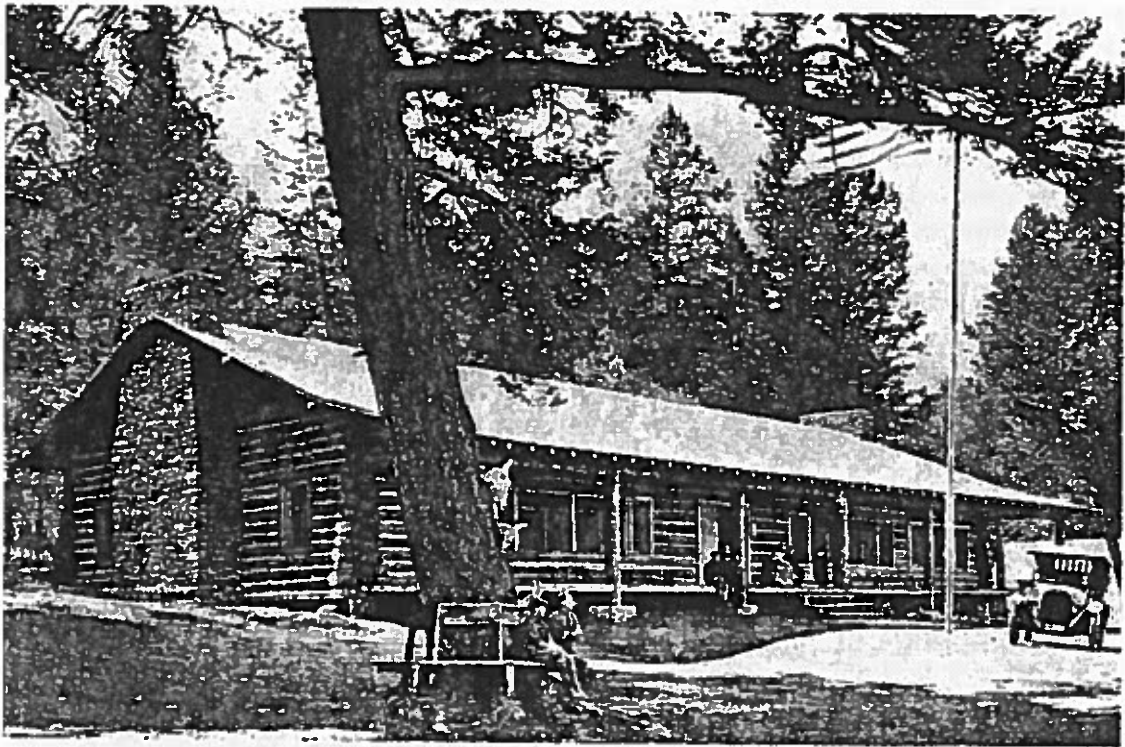
*Roosevelt Lodge soon after completion with landmark Douglas-fir and early, primitive version of seat encircling it. Source: YELL archives, pamphlet for Yellowstone Park Forest and Trail Camp for 1921 season.*

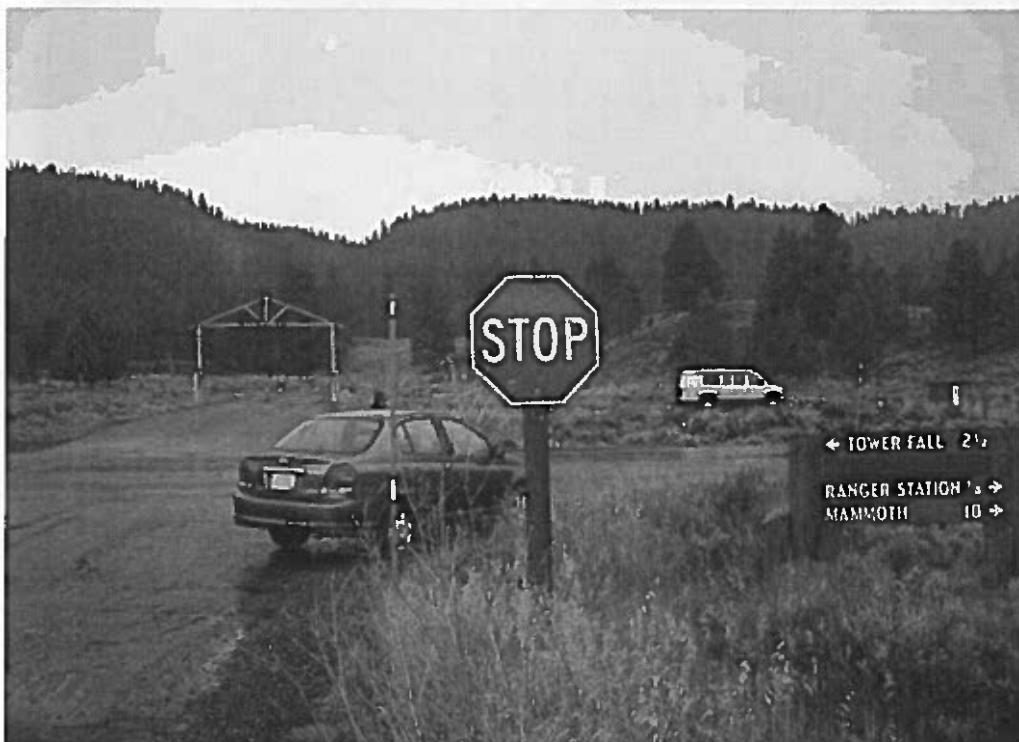
*At the junction, the lodge is obscured from view, but a log gateway erected in 1961-1962 (outside the district) now announces its presence. Source: Shapins Associates, 2004.*

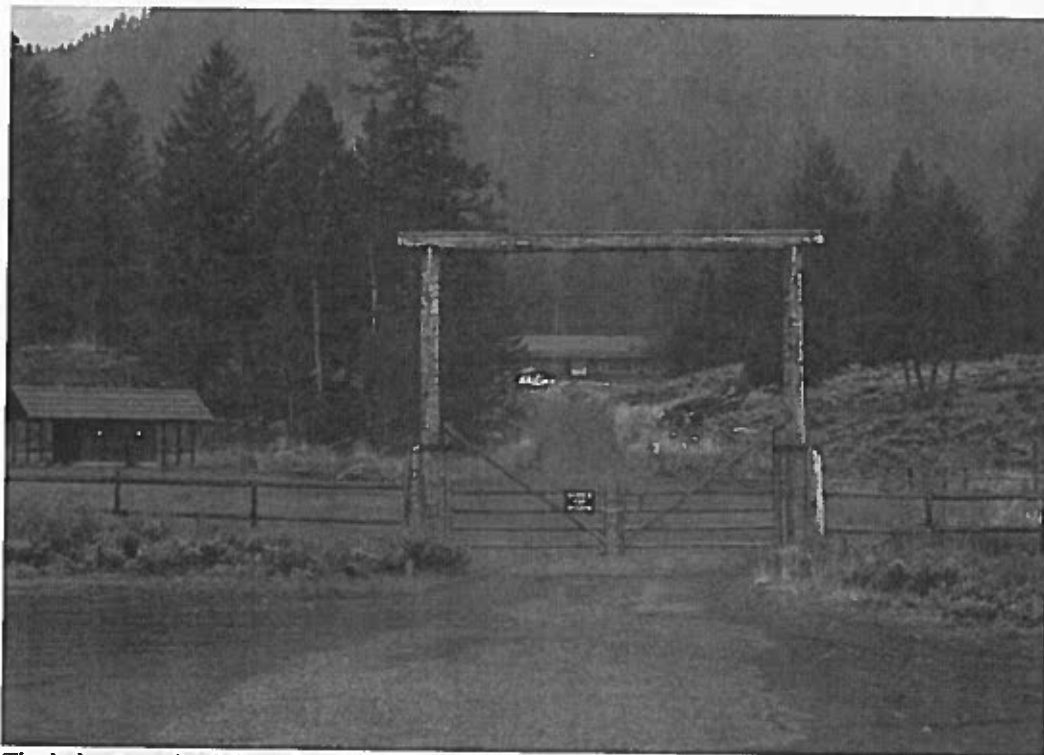
*The lodge is set back from the road, located behind a natural vegetative screen. This second log gateway frames a direct vista of the lodge from the corral area, but it was erected after the period of significance. Source: Shapins Associates, 2004.*

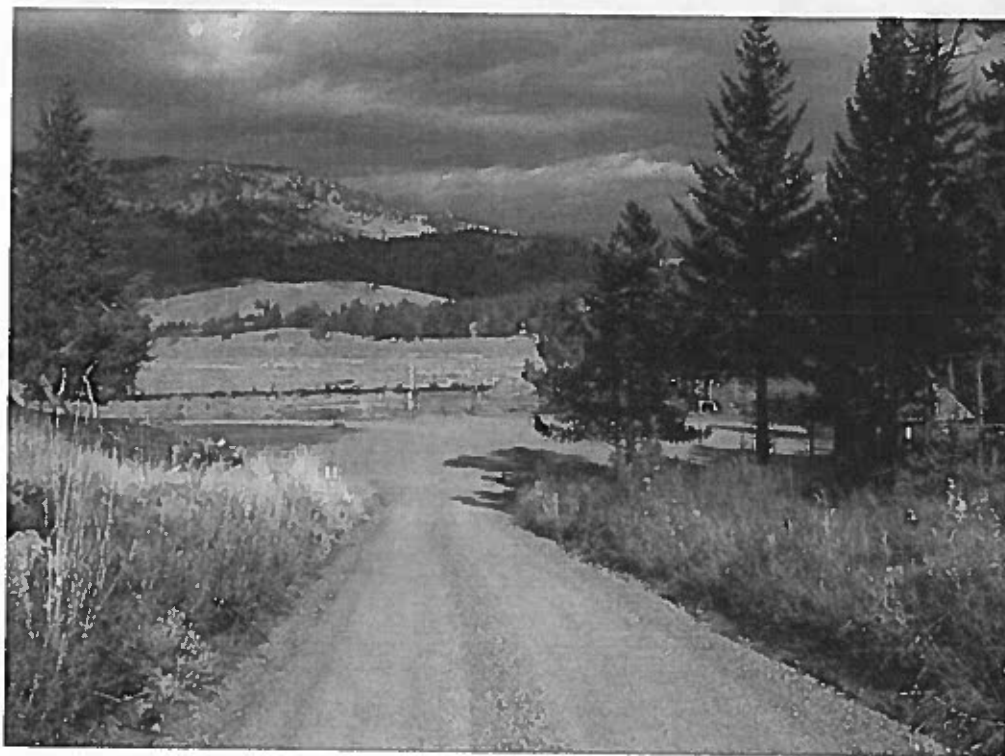
*The corral operations and staging area remain obscured from lodge views and do not interfere with distant views to the valley. Source: Shapins Associates, 2004.*

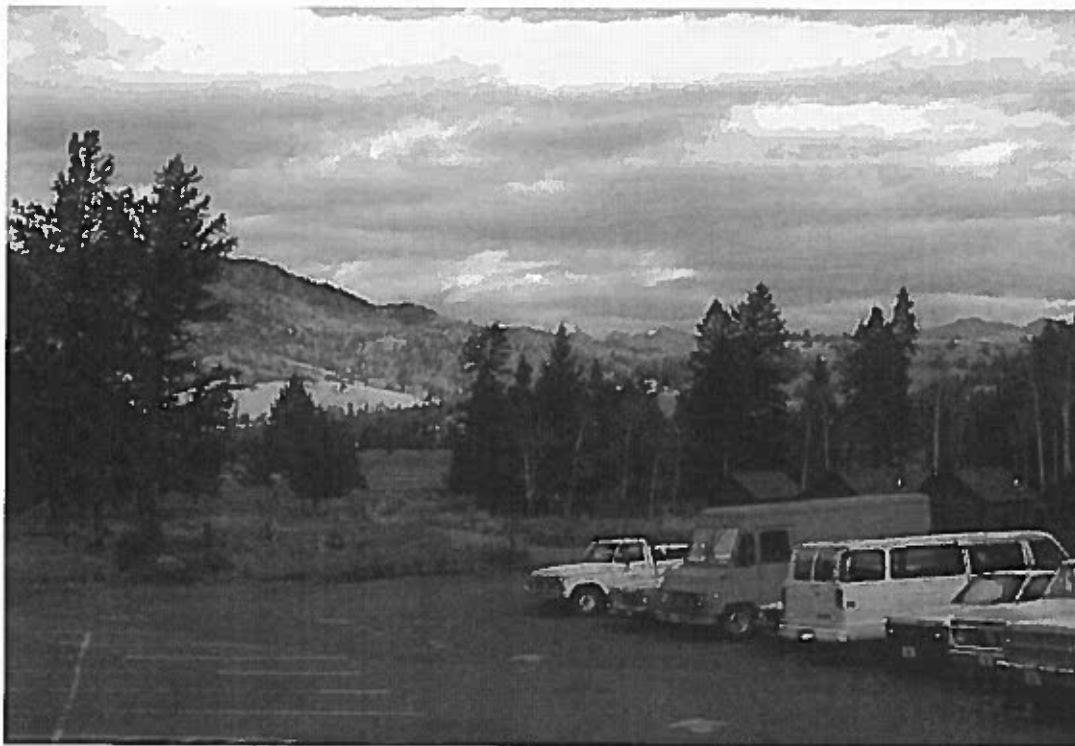
*Views from the lodge porch have been compromised by the asphalt parking area. Source: Shapins Associates, 2004.*

Today, the asphalt parking lot is a large and conspicuous feature that does not reflect the historic circulation system. In places, very large, peeled log curbs define its edges. The lot extends quite close to the lodge building, and wraps around its side to the service area. A wide asphalt walk runs the length of the building façade, only separated from the asphalt lot by one of the log curbs. Other walkways that lead to important buildings are also asphalt and lined with (smaller) peeled logs. Near the lodge building itself, the walk system does not reflect historic conditions. Gravel roads service the cabin areas. Just northwest of the main lodge, a curved informal gravel lot serves many employee cabins. This gravel lot is separated from the main lot by only a thin grassy strip. Combined with the asphalt parking lot and the wide asphalt path, the inescapable impression of the area in front of the lodge is of a broad expanse of paved surface.
