## Burned Area Emergency Response (BAER) Plan Mud Lake Complex

Unit: National Park Service, Big Cypress National Preserve, FL

Date: May - July 2015

Incident Number: Mud Lake Complex: PFFSJP9X0

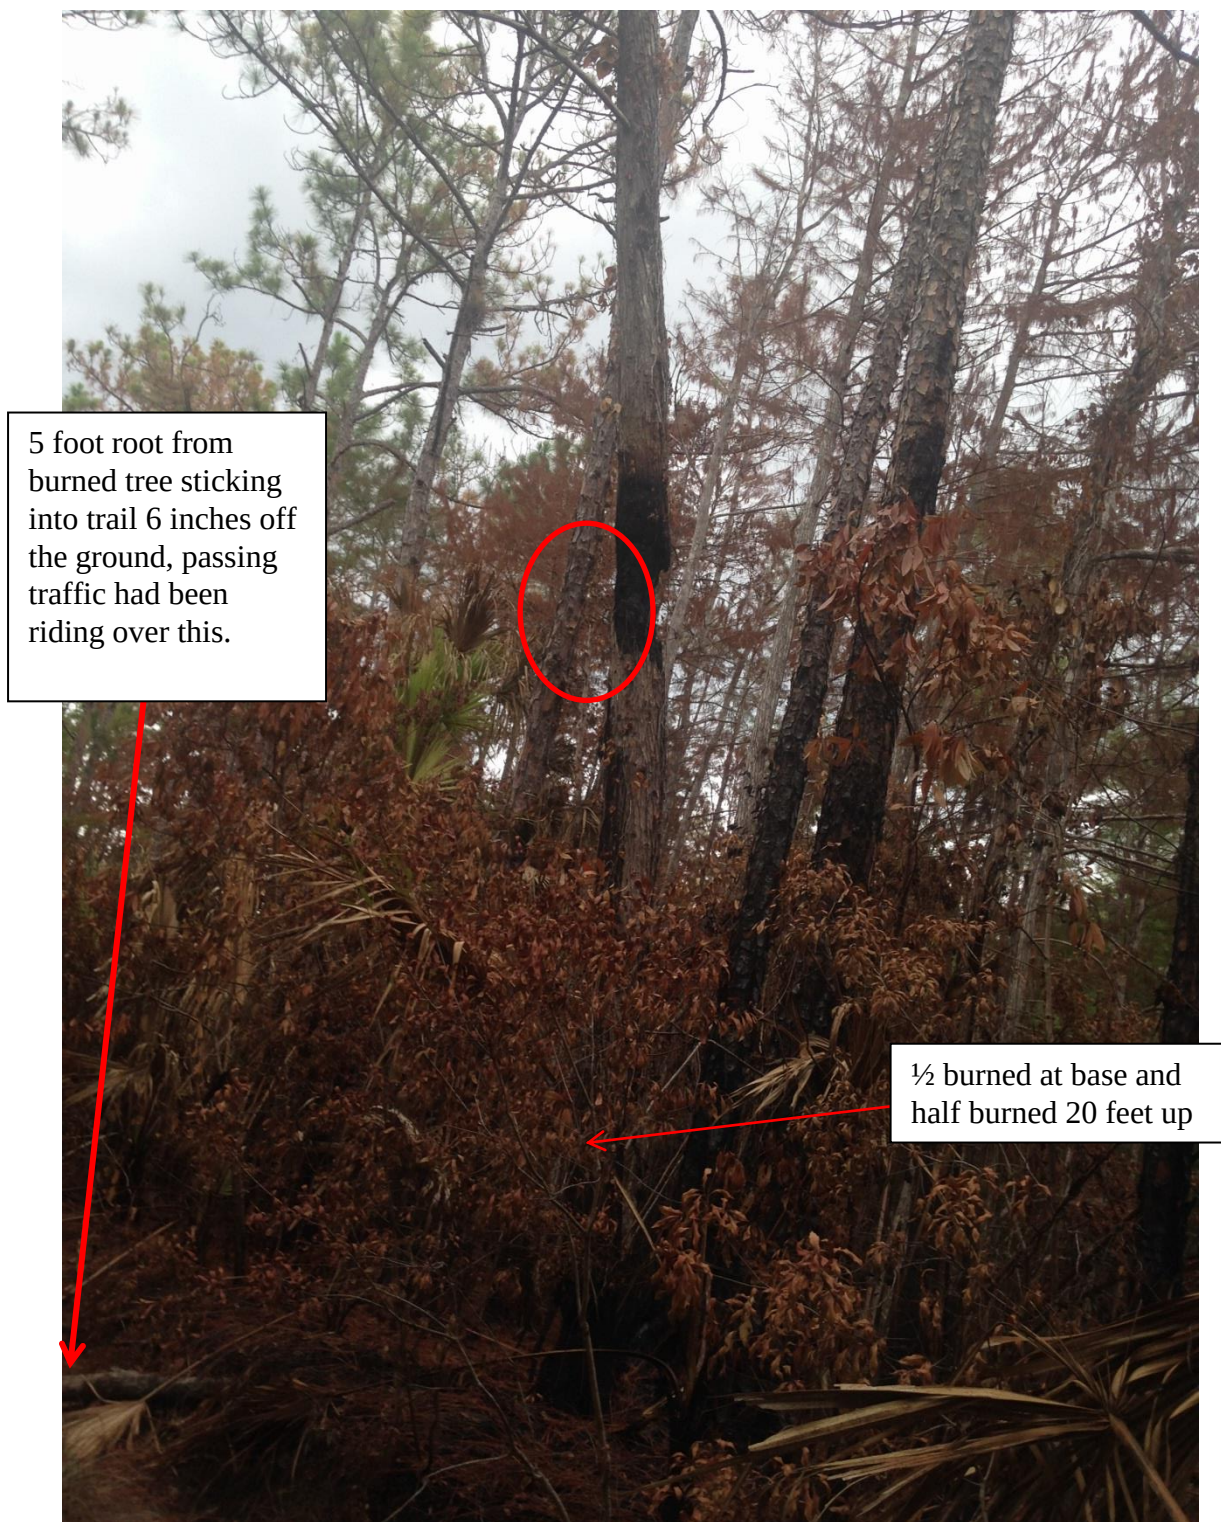
5 foot root from  
burned tree sticking  
into trail 6 inches off  
the ground, passing  
traffic had been  
riding over this.

½ burned at base and  
half burned 20 feet up

Hazard tree along the Monument Trail, fire management crews removed this tree

**Hazard Trees:** Land managers have a responsibility to assess and remove trees that have become hazardous due to fires in areas of public use and in areas where employees will be working. Observation and information from local resources suggests that hazard trees are not a tremendous issue because many of the burned trees harden and stay standing for years providing excellent wildlife habitat. Still an assessment must be completed to determine which trees are an eminent threat to employee and public safety. Burned trees along a trail corridor do not automatically become hazard trees to remove. Trees that clearly and obviously will fall across the trail or are in close proximity and appear unstable should be removed in areas where crews will be working to restore the trail tread or at trail junctions or anywhere else that the public or employees would be inclined to stop along the trail. The amount and type of hazard trees to be removed should be determined through discussions with those qualified employees completing the assessment and trail managers who understand use patterns and maintenance needs. All of the Hazard Tree Assessment work should be completed as soon as possible and before the area is reopened to the public.

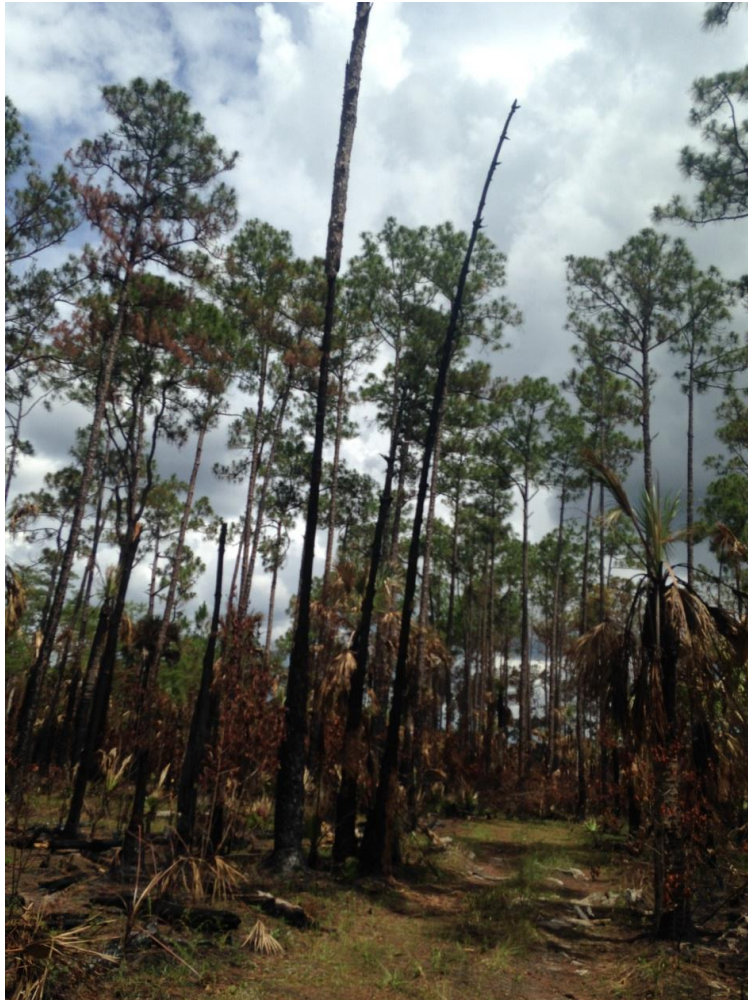
Hazardous Trees along the North end of the Boot Hill West Trail

**Boot Hill West:** This trail was completely burned and was rough before the fire, but passable. No tread repair funds are being requested as fire traffic did not use this trail heavily. The primary concern on this trail is signing and hazard tree assessment and removal.

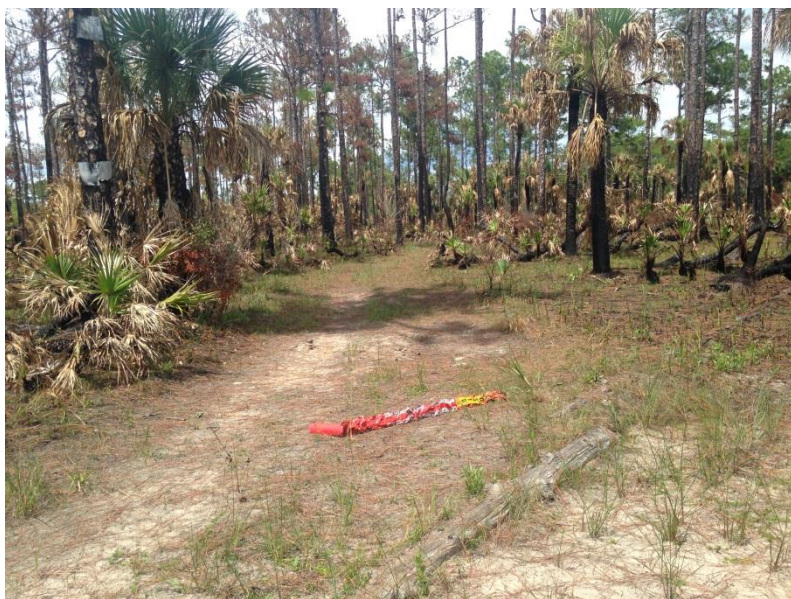
**Melted Sign on Little Deer Trail**

| Approximately 15.1 miles of trail impacted by the Ellison fire is in need of heavy sign replacement and/or repair. Signs have been destroyed due to fire or run over by fire vehicles. Signs fabrication will be contracted out. NPS Day-labor staff will repair/replace signs. |

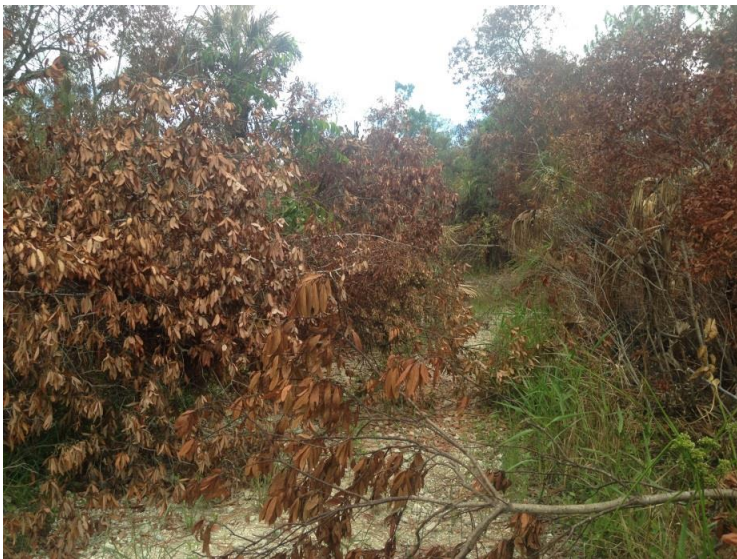
**Worst brush on Little Deer Trail**

**Little Deer Trail:** This trail was completely within the Ellison fire. It received little fire traffic during the incident. The tread has no significant impacts. There are brushing needs and hazard tree assessments as well as some burned signs. See photo above for worst brush conditions along trail

**Brushing:** Brushing activities are being requested for trails that were within the fire areas. The brushy character of some of the lesser used trails resulted in burned vegetation laying over into the trail tread and making travel difficult, unpleasant and in some instances unsafe. The safety aspect is related to burned branches from brushing sticking directly into the trail at a height where they can act as a spear for operators and passengers of off road vehicles. Again conditions were assessed and given a qualitative rating and costs were derived. Heavy brush was costed at \$3,000/mile, moderate at \$1,500/mile, and

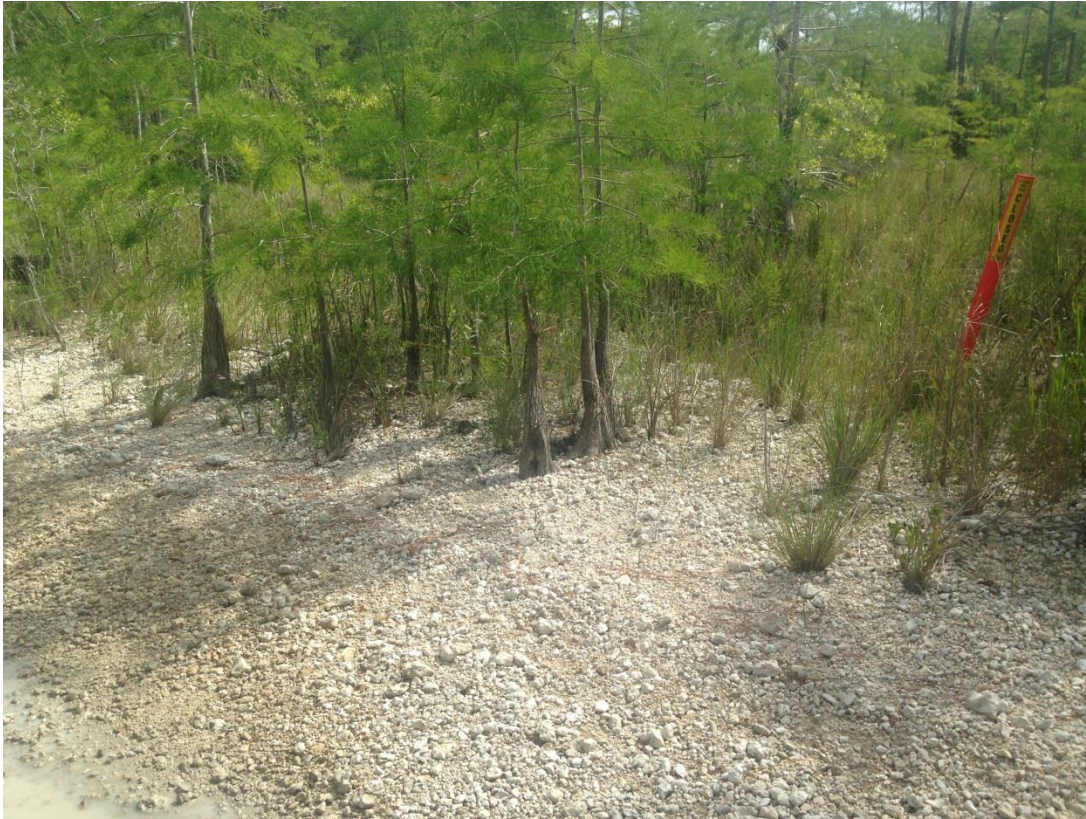
**Trail Tread:** 7 miles of this trail was newly improved by preserve crews prior to the fire, they were working on it when the fire started. This segment of trail sustained heavy vehicular traffic during fire operations. Normally this segment of road is only traveled by OHVs, UTVs, and buggys with a speed limit of 15 mph. The fire management traffic consisted of buggies with water tanks, full size trucks and engines, and many UTVs. This heavy and abnormal traffic caused damage to the newly surfaced areas by displacing the filled material outside of the trail prism. Other trails in the preserve used for fire operations access did not sustain this level of damage as they had time to setup and receive normal traffic for a year or more and sit through the wet season 60 day closure, making them significantly more resistant to damage. In many spots the material was displaced into the surrounding cypress and other

Buckskin Trail, Fresh material displaced from tread into cypress trees

vegetation making retrieval unfeasible without severe damage to vegetation. Repairs will consist of additional hauling of material and grading along many segments of this trail; some repairs can be made by grading the existing material and surface. The incident agreed to purchase 1,000 yards of material to assist with these repairs. Discussions with local trails specialist indicate that this repair work will require about 4 weeks of work by 2-3 operators with off road dumps and tractor with box scraper. With the limited time available the necessary repairs will not be able to be completed before the wet season begins.

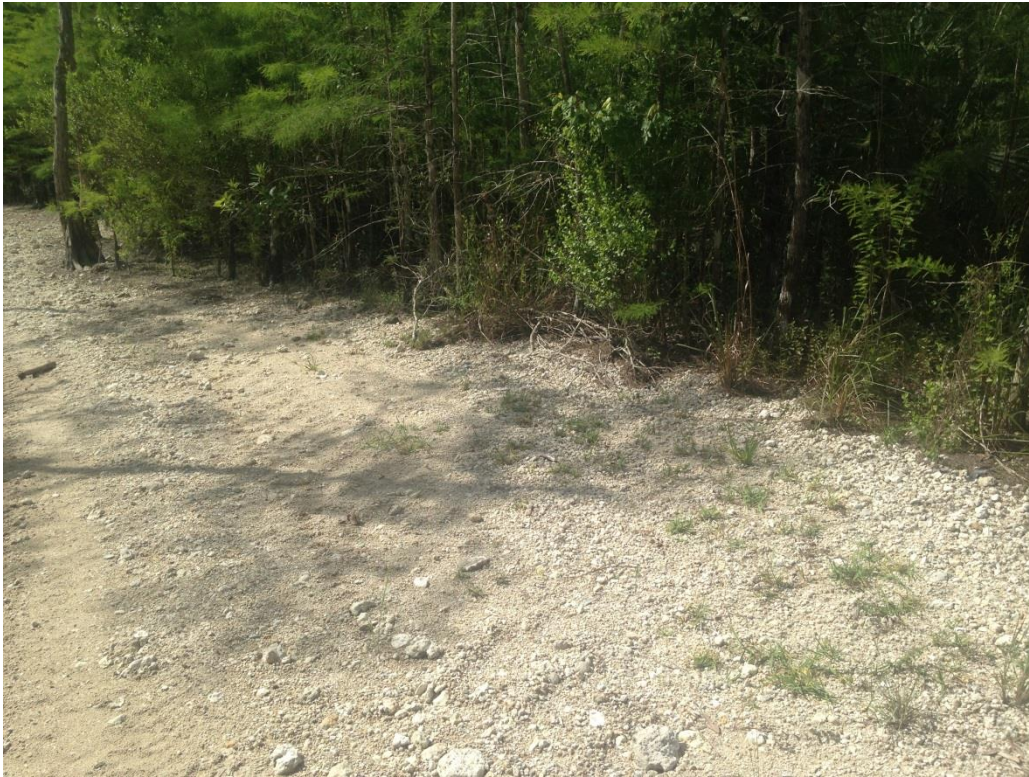
**Buckskin Trail, Some material will be reclaimed from this spot, but much of it has been lost inside the cypress**

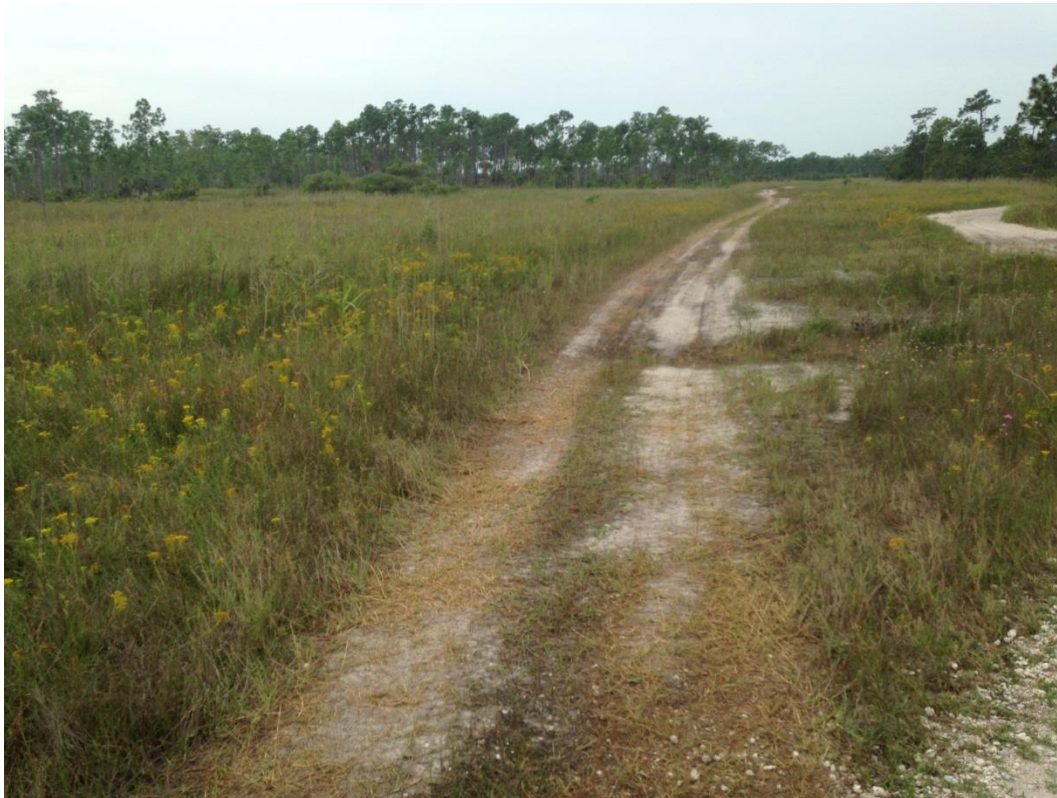
**Buckskin Trail, braiding and fresh material pushed outside of tread**

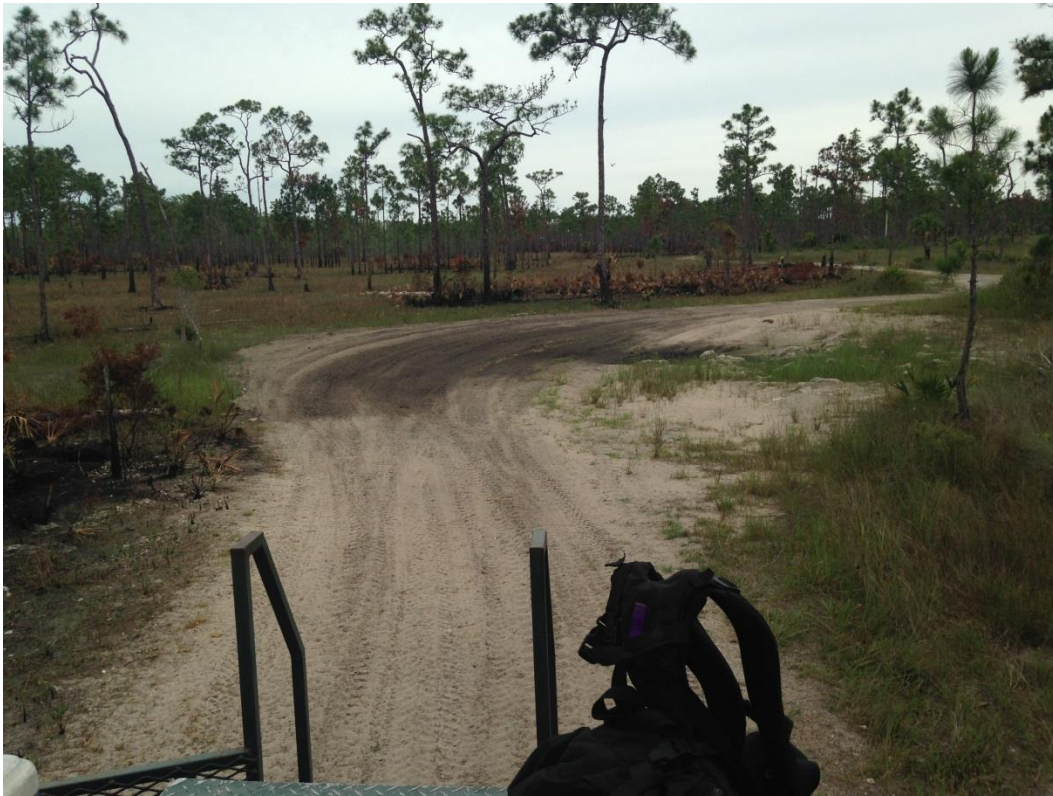
**Buckskin Trail, material is bermed up and rutting has occurred**

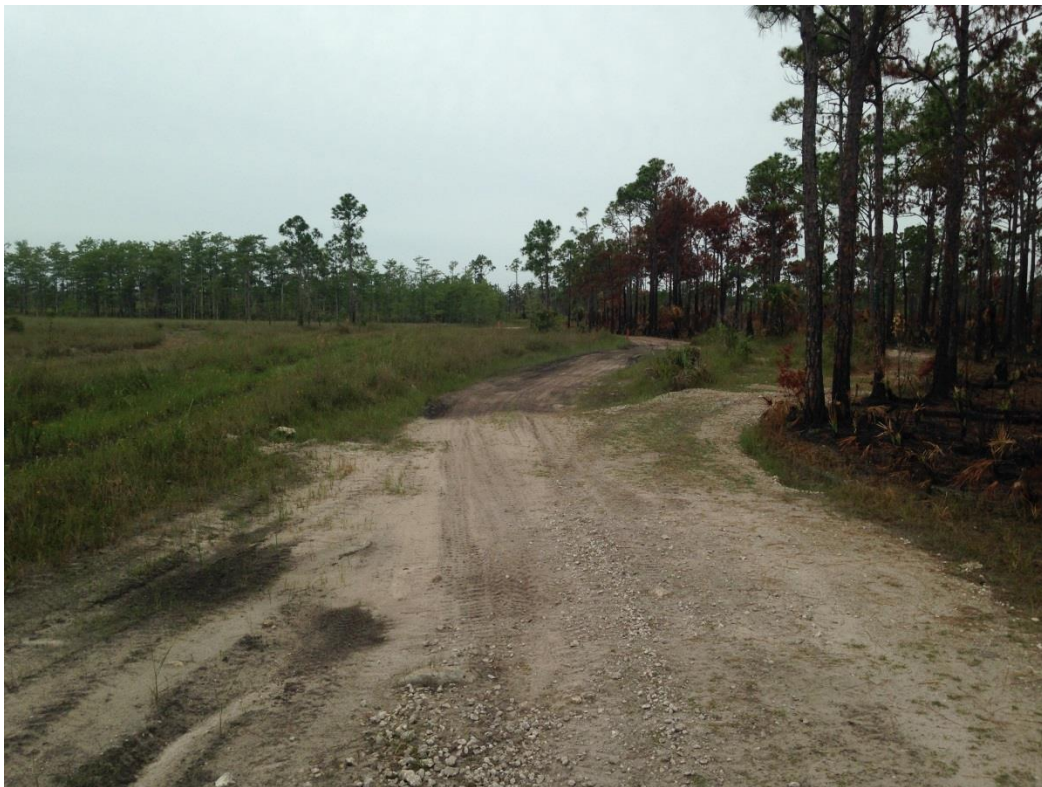
**Buckskin Trail, evidence of recent maintenance and heavy traffic cutting turn, material being displaced.**

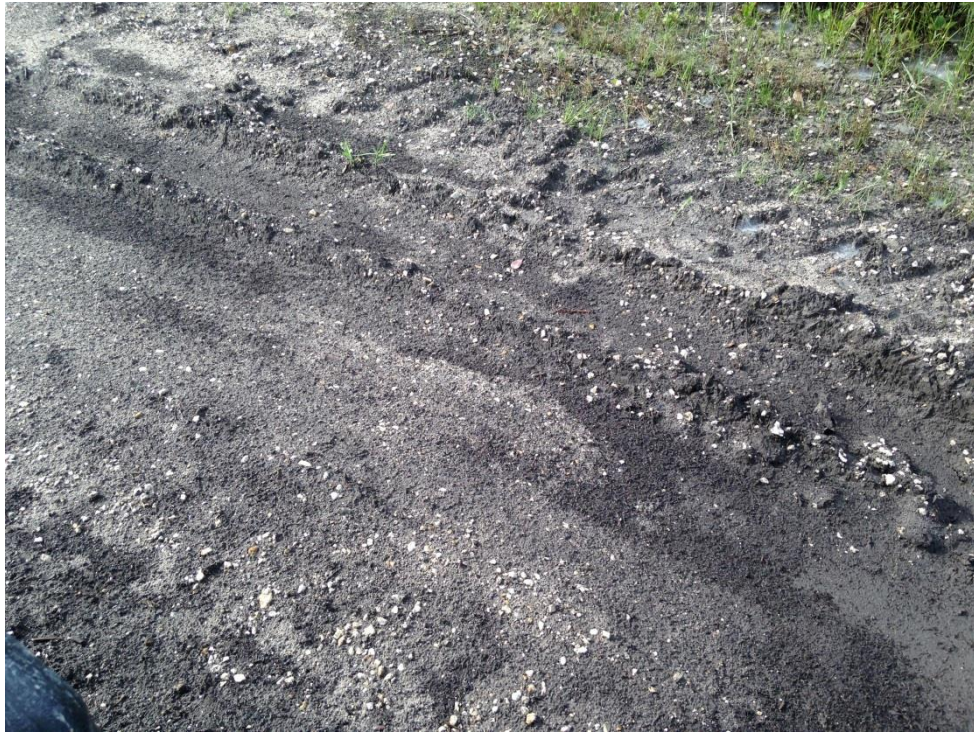
**Concho Billie Trail:** This 27 mile long trail was only burned along 1.3 miles of its length and used for access for 10 miles of its length. This trail had been maintained the previous year and held together exceptionally well, but still had areas of impact from fire traffic. One of the largest contributors to material displacement and rutting was what appears to be dually tire tracks left from type 6 engines. Some shortcutting was observed and some displacement of material that appeared to be recent. Repairs will be much easier than those required along the buckskin trail.

**Type 6 Engine tracks on Concho Billie**

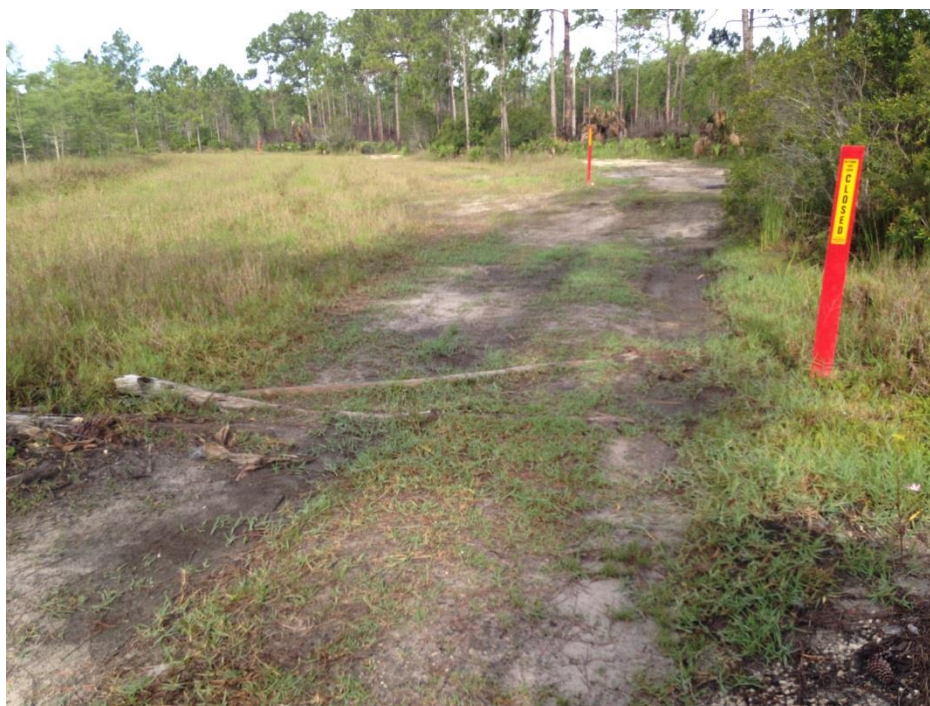
**Concho Billie Trail, short cutting**

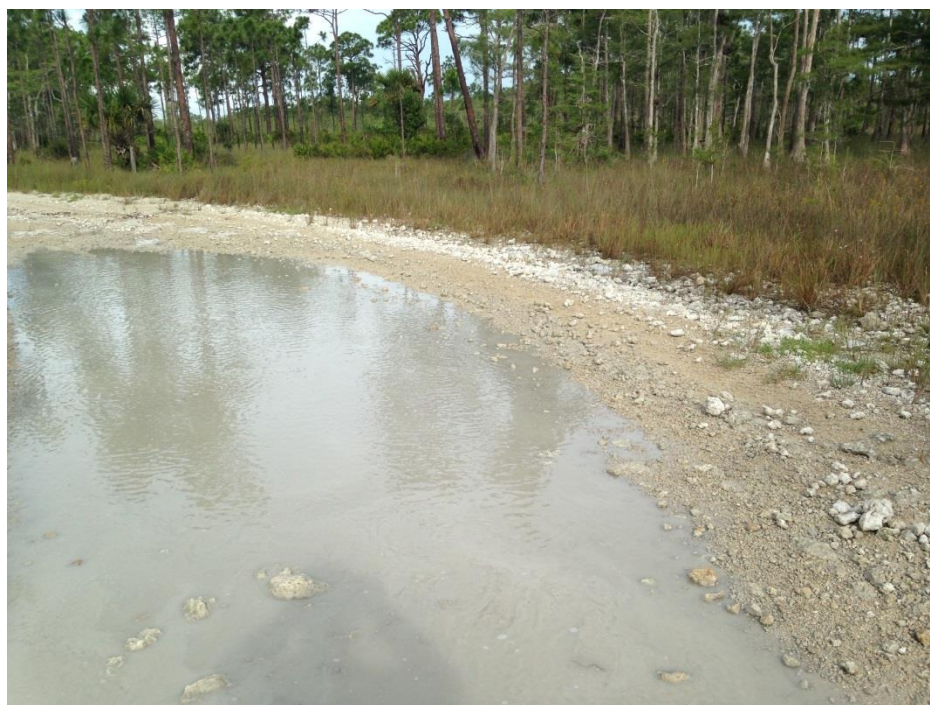
**Concho Billie Trail, displaced material**

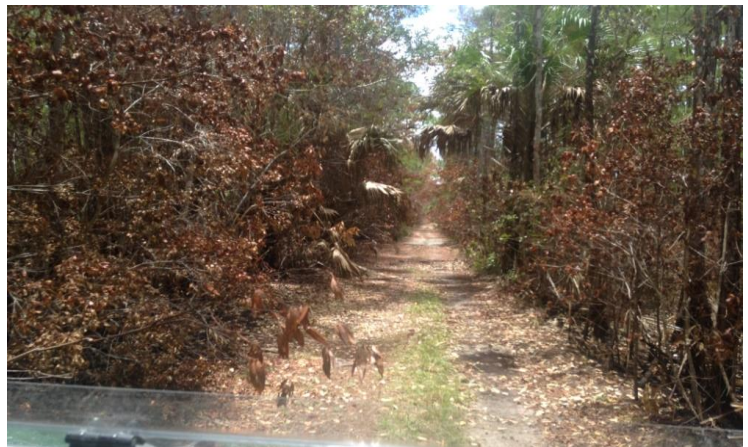
**Monument Trail:** 4.6 miles of this trail were burned on one side and the other 5.4 miles was not used as a primary access route and so very little damage occurred on the southern segment. The burned segment lost signs and braiding occurred due to fire suppression traffic. Hazard tree assessment and brushing will need to occur along the burned section of this trail.

**Worst brush on Monument Trail**

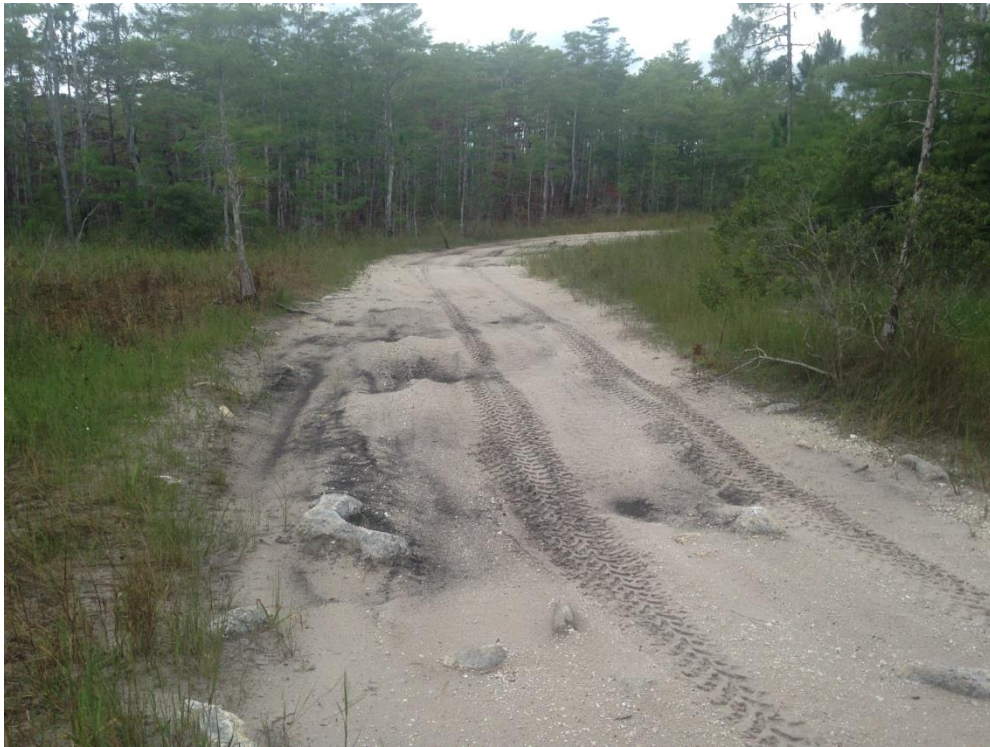
**Monument Bypass Trail:** This trail received heavy fire traffic and some braiding and rutting developed during this activity. Where the fire burned to its edge it will need brushing and at its junction with the Buckskin Trail 2 different closed routes were driven on and used to access the fire area that will need to be closed and possibly rehabilitated.

**Monument Bypass Trail, widening of the trail tread and displacement of wet soils**

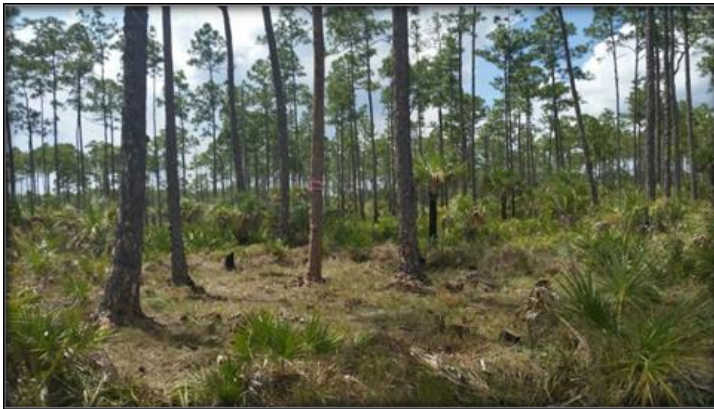
Fig. 1

Fire protection provisions that were prescribed, combined with hand-lighting at base of trees, were effective for tree protection in terms of: resin did not ignite, bole was not severely scorched thus cambium was not damaged, and feeder roots appeared healthy, alive, and moist even at shallowest growth zone. Cluster 64 had adults feeding 3 chicks (photo of cavity) whose behavior indicated they had hatched well before the fire had passed through, and were receiving steady deliveries of insects from the parents Fig.4. *Update from May 28 visit to Cluster 64 . One male hatchling only observed in nest cavity.* Eggs had been confirmed in the cavity of tree 19 in Cluster 61 during the site visit one week prior. The peep camera used on May 28<sup>th</sup> revealed a clean, empty cavity. The bole of this particular tree was not charred, however, a pine tree well within the recommended 5 pace distance to the nest tree showed signs of moderate intensity heat that *could* have contributed to nest failure (Fig. 5).

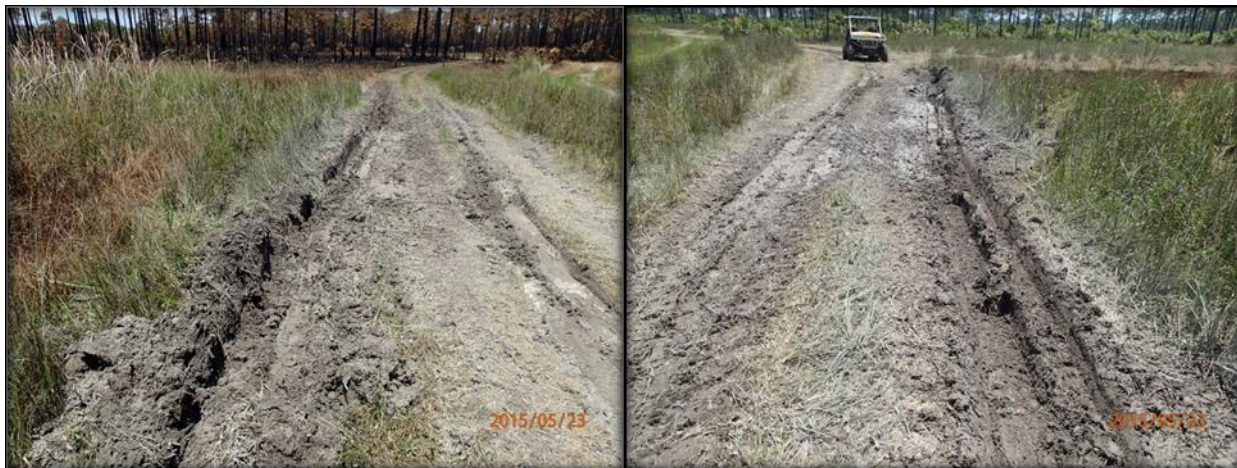
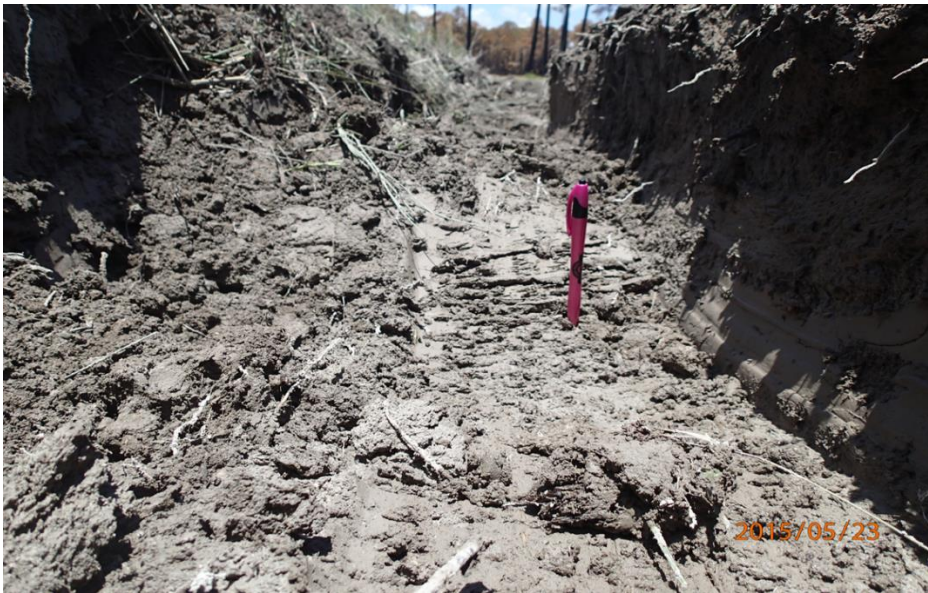
Increased traffic on trails shows areas that would require maintenance in order for it to be the safe and preferred path for public use rather than creating a situation where the public would prefer the natural area than the trail. Photos only show tracks that were made in the previous two operational periods, since the rain of May 22nd.

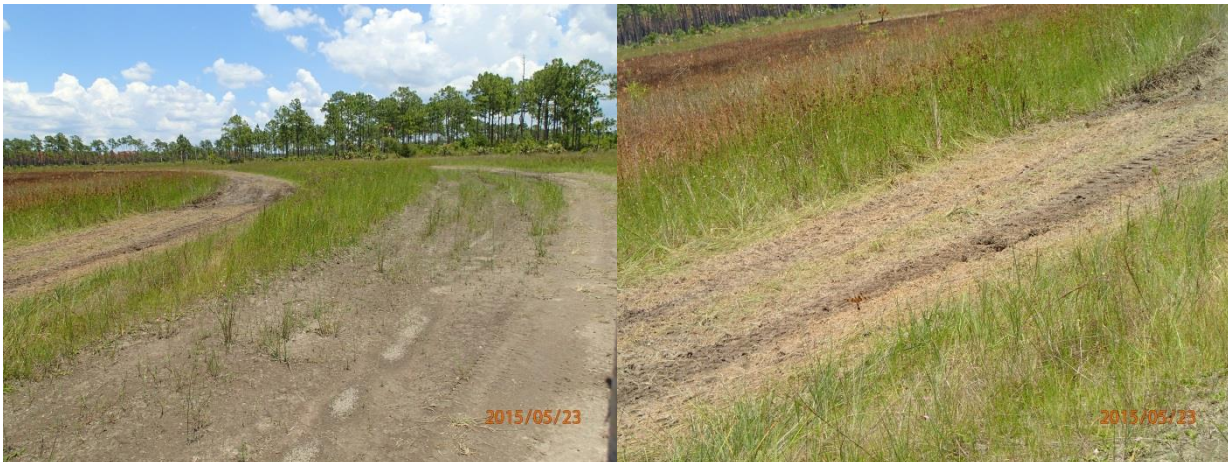
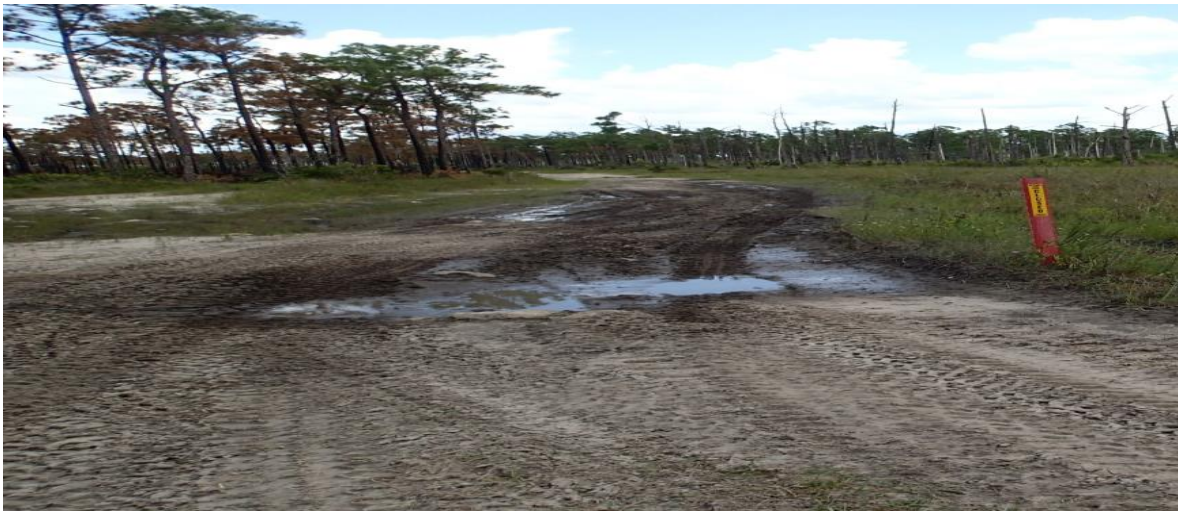
In several areas, short cuts previously made by the public were followed by fire traffic rather than taking longer route on the improved trail. Braided routes created by the public were used similarly by fire traffic, rather than focusing vehicles on only the one designated route. In certain locations, no markers were in place to indicate which of several routes was the preferred trail.

**\*\*See report submitted by Burned Area Rehabilitation (BAR) Trails Specialist Jason Williams for more information\*\***

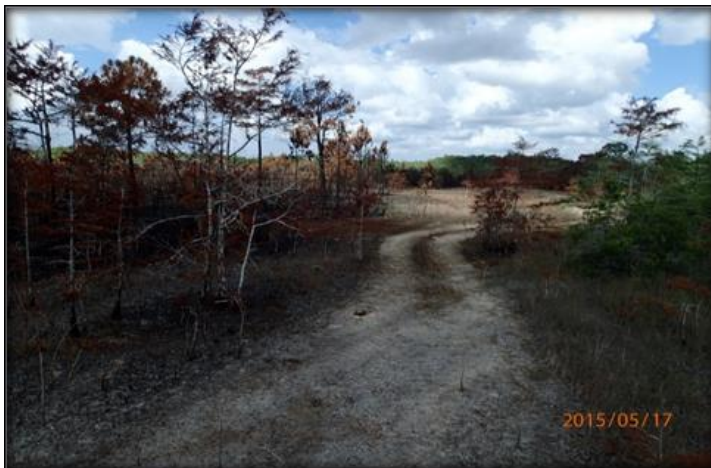
The west line buggy tracks were concentrated mostly on the perimeter of the ephemeral prairie.

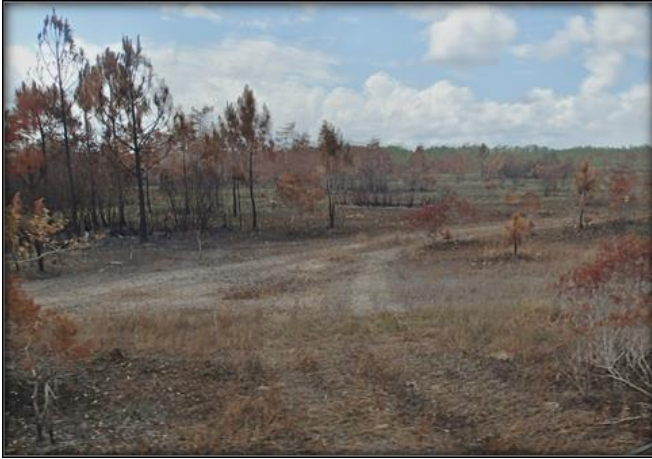
Multiple passes cross-country was evident near the ignition point from initial attack activities (e.g., chasing spots and flare-ups).

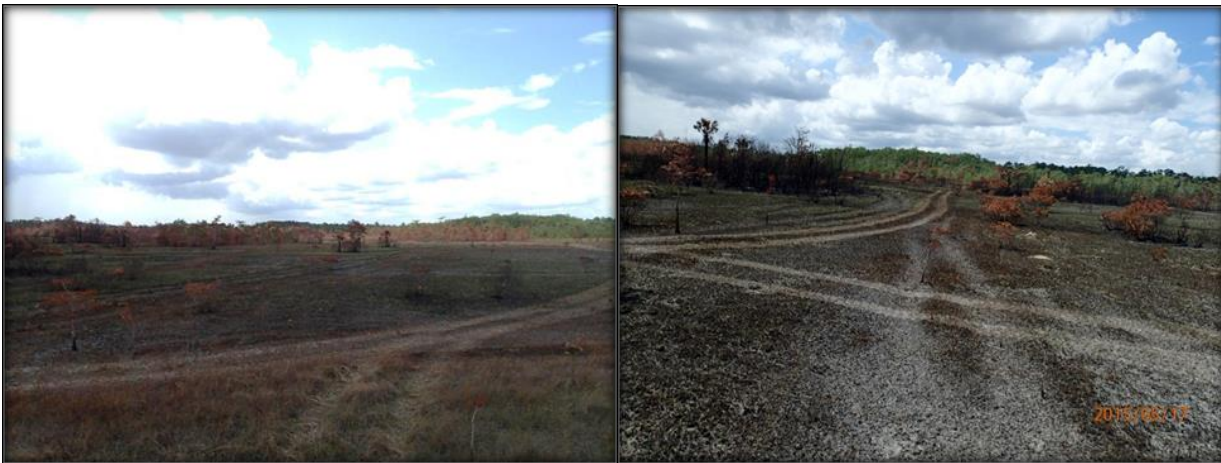
Tracks were initially highly apparent due to contrast with ash. This was not from compaction, but from clearing of the ash layer by the tires.

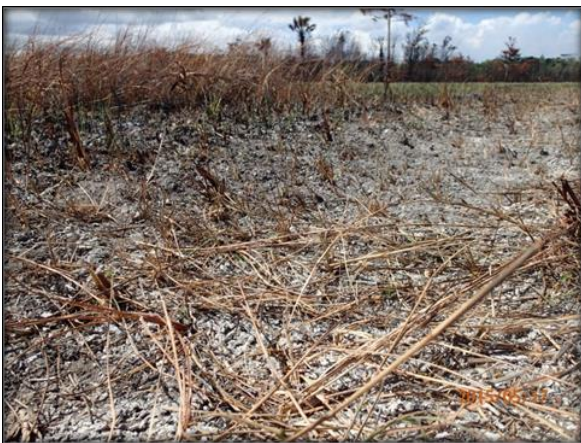
Compaction did not exceed 2-inches, and was within normal surface variation of basin topography.

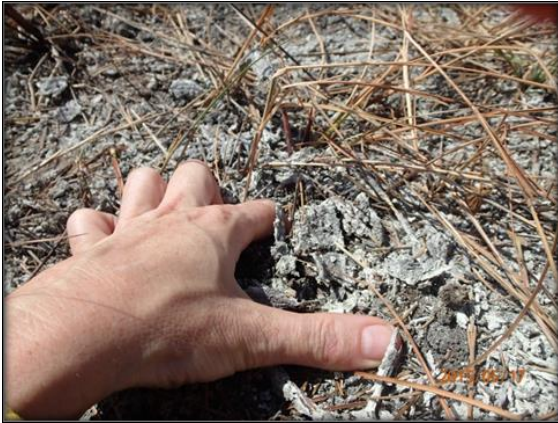
Buggy ruts did not result in compaction that would impede re-establishment of wetland vegetation. Soils gave easily to pressure.

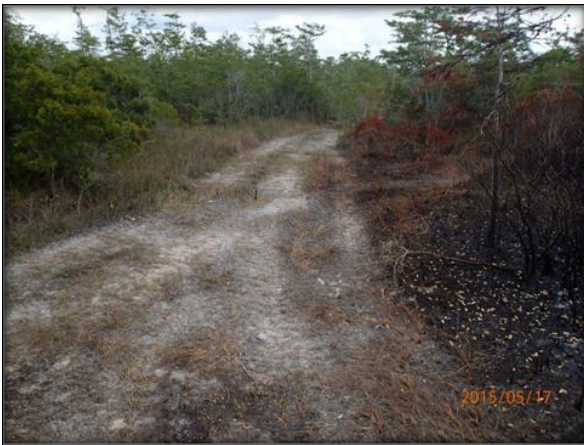
Vegetation persists on tracked areas as source for recolonization during rainy season.

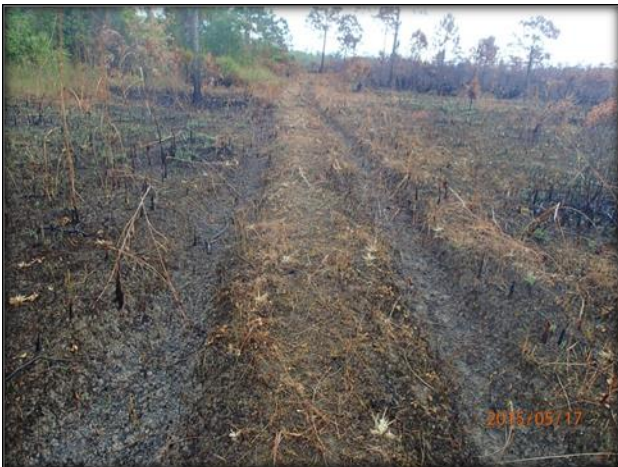
The Wilderness portion east of the land owner access road has a deep set of tracks that were not a result of suppression activities in the 2015 . Trees growing in the center line are of sufficient size to suggest that the tracks predate the analysis to qualify as wilderness. Photo was taken facing west, at 26 9.33.9, 81 4.0.

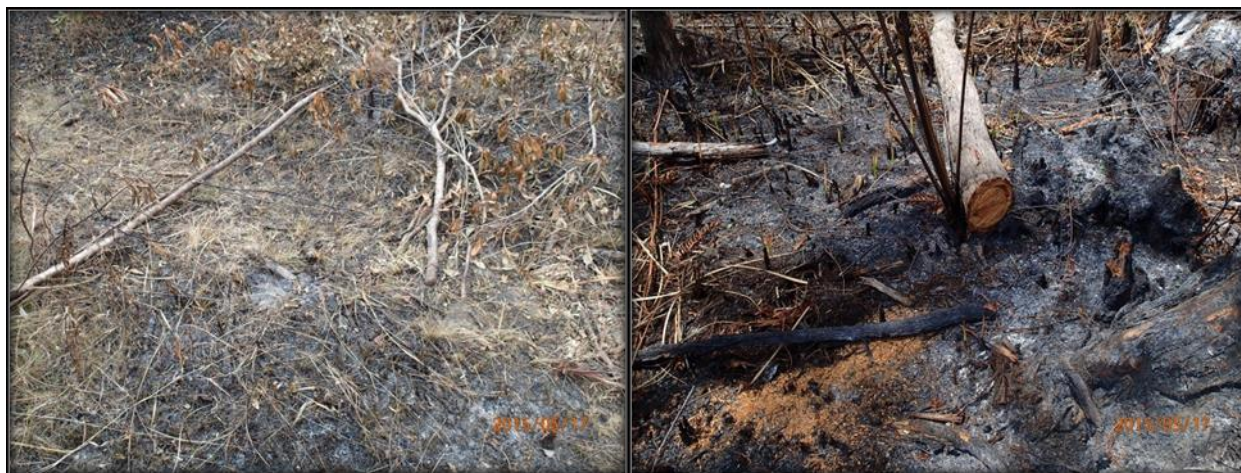
Chainsaw use was discriminate based on risk of spread of fire. I observed no more than 20 points where saws were used in the eligible wilderness. Small trees were scattered when cut.

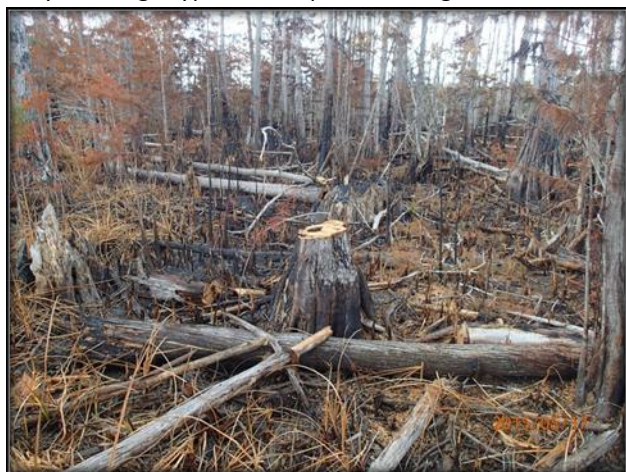
Only one large cypress stump was left high. It is in the interior of a swamp at 26;9;33.9 81;4;0

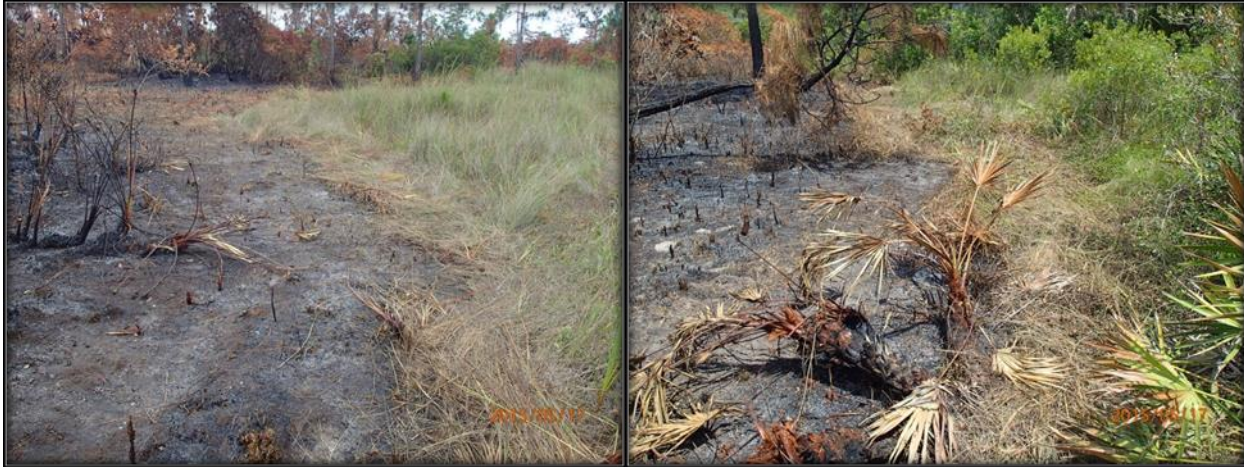
Hand lines blended with natural features of wetland, and were only to surface of mineral soil. No trenching or rutting was observed.

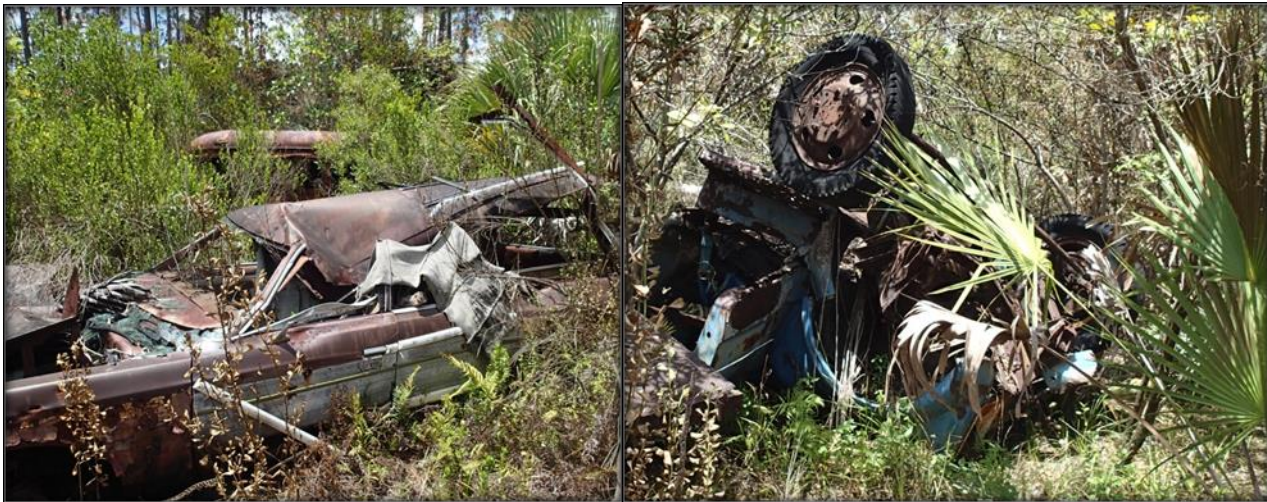
Firefighters showed Carrie where the fire had revealed and burned 3 abandoned vehicles (models circa 1970's). The Addition Lands had not been previously burned by prescription or wildfire, so the fire impacts on these vehicles are results from the Square Fire. The vehicles create firefighter safety concerns due to the acutely dangerous level of toxins that have been documented in smoke from burning vehicles, and their continued presence is a health hazard for personnel during future fire operations. The burning of these vehicles also creates environmental health concerns due to the heavy metals and petroleum that could be released from heat and damage to vehicle parts and battery housing. Photo taken at 26;12;43.0,

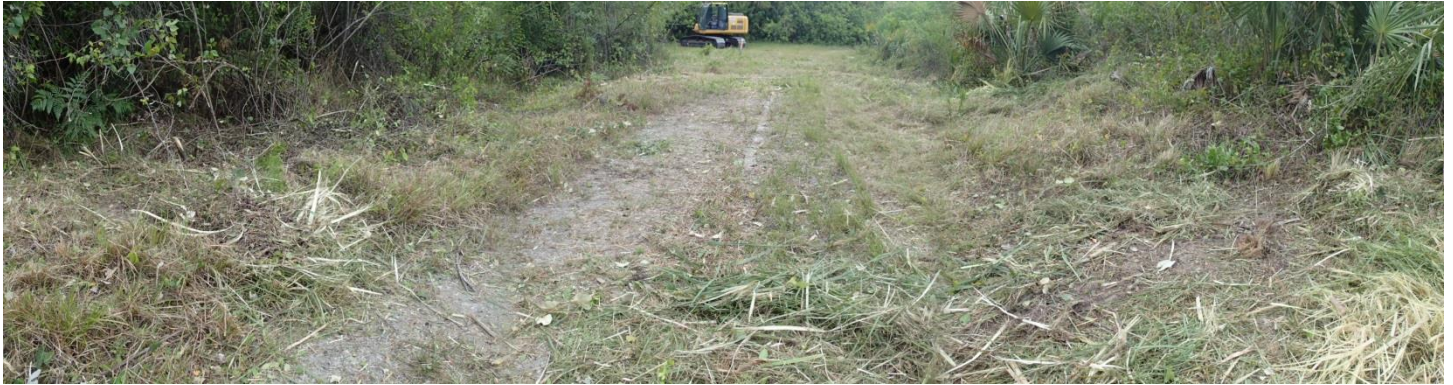
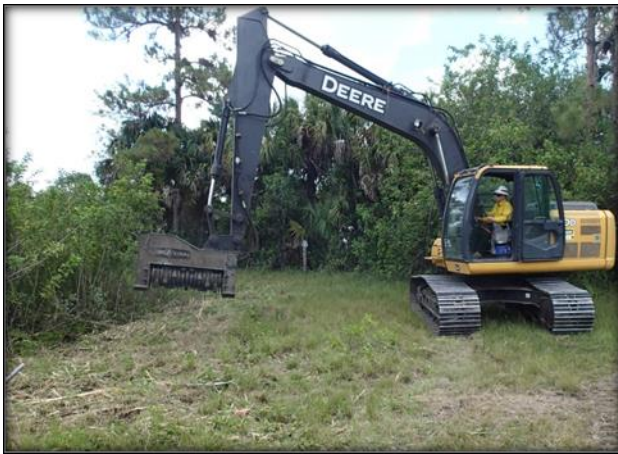
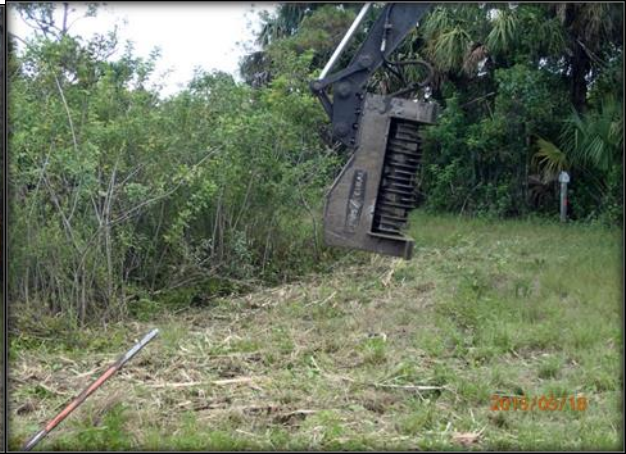
Nobles Grade was masticated along the road crown above the root crown of vegetation, and along overhanging lateral limbs and branches. Nobles-Grade had no subsurficial disturbance. Cogongrass was flagged and avoided. BCNP used peanut oil in the hydraulic system of the excavator mounted with a mastication head to insure that any hose or connection leaks would emit only a biodegradable substance.

Impacts to Bundschu Grade vegetation were minimal. Flush cut any high stumps and scatter debris out of sight.

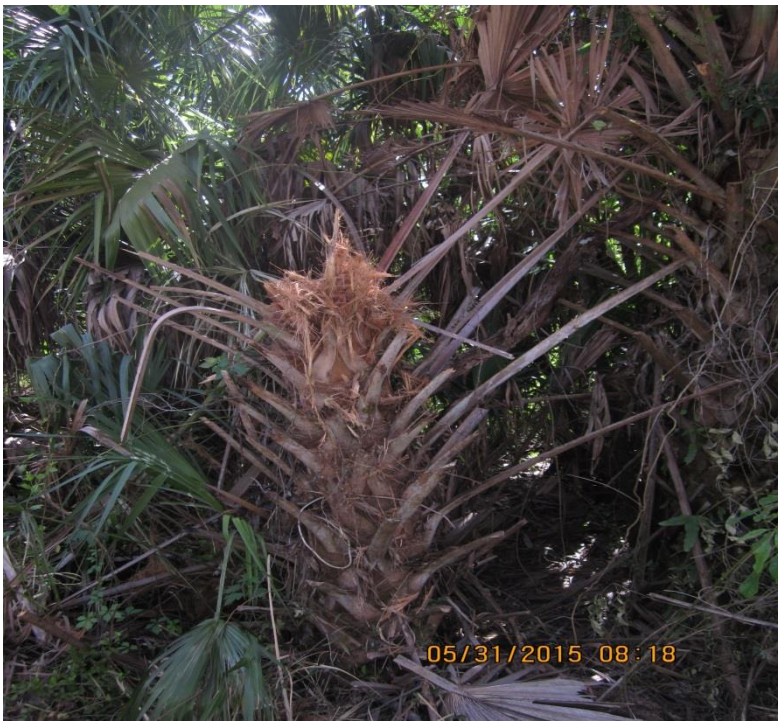
Cabbage palms were topped to remove fire hazard. Some palms may recover, however some may not. Using an excavator with a tree cutter will mitigate some of the visual impacts of the mastication project.

Nobles Grade mastication revealed a gas pipe that could hold hazardous materials. It did not appear maintained and managed. This pipe is not related to the incident suppression actions, but could be an additional resource concern for the Preserve. Cogongrass was on west side of Nobles Grade road at pipe location. Photo take at 26;12;59.0 81;5;49.0
