## Burned Area Emergency Response (BAER) Plan Mud Lake Complex

Unit: National Park Service, Big Cypress National Preserve, FL

Date: May - July 2015

Incident Number: Mud Lake Complex: PFFSJP9X0

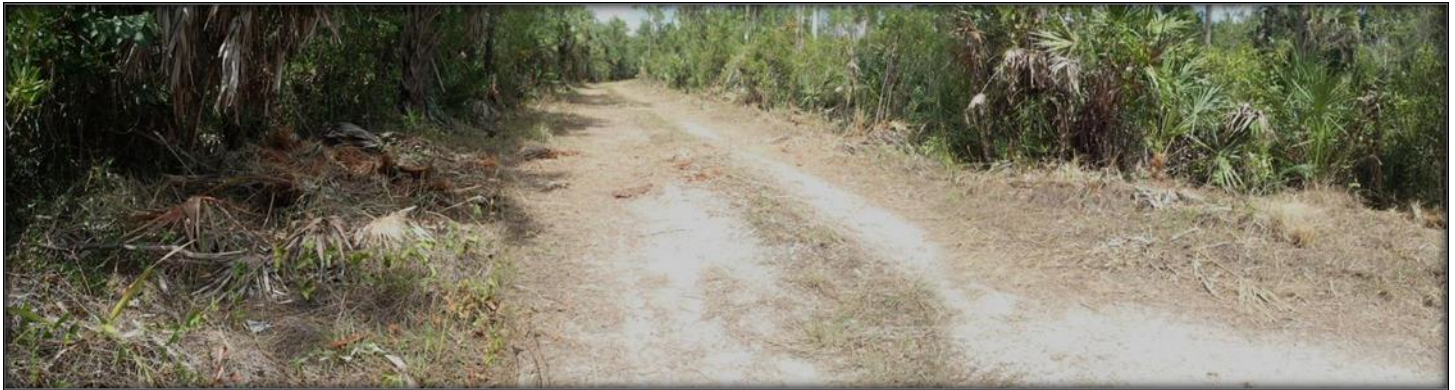
ADD 9 trail was masticated along the road crown above the root crown of vegetation, and along overhanging lateral limbs and branches. ADD 9 had no subsurficial disturbance.

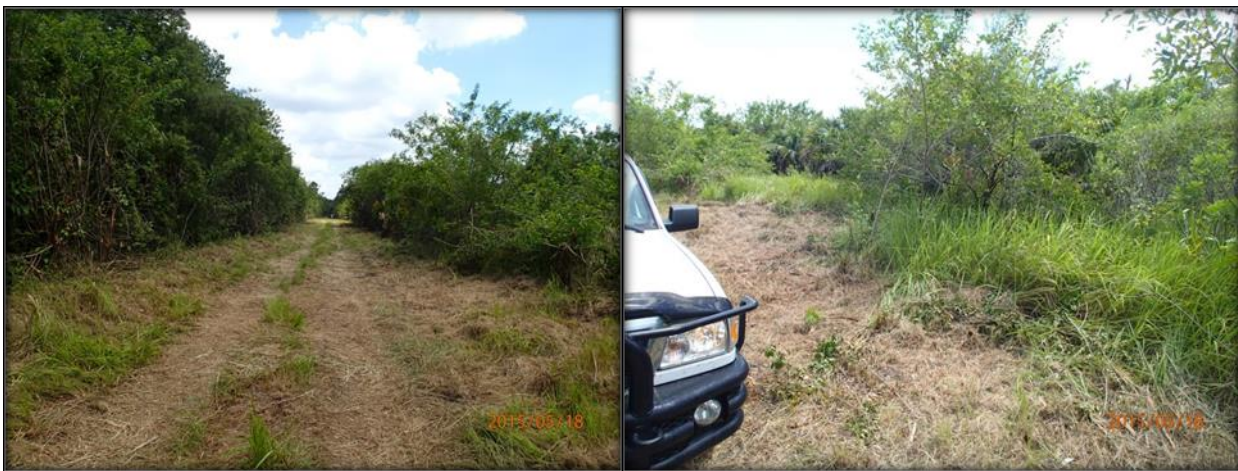
Photos taken at: 26;12;50.96 81;6;30.76

ADD 9 trail had a patch of cogongrass masticated. There was no displacement of rhizomes, no soil disturbance, and no plants in seed production, which could have increased spread. Monitor area in the future for additional invasive plant infestations.

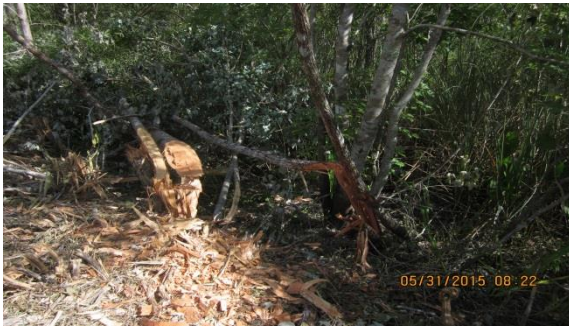
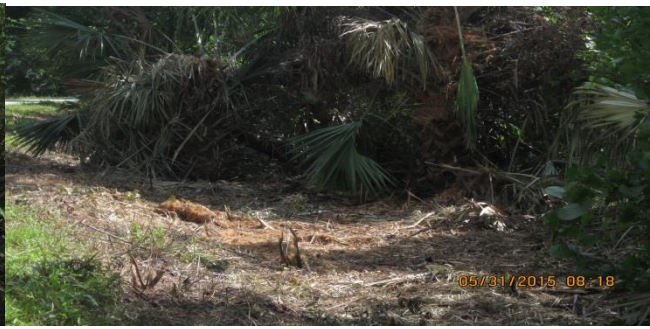
As the Square Fire made a run to the northwest, the Red Team and BICY management made the decision to prep contingency lines in the Bear Island Unit 4 with two pieces of heavy machinery. These excavators cleared vegetation along Bear Island Grade, Hard Rock Grade and Perrocchi Grade with the intent to hold the fire to these trails with burn-outs. The excavator with the mulch head was the best piece of equipment for the job as it was quite effective at grinding up cabbage palms and stumps. As a result of successful suppression efforts, this finger of the Square Fire did not reach Bear Island Grade. The immediate repair on these trails could be mitigated fairly quickly by flush cutting tree stumps, bucking larger rounds into firewood size pieces (the trail is used by campers) and stacking along the trail edge. Employ the excavator with tree cutting attachment for cabbage palms. Chainsaws would be sufficient for flush cutting tree stumps and bucking larger logs.

Excavator impacts along the Florida Trail north of DP 6 on Nobles Grade could be mitigated in a short period of time. Debris needs to be cleared off of trail to avoid hiker hazards and a few stumps and stobs need to be flush cut.

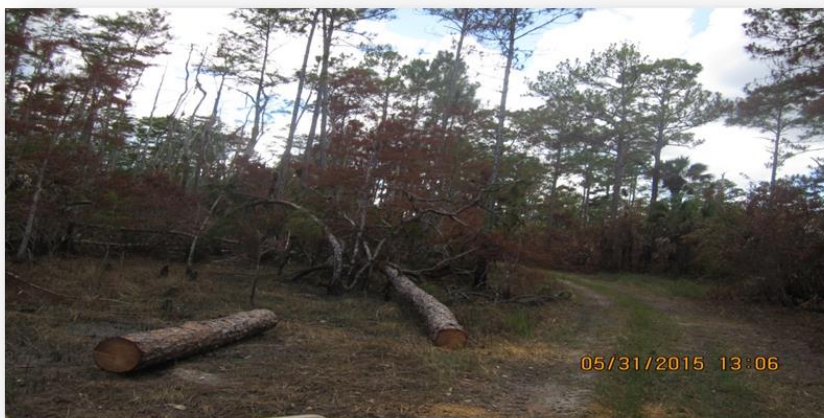
There are 3 large diameter trees like this located on the ADD 9 trail off of Nobles Grade heading west toward DP 4. Disguise ends of logs with blackening, angle cut and hide with brush.

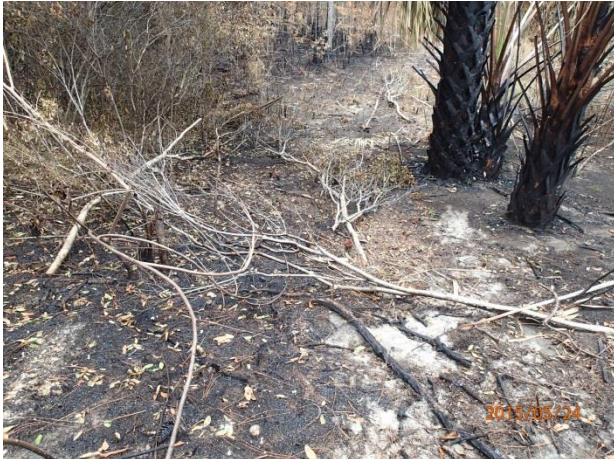
The DP4 handline had negligible soil impacts. At the west end, the vegetation was not cut flush to ground, leaving mid-calf sharp stobs. Brush work was not placed with tops towards trails. This condition extends about 50 yards east on the line.

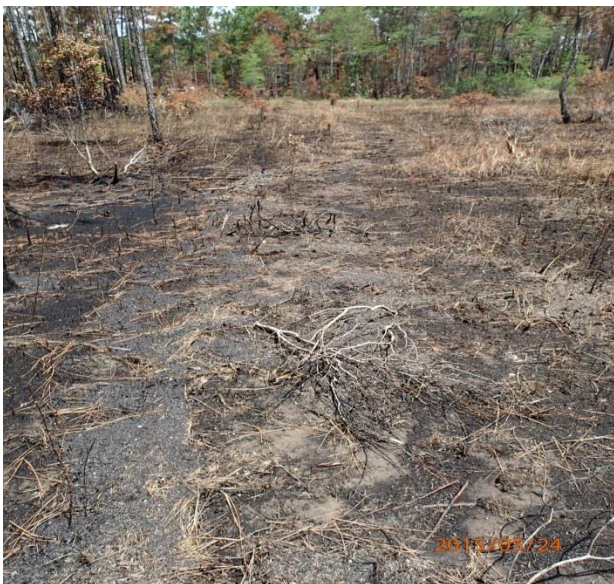
Where DP4 handline turns south to ADD 8/9, the vegetation was more sparse and smaller diameter in a swamp. High stobs were less apparent and looked like natural burned sapling stumps.

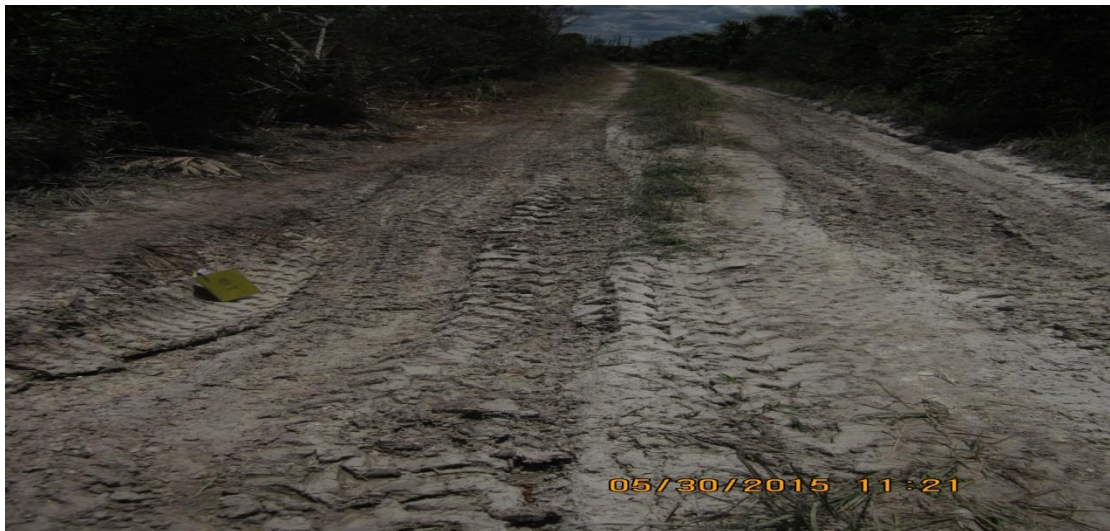
The elevated road system on the Square Fire was not engineered for frequent travel, making the road structure sensitive to the amount of vehicle use for suppression activities especially after water levels in canals were elevated by the release of Okeechobee water and two days of heavy rains. Bundschu Grade and Nobles Grade require stabilization. The driveway of the Baker Camp may require some maintenance due to structure protection efforts.

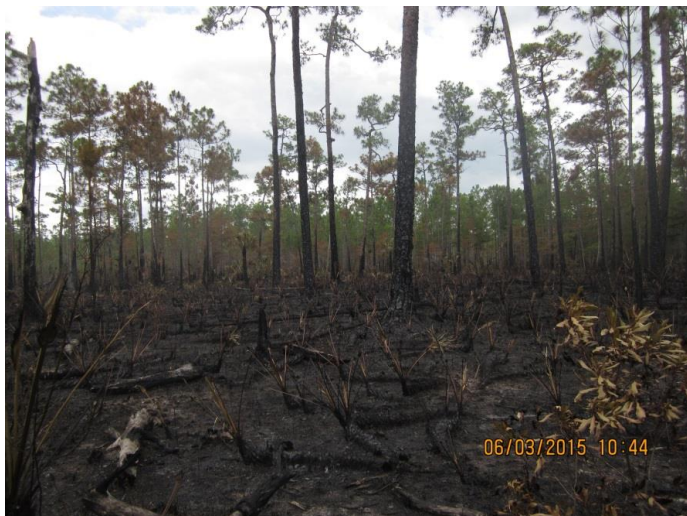
Mixed pine and cypress had moderate- moderate + severity with litter and duff burning to white ash and 80-100% scorch

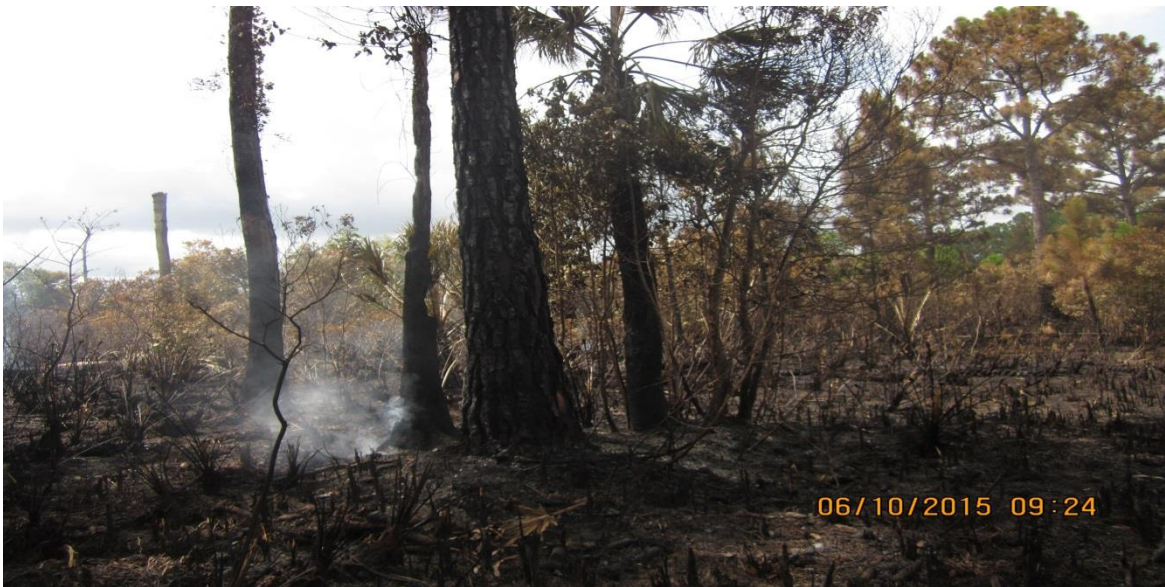
Fire effects were mixed with higher intensities in pine stands probably when strong wind gusts were occurring. Due to incoming weather, I was unable to assess RCW cluster # 47 within the burned area. However, I do have concerns for the live cavity trees due to observed buildup of litter and duff in an adjoining pine stand. The fire intensity overall was such that char and scorch most likely would not seriously impact the trees. The sustained duration of heat creeping at the base of the trees could be sufficient to cause mortality.

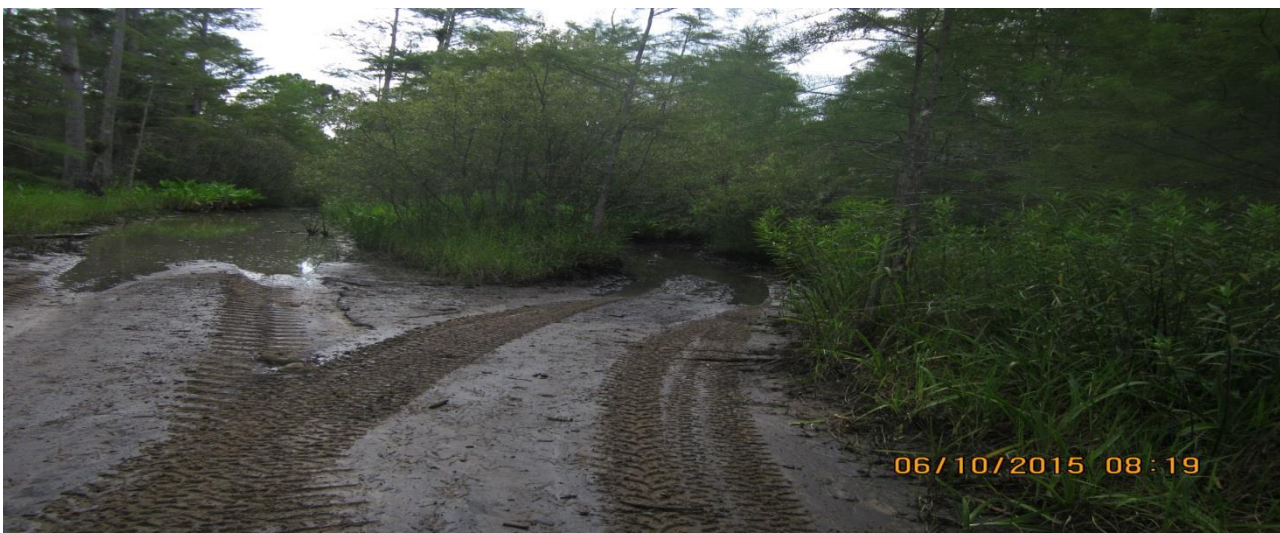
The Windmill Tram and Burns Lake Trails were utilized to access this fire. Buggies and UTV's utilized paths cut by previous trail users to avoid deep holes. These paths predated the fire but were possibly made worse by increased traffic.

A culvert (N26°00.299 W 081° 15.781) on the Windmill Tram Trail requires repair.

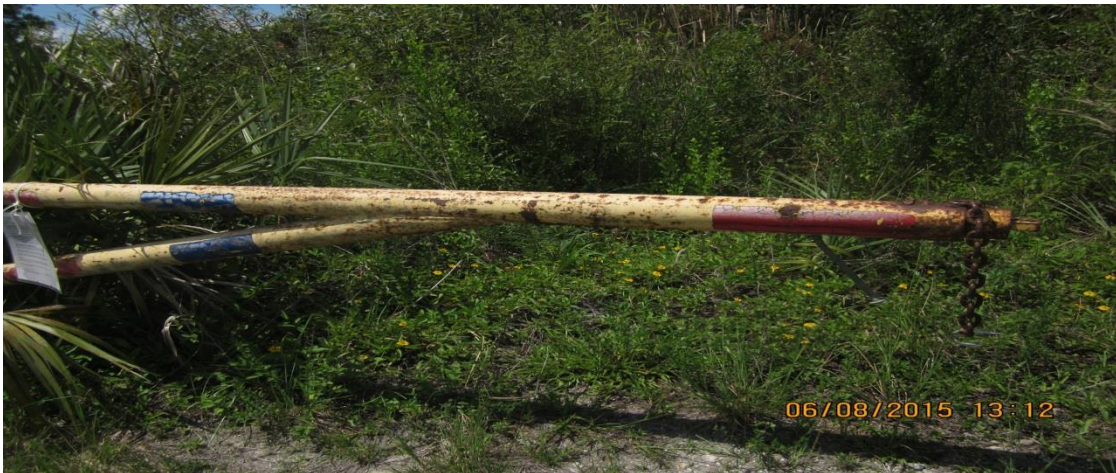
The gate lock at the Windmill Tram Trail was broken prior to fire staff accessing the fire.

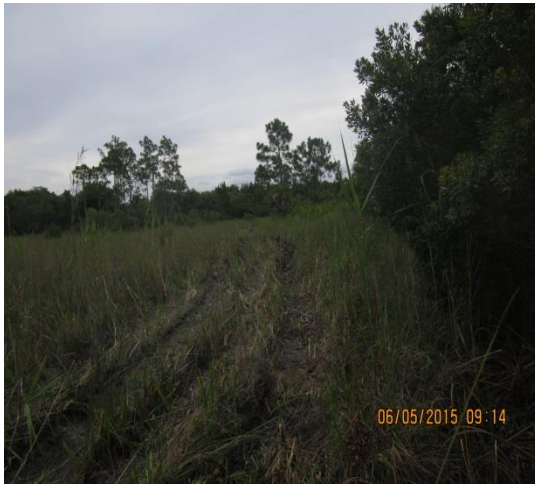
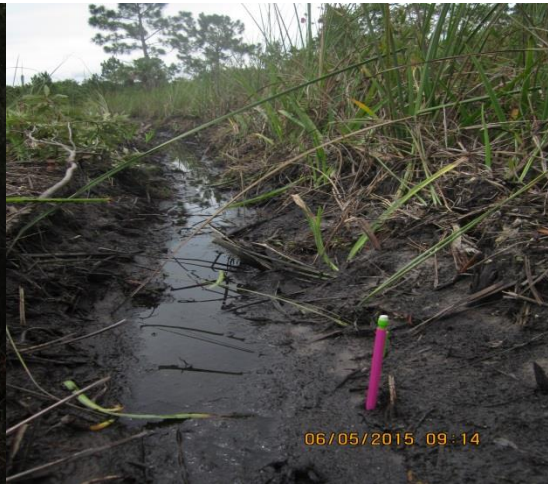
West edge of

4-5 trees felled. Short, minimal handline constructed along southern end of fire.

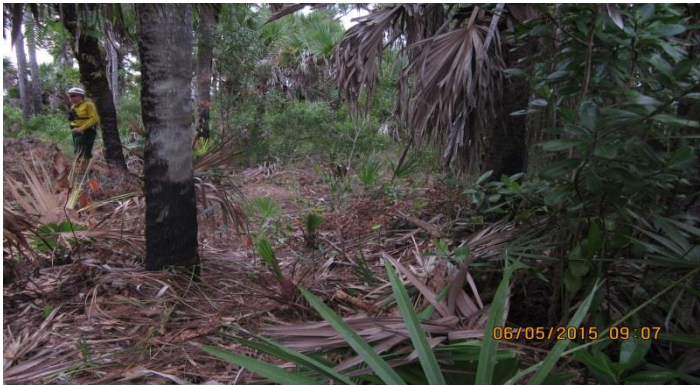
Handline already recovering

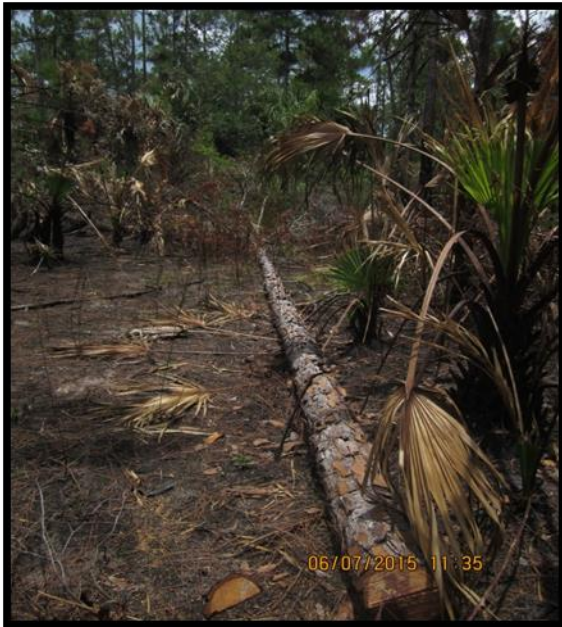
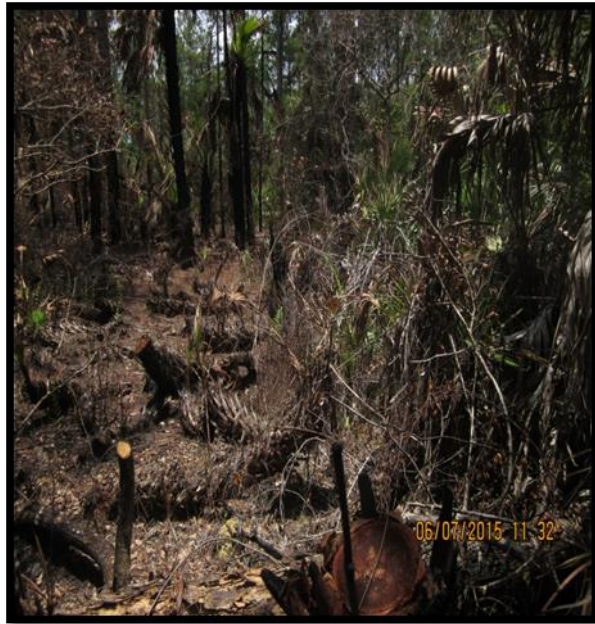
Sanctuary Fire: Fields was able to survey on June 7. Buggy access on designated trail to Tin Camp. Fire required felling about 3 trees. Some cabbage palms along the west and south fire edge were cut @ knee level. Flush cut palm stobs.

The Sanctuary Fire was small, but moderately high intensity with 90+% scorch and ~15 meter char observed.

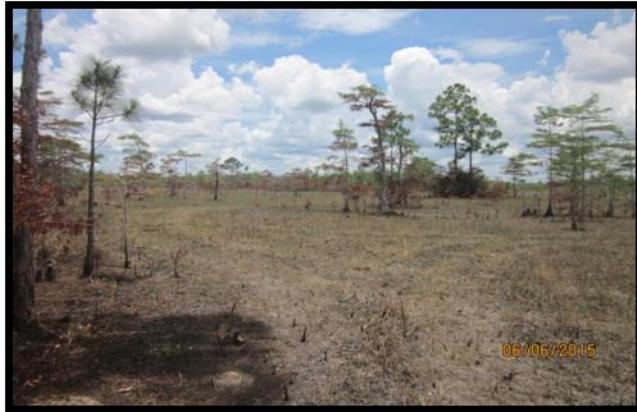
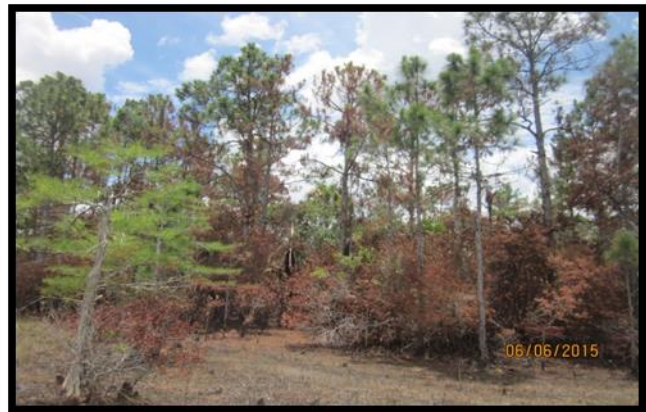
Hobo Fire: Fields surveyed the Hobo Fire on June 6<sup>th</sup>. Buggy access to Hobo Camp by trail. Private lands already had buggy lines established from one camp to the other, in excess of 3-4 feet deep. Fell about 3 trees. Minimal suppression impacts. No repair work necessary.
