# BROADWAY BOULEVARD HISTORIC TREATMENT PLAN TECHNICAL MEMORANDUM

**Prepared by**  
AECOM Technical Services  
Charlottesville, VA

**Prepared for**  
City of Galveston, Texas  
December 2011

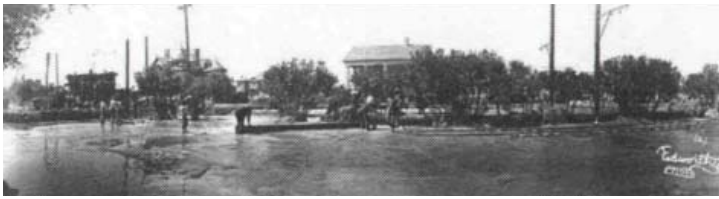
*Grade raising on Broadway near 23rd Street. (Source: Rosenberg Library)*

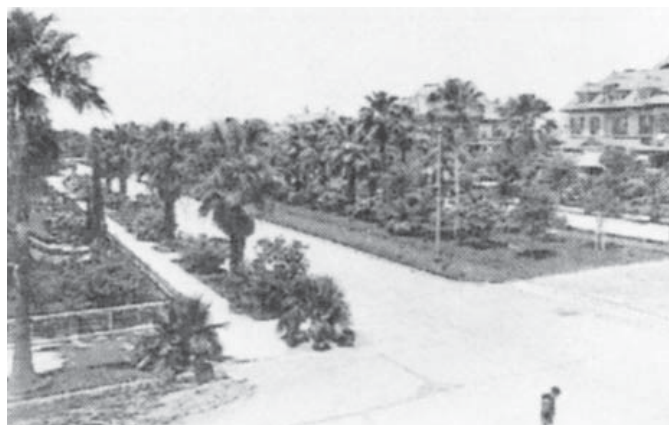
*Mature palms and oleanders planted at Broadway. (Source: Rosenberg Library)*

intersections with the side streets. A low curb demarcated the edge of the esplanade. The outside edges of the boulevard were lined by a planted strip, providing a vegetated buffer for pedestrians on the sidewalks that ran along the mostly fenced residential properties. This planted area was lined with palms, as well as lawn and other low vegetation. The roadway and sidewalks appear to have been paved in concrete, with brick curbing on the side streets.

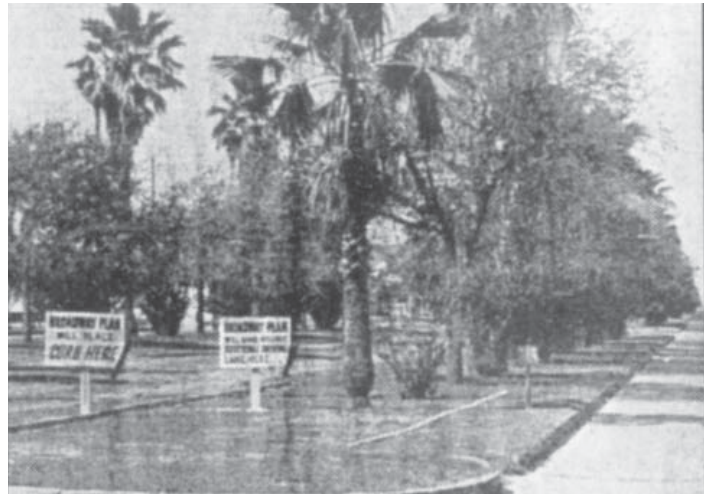
*Aerial photograph of Broadway Boulevard showing the proposed esplanade reduction, 1950. (Source: Galveston Daily News, March 23, 1950)*

Over the second part of the 20th century, the character of Broadway Boulevard evolved as street car traffic was replaced by car traffic. The planted esplanade was reduced from 98 to 36 feet in order to accommodate two more lanes of traffic.<sup>16</sup> Light fixtures were updated and subsurface utility lines were installed. In the 1990s, the City undertook a planting program with the Texas Department of Transportation that resulted in the retention of the palms and oaks, but removal of the oleanders due to concerns about maintaining visibility and sight lines at the busy intersections. Small circular planting areas were added within the esplanade at each road intersection. This program continued through 2008, when Hurricane Ike struck Galveston.<sup>17</sup> This devastating hurricane flooded the city with salt water, killing many trees that were not toppled by the winds, resulting in a loss of almost 40% of the city's trees. The oaks and palms that had graced the Broadway Boulevard esplanade were severely damaged or lost.

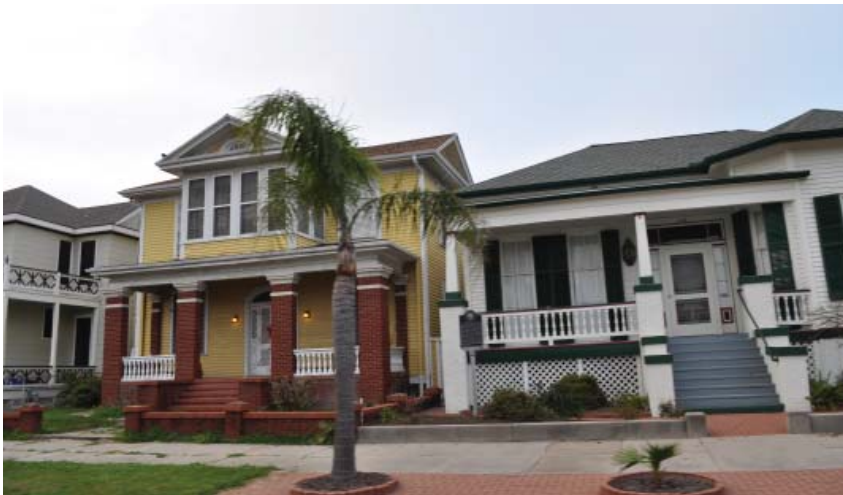
*Examples of historic architecture along the boulevard.*

The buildings along Broadway Boulevard are typically late 19th- and early 20th-century Victorian, or late 20th-century modern in style. The Victorian structures feature pitched roofs, wood siding or red brick, and are one to three stories tall with porches facing the street. The late-20th-century buildings are typically brick structures with few windows; commercial buildings of this type are typically of painted brick and display large signs.

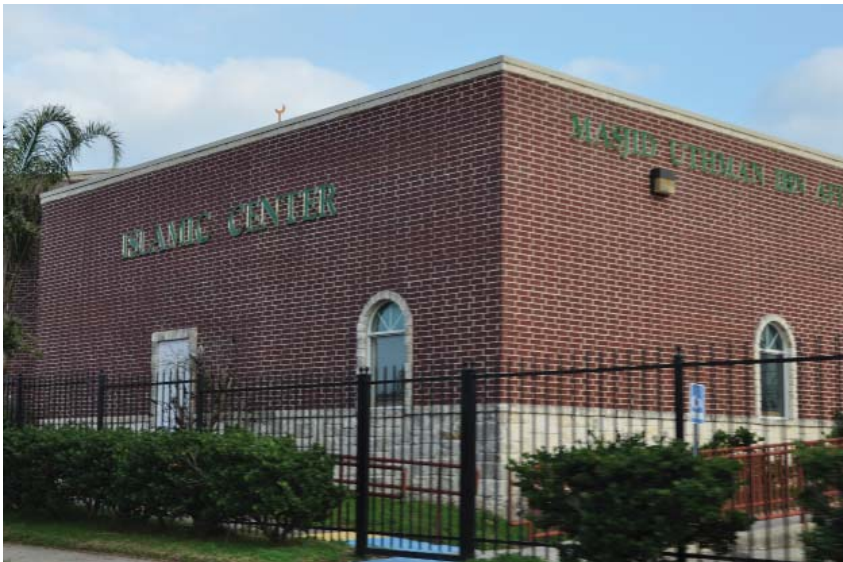
*This rectilinear, brick structure is typical of the modern architecture along the boulevard.*

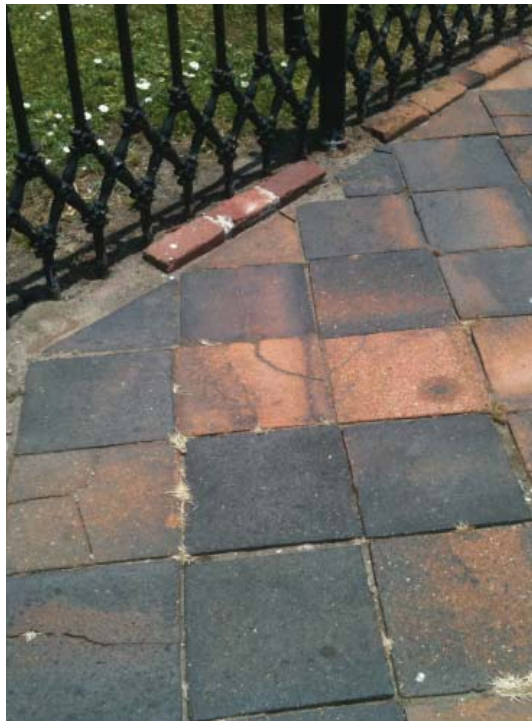
*Patterned sidewalk pavers*

Sidewalks along Broadway are primarily of concrete, although a decorative pattern is found in some small areas near historic buildings—eight inch squares of black paving alternating with squares of red brick. In many locations, the sidewalk has been damaged by tree roots. Some brick paved areas are located at the ends of each block of the esplanade.

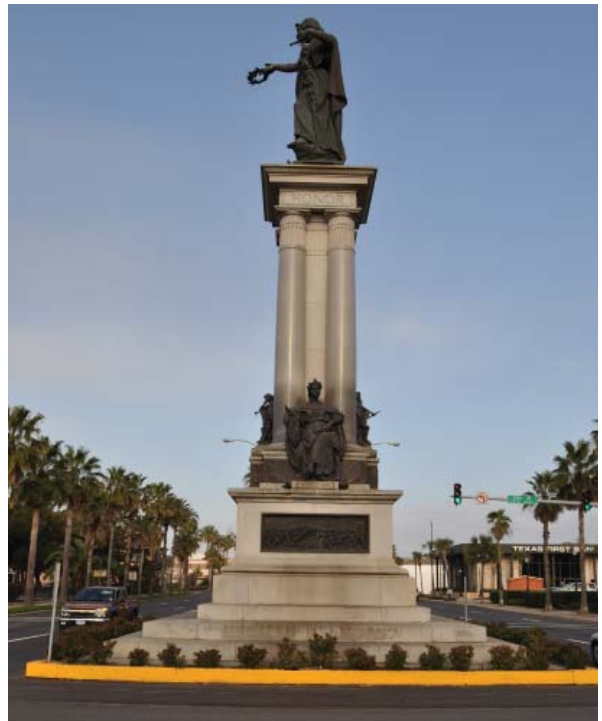
*Texas Heroes Monument.*

The **Texas Heroes Monument** at the intersection of Rosenberg Avenue is a 72-foot-tall bronze and granite monument encircled by dwarf oleander. The patina from the bronze sculptures and reliefs has stained the granite plinth in some areas.

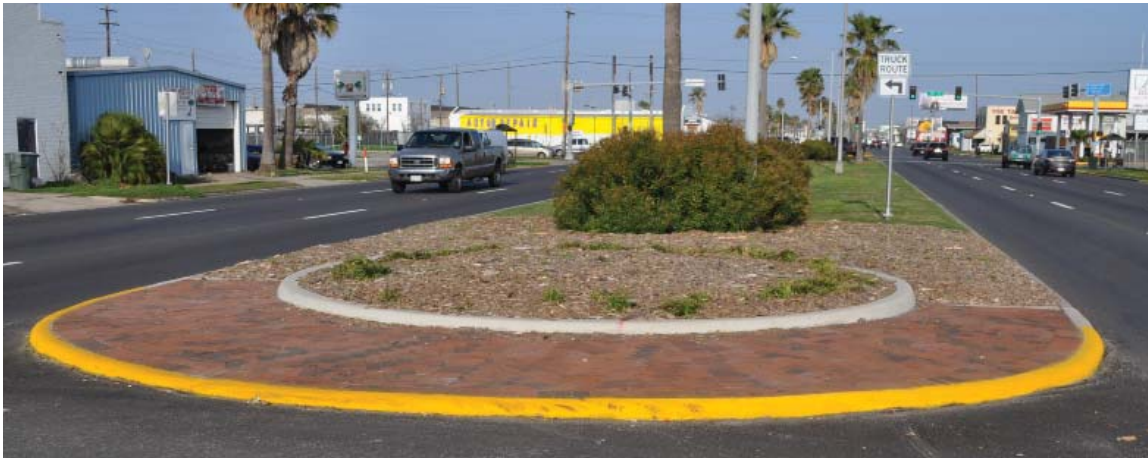
*This circular, curbed planting bed is typical of every segment of the median.*

Recently-installed circular planting beds defined by a low concrete curb are located at the end of each block of the median. The plantings in these beds have not thrived, and many are missing plantings altogether. Large above-grade utility boxes and street lights stand in some planting beds. Brick paving installed in a semi-circle around the median end of each planting bed provides a refuge for pedestrians. Mulched areas encircle the other half of each planting bed.

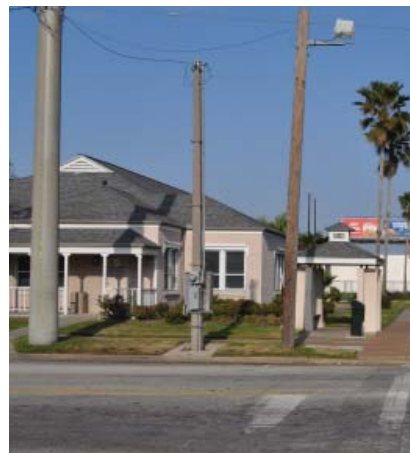
*Utility poles.*

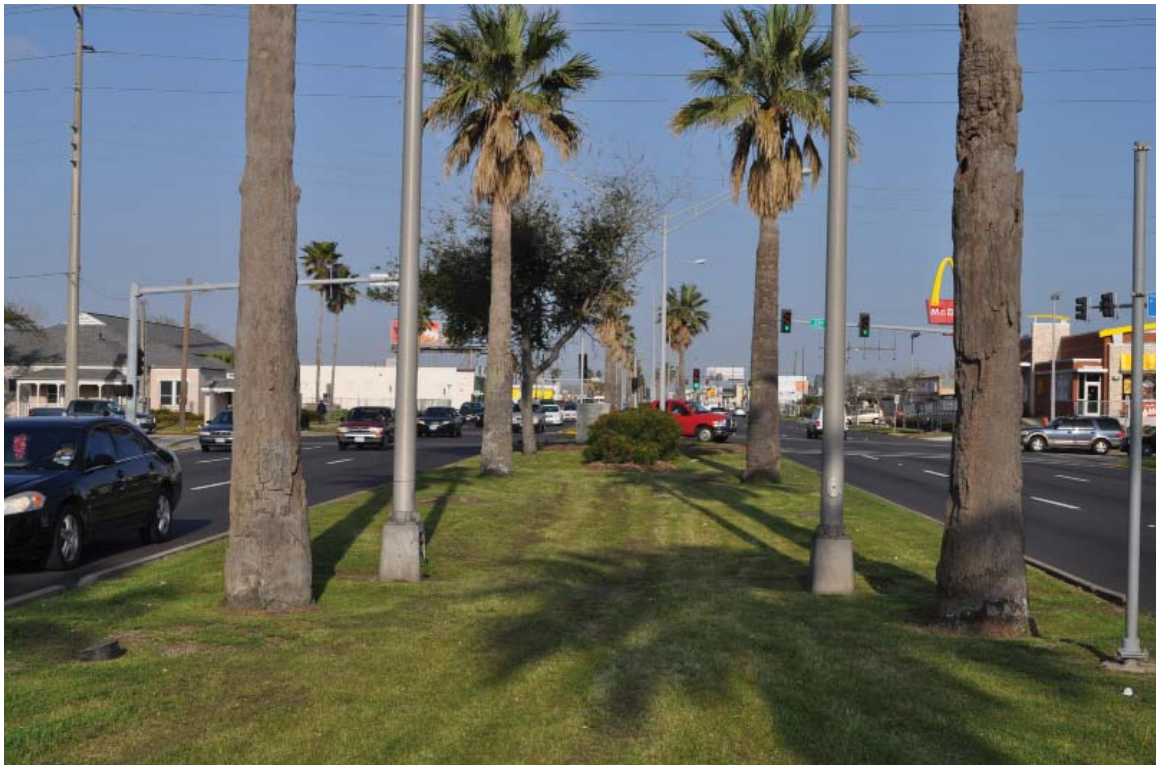
*A double row of palms on the median, with occasional oaks and street lights.*

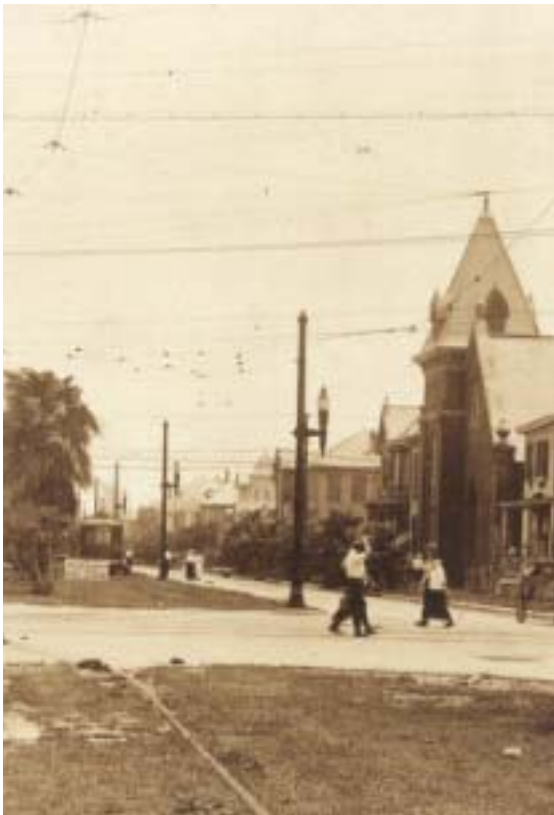
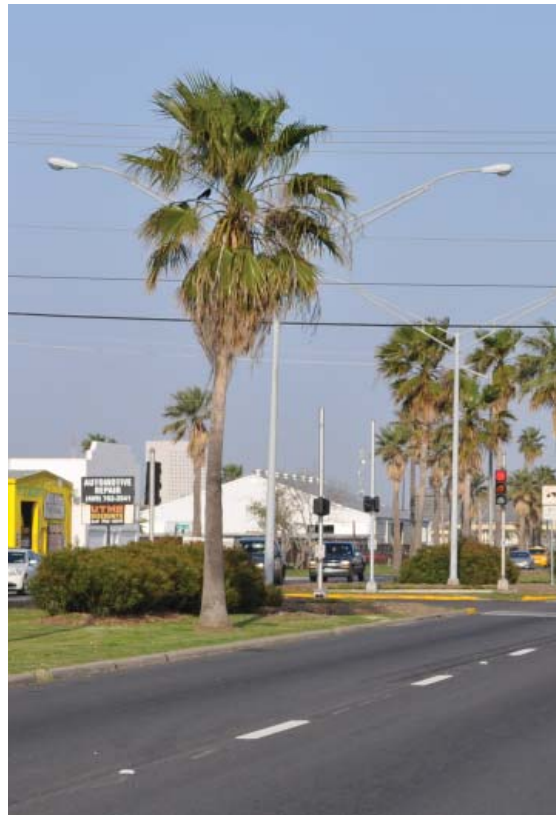
*A comparison of streetlights; historic (left) and existing (right). Lights are required for vehicular and pedestrian safety, but the current lights do not contribute to the historic character of the boulevard. Treatment recommendations for lights are included later in this report.*

Results: Broadway Boulevard's modern small-scale features including street lights, utility boxes, signs and signals are *non-contributing*. Brick paving and curbed planting beds are non-contributing but *compatible*. The replacement of historic lighting with large, historically incompatible lighting diminishes the historic character of the boulevard. New transportation and safety features such as traffic signals and signs, while not historic, are necessary for vehicular and pedestrian safety.
