#### 4 Whitmore Hall Facade, Sheldon Jackson School National Historic Landmark HPF #16003

Day 1: Tuesday, July 12, 2016

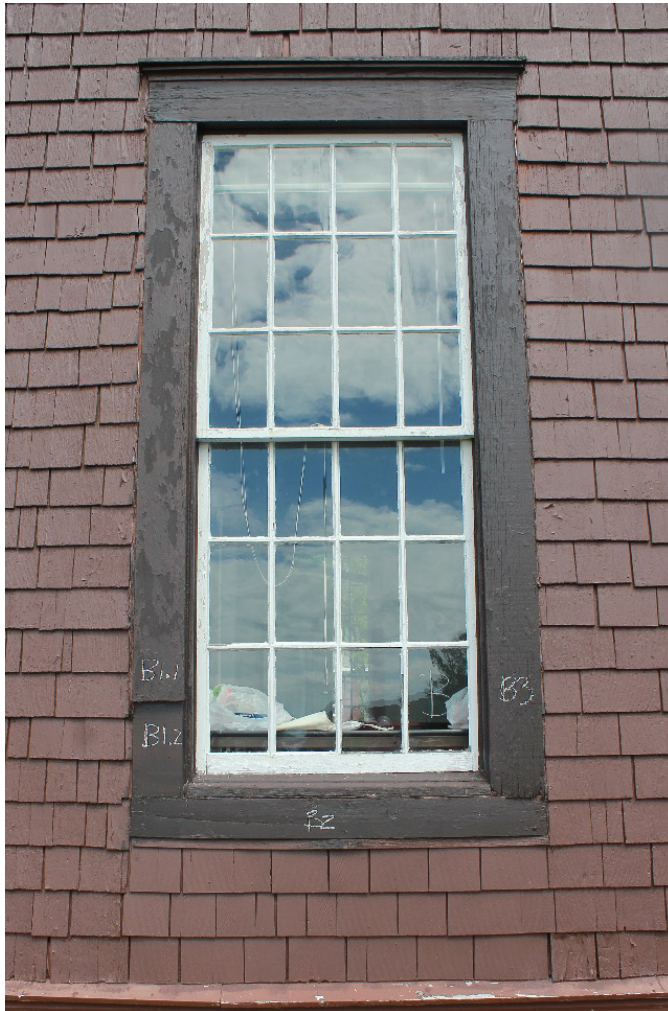
An example of the window casings that were replaced and made to reach the drip-cap. The top casings were also replaced.

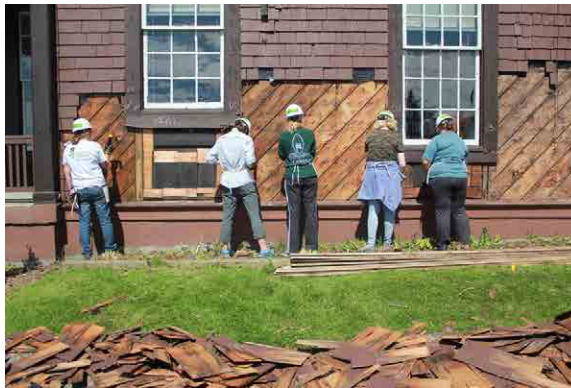
Interns removing old cedar shingles and nails.

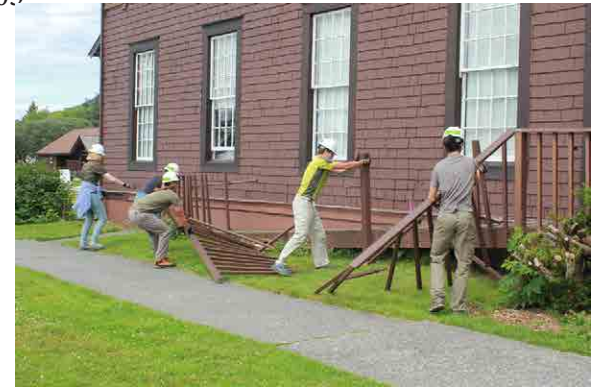
Interns removing the ramp that was on the left side of the porch.

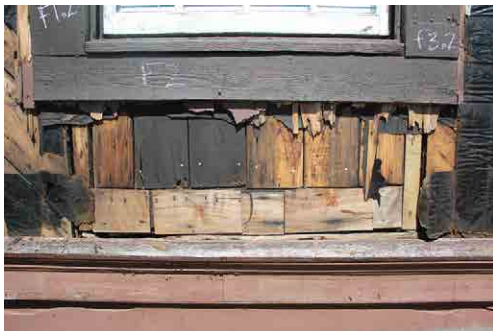
Boards that covered many hidden panels underneath all windows.  
[Window F]

Day 2 started with removing wood that covered panels that have been hidden for decades under the first floor windows. We then went over scaffolding safety and erected scaffolding along the south façade. There was a total of two levels so we could reach the top floor of the building.

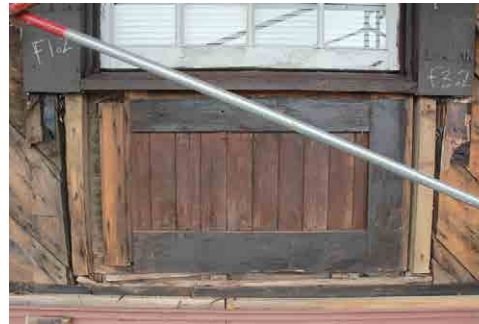
Panel that was hidden under Window F that is missing a board.

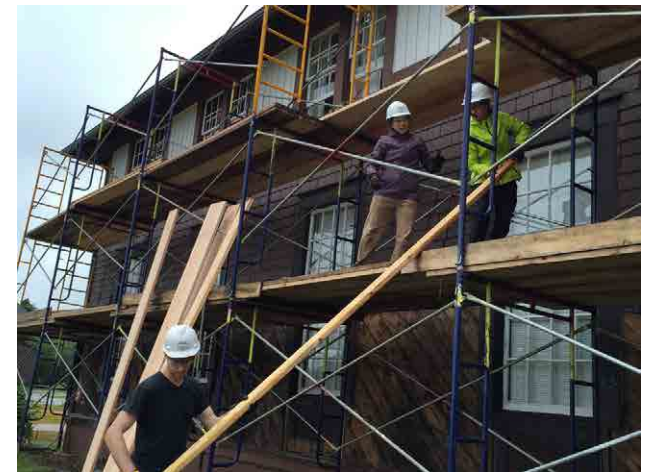
Interns erecting the scaffolding.

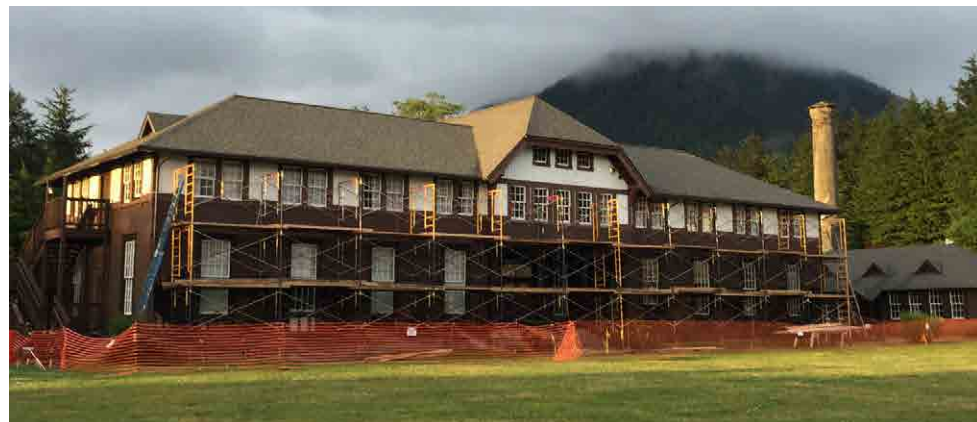
Scaffolding completely erected.

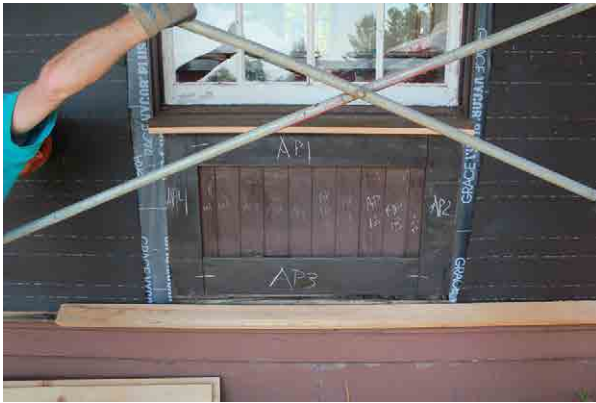
Vycor and 15 lbs Felt have been installed around Window A.

Today we added some extra safety measures that were suggested to us by the OSHA consultants, including: mud sills, mid-rails, and doors for the ends of the scaffolding. We attached Vycor around the edges of the windows to prevent water from getting in and attached 15-lb felt water proofing to the building. We also installed the new casings to the first floor windows.

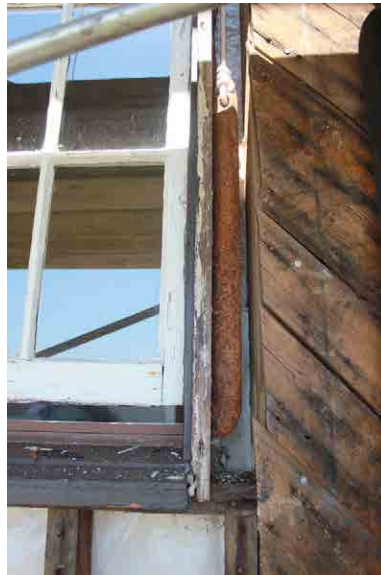
A window sash that was hidden beneath a casing.

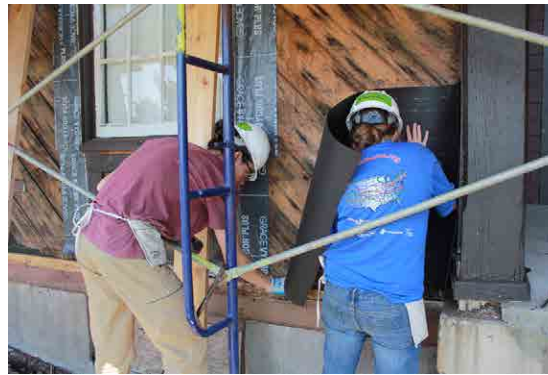
Interns installing a section of 15 lbs Felt.

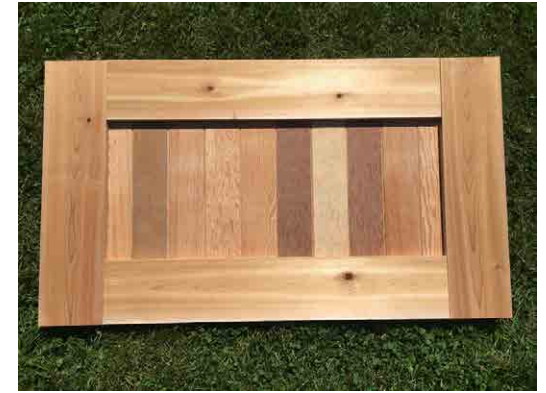
The panel that was fabricated to be installed under window G as the original was missing.

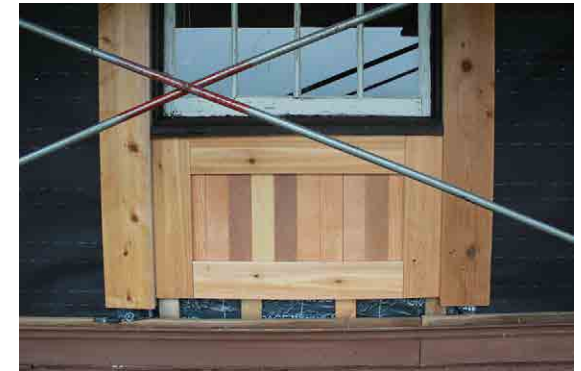
The new panel and casings have been installed for Window G with Vycor and 15 lbs Felt.

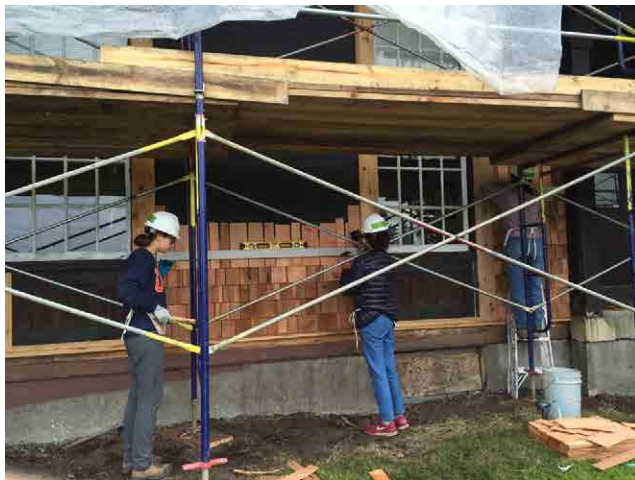
Interns putting on new cedar shingles.

We also fixed a hole in the wall on the west corner of the building that was uncovered when removing old shingles. We then started putting on new cedar shingles. The first row was cut to an angle of  $19^\circ$  so water would move away from the building and not go under the bottom shingle.

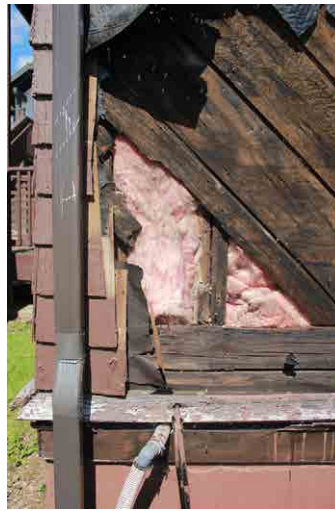
Hole in the west corner of the wall.

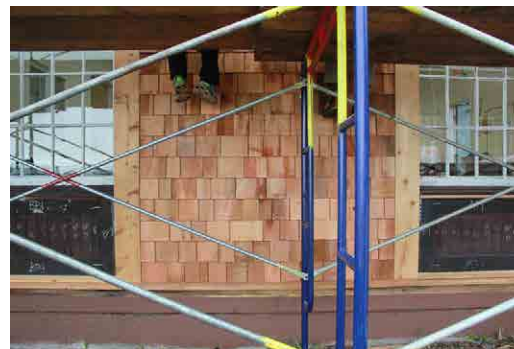
Interns putting on new shingles on the second level of scaffolding.

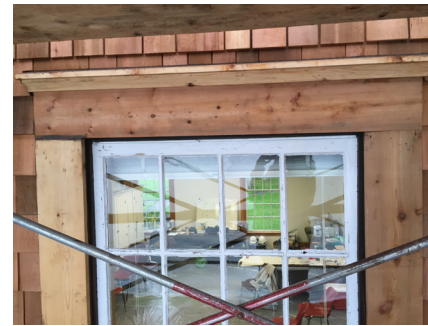
New header installed over the windows.

Today we continued to put on new shingles and Vycored remaining sections of the windows. A few interns in the shop fabricated new headers for all the first floor windows and installed them. An intern also did a field drawing of the porch of North Pacific Hall to see how to replace sections of the porch on Whitmore Hall.

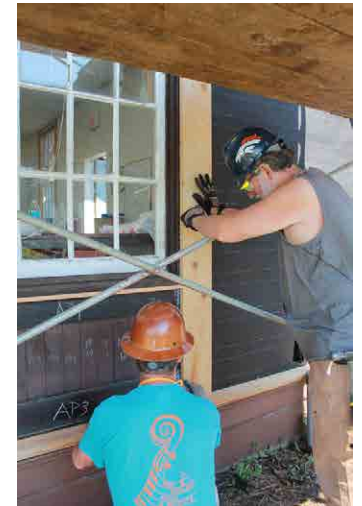
Larry and Pete raising the drip-cap and making sure the casing fits correctly.

Installed New Drip-Cap (With  $20^\circ$  angle)  
 Moved drip cap up to meet bottom of casing  
 Cut shingles @  $19^\circ$  on bottom for first row against drip cap  
 Patched hole in wall on bottom left edge of building  
 Finished putting on casings/ secured them  
 Secured Belly Band  
 Measured Lines for shingles  
 Started putting on shingles

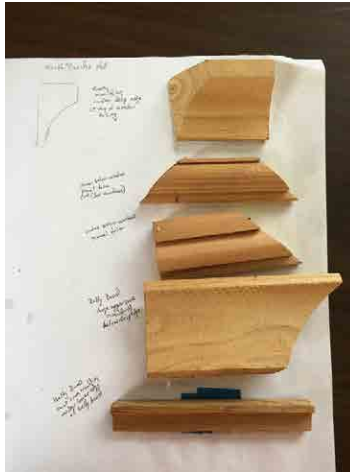
Samples of moulding from North Pacific Hall. The moulding created for under the drip-cap is the second from the bottom.

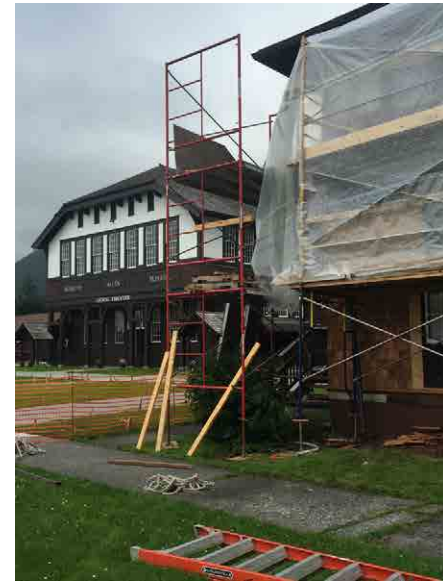
Scaffolding that was erected on the west side of the building.

Day 8: Monday, July 25, 2016 Today we finished shingling the main part of the façade. A section of scaffolding was erected on the west side of the building to make shingling the corner easier.

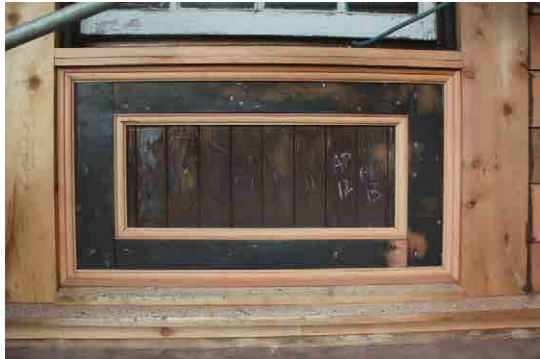
Window panel with new moulding.

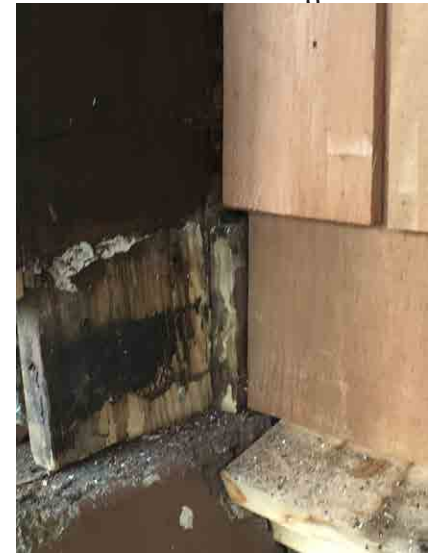
Rotten piece of porch column that will be replaced.

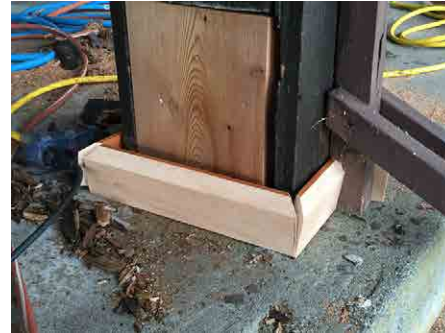
Section of column that was replaced due to rot.

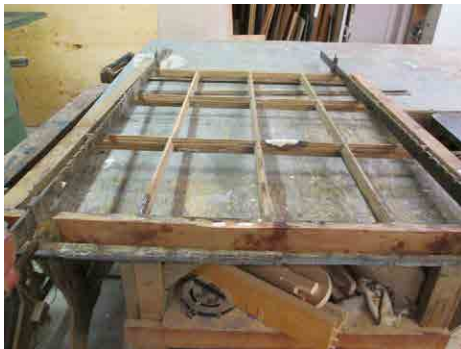
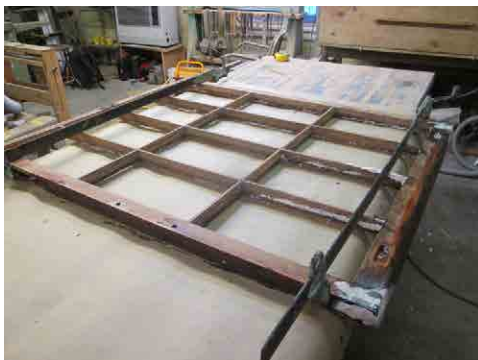
Left, top, one of the three windows completely rebuilt during the winter 2016-17. Left, and below left, the two sash from one of the windows undergoing restoration. (The putty and paint are removed with the help of our steamer, rotten parts are either consolidated with liquid epoxy, replaced with new wood, or built up again using epoxy putty. Then they are shaped and sanded, repainted, reglazed, and replaced.)
