# RECONNAISSANCE SURVEY OF THE CITY OF ANACORTES

*SOUTH OF 24<sup>TH</sup> STREET TO CITY LIMITS*

**ANACORTES, WASHINGTON**

August 2011

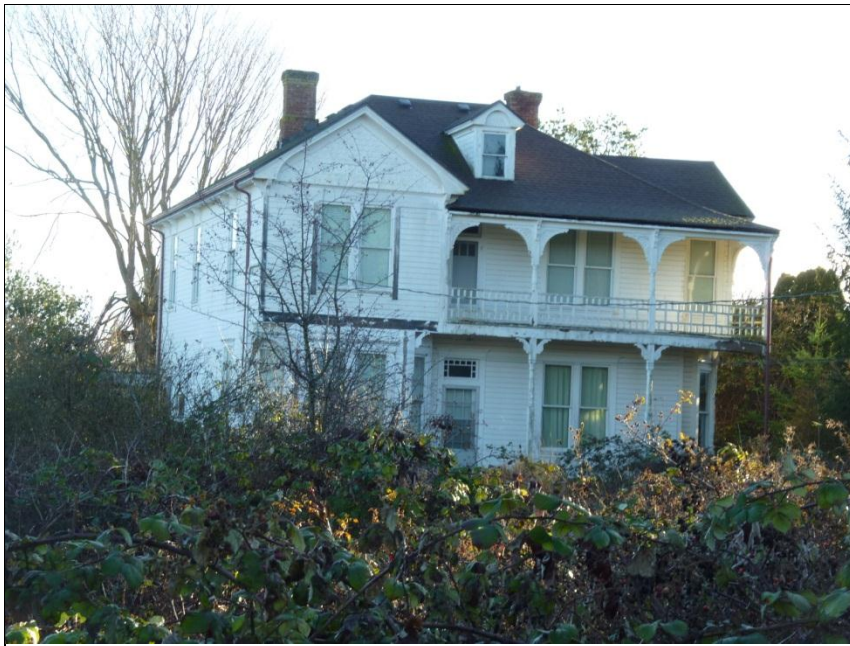
**Figure 3: House at 3903 H Avenue**

Constructed in 1885, this two and a half story Queen Anne style house sits on a concrete foundation, is clad with clapboard and fishscale shingles, and has a gable-on-hip composition roof. Even though it is

one of the oldest extant houses in Anacortes, it retains much of its original materials and has been very minimally altered. The front facade includes the main entry on the first story beneath a tripartite arched balcony, which is supported by narrow milled wood pillars and decorative brackets. The northwestern pillar has been replaced with metal beam, and the balcony appears to be settling. The front door is not entirely visible behind the aluminum screen door, but it may be original. It sits beneath an eleven light wood casement transom window. Pairs of one-over-one double-hung wood sash are placed directly to the right of the main entry door, a pattern which is replicated on the second story. The second story includes the delicate triple arched balcony with milled pillars and balustrade. A balcony door sits directly above the primary entry.

The front facade gable end features a bay window on the first floor, but its details were not visible from the driveway. The gable end second floor includes a projecting bay with a pair of double hung wood sash. The projecting bay is supported by decorative kneebraces, similar to those that support the balcony. Above the bay, the gable is clad with fishscale shingles, with flared fascia along the roof edge. A single dormered gable with a one-over-one wood sash window projects from the third story roofline.

Secondary facades include simple fenestration, with narrow, single one-over-one double-hung wood sash windows. The second story window corners serve as kneebrace locations for the eaves, creating an elegant pattern in the otherwise simple facade.

This house is an excellent and rare example of a 19<sup>th</sup> century Queen Anne-style house south of 24<sup>th</sup> Street in Anacortes. It is eligible for listing in the NRHP and as an Anacortes landmark.

| 3903 H Avenue | 1885 | Constructed in 1885, this is one of the oldest, if not the oldest, extant buildings in Anacortes. It retains a very high level of integrity and considering its age, has been altered extremely little. Because of its architectural significance, and as a rare and distinctive example of a 19th century building in Anacortes, it is recommended eligible for listing in the NRHP. |

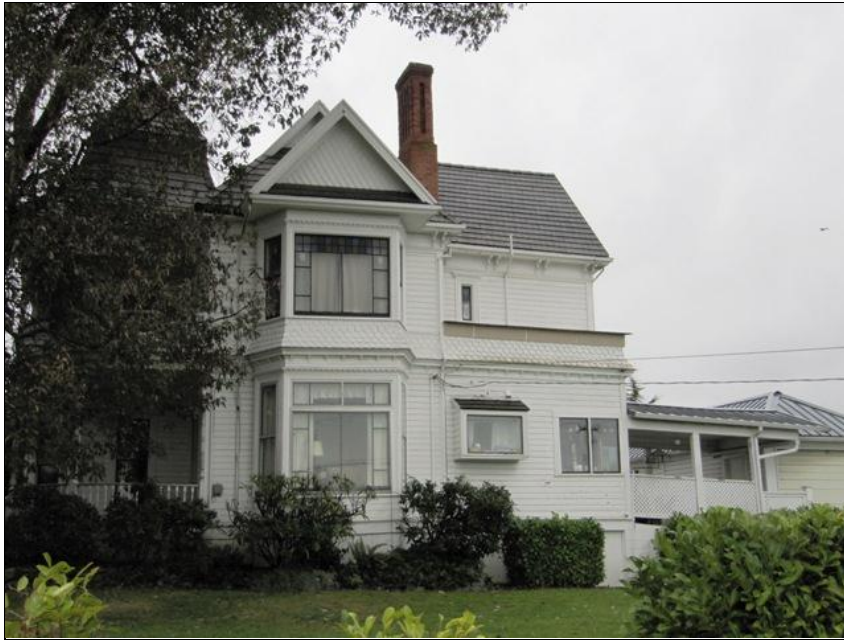
**Figure 4: House at 1304 32nd Street**

Constructed in 1910, this large two and half-story Queen Anne style house is irregular in form and has varied rooflines and sits on a concrete foundation. The roof is covered in composition shingles and the exterior walls are primarily clad in wood clapboard, with fish scale and diamond pattern wood shingles on some wall surfaces. The original asymmetrically arranged plan is relatively intact with the exception of the two-story addition at the rear northeast corner that may be an enclosed porch. Original features include the recessed, two-story curved wrap-around porch at the front southeast corner with decorative railing and balustrade; the two story gabled bay window on the east side elevation; prominent three-part bay window on the first story primary elevation; a front gable dormer; the distinctive prominent corbelled brick chimney; the bell-shaped tower roof projection; and details such as decorative brackets at the porch and roof eaves and spindlework porch supports and railings and the varied textured wall surfaces. All of these are hallmarks of the Queen Anne style. Additionally the majority of the windows are original Queen Anne style window types in wood sashes, including many single hung sashes with multilight transoms and/or multilight sidelights.

| <b>Address</b> | <b>Year Built</b> | <b>Significant Characteristics and Features</b> |
|---|---|---|
| 1304 32 <sup>nd</sup> Street | 1910 | This large Queen Anne style house (noted in some sources as the W. T. Odin House), constructed c. 1910, is a relatively intact and good example of Queen Anne style architecture that was popular from the late 19th century into the early part of the 20th century. It dates to the early settlement of Anacortes and |

| | | additional information about early residents may reveal other significant associations relevant to the historical development of the city. It is recommended eligible for the NRHP. |

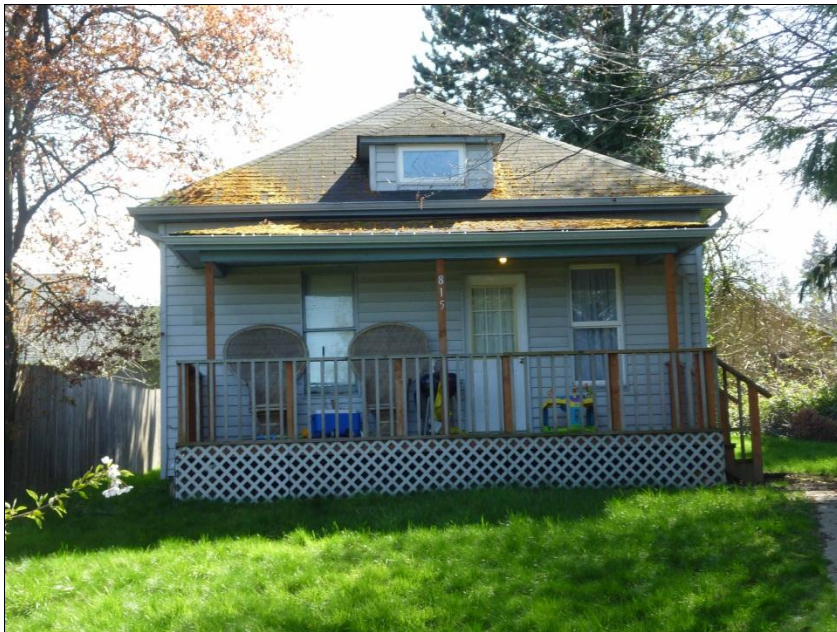
**Figure 5: House at 815 36<sup>th</sup> Street**

Constructed circa 1920, this one and a half story house sits on a concrete foundation, is clad with vinyl siding, and has a composition pyramidal roof with a hipped roof dormer. Fenestration is largely replacement vinyl sash. The front façade is dominated by a nearly full-façade porch with a shed roof and supported by three unadorned wood beams. The door is asymmetrically placed on the wall and is flanked by double-hung windows. This small house is very typical of Anacortes workforce housing that was developed in the early 20<sup>th</sup> century to respond to the influx of workers who came to Anacortes to take advantage of the jobs in the many waterfront mills and canneries. This house has been modified with replacement materials, which have altered the building's integrity.

Although this particular pyramidal-roofed house is not eligible for listing in the NRHP or as an Anacortes landmark, it is included here because it is a typical form seen in Anacortes, built in an era that was characterized by rapid growth.

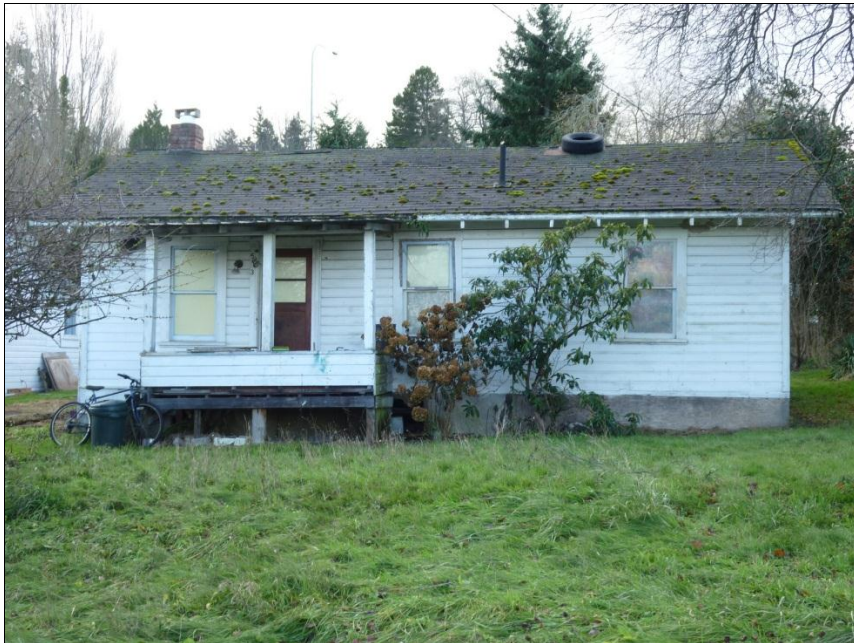
**Figure 6: House at 513 35<sup>th</sup> Street**

Constructed in 1935, this one-story house sits on a concrete foundation, is clad with clapboard siding, and has a side-gabled composition roof. The front facade includes an asymmetrically-placed front door sheltered by a shed roof supported by three wood columns. The porch has a closed porch railing and no apparent handrail. To the left of the front door is a single one-over-one double-hung wood sash window, and to the right of the door are two one-over-one double-hung wood sash windows. Side facades include similar fenestration. Other details include exposed rafter tails and a brick interior chimney.

Although this house retains many of its original materials and characteristics, it appears to have been built quickly and without design. Although this particular house is not eligible for listing in the NRHP or as an Anacortes landmark, it is included here because it is a Vernacular-style house in a very common form seen in Anacortes, built in the Depression era.

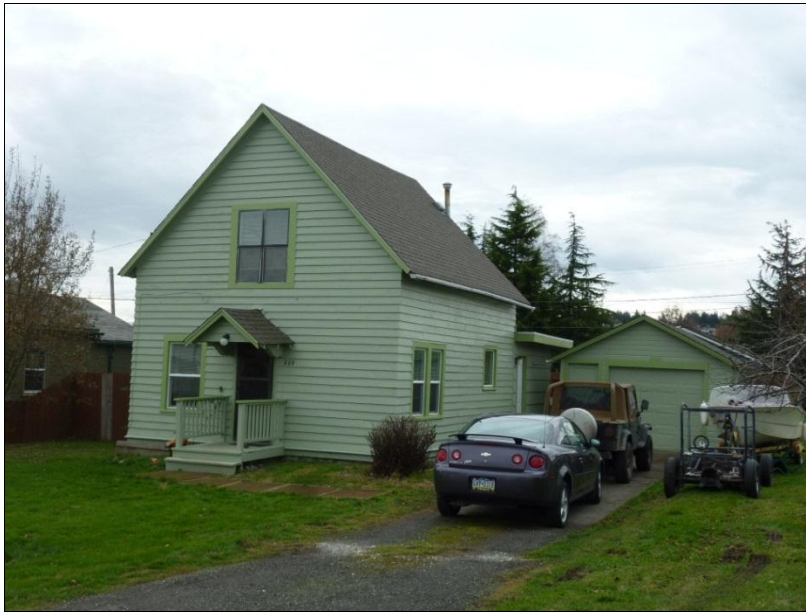
**Figure 7: House at 809 27<sup>th</sup> Street**

Constructed c. 1925, this 1.5 story Vernacular-style house features a concrete block foundation, horizontal clapboard siding, and a relatively steeply front gabled composition roof. The front facade includes a centered entry door accessed by two steps and sheltered by a gabled pediment roof supported by curved brackets. The railing and finials are non-original. The porch roof has exposed rafters, but the main house roof does not. To the left of the door is one one-over-one vinyl sash window,

and another pair of one-over-one vinyl sash is located beneath the gable peak. There are large shed additions on the left and rear of the house, clad with combed asbestos siding and with aluminum windows. A pair of one-over-one vinyl sash is also on each side facade.

Although this particular house is not eligible for listing in the NRHP or as an Anacortes landmark, it is included here because it is a simple, utilitarian, 1920s-era Vernacular-style house in a very common form seen in Anacortes.

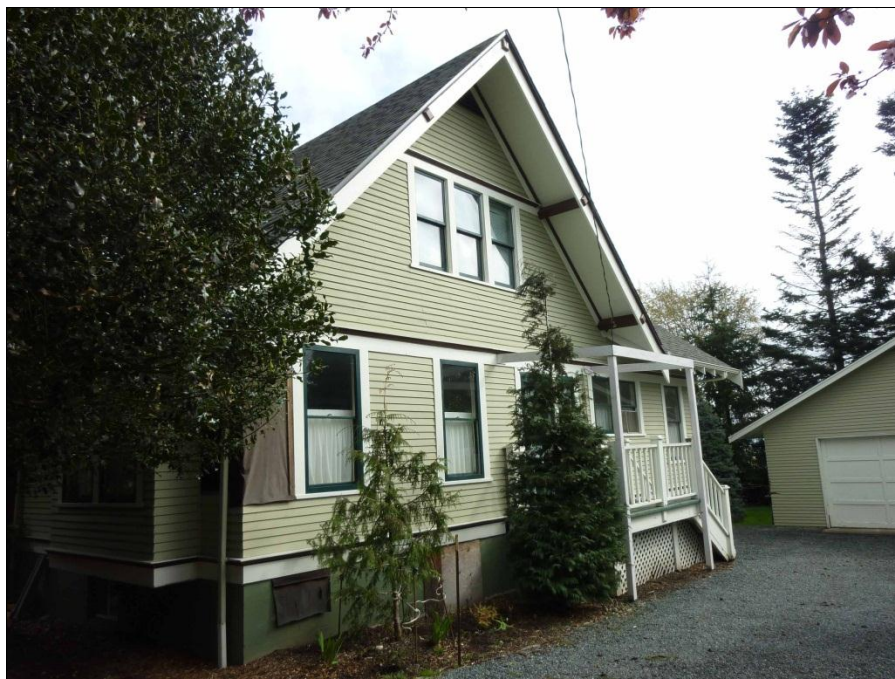
**Figure 8: House at 3601 Commercial Avenue**

This Craftsman-style house in very good condition and retains a high level of integrity. Constructed in 1920, the relatively steeply pitched one-and-a-half story cross-gabled house sits on a concrete foundation, is clad with wood clapboard siding, has an internal brick chimney, and has a composition roof. Visible windows appear to be original double-hung wood sash. The house sits behind dense foliage and was difficult to see from the street, but a Skagit County Assessor photograph from 2007 provides additional information. The façade visible from the street shows the primary wing beneath the gable peak and a secondary wing to the right, or east, of the entry. The glass and paneled door, flush to the house and unsheltered, appears original, and is accessed by a newer wood deck. To the right is a door-height sidelight, and further right is a pair of square double-hung sash and then a standard size double-hung wood sash window. To the left, or west, of the door are three standard size double-hung wood sash windows. Craftsman details include flared lintels, fascia trim, exposed rafter tails, and capped rafter ends at the gable. This house appears to retain a high level of integrity, and possesses distinctive Craftsman-style details, and is therefore recommended eligible for listing in the NRHP and as an Anacortes landmark.

| 3601 Commercial Avenue | 1920 | This house appears to retain a high level of integrity, and possesses distinctive Craftsman-style details, and is therefore recommended eligible for listing in the NRHP. |

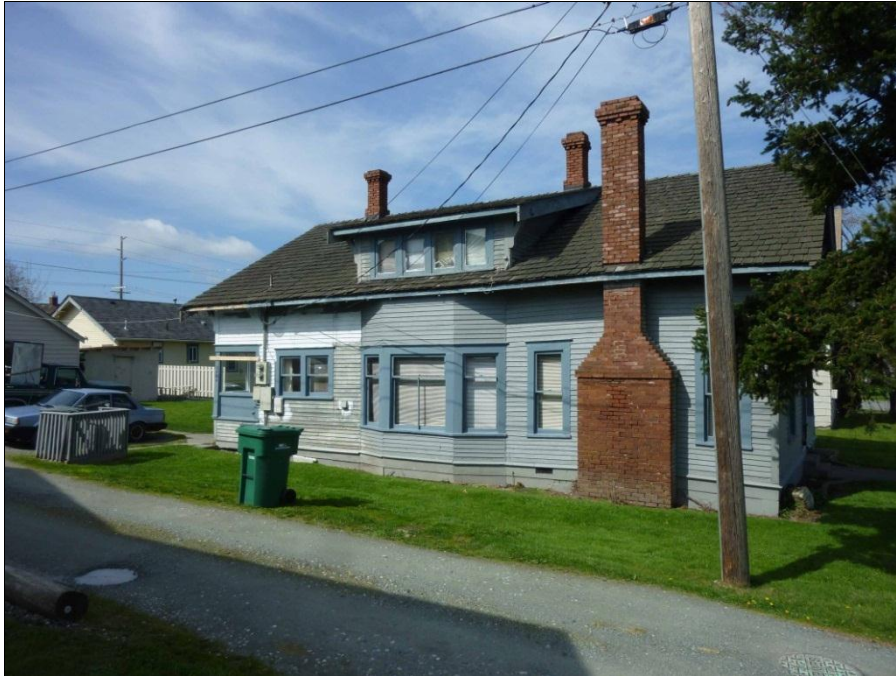
**Figure 9: House at 2604 R Avenue**

Constructed in 1925, this one-and-a-half story house sits on a concrete foundation, is clad with clapboard wood siding, and has a front-gabled wood shingled roof. The house includes two brick internal chimneys and a brick side chimney. The front façade has been modified, and now has a recessed entry with two entry doors, likely for use as a duplex. This type of entry and trim is widely seen around

Old Town, and is likely original. However, the front door has been modified and a second door added to accommodate the building's current use as a duplex. A single two-light window sits to the left of the entry. Fenestration includes largely wood sash windows, including double-hung, two-light, and fixed. Window trim has gently flared lintels. Secondary facades include shed and gabled dormers and a bay window.

This house retains most of its original materials and form, and appears to be one of the more intact of its type. Therefore, it is recommended eligible for listing in the NRHP and as an Anacortes Landmark.

| 2604 R Avenue | 1925 | This house retains most of its original materials and form, and appears to be one of the more intact of its type. Therefore, it is recommended eligible for listing in the NRHP under Criterion C. |
