# Lone Mountain 1 Post-Fire Response Plan

Lake Chelan National Recreation Area

**DATE:** September 23, 2014

**PREPARED BY:** National Park Service Lone Mountain 1 BAER Team

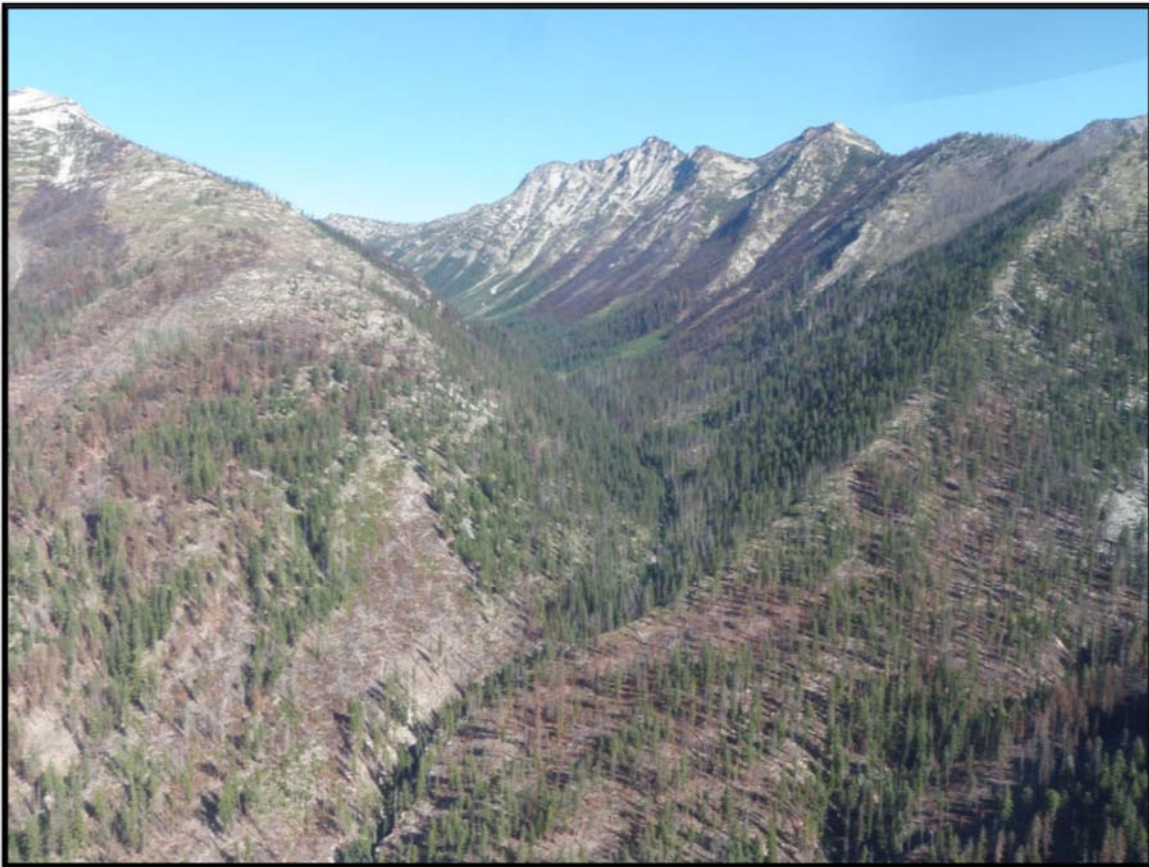
**Figure 2. A view up Rennie Creek Watershed showing burned conditions.**

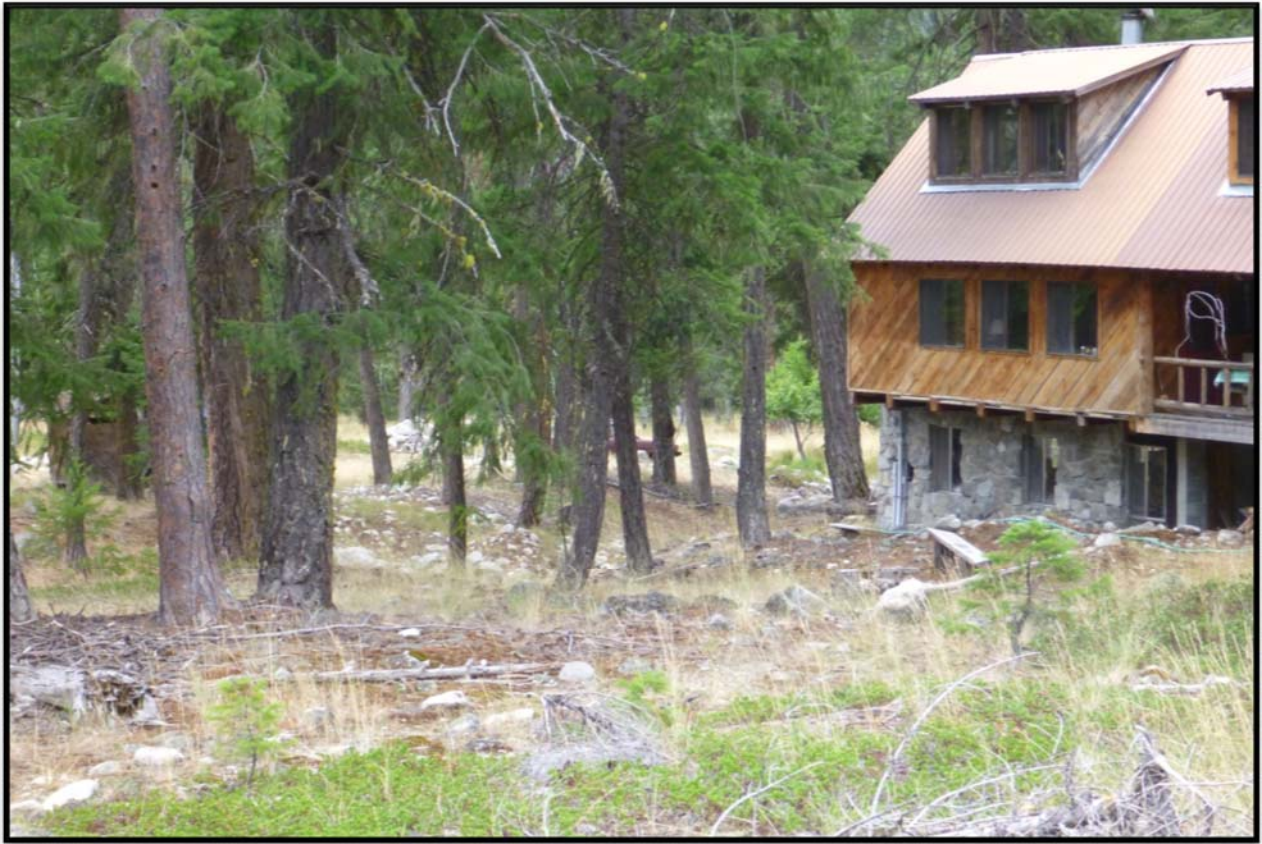
The three homes on the west side of the Boulder Creek alluvial fan are also at risk to flooding. There are abandoned channels throughout the area, and in the case of channel migration on the fan, water may be channeled to these homes. However, this is a very unpredictable situation, and it is unlikely that this will happen. In the remote chance that this does happen, it is likely that the water will be channeled away or in between the homes in abandoned channels (**Figure 4**). Additionally, the homes are well suited for such an event due to solid rock lower stories or raised foundations.

**Figure 4. Abandoned channels around and between homes on the west side to the Boulder Creek alluvial fan.**

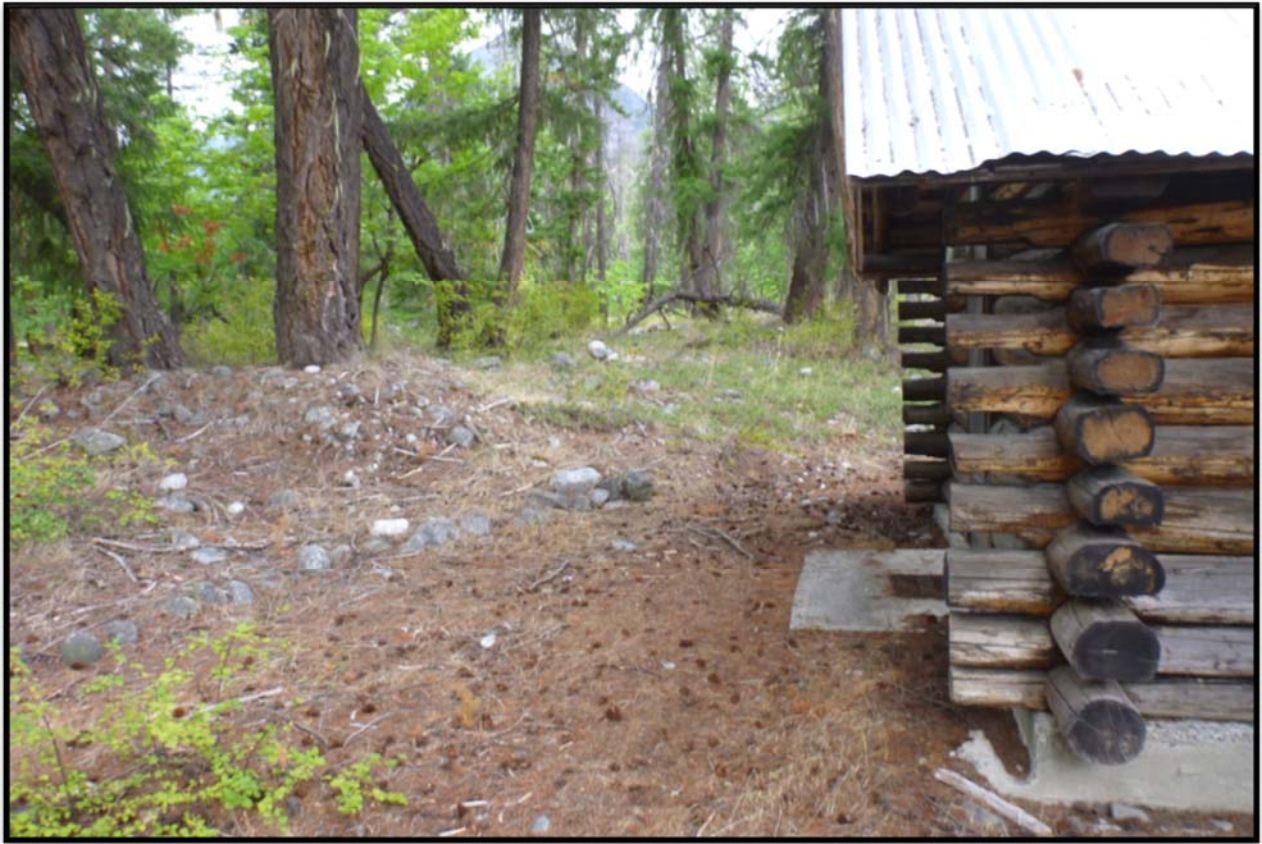
The Washington Department of Fish & Wildlife (WA DFW) cabin on the left side upstream side of Boulder Creek Bridge is also at increased risk of flooding as demonstrated by deposits from what is considered the 1948 flood (**Figure 5**). However, the cabin is situated away from the active channel, and flood relief channels should keep water away from this cabin. It is believed that the cabin did exist in 1948. There is no field evidence to suggest that the cabin has been flooded in the past, however ditches have been dug around the cabin to divert water away. The cabin should only be subject to nuisance flooding, unless an even bigger than the 1948 storm occurs, in which case BAER treatments would be ineffective due to the magnitude of the flood (see Values at Risk introduction below).

**Figure 5. WA DFW Cabin with flood deposits of unknown age (1948?) in background.**

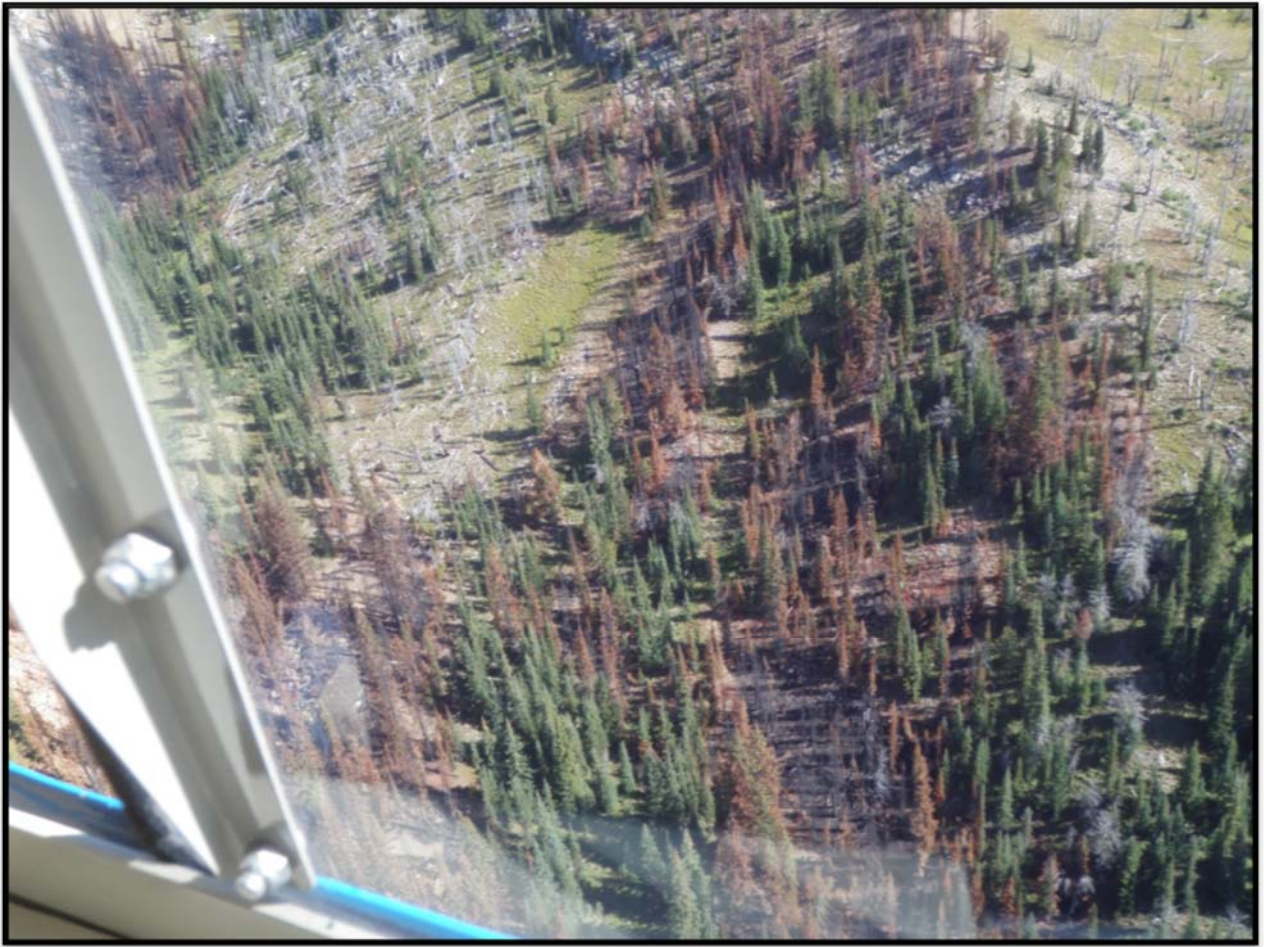
Whitebark pine (*Pinus albicaulis*) is primarily found on the eastern slopes of LACH with in the North Cascades National Park Service Complex, however, some small populations can be found scattered north of LACH in North Cascades National Park and within Ross Lake NRA. Whitebark pine (*Pinus albicaulis*) is a federally listed candidate species. It was listed in July of 2011 by the U.S.F.W.S. as a Listing of Priority Number (LPN) 2, which means that it had been determined that threats are of a high magnitude and are imminent. Threats to this species are white pine blister rust, a non-native introduced rust, Mountain pine beetle, catastrophic fire, fire suppression, and the environmental effects of climate change. Whitebark pine is found on the ridges and upper areas of the drainages found within the Lone Mountain 1 Fire. Many trees with the Rennie Creek Basin have been burned (**Figure 6**) (personal comm. Michael Koenen, and observations by M. Bivin via helicopter, 9/4/2014).

**Figure 6. Burned whitebark pine trees in Rennie Creek Basin**

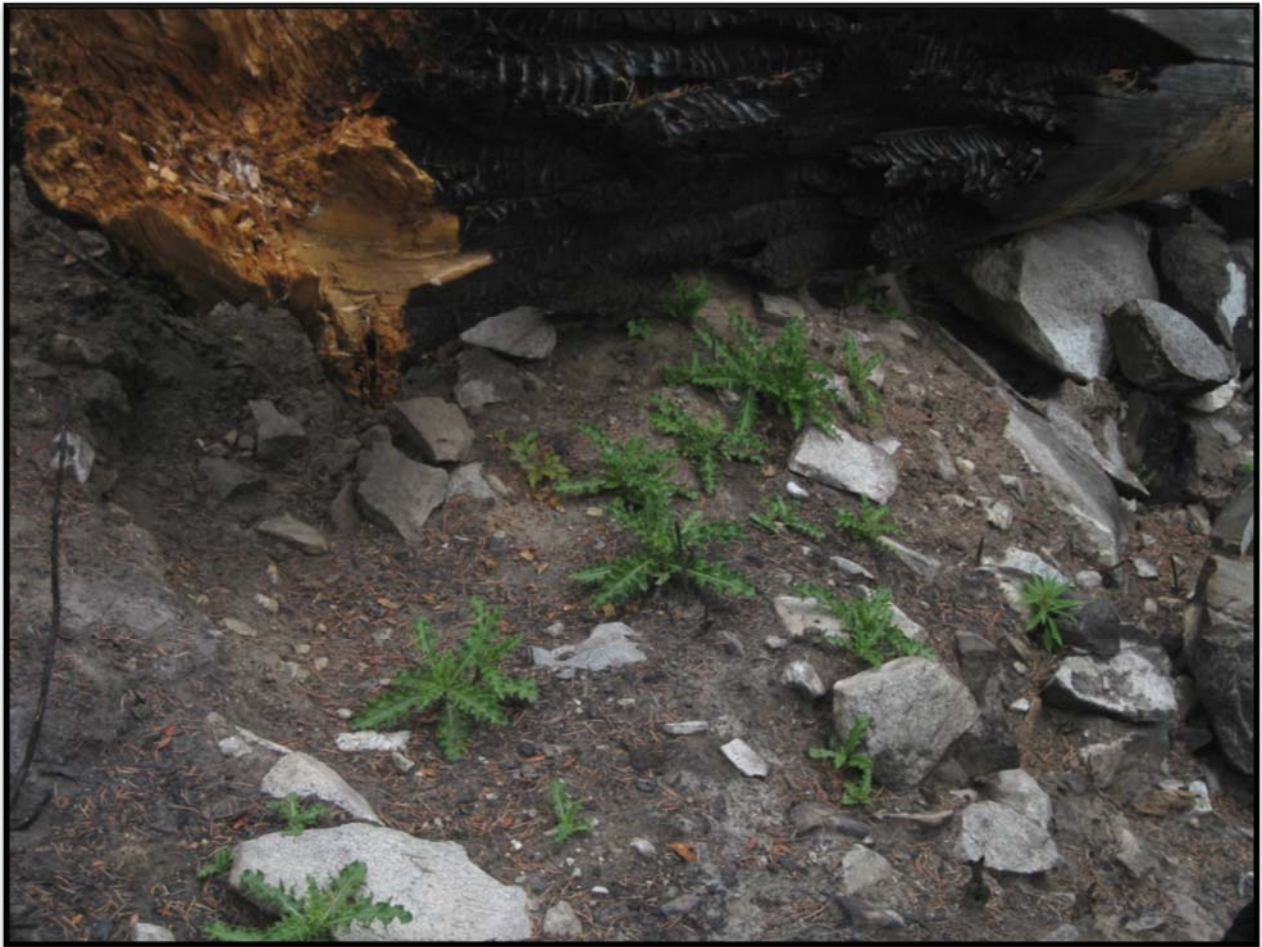
The primary invasive plant species of concern within the Lone Mountain 1 Fire is Canada thistle (**Figure 7**), for the following reasons:

**Figure 7. Canada thistle infestation along the Boulder Creek Trail.**

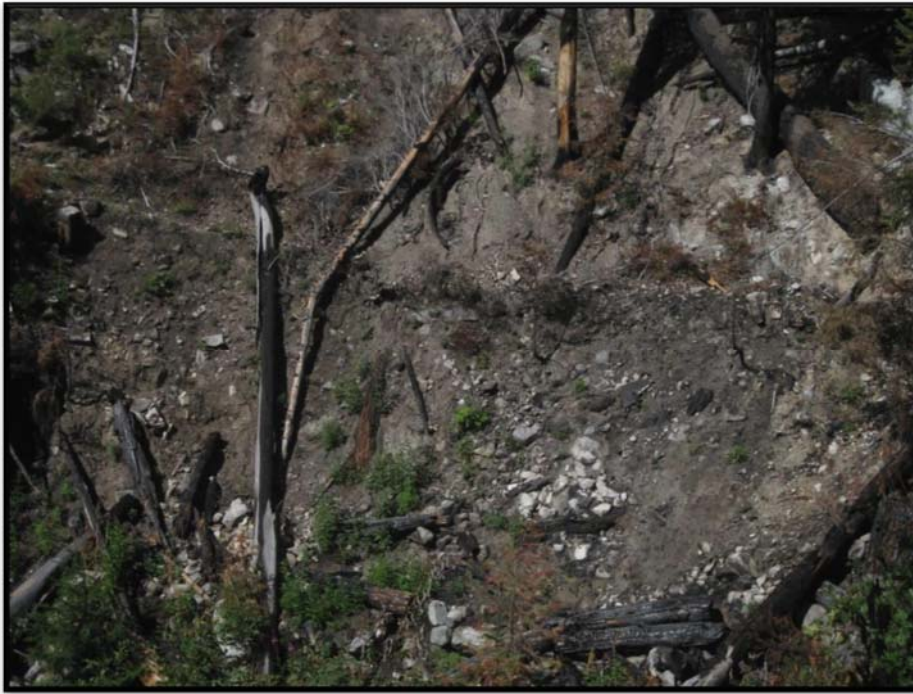
Approximately 3,000 linear feet of tread on the Boulder Creek trail was damaged by fire, either by debris falling onto it or by having roots and organic material (duff) burned out beneath it. Many trees have fallen across the trail already (**Figure 9**).

**Figure 9. Burned over trail showing loss of tread, burned logs, potential for erosion.**

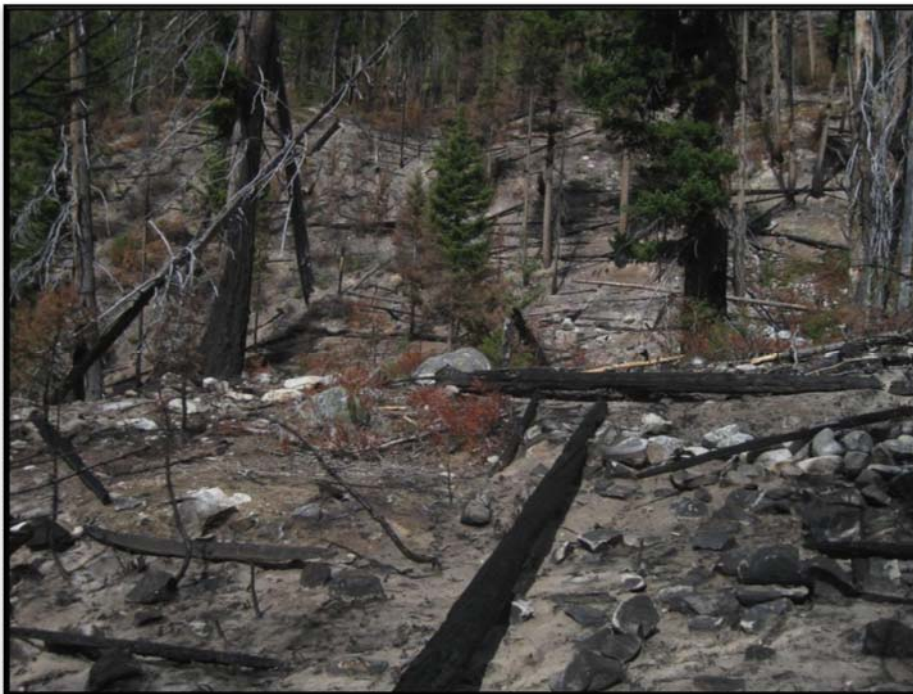
At Rennie Creek camp, two tent pads and the wooden pit toilet burned. Although the third tent pad did not burn, it has several hazard trees surrounding it (**Figure 10**).

**Figure 10. Rennie Creek campground, tent pad.**

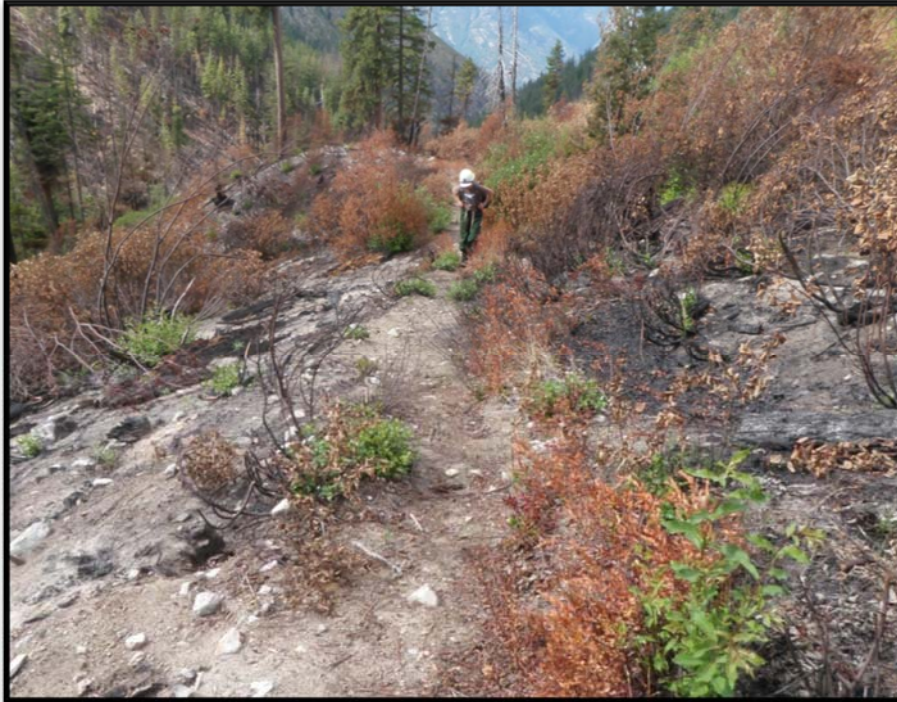
Based on experience from both the 2006 Flick Creek fire and the adjacent 2010 Rainbow Bridge fire, trail brush will grow quickly and soon become a trail maintenance issue. **Figures 11 and 12** show the presence of ceanothus in the burn area and adjacent 2010 Rainbow Bridge fire.

**Figure 11. Ceanothus-lined trail, Lone Mountain 1 fire.**

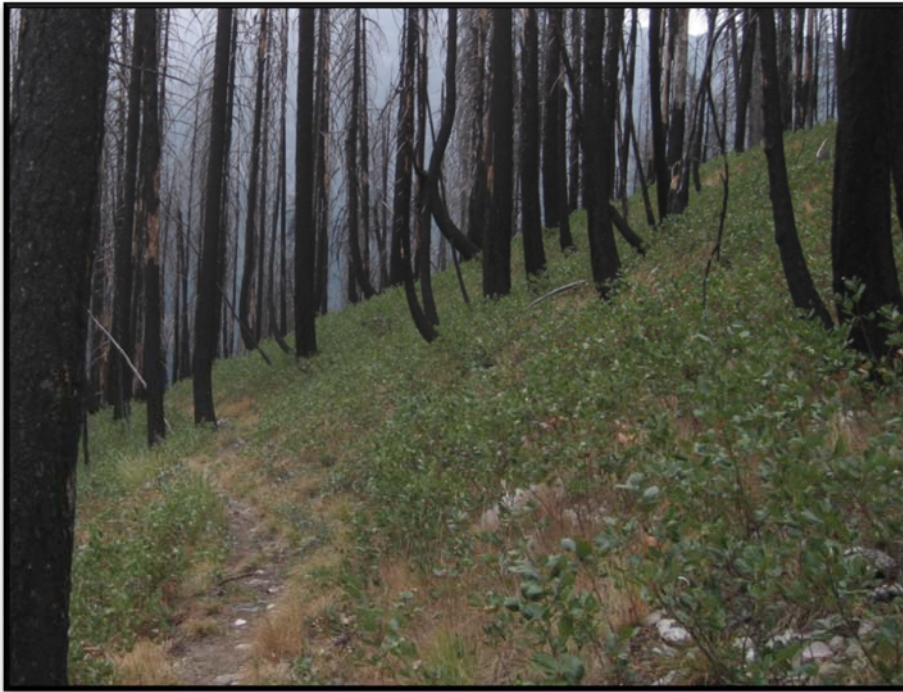
**Figure 12. Extensive ceanothus regrowth in adjacent 2010 Rainbow Bridge fire**
