# Pipeline Road Post-Fire Response Plan

Big Thicket National Preserve

**DATE:** May 12, 2011

**PREPARED BY:** National Park Service Pipeline Road BAER Team

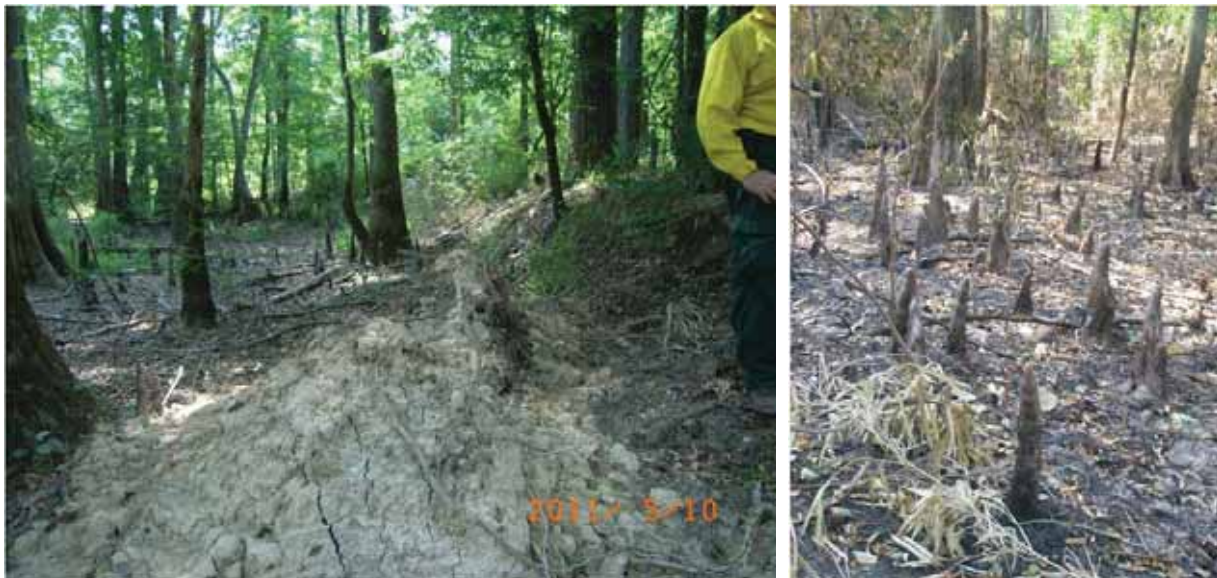
- Soil berms or “push-up piles” were created by dozers bisecting continuous flat-lying wetland areas.
- Wetland bottomland, including cypress knees, vegetation, and soils were impacted with newly formed depressions, soil mounds, and compaction of soil in the tracks created.

Left: Picture shows a push-up pile created by dozer in cypress wetland bottomland. Right: Picture show a dry, wetland bottomland with burned cypress knees.

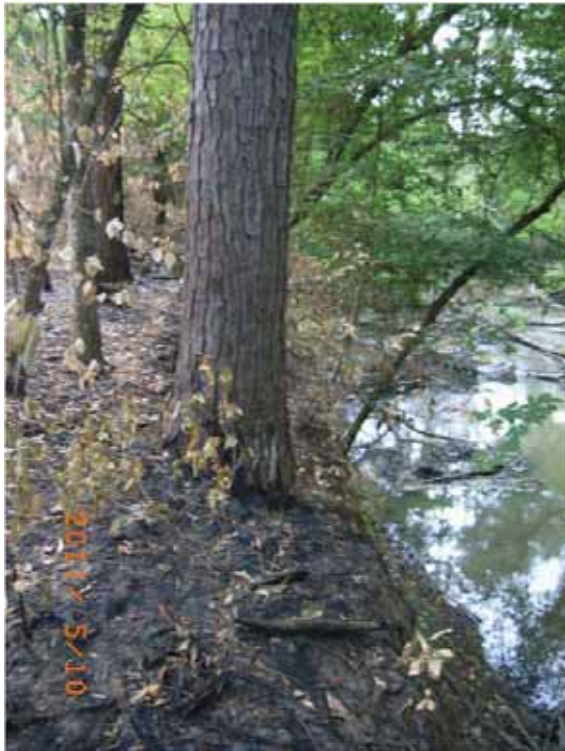
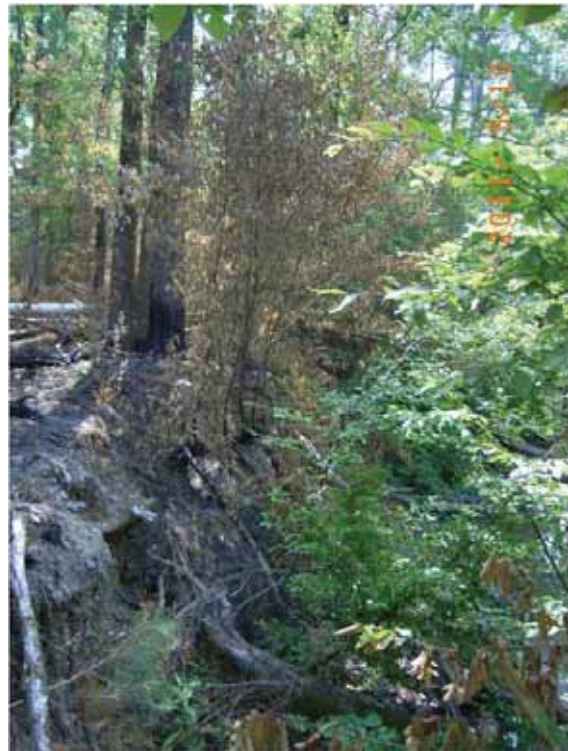
Above: Pictures showing burned left bank of Turkey Creek. Tree canopy, leaf litter, some shrubs and downed trees remain on top layer of soil.

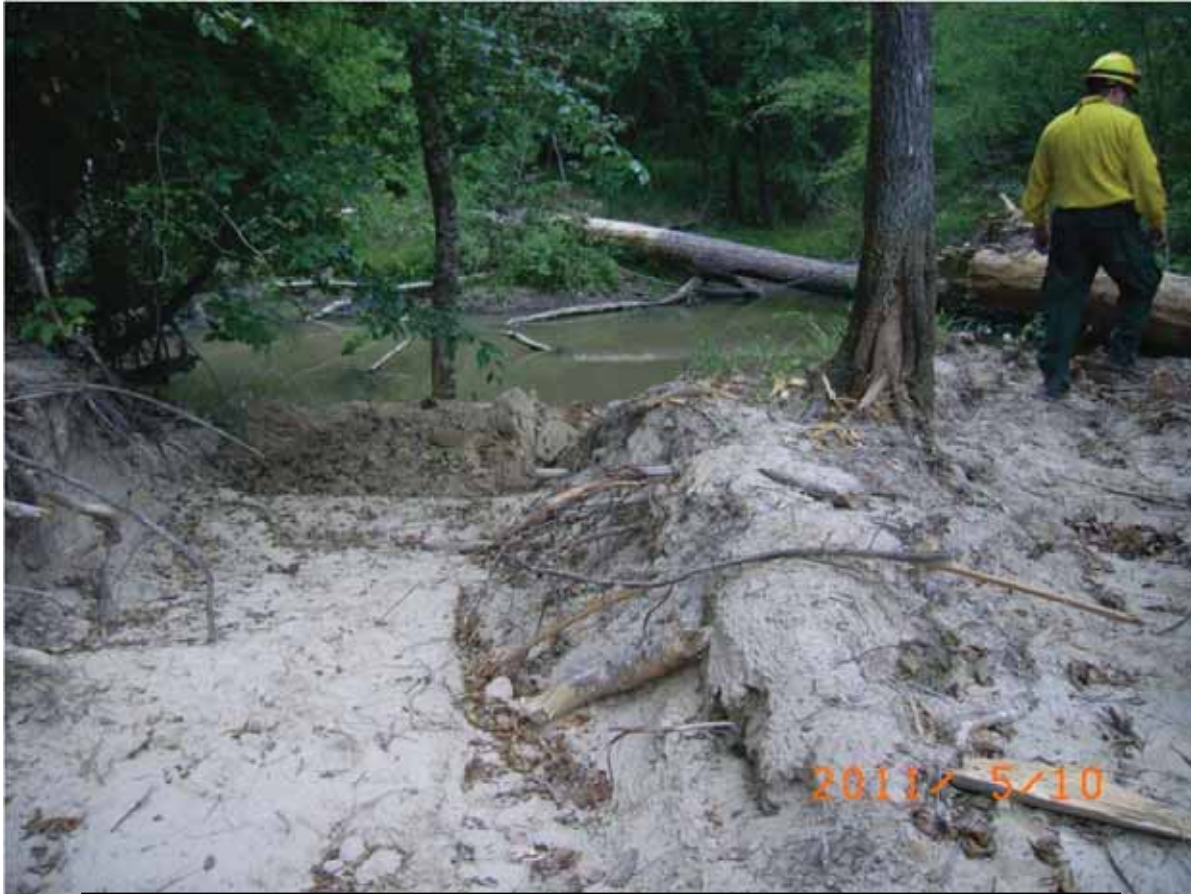
Above: Shows dozer line and push-up pile at left bank on Turkey Creek.

Return soil side cast berms, and recover “fill” materials and replace in “cut” banks along dozer lines blending disturbed areas to fit the natural contours.

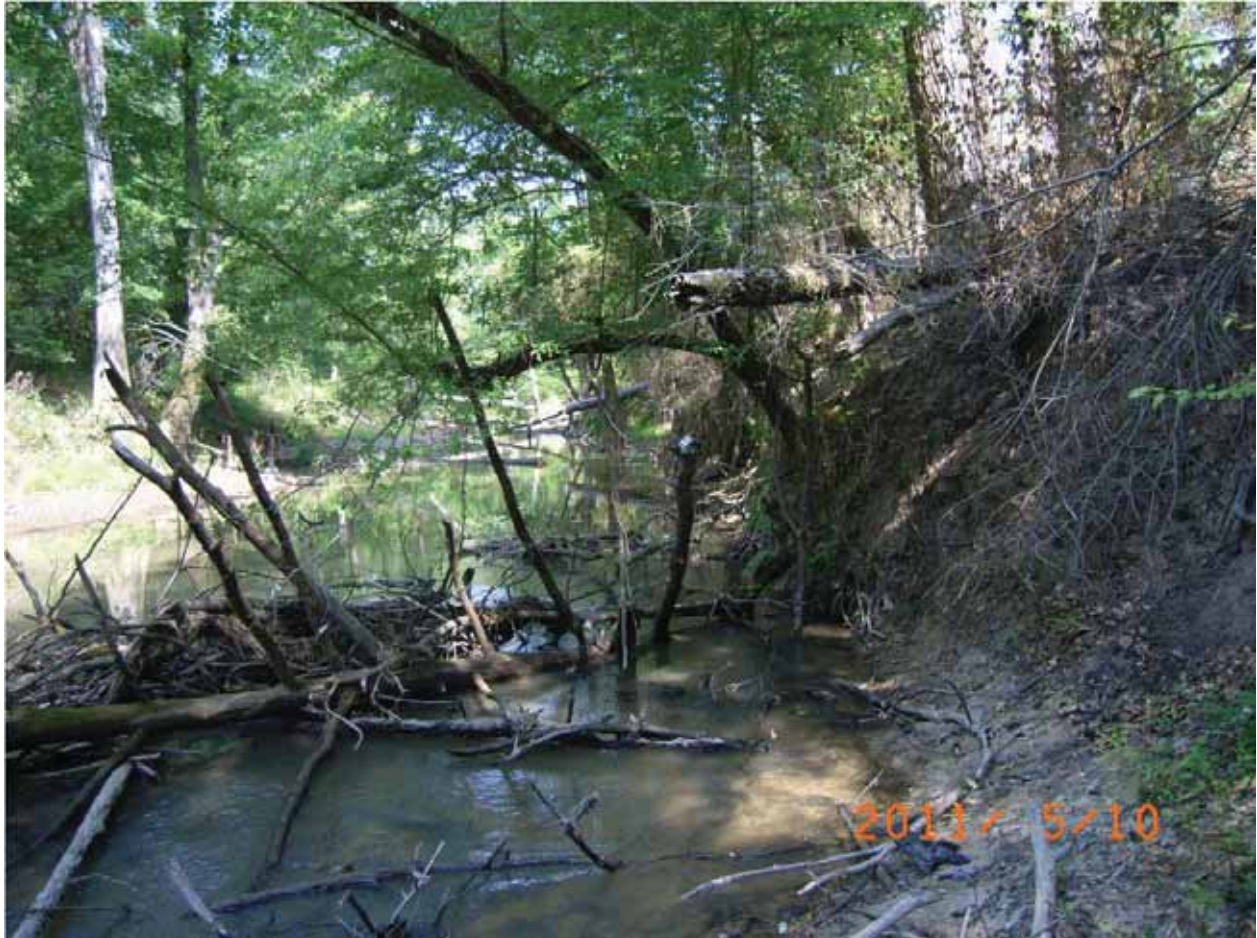
Above: Typical, incised Turkey Creek streambank. Looking upstream at left bank, burned area above, note unburned plants and vegetation in bank.

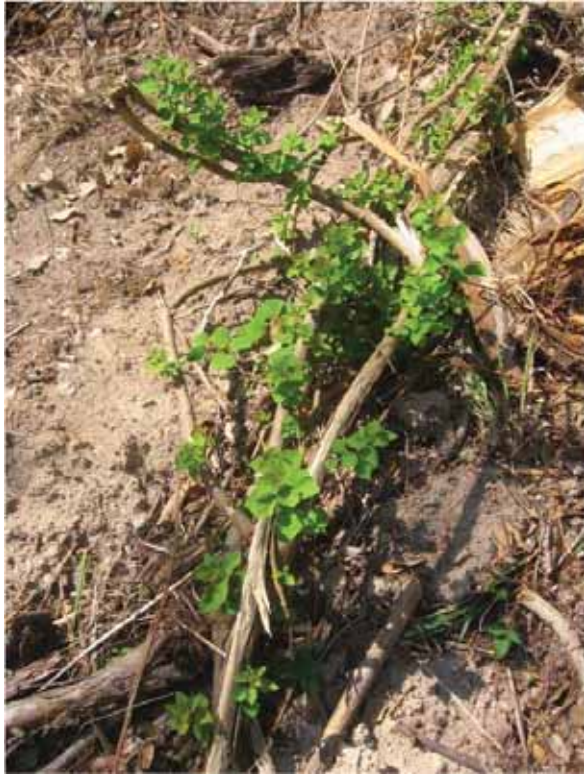
Resprouting tallow from downed trees in dozerline

- 1) Replace soil in dozer line; cover with woody debris (non-specification related)
- 2) Treat priority exotics that may be a seed source within a 50 foot buffer of the dozer line to reduce germination potential within the disturbed area. Treat all exotics within dozer line for three continuous years

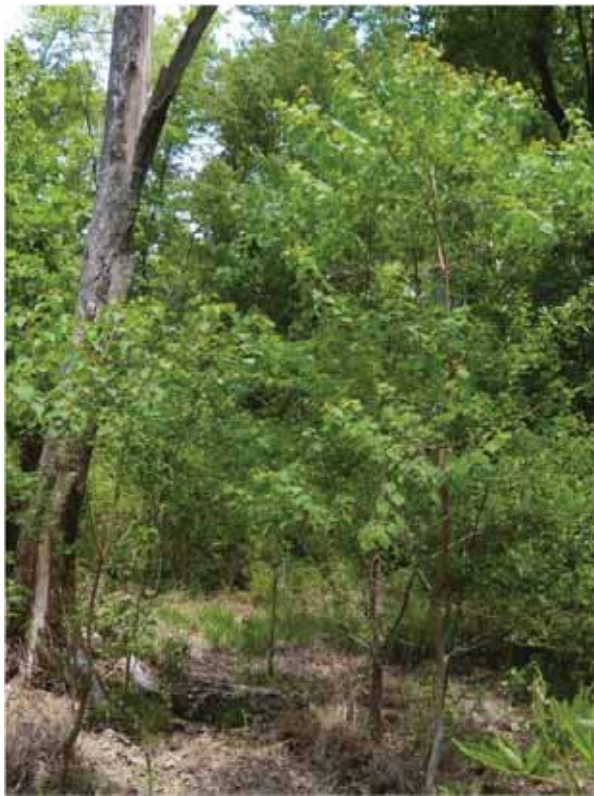
Tallow seed source adjacent to dozer line

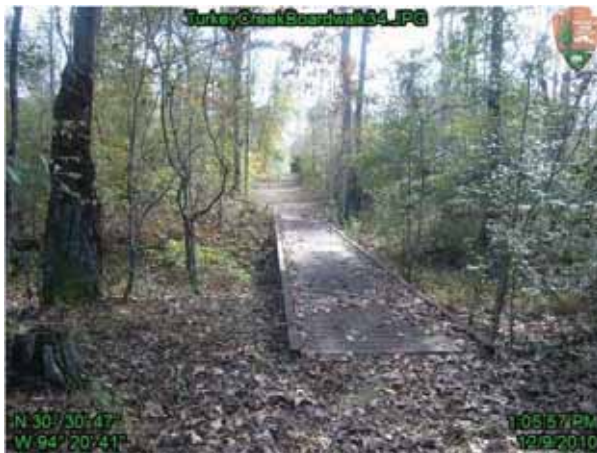
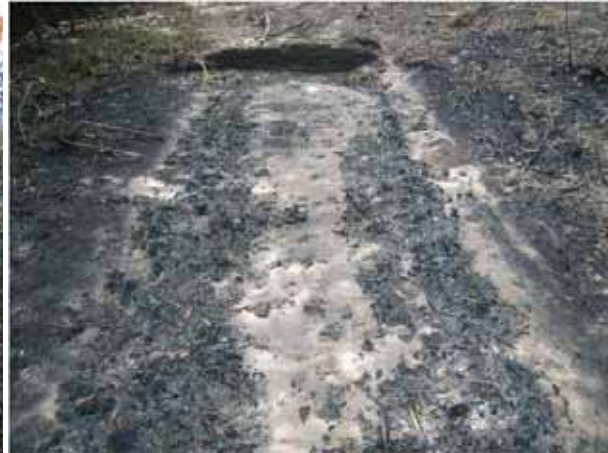
Eight boardwalks (light foot bridges), and 5 benches were burned:

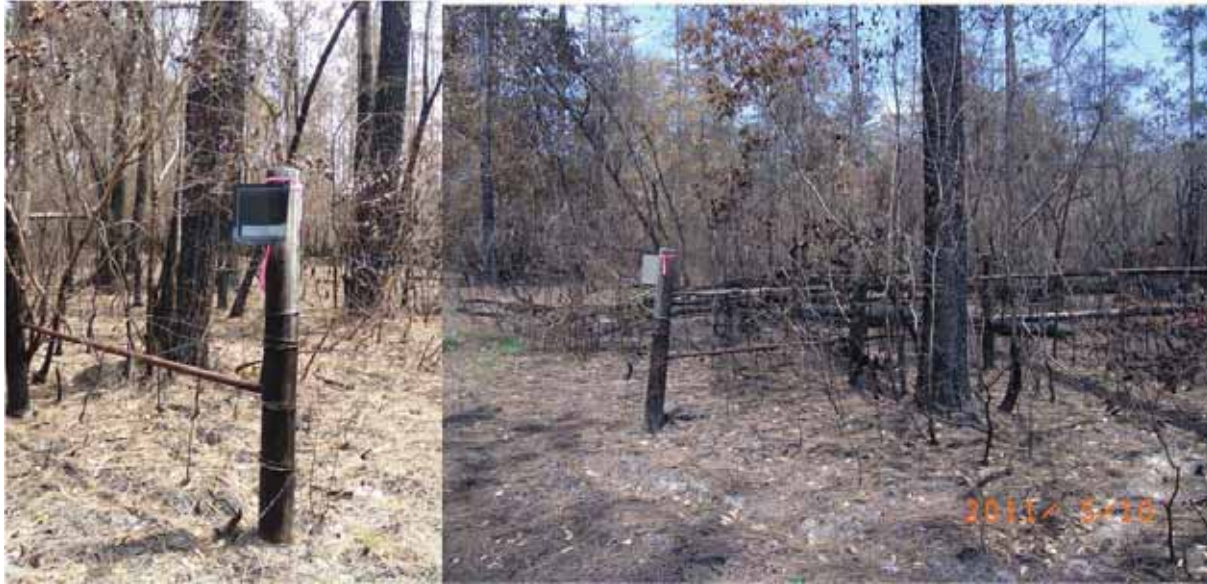
2.19 miles of Preserve boundary was burned through by the Pipeline road fire; .39 miles North of Gore Store road, 1.8 miles South of Gore Store Road. “US Government Property” signs were melted and yellow paint blazes on trees were blackened. An area of pine forest on the south at the pipeline and boundary may have stand mortality due to fire intensity. This area also has a section of Preserve fencing. A five strand barbwire on metal T-post. A gate or gap blocking access down the pipeline has been missing for some time.

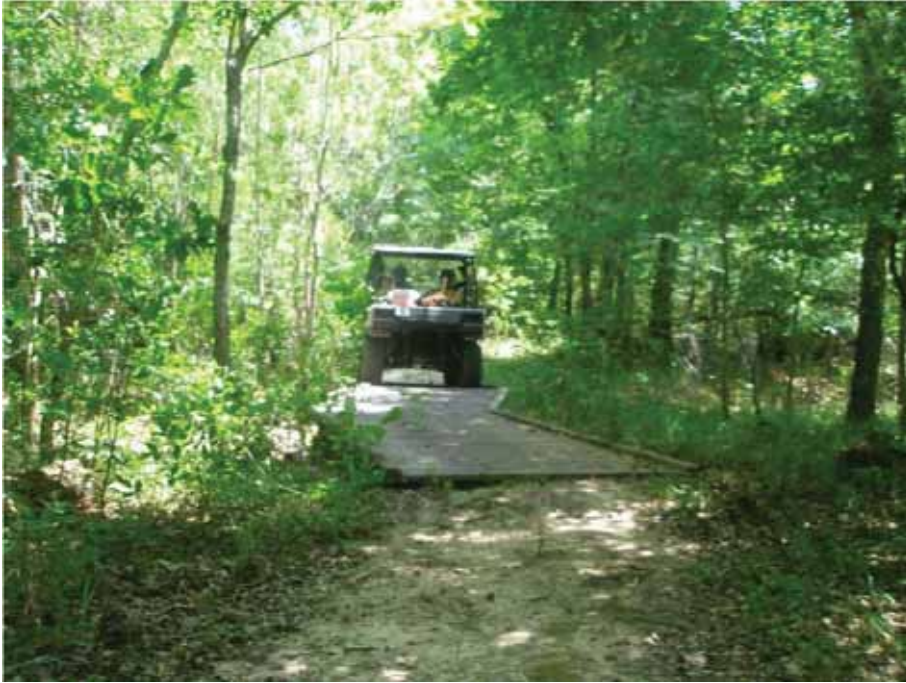
**Photo 1.** Unburned boardwalk across a wetland.

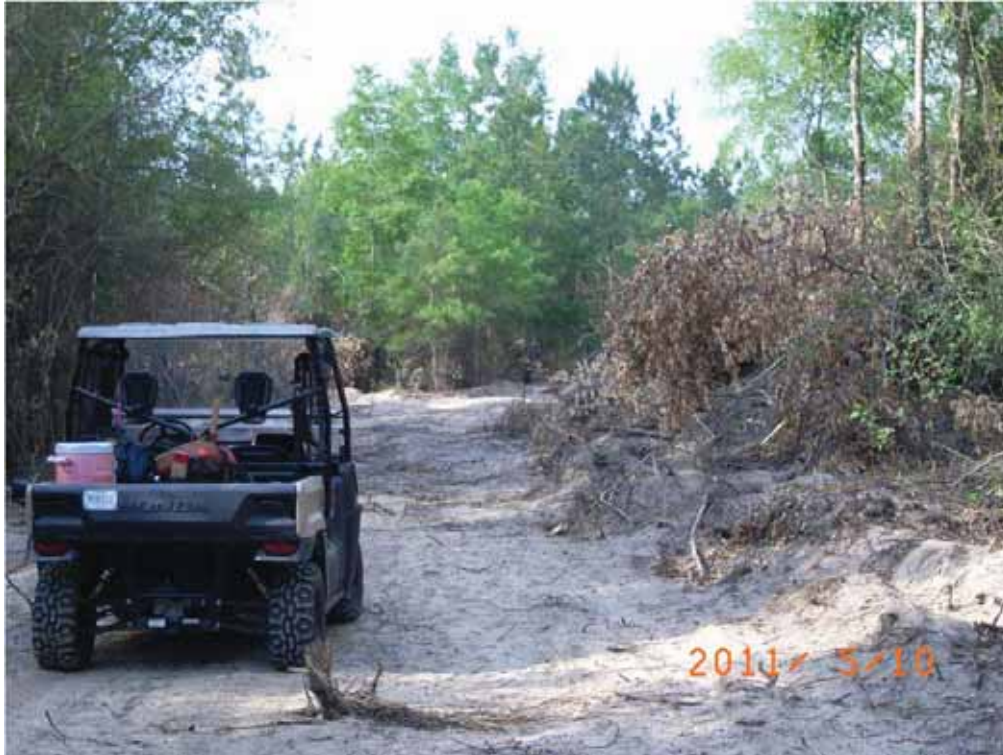
**Photo 3.** Vegetation pushed to the side from dozer line construction.

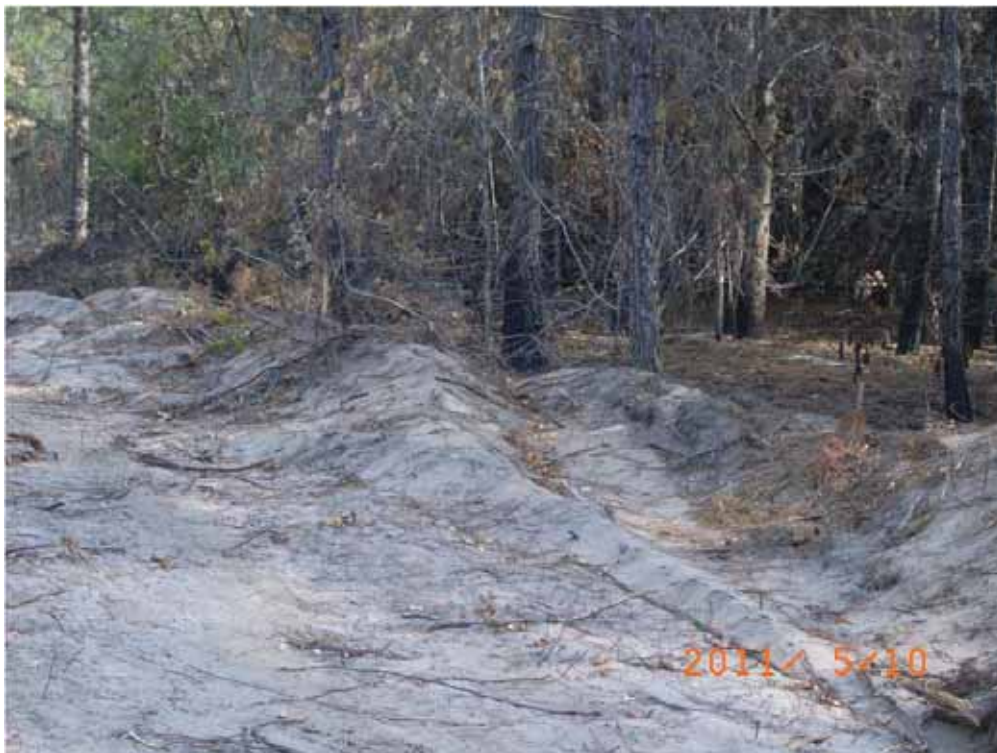
**Photo 4.** Soil disturbance from dozer line construction.
