# **Horseshoe 2 Fire**

## **BURNED AREA EMERGENCY RESPONSE PLAN**

**UNIT:** Chiricahua National Monument

**DATE:** July 2011

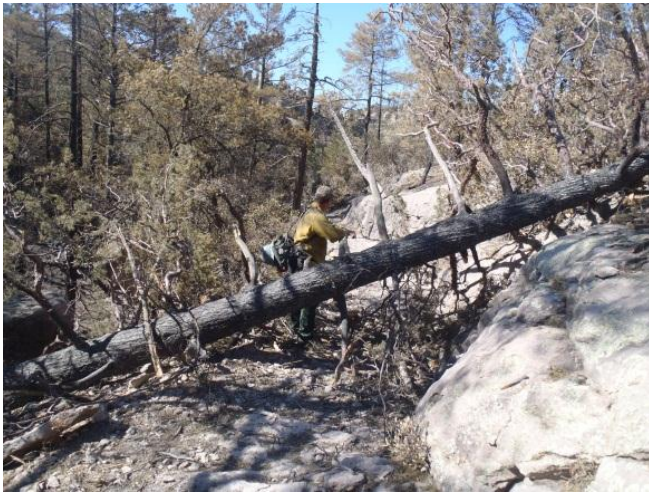
The trails system, a historical resource associated with the Civilian Conservation Corps, was partially burned over in the Horseshoe 2 Fire (See Recommendations). There are 17.5 miles of trails within the park.

Tree in middle of trail

| Number and Describe Each Task: |
|---|
| <p>A. General Description: The trail system, a historic resource associated with CCC, was completely burned over. Hazards must be removed from the trail and the trails repaired to maintain their drainage design in order to prevent unacceptable damage to this historic resource and to prevent damage to downslope resources and public safety. Work that needs to be performed includes: fill stump holes in trail tread (31), repair log outs (98), remove rockslide material (80 linear feet), and repair/install waterbars (1815). In addition, assessments need to be completed for Natural Bridge Trail, Sugarloaf Trail, and Whitetail Trail. Trails will need to be maintained yearly to assess damage due to fire related environmental challenges such as flooding and logouts.</p> <p>B. Location/(Suitable Sites): Total of 17.5 miles of trail need to be treated including: Echo Canyon Trail (1.6 miles), Ed Riggs Trail (0.7 miles), Mushroom Rock Trail (1.2 miles), Inspiration Point Trail (0.5 mile), Big Balanced Rock Trail (1.0 mile), Sarah Deming Trail (1.6 miles), Upper Rhyolite Trail (1.1 miles), Hailstone Trail (0.8 mil), Lower Rhyolite Trail (1.5 miles), Natural Bridge Trail (2.4 miles), Sugarloaf Trail (0.9 miles), Whitetail Trail (4.2 miles)</p> <p>C. Design/Construction Specifications: Complete following repairs using NPS trail maintenance standards and with sensitivity to the historic elements of the trail system: A) Echo Canyon Trail: 14 stump holes, 42 logouts, 151 waterbars; B) Ed Riggs Trail: 4 stump holes, 26 logouts, 173 waterbars; C) Mushroom Rock Trail : 3 stump holes, 12 logouts, 130 waterbars; D) Inspiration Point Trail: 35 waterbars; E) Big Balanced Rock Trail 1 log out, 84 waterbars; F) Sarah Deming Trail: 8 stump holes, 5 logouts, 80 linear feet rock slide, 446 waterbars; G) Upper Rhyolite Trail: 2 stump holes, 12 logouts, 314 waterbars; H) Hailstone Trail: 17 waterbars; I) Lower Rhyolite Trail: 141 waterbars; J) Natural Bridge Trail: complete assessment, 284 waterbars; K) Sugarloaf Trail: complete assessment, 40 waterbars; L) Whitetail Trail: complete assessment. Work will be performed by the SAGU trail crew under the direction of the Chief of Facility Management and BAER Implementation Leader. It is anticipated to take a 6 person crew 6 weeks to complete this work, plus additional time for the work leader and maintenance worker for prep, plus admin support. In out years</p> <p>D. Purpose of Treatment Specifications: Repair/restore the trails for safe visitor use, protect the historic resources, and prevent further damage to the trail and downslope resources/public safety concerns as a result of post-fire watershed events.</p> <p>E. Treatment Effectiveness Monitoring Proposed: Trails will be reassessed after major rain events to determine their safety for public and/or staff use (including BAER), and to determine the effectiveness of prescribed treatments, and to determine if additional treatments are warranted.</p> |

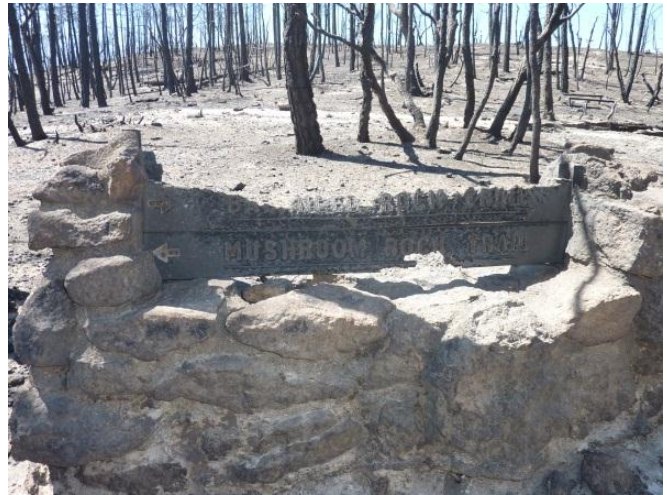
Burned trail sign

- A. General Description: Minor infrastructure in the park was burned by the Horseshoe 2 Fire, including a meteorological station used by the Sonoran Desert I&M program, 6 wayfinding signs on park trails, and 6 picnic benches. These items need to be replaced, and interpretive panels need to be redesigned due to features changed due to fire. The National Weather Service

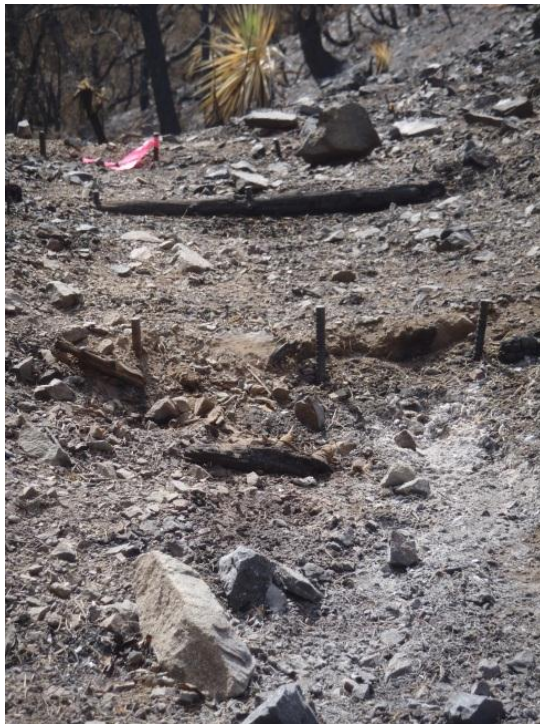
Looking up trail at burned wooden structures

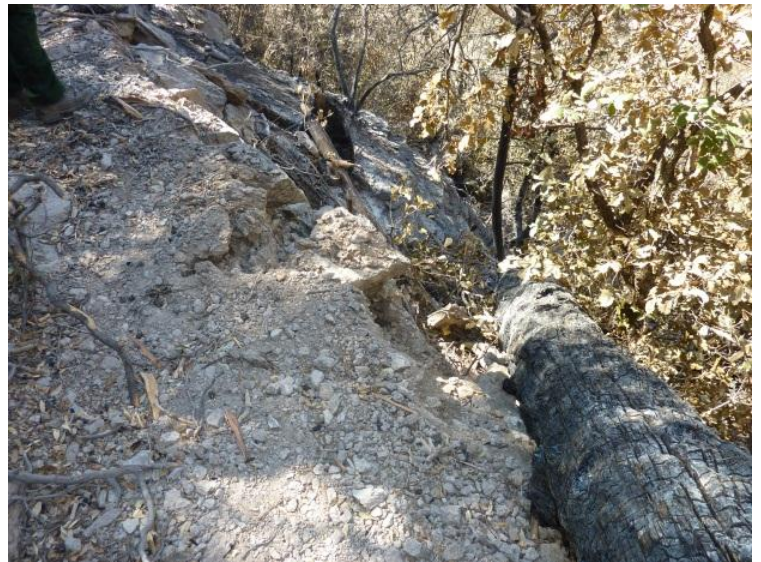
Damaged rock retaining wall on Mushroom Trail

| <b>Number and Describe Each Task:</b> |
|---|
| <p>A. General Description: Approximately 120 linear feet of historic CCC era rock retaining wall along the Mushroom Rock Trail has been severely damaged and is in need of immediate repair to prevent additional damage to the trail system and downslope resources and public safety.</p> <p>B. Location/(Suitable Sites): Mushroom Rock Trail</p> <p>C. Design/Construction Specifications: A NPS mason and trail crew will be used to restore the damaged wall using appropriate techniques and materials. The work will largely be done using hand tools in order to maintain historic integrity and because this area is in designated wilderness. It is estimated to take a 6 person work crew 4 work weeks to complete the job. It is anticipated the SAGU Trail Crew will be detailed to perform this work.</p> <p>D. Purpose of Treatment Specifications: Restore an important element of a historic resource and mitigate further damage to the trail and downslope resources and public safety. This treatment must be completed prior to re-opening the trail system to park visitors.</p> <p>E. Treatment Effectiveness Monitoring Proposed: The treatment will be inspected by a qualified Cultural Resource Specialist and NPS personnel with masonry experience.</p> |

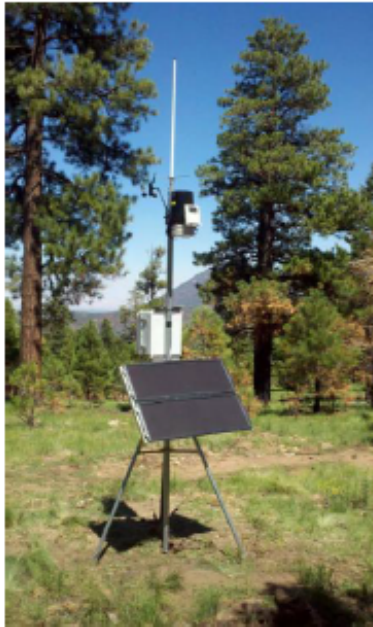
## **How to Build a Portable Self-sufficient Real-time Weather Station Utilizing the Amateur Radio APRS Protocol for Communication**

This sheet describes a portable, battery/solar-powered weather station that can be used in permanent, semi-permanent, or portable installation sites to observe the weather, especially precipitation amounts. As a portable unit, it can be taken to a remote location and set up quickly for short term or short fused weather events, and just as quickly removed after the weather event you are sampling has ended. Or, it is durable enough that it can be set up in a remote location and left there for a longer period of time, perhaps a few weeks to a few months. In addition, since it is battery and solar powered, it can be set up at remote locations where commercial A/C power is not available. Some examples where this can or has been used successfully in portable situations include forest fires, post forest fire burn areas (for heavy rain monitoring and flash flood risk assessment), special event locations where temporary weather monitoring is required, and long term locations where weather monitoring has not been previously possible. Once the parts are acquired and initial construction has been completed, subsequent setup and installation (and disassembly and removal) time take about one hour.

The weather data from this station is digitally communicated in real-time via amateur radio automatic packet reporting system (APRS). A licensed amateur radio operator is required to be involved in this system to serve as the control operator per FCC requirement. The following web sites will provide more information about amateur radio, how to obtain an amateur radio license (required for this type of weather station), and APRS background information:

- B. Location/(Suitable Sites): multiple sites, see description below.
- C. Design/Construction Specifications: An important meteorological station in the Sugarloaf Mountain area was destroyed by the fire. This unit is managed by the Sonoran Desert I&M program (SODN) and also provides real time weather data accessible to the Visitor Center. It needs to be replaced and the telemetry needs to be upgraded to provide more reliable real-time data transmission in order to better inform the park's post-fire flood evacuation effort. Six picnic table benches in Bonita Creek Picnic Area were damaged by fire and will be replaced in kind. Six trail signs need to be replaced. The National Weather Service will temporarily place a portable Self-sufficient real-time weather station utilizing the amateur radio APRS protocol for communication.
