# Rainbow Bridge Post-Fire Response Plan

Lake Chelan National Recreation Area

**DATE:** September 18, 2010

**PREPARED BY:** National Park Service Rainbow Bridge BAER Team

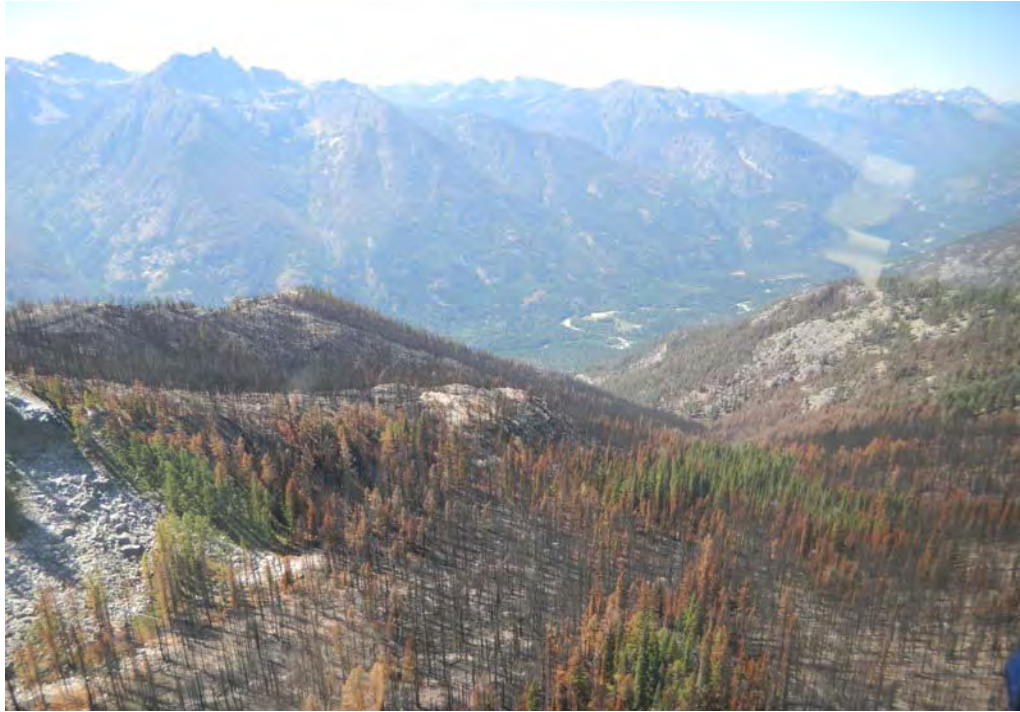
In the Little Boulder Creek watershed, 894 acres or about 88% of the watershed burned (**Table 3**). About 42% of this area was mapped as moderate to high soil burn severity. **Photo 1** depicts an extensive area of high soil burn severity ringed by areas of low and moderate severity in the upper portion of this watershed.

**Photo 1.** Soil burn severity mosaic in upper Little Boulder Creek watershed with extensive areas of soil burn severity also indicated on the BARC map. High severity is indicated by the lack of needles on the trees and a white ash layer. Moderate severity is indicated by the presence of brown or scorched needles still on the trees.

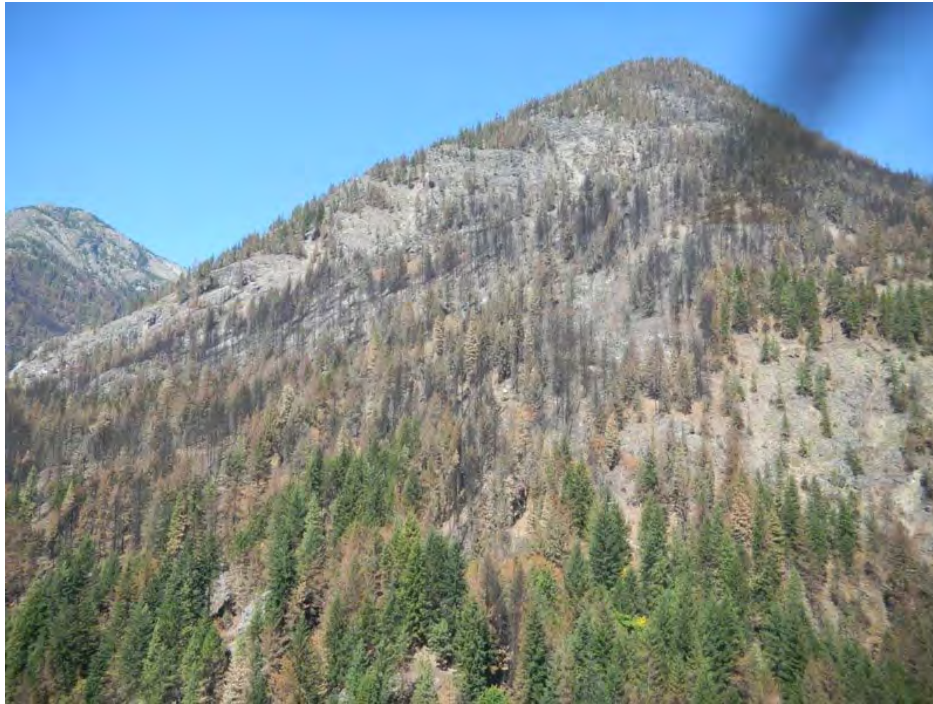
In the Stehekin 2 watershed 295 acres burned, 35 percent of which received moderate to high burn severity with 3 percent mapped as high soil burn severity. **Photo 2** depicts the mosaic of soil burn severity evident in this inter-watershed.

**Photo 2.** Mosaic of soil burn severity in upper Stehekin 2 inter-watershed. High severity is indicated by the lack of needles on the trees and a white ash layer. Moderate severity is indicated by the presence of brown or scorched needles still on the trees.

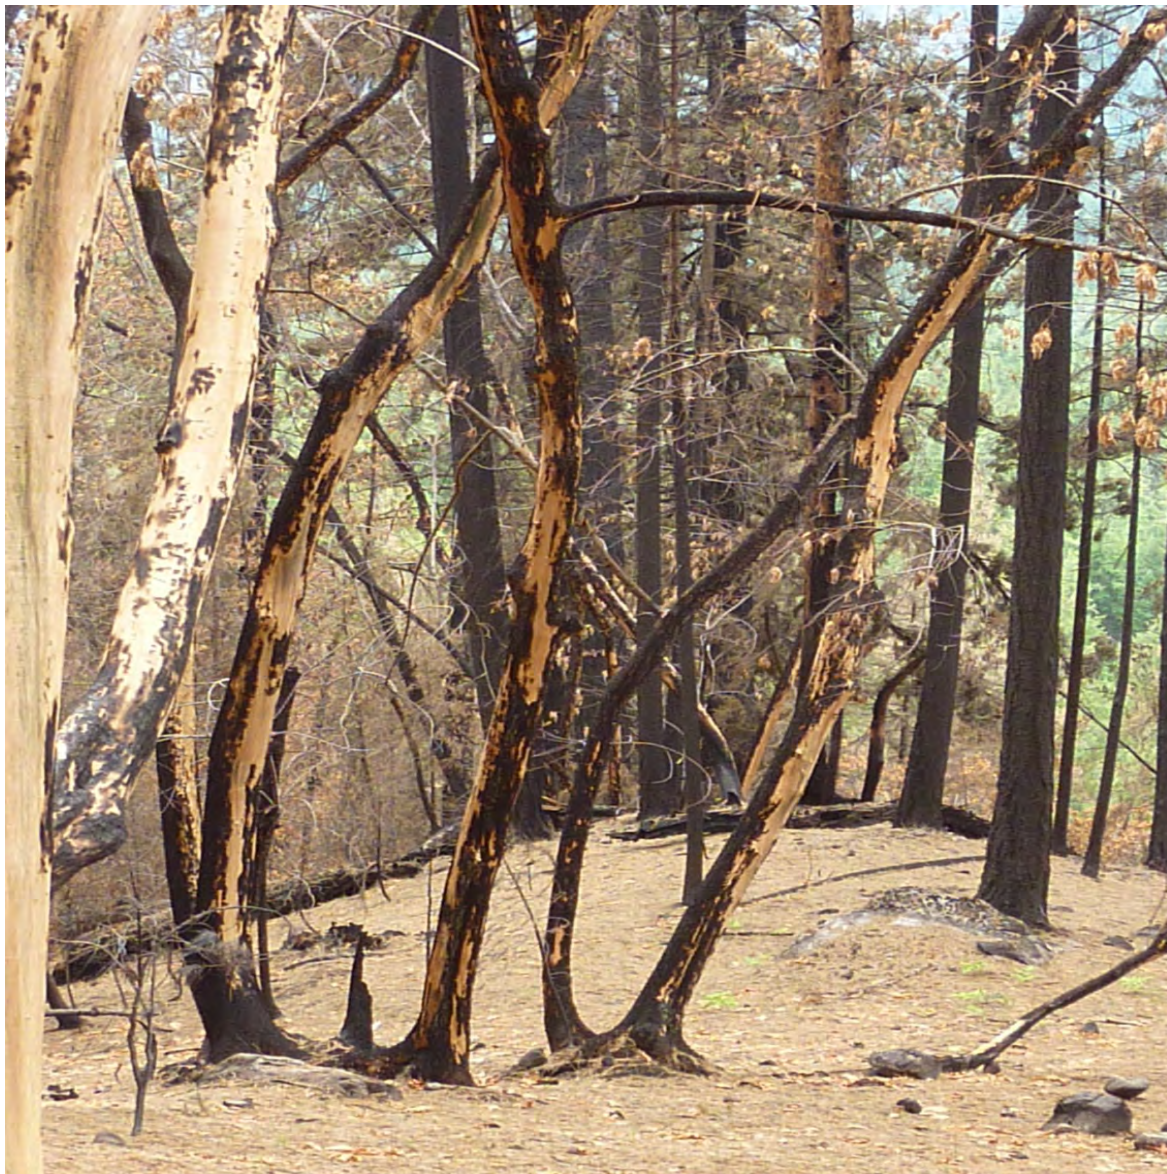
**Photo 4.** Areas of needle cast will provide a seed bed for increased germination of cheatgrass

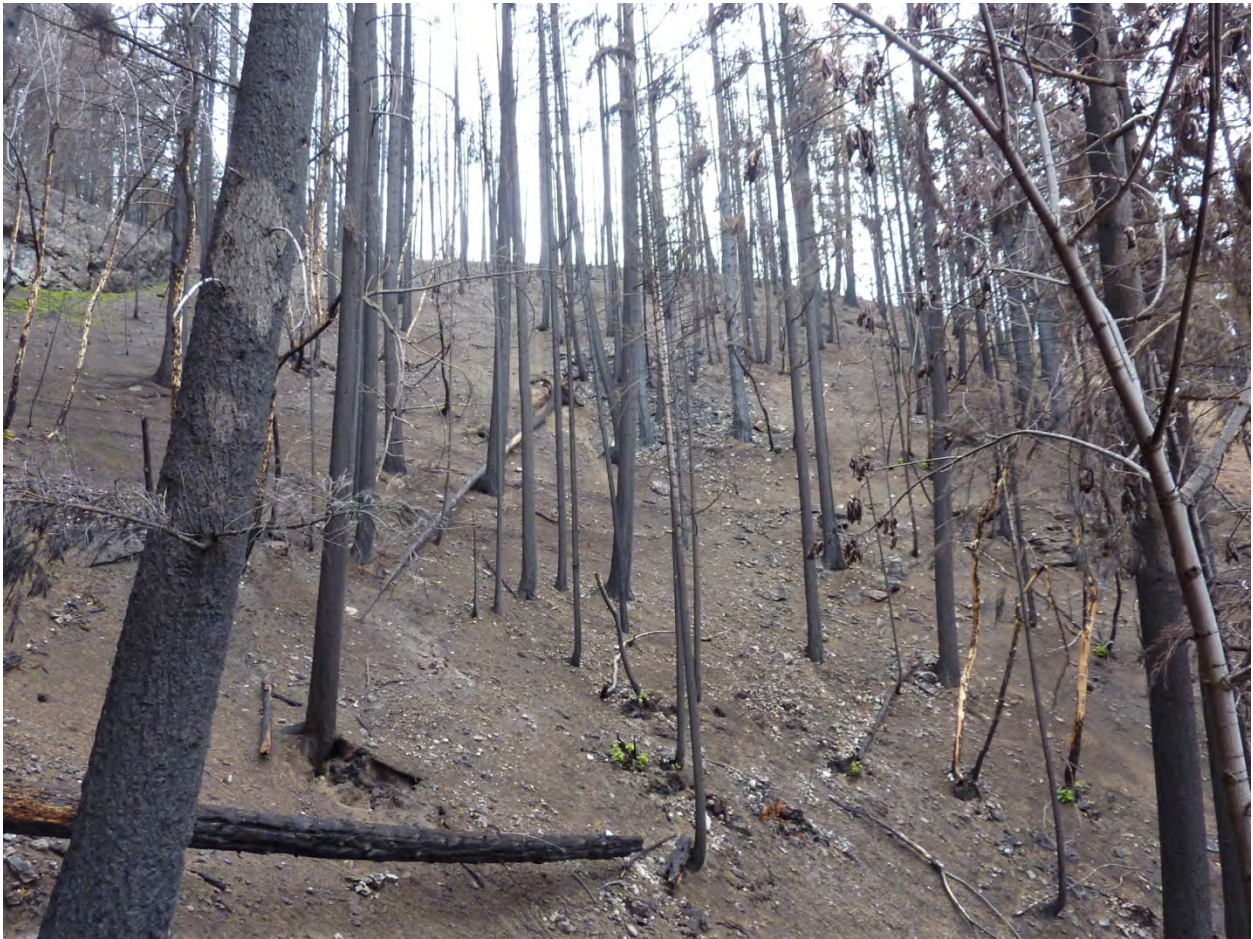
**Photo 5.** Lack of canopy as a result of high fire severity will provide a competitive advantage for cheatgrass populations to establish

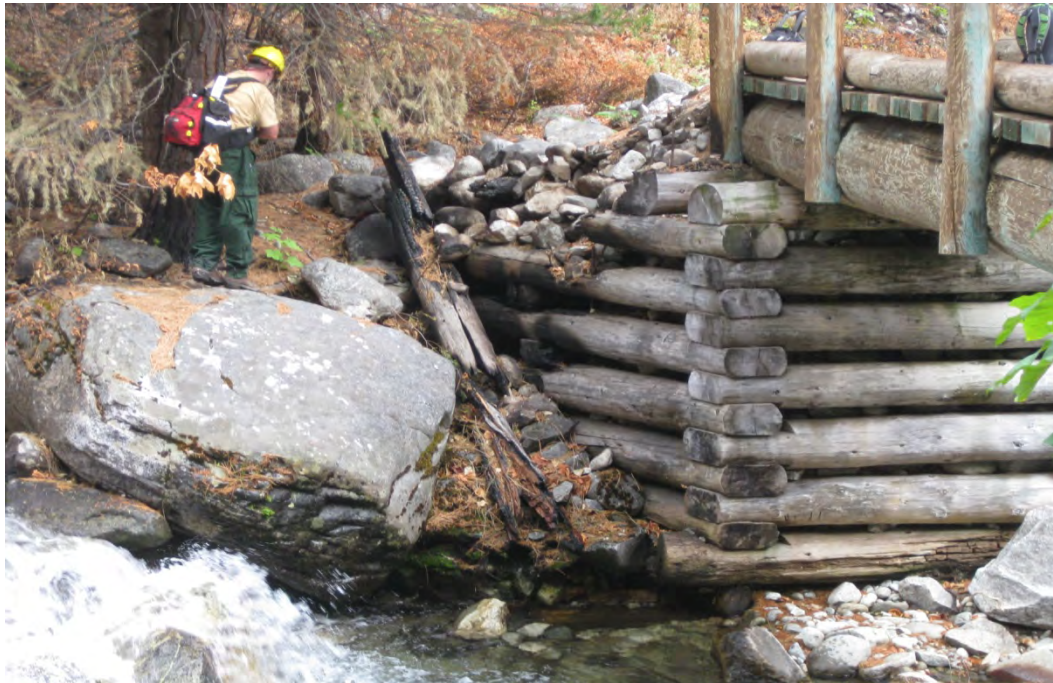
Minor Facilities: Minor facilities included within the burn area include several trails (Rainbow Loop trail; Rainbow Creek trail; Boulder Creek trail), campgrounds (Rainbow Bridge camp and Hooter camp), the Rainbow Bridge that spans Rainbow Creek, and signs along the trails. Field reconnaissance by trail crew employees and the BAER Team documented damage to several of these facilities, and funding is requested through the Burned Area Rehabilitation program to replace trails, signs, campsite facilities, and a bridge crib wall that burned (*Specification R-3*).

**Photo 6.** Crib wall of Rainbow Creek bridge.

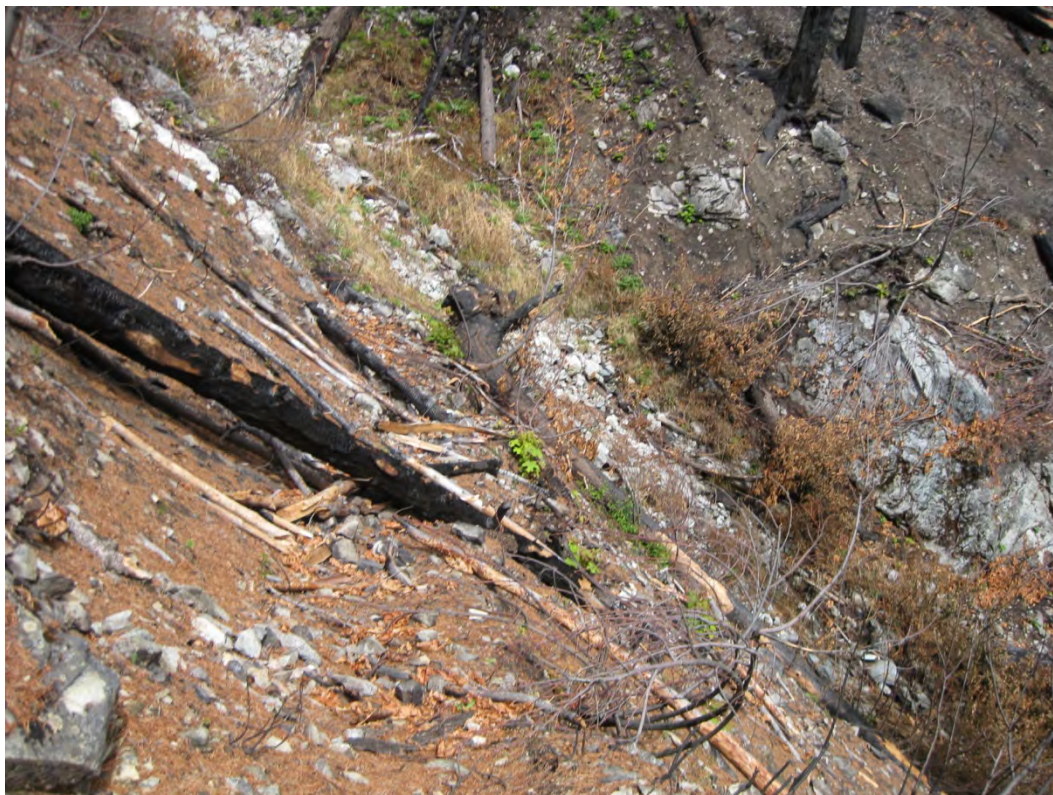
The Boulder Creek trail has roughly 4000' of trail tread damage due to root/organic material burnout or rock fall/debris fall onto the trail (**Photo 7**). Roughly one month after the fire, there are some sections with vegetation already growing directly on the trail tread. The Hooter camp was burned over completely; at least 15 hazard trees now surround the camp (**Photo 8**). The camp sign was burned in the fire.

**Photo 7.** Boulder Creek trail with windfall, rockfall, and tread damage

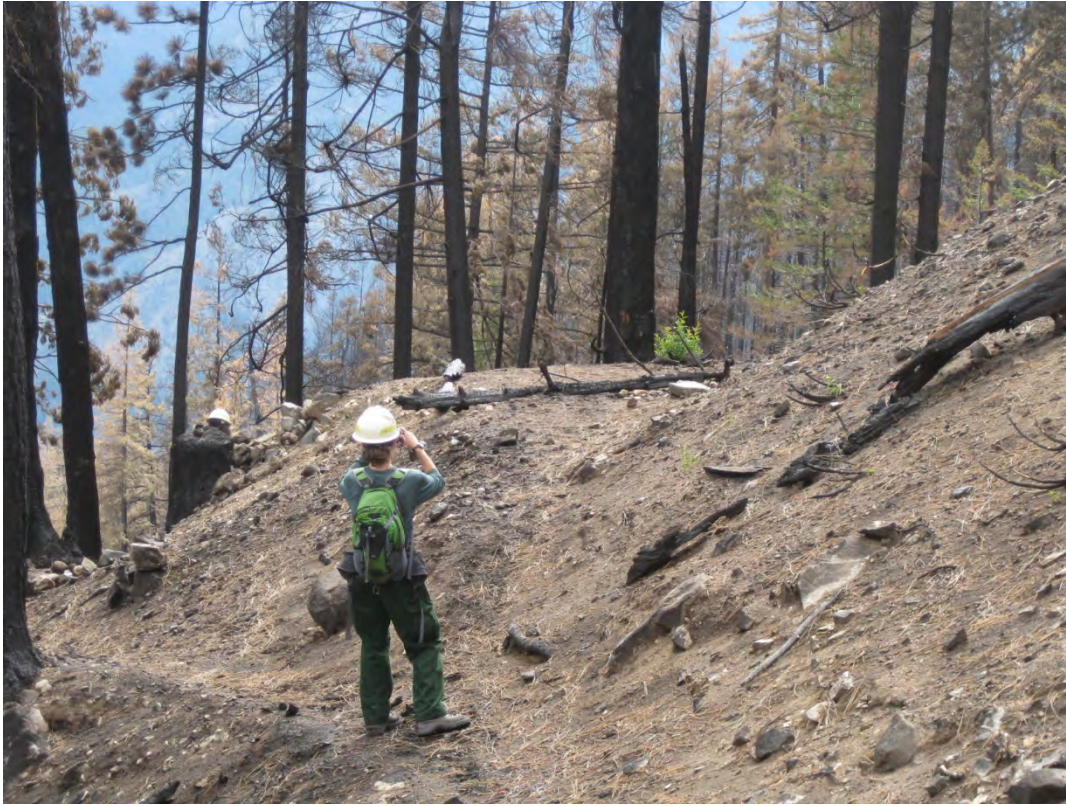
**Photo 8.** Hooter Camp, with all trees surrounding it burned.

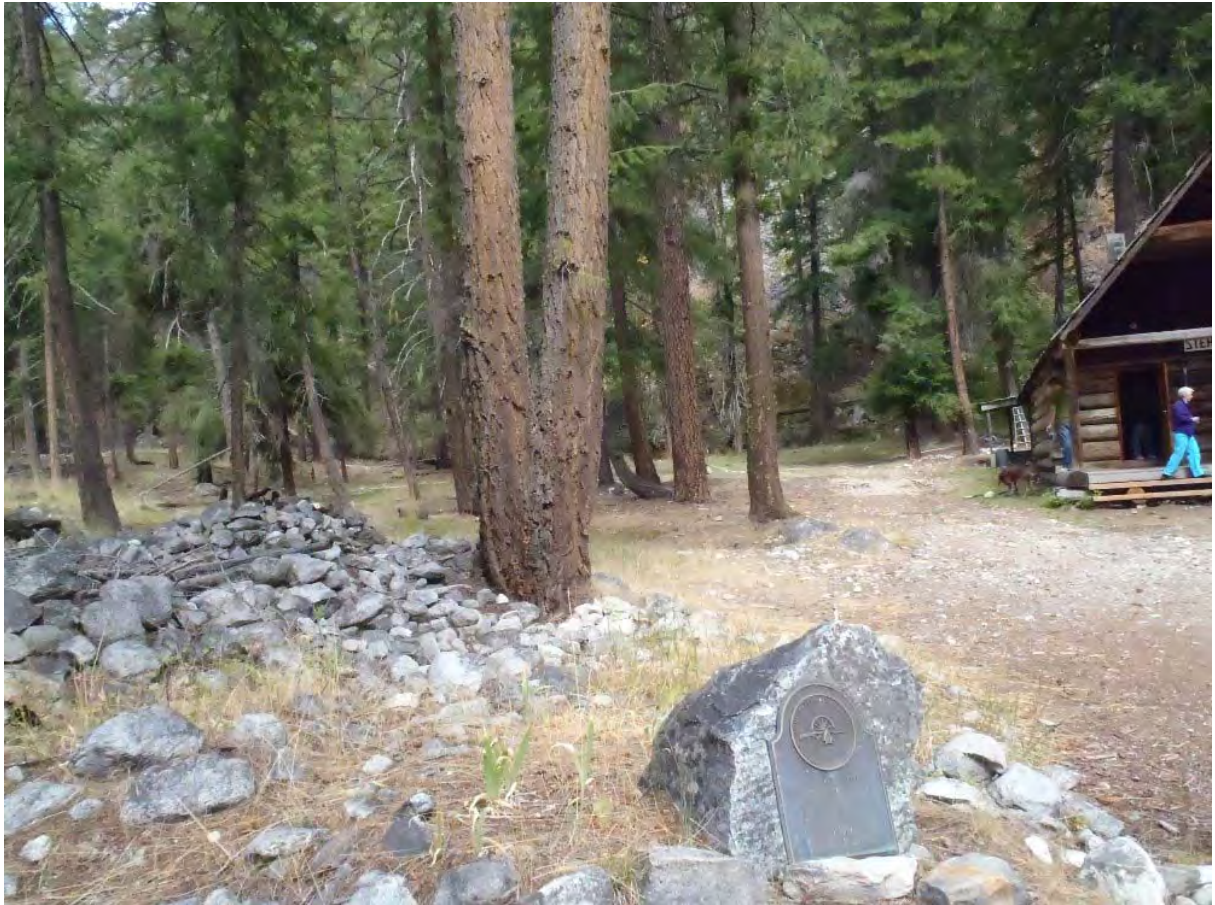
**Photo 9.** National Register plaque in the foreground, Stehekin School in the background.

The Stehekin School was built in 1921 by valley residents and in May, 1974, it was listed on the National Register of Historic Places by the National Park Service (**Photo 9**). Use of this one-room log structure as a school ceased in 1988 following the dedication of a new school located a short distance down valley. Today the school serves as a self-guided museum, allowing park visitors to view furnishings, photographs, and displays that tell the stories of Stehekin school life, and evoking the feel of community-based education that developed in Stehekin valley in the 19<sup>th</sup> Century.

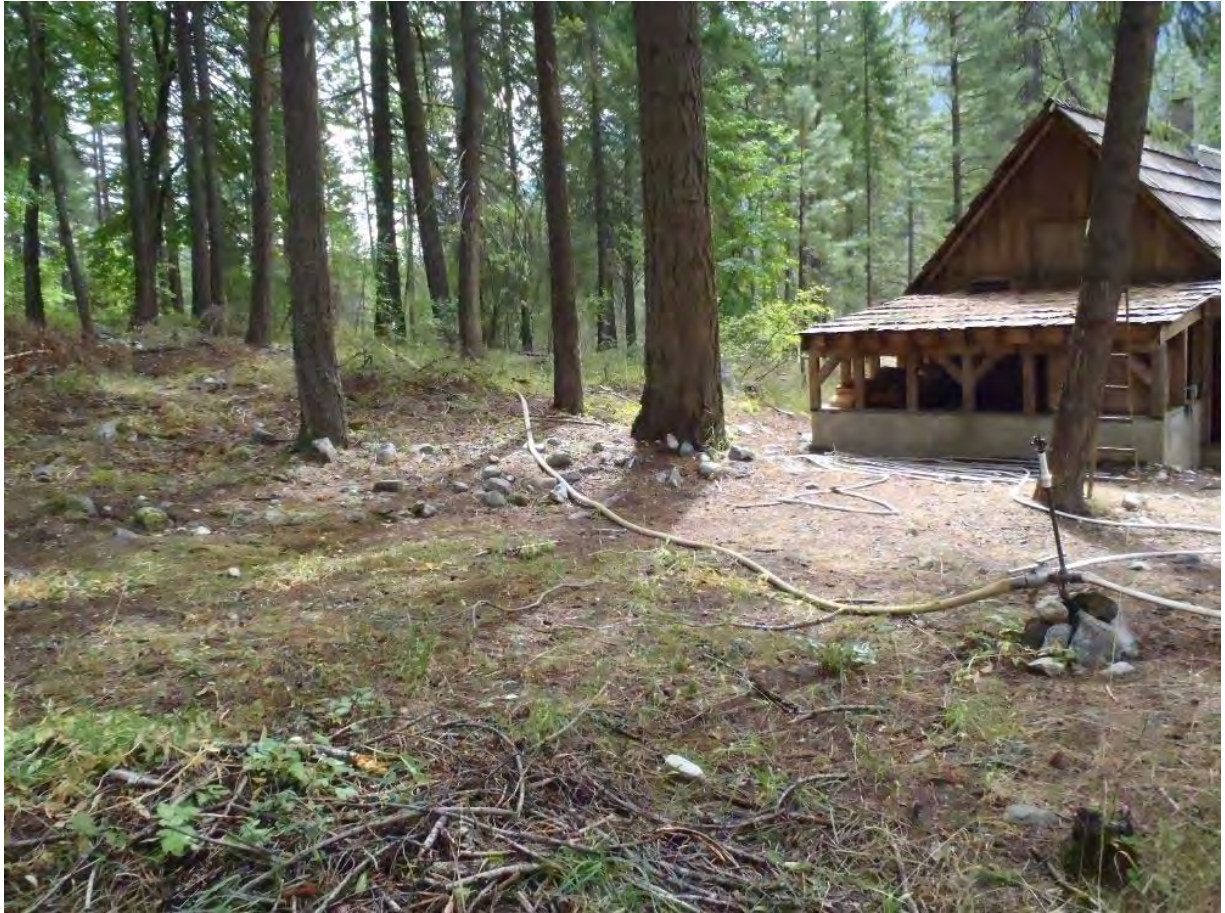
**Photo 10.** The back of the Stehekin School, showing the sprinkler hose layed during the Rainbow Bridge Fire.

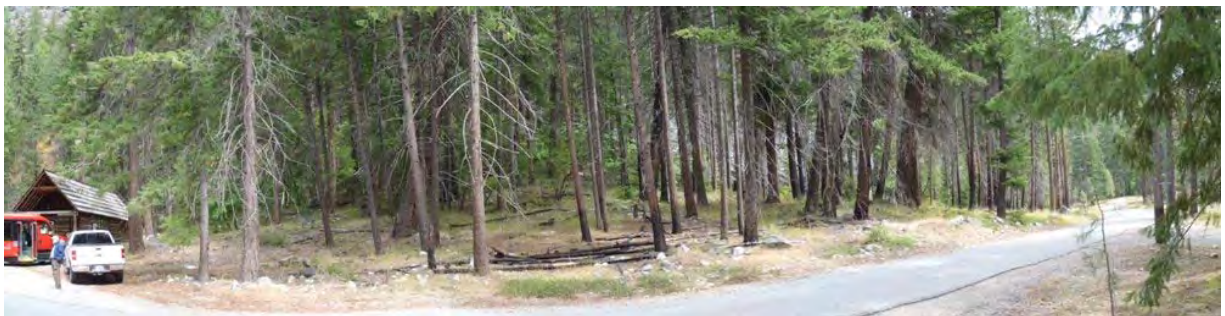
**Photo 11.** Showing the front of the Stehekin School, the Stehekin Valley road, and the toe of the debris cone in the center of the photo.
